# Inspection Photos

Operator: NOBLE ENERGY INC - 100322

Location ID: 326752

Inspection Doc. Number: 675103784

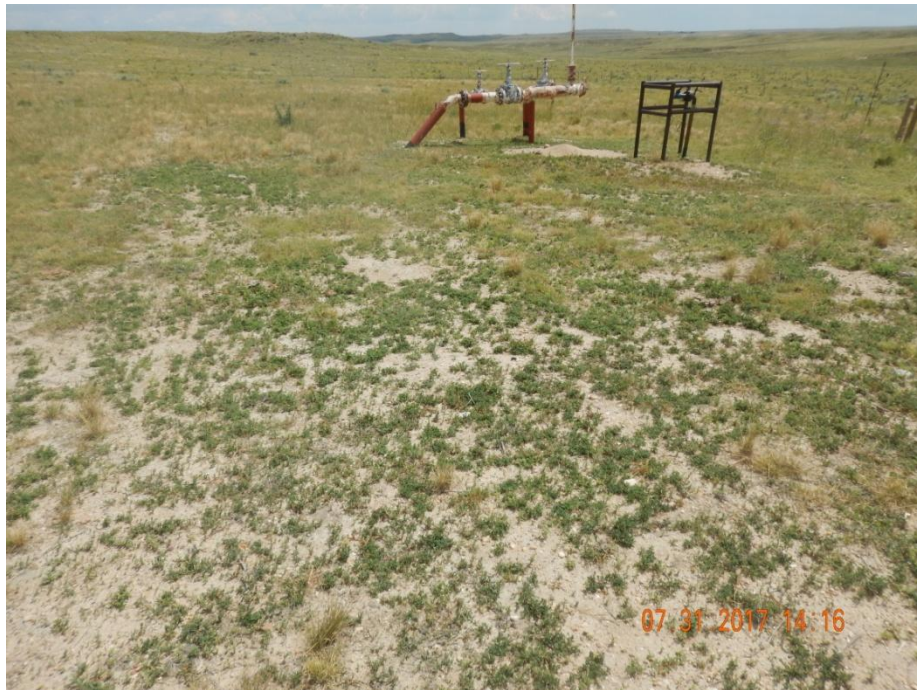
**Photo 1:** Photo taken from the location, facing south. Photo shows large areas of the location where vegetation is not progressing towards reclamation requirements. Vegetation seen is predominantly undesirable weedy plant species such as Kochia and Russian thistle. Photo also shows pipe equipment remaining on location.

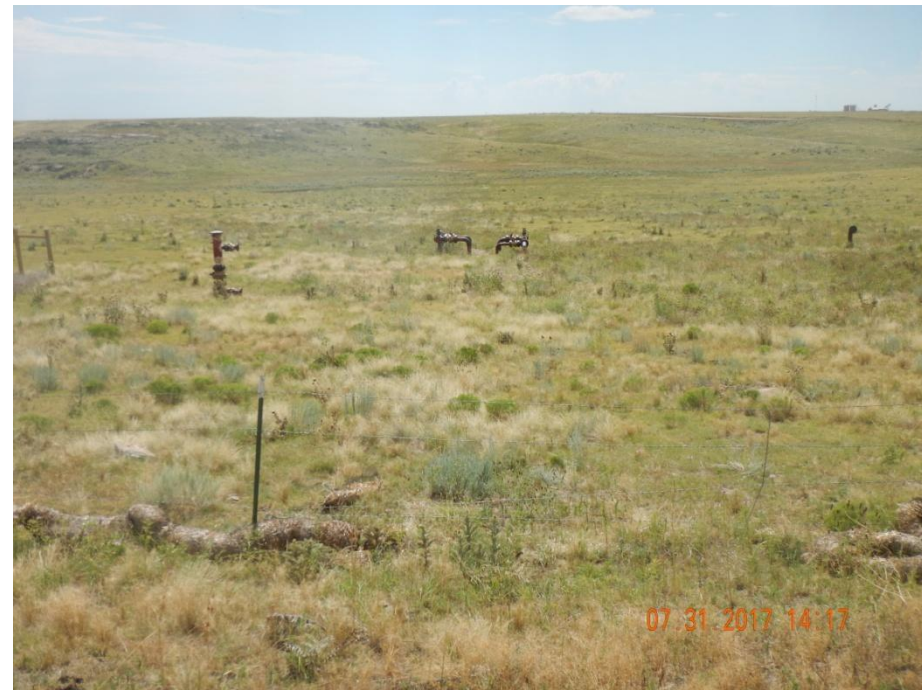
**Photo 2:** Photo taken from the location, facing west. Photo shows pipe equipment remaining on the location.

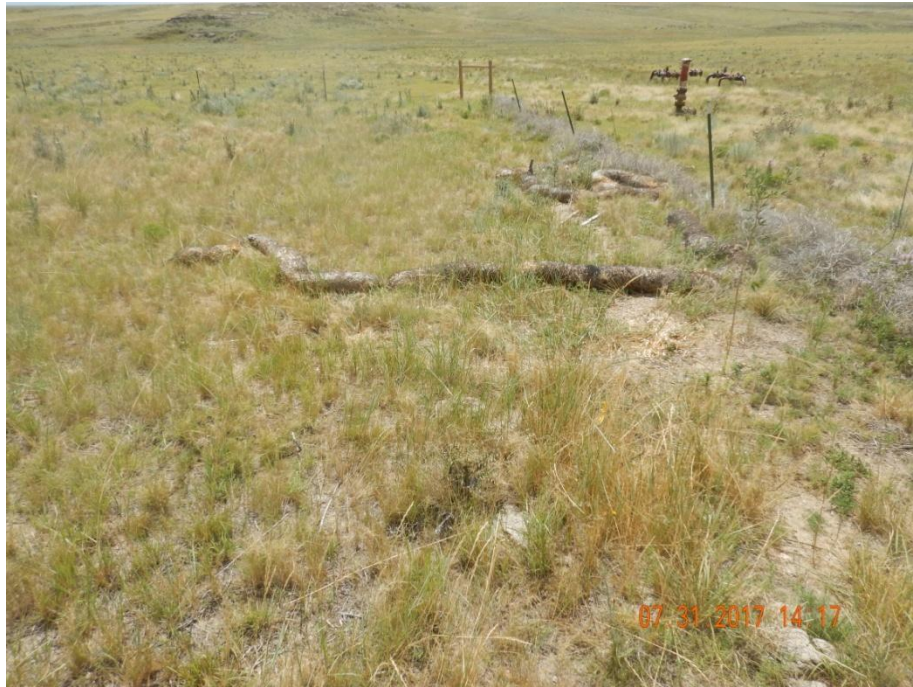
**Photo 3:** Photo taken from the location. Photo straw wattles on location. Wattles were likely used as a stormwater BMP, however wattles have not been maintained and are now debris.

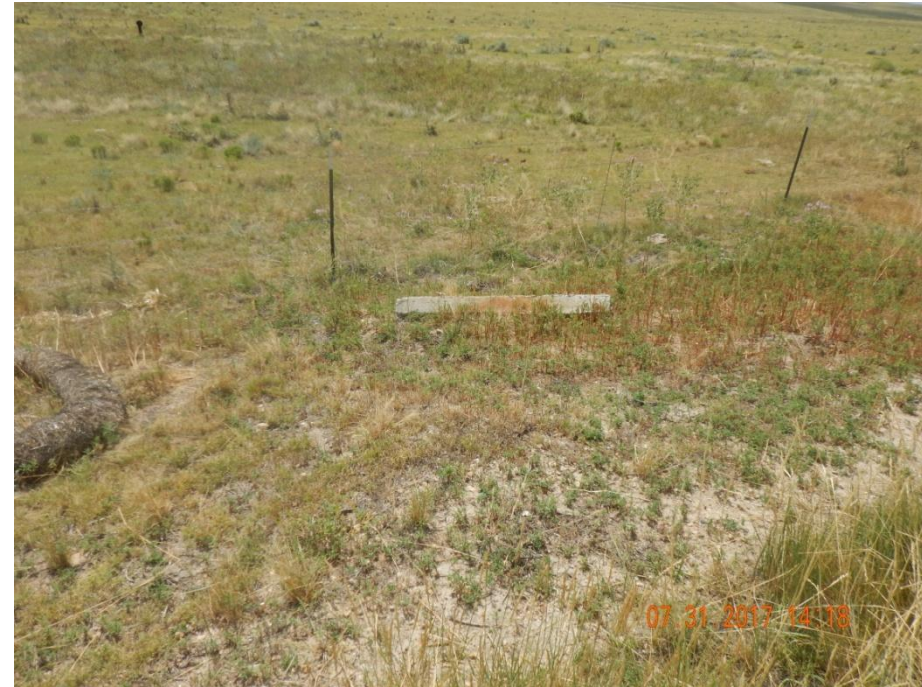
**Photo 4:** Photo taken from the west end of the location. Photo shows concrete debris remaining on the location.

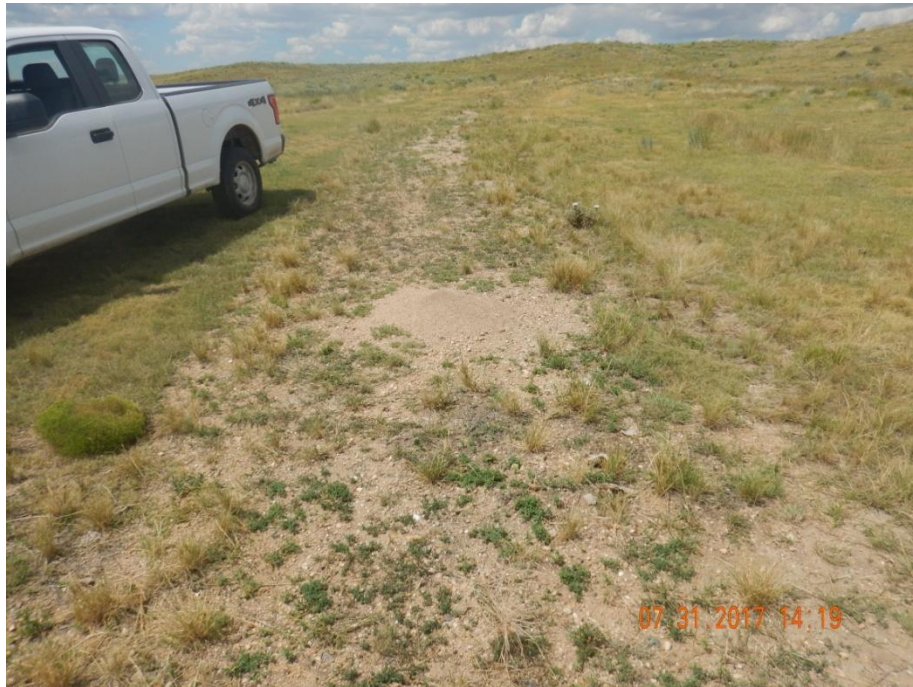
**Photo 5:** Photo taken from the access road on the north end of the location, facing north. Photo shows gravel remains on access road, and access road has not been re-contoured or re-graded.

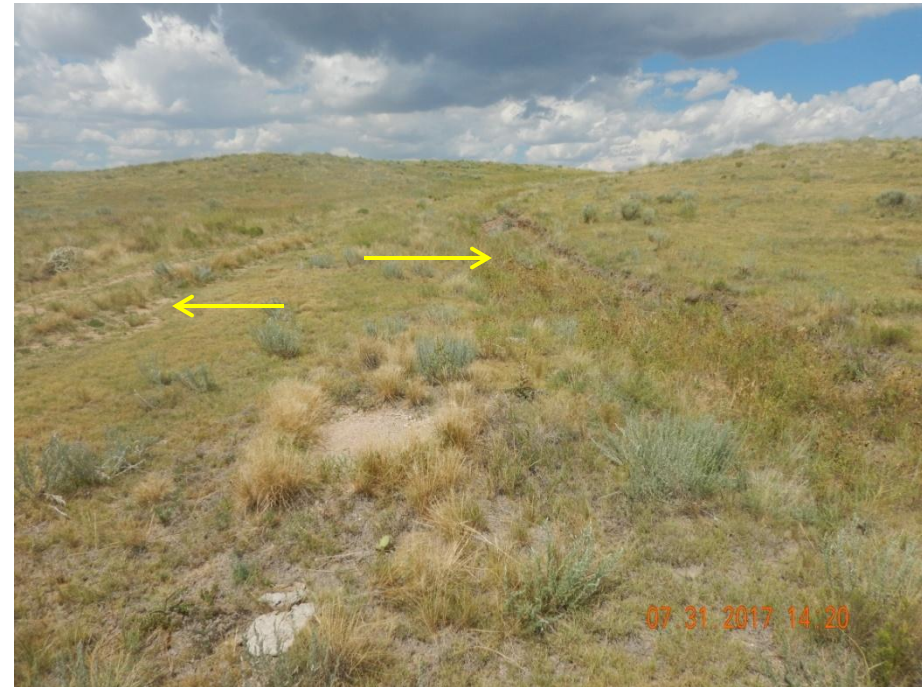
**Photo 6:** Photo taken from the access road on the north end of the location, facing north. Photo access road has not been re-contoured or re-graded. Arrow to the left shows road, arrow on right shows a ditch parallel to where the road travels uphill.

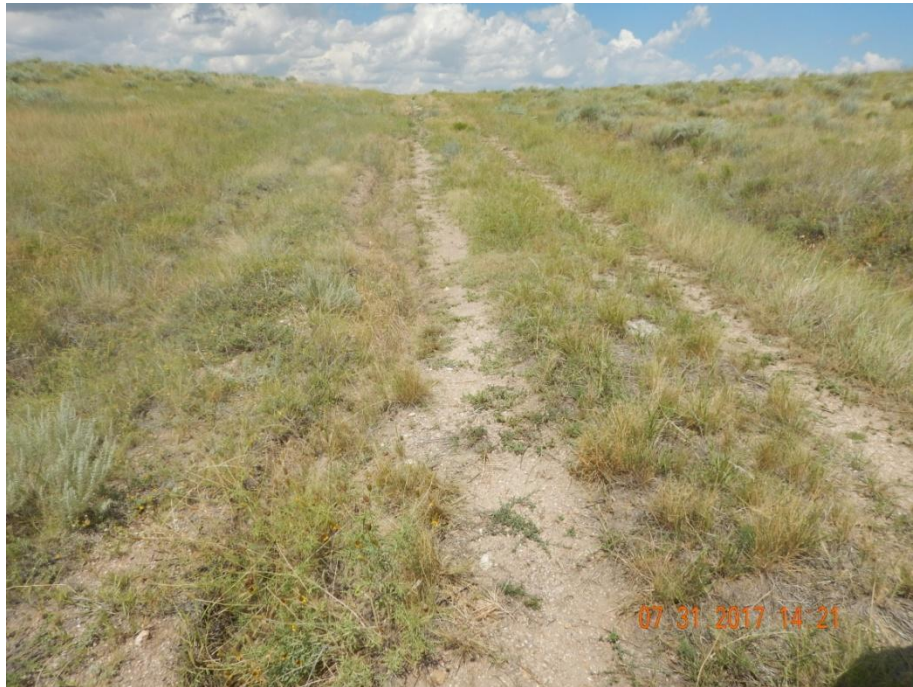
**Photo 7:** Photo taken from the access road on the north end of the location, facing north. Photo shows access road has not been re-contoured or re-graded.

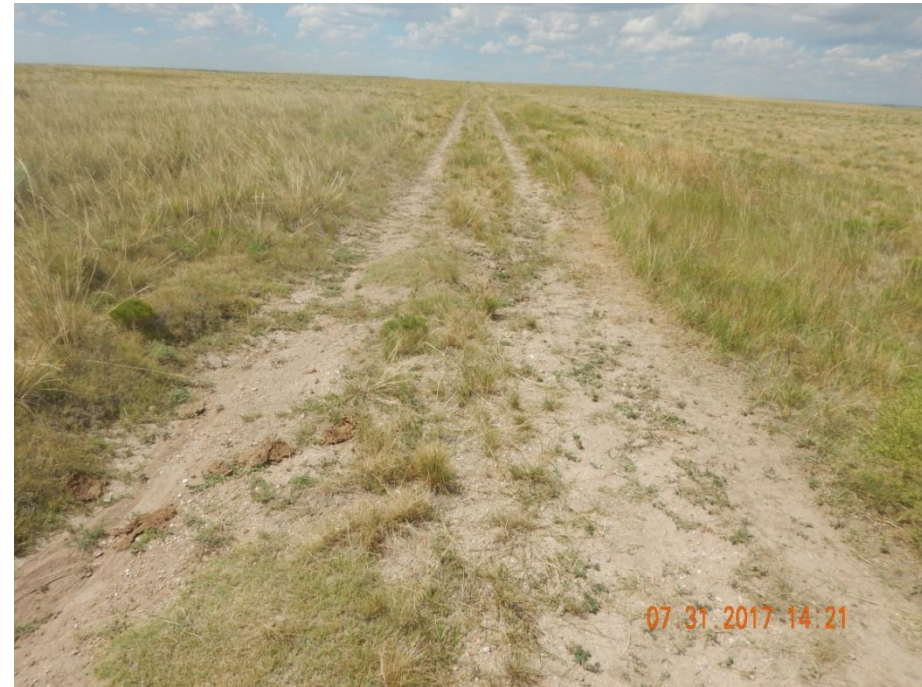
**Photo 8:** Photo taken from the access road on the north end of the location, facing north. Photo shows access road has not been re-contoured or re-graded.

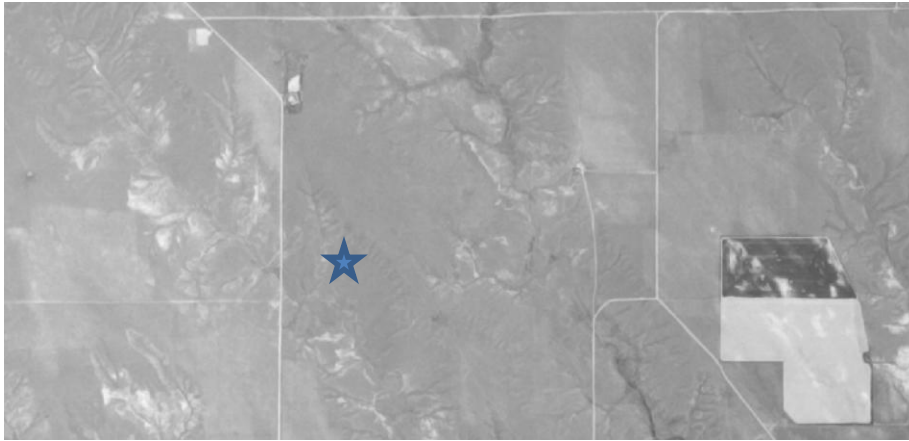
**Photo 8:** May 1985 aerial imagery. Star indicates location of the well. Well was spud 9/21/1987. Photo shows location and access road pre O&G disturbance. Photo shows access road had not been pre-existing.

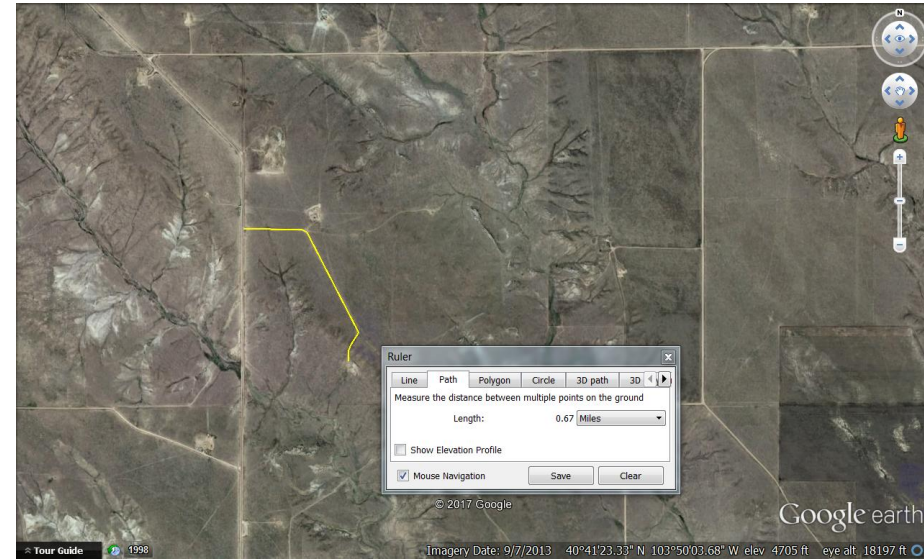
**Photo 9:** Most current available aerial imagery (2013). Photo shows ~0.6 miles of access road that requires reclamation.
