Inspection Photos
Location Name: Hi-Land 10B
API: 05-001-08767

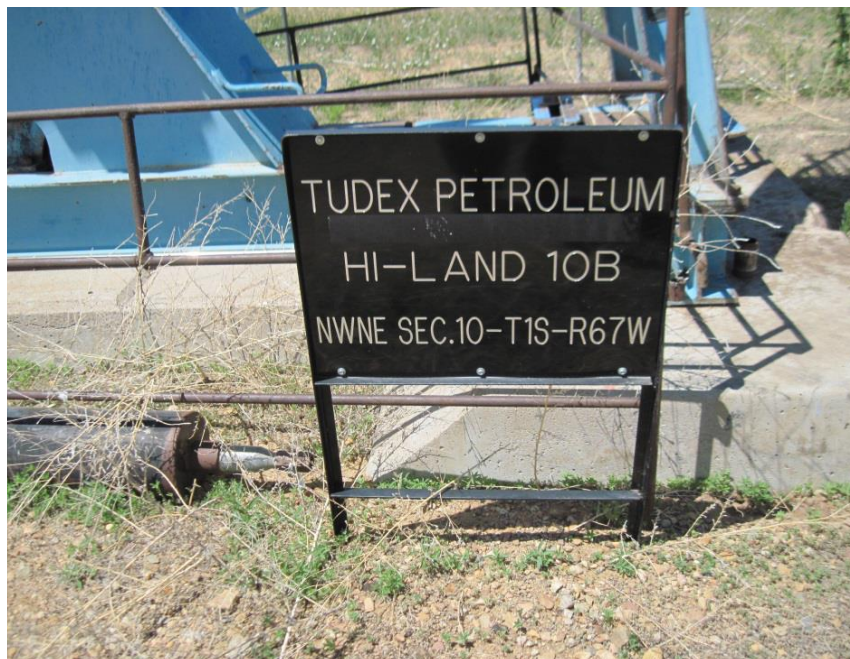
Wellhead signage from 6/20/2017 inspection, no emergency contact info.

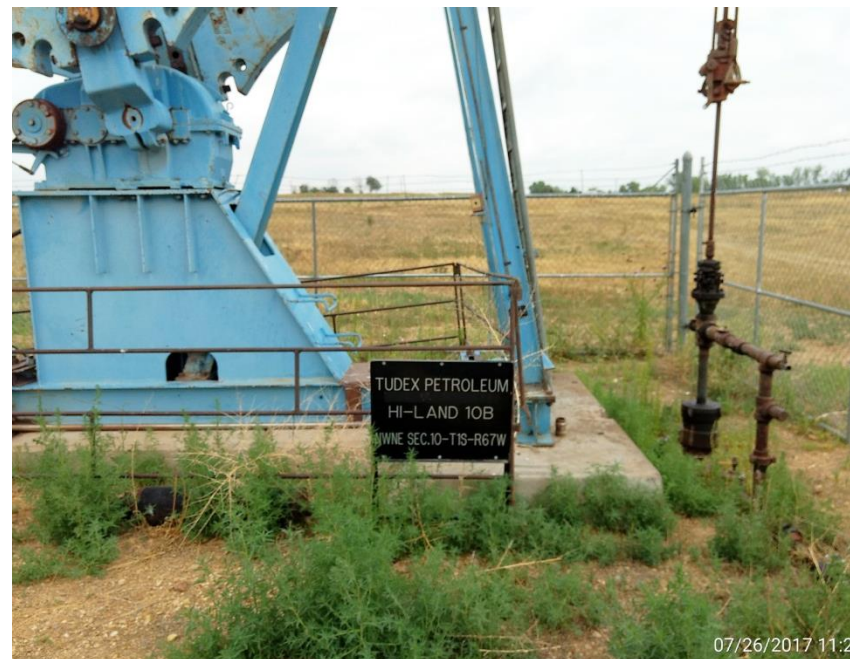
Wellhead signage, **Corrective action: emergency contact info not updated.**

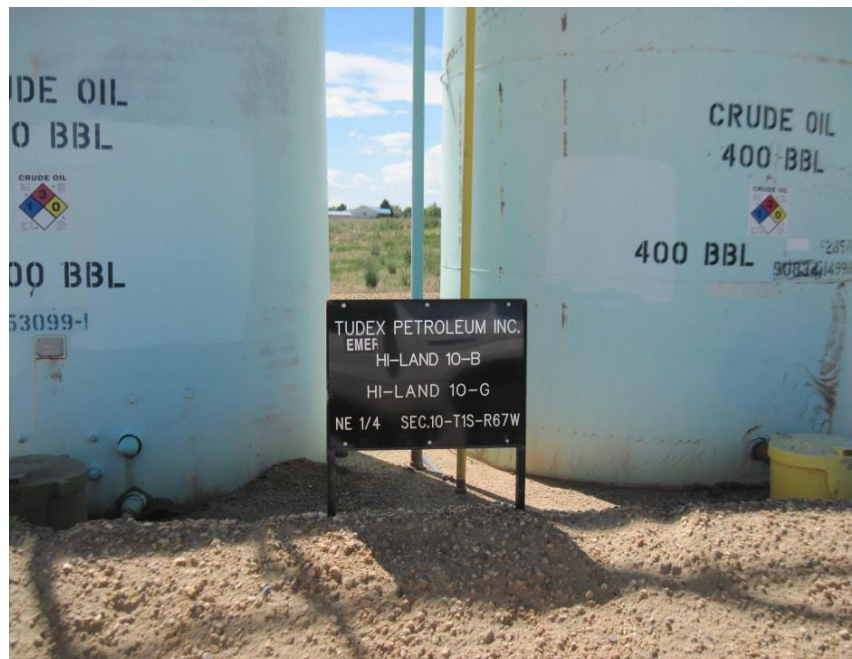
Tank battery signage from 6/20/2017. No emergency contact info.

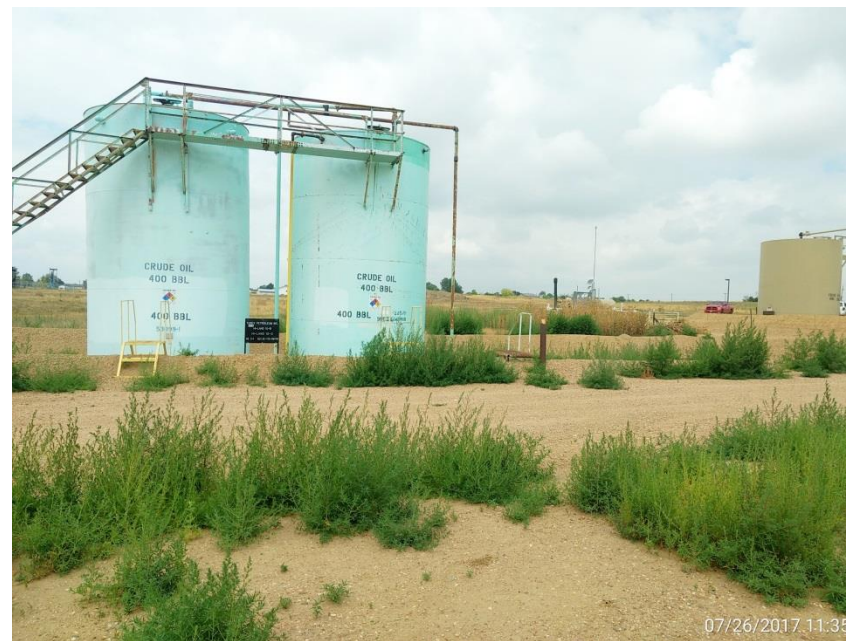
Tank battery, **Corrective action: No emergency contact info updated, weeds, tank paint.**

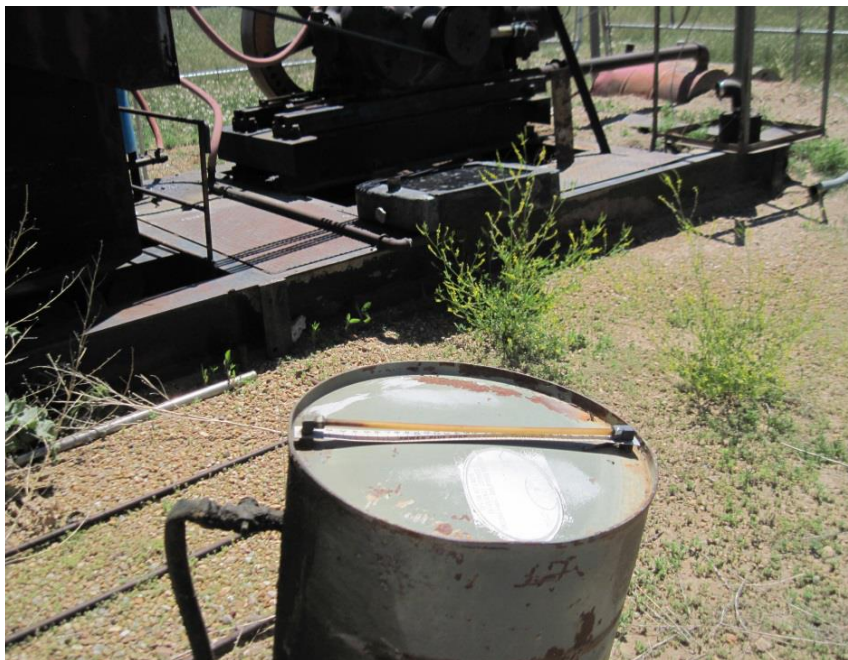
Tank battery signage from 6/20/2017. **No emergency contact info.**

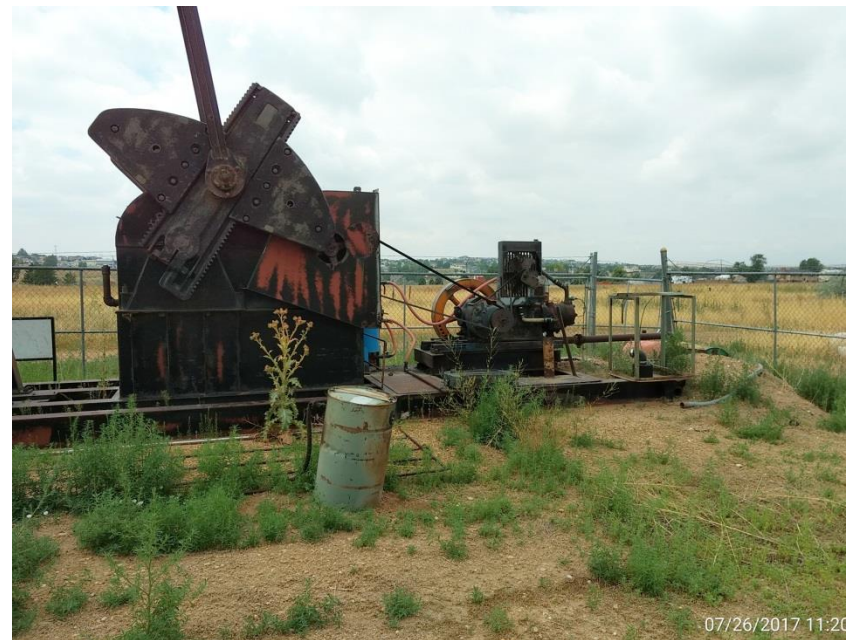
Tank battery, **Corrective action: No emergency contact info updated, weeds, tank paint.**

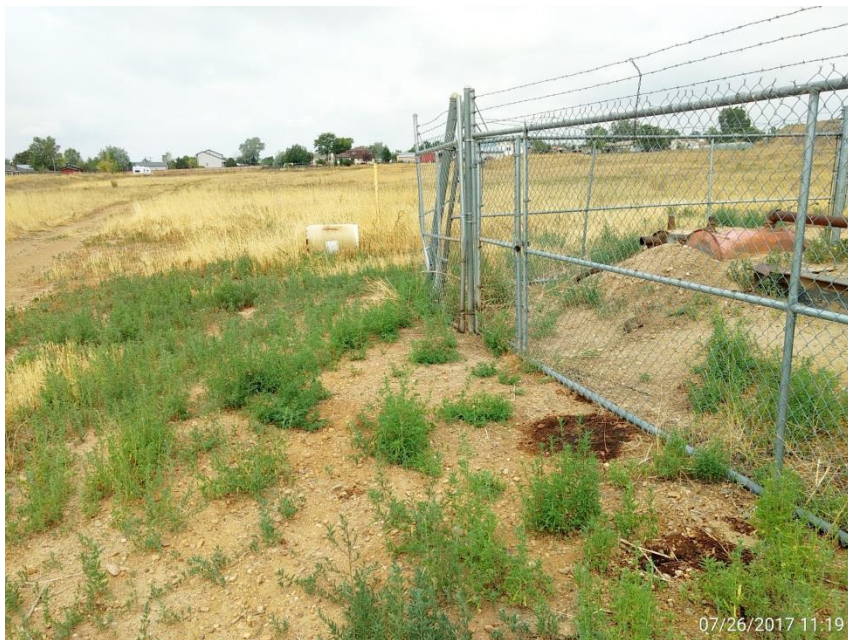
Outside of wellhead, Corrective action: Stained soil, weeds, and trash

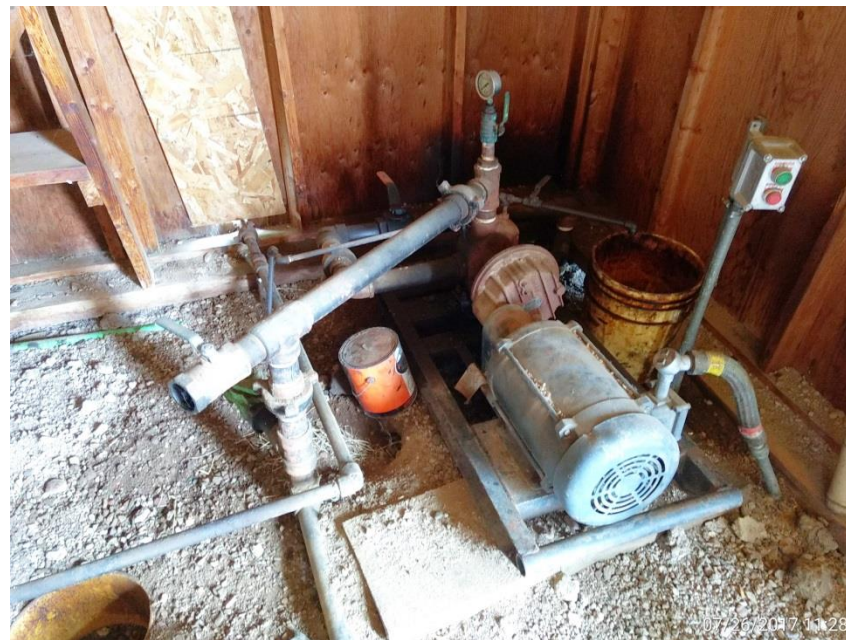
Inside of separator housing, Corrective action: trash and stained soil around electric pump

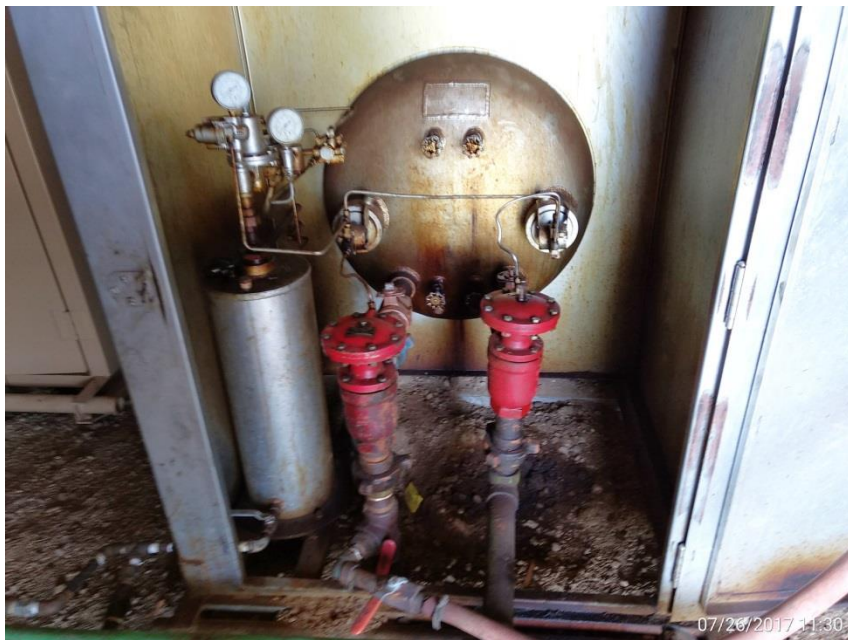
Inside of separator housing, Corrective Action: Stained soil inside of separator cabinet

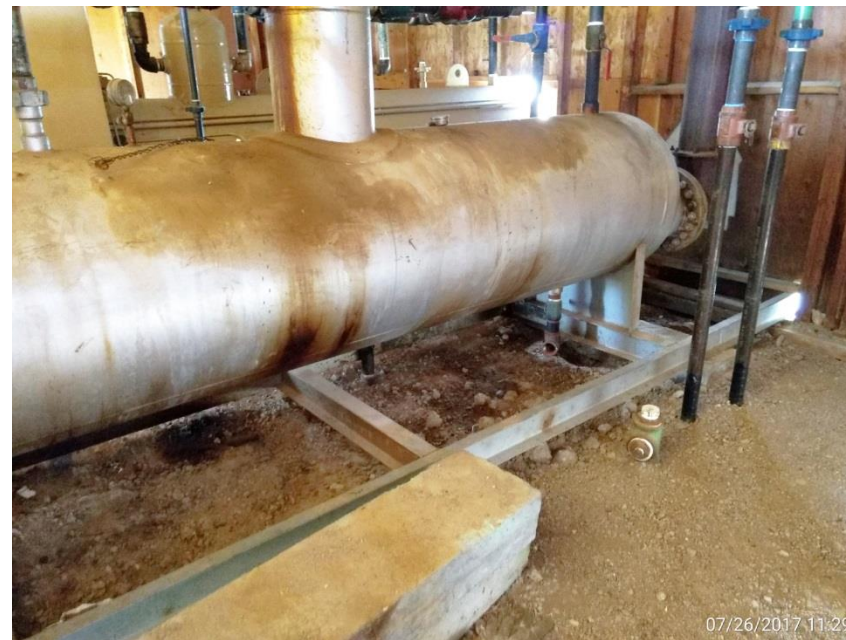
Inside of separator housing, Corrective action: Stained soil at separator. Note Unidentified riser.

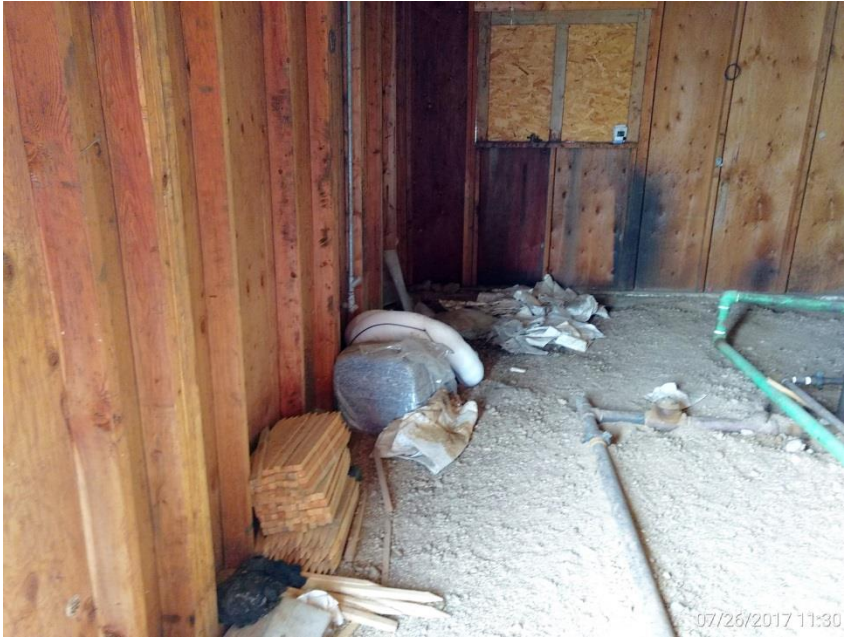
Inside of separator housing, **Corrective Action: Trash and unused equipment storage.**

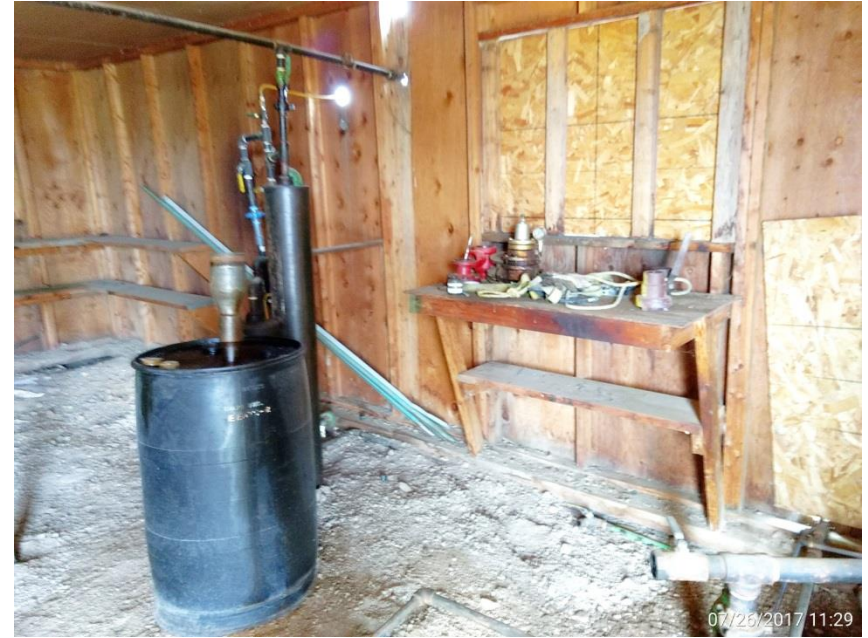
Inside of separator housing, **Corrective Action: Trash and unused equipment storage.**

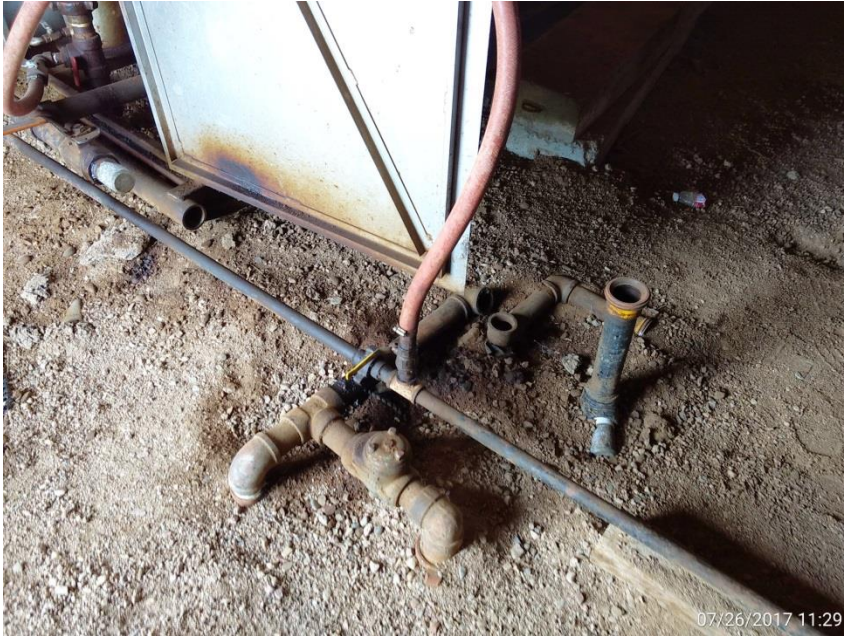
Inside of separator housing, Corrective Action: stained soil,
Note: Unidentified risers.

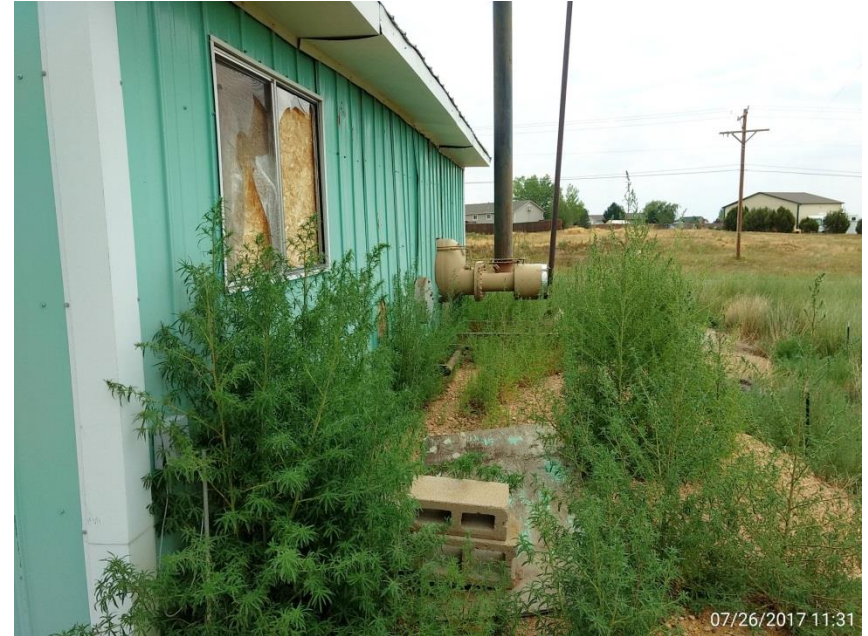
West of separator housing, Corrective Action: Trash and
weeds.

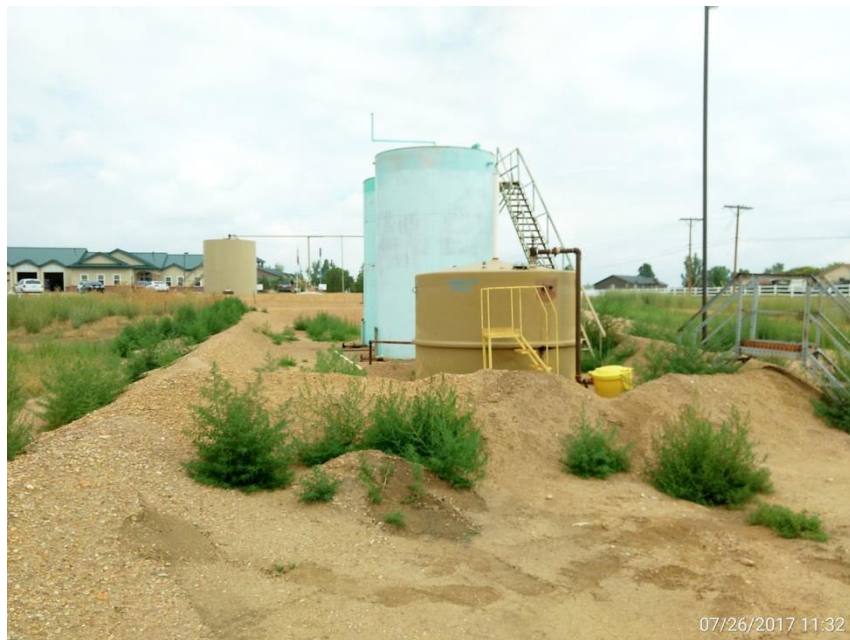
Tank battery, Corrective Action: Berm maintenance and weeds.

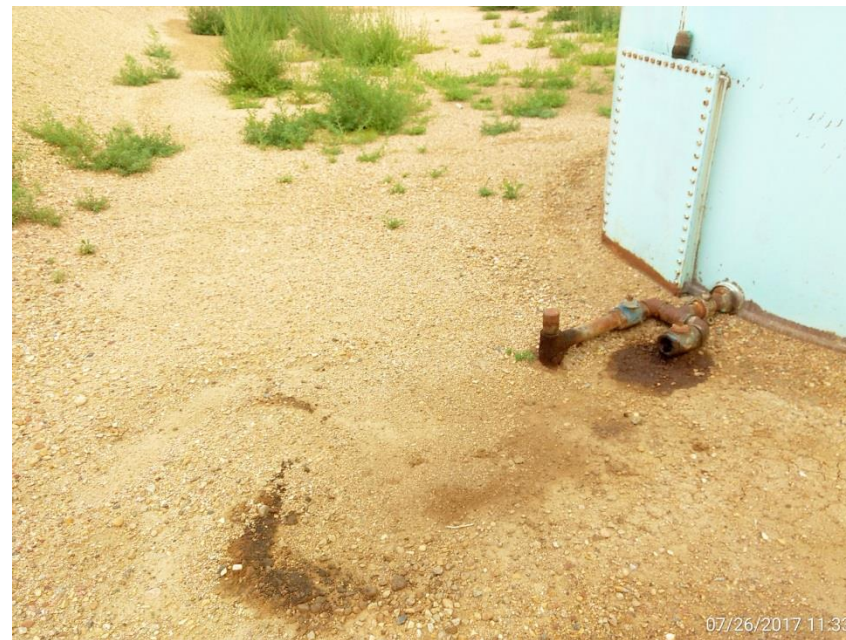
Inside of oil/water tank berm, Corrective Action: stained soil and weeds.

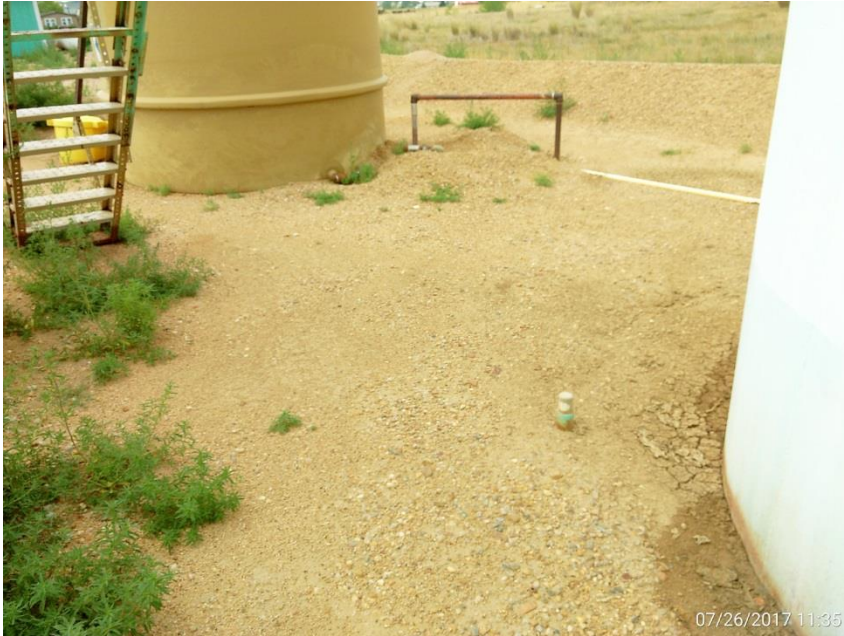
Inside of oil/water tank berm **Note: Unidentified riser (1)**
39.983695, -104-856856

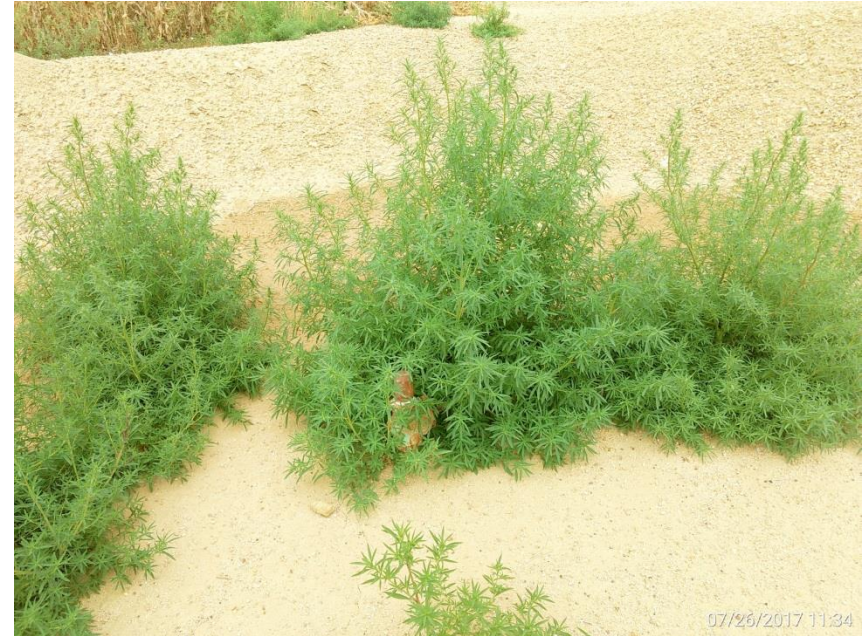
Inside of oil/water tank berm **Note: Unidentified riser (1)**
39.983798, -104.865842

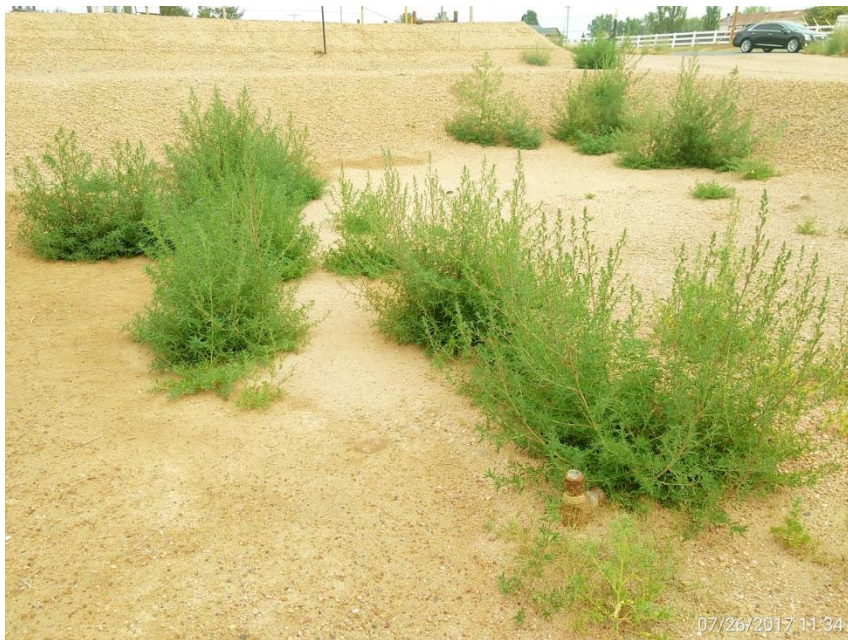
Inside of oil/water tank berm **Note: Unidentified riser (1)**
39.983847, -104.865886

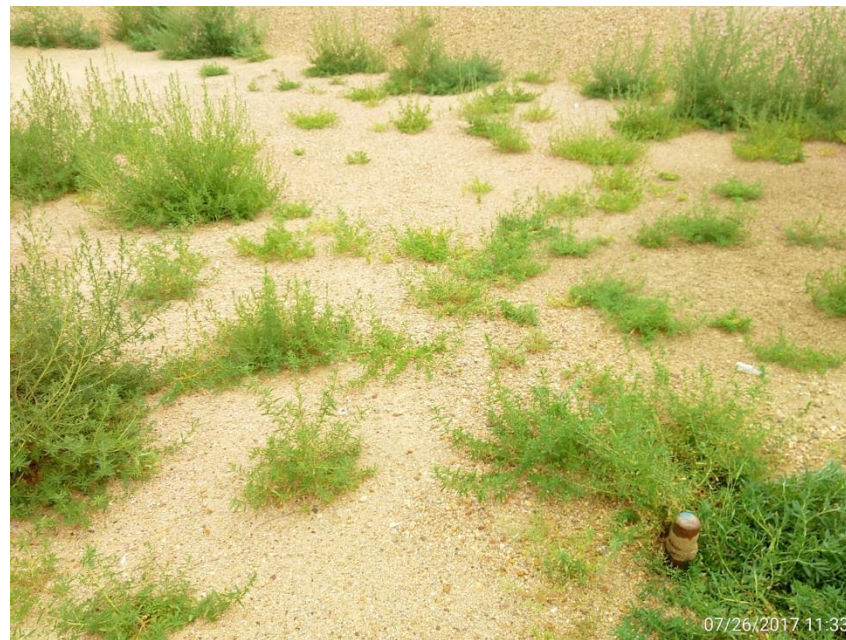
Inside of oil/water tank berm **Note: Unidentified riser (1)**
39.872831, -104.865848

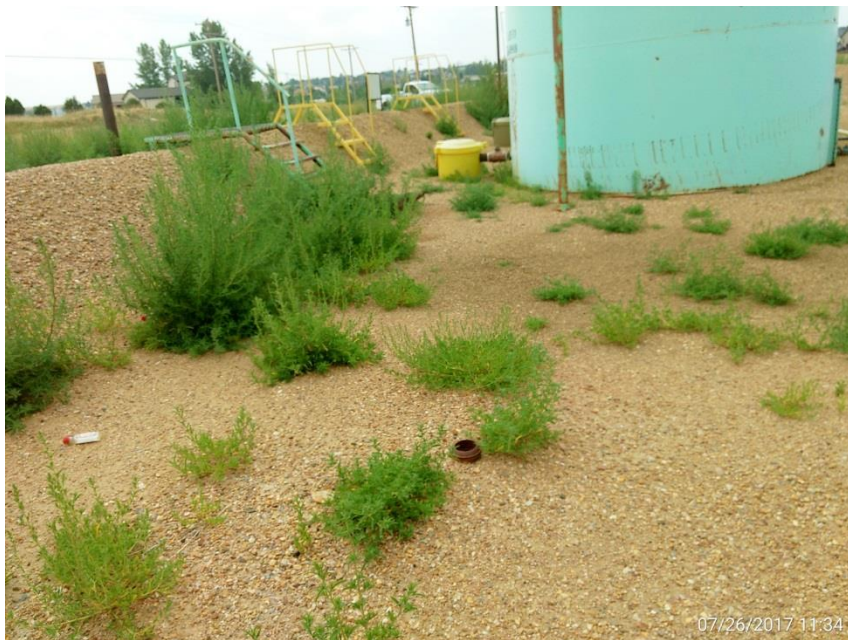
Inside of oil/water tank berm **Note: Unidentified riser (1)**
39.983829, -104.865873

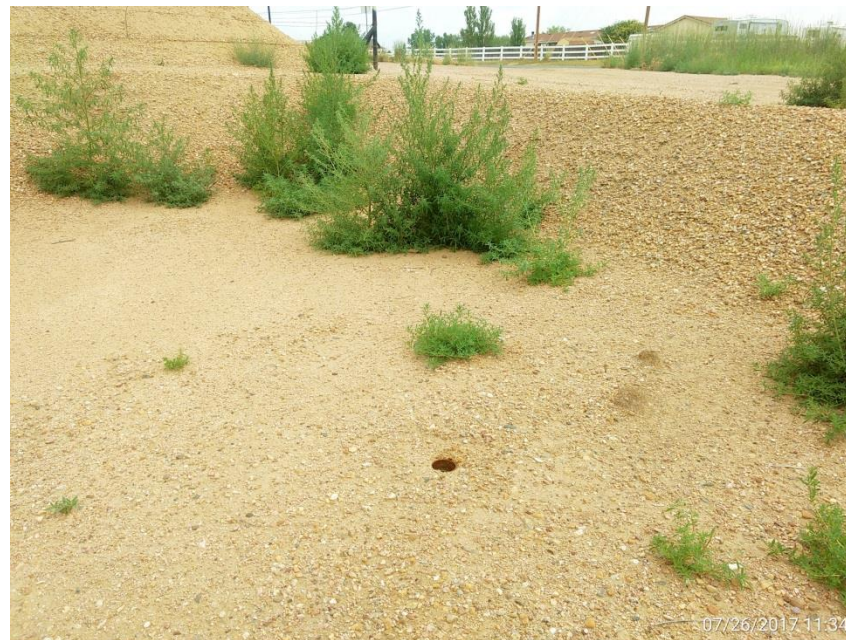
Inside of oil/water tank berm **Note: Unidentified riser (1)**
39.983812, -104.865886

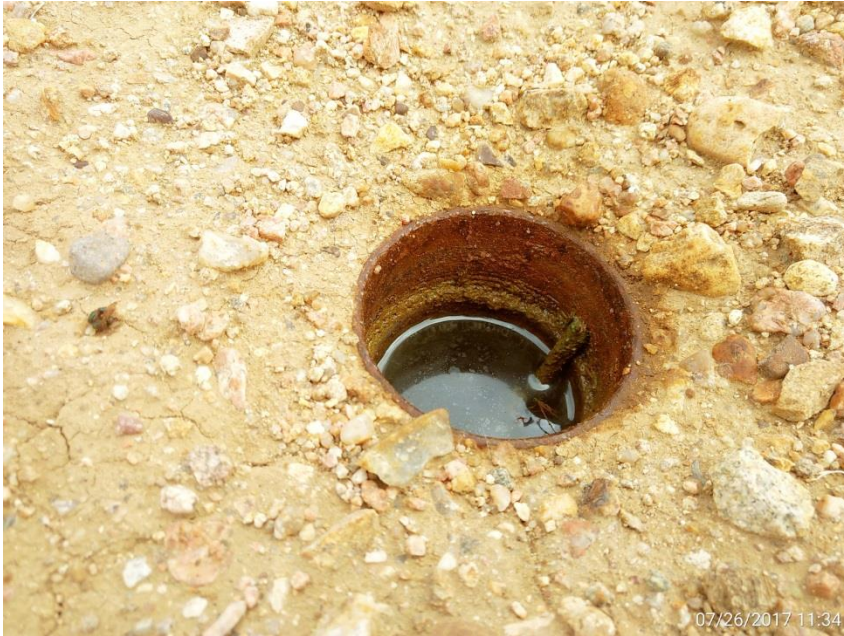
Inside of oil/water tank berm, riser detail

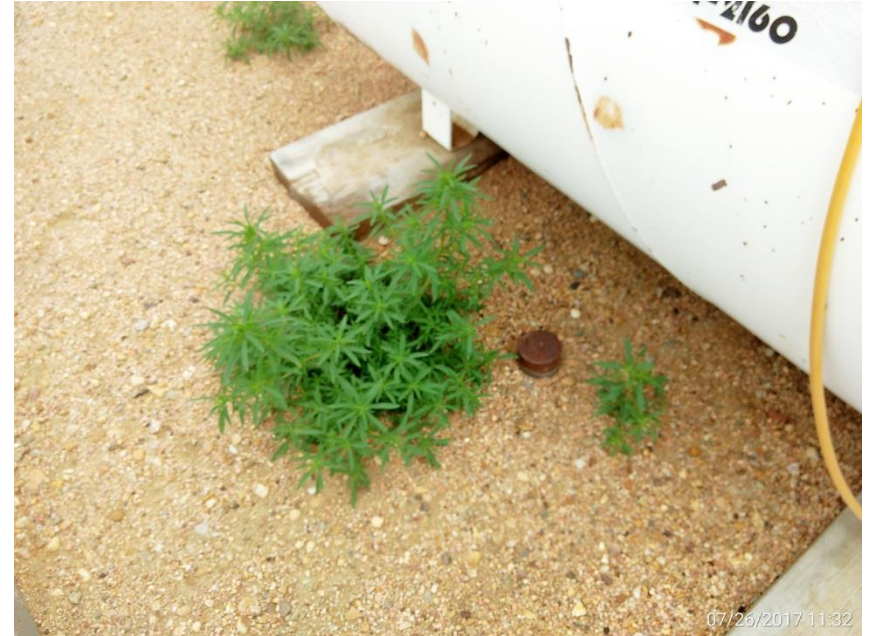
West of separator housing unit, Note: Unidentified riser (1)
39.983403, -104.865932

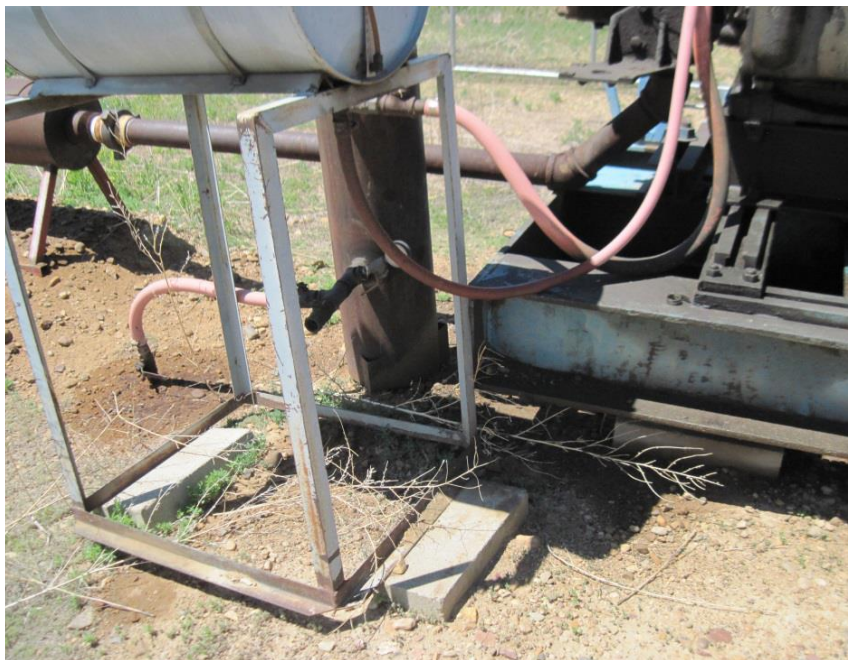
**Pumping unit long run drum, 6/20/2017 inspection photo,
Corrective action, stained soil.**

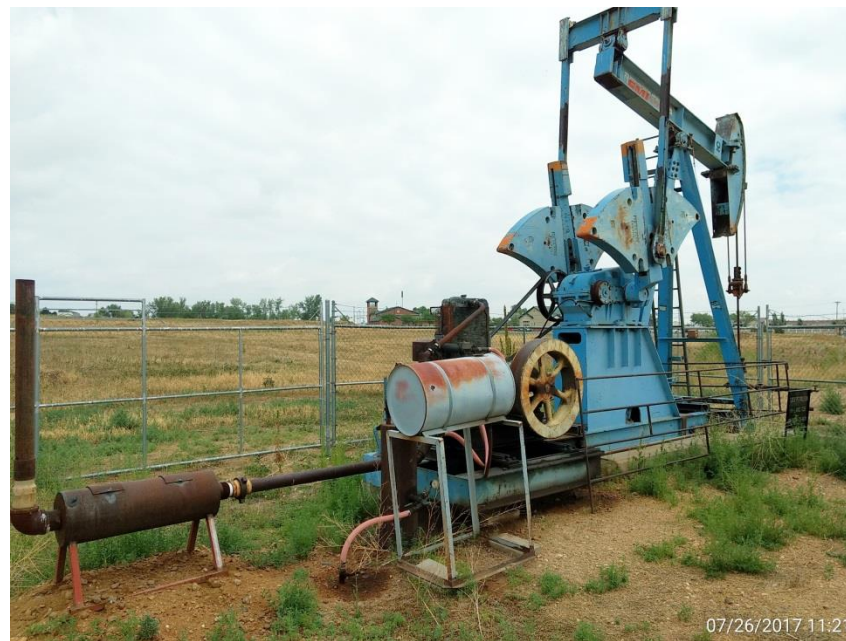
**Pumping unit, Corrective action: stained soil not
remediated.**
