Inspection Photos
Location Name: Croff 12-5
API: 05-001-08162

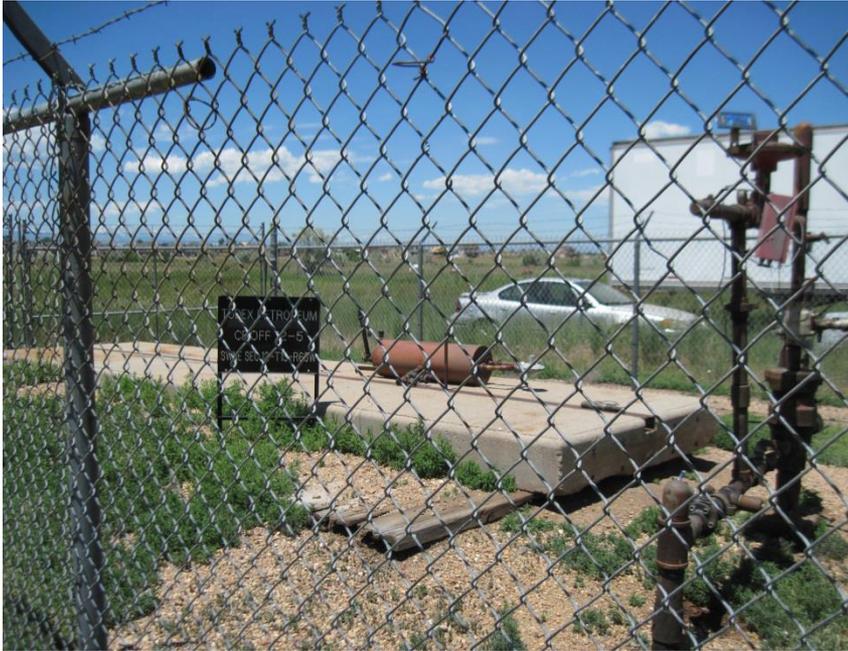
Signage from 6/20/2017 inspection, No emergency contact info, unused scrubber.

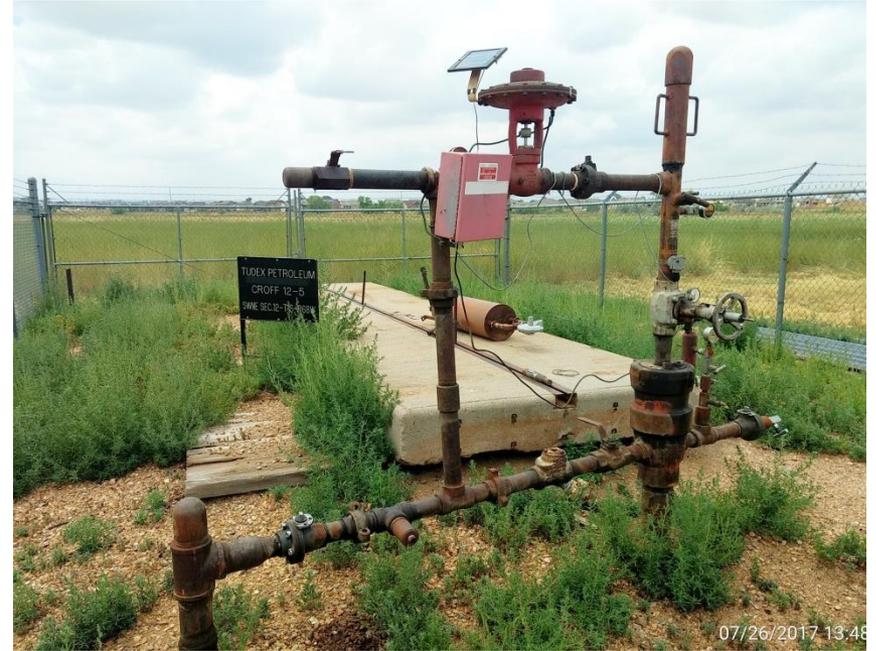
Wellhead, **Corrective action: Emergency contact info not updated, scrubber not removed.**

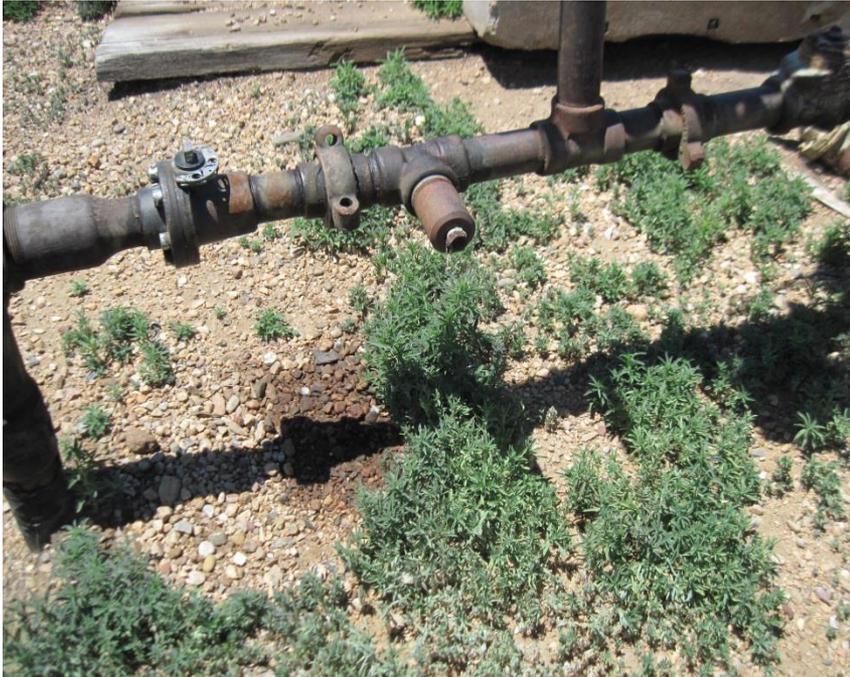
Stained soil at wellhead from 6/20/2017 inspection

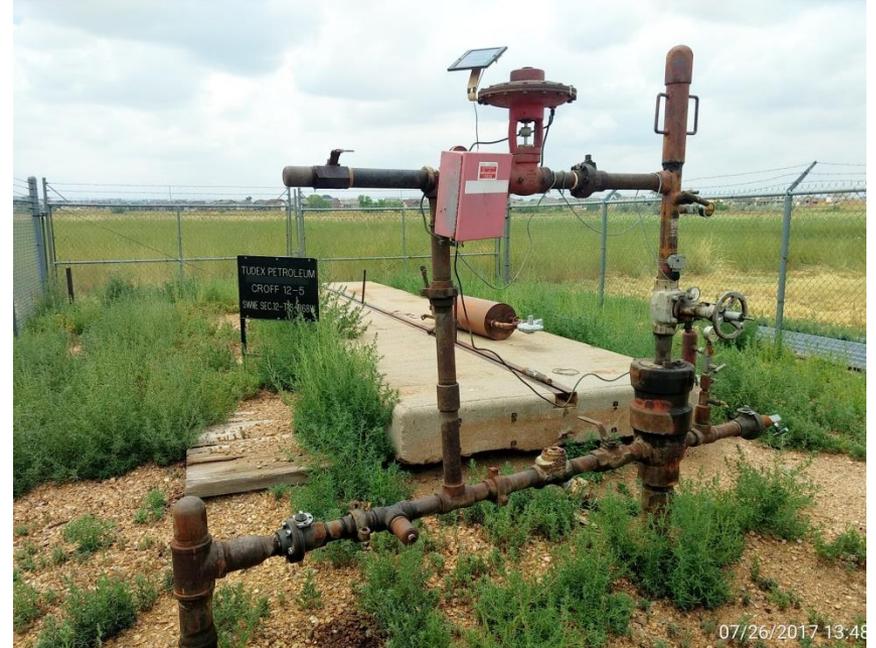
Wellhead, **Corrective ation: stained soil not remediated.**
