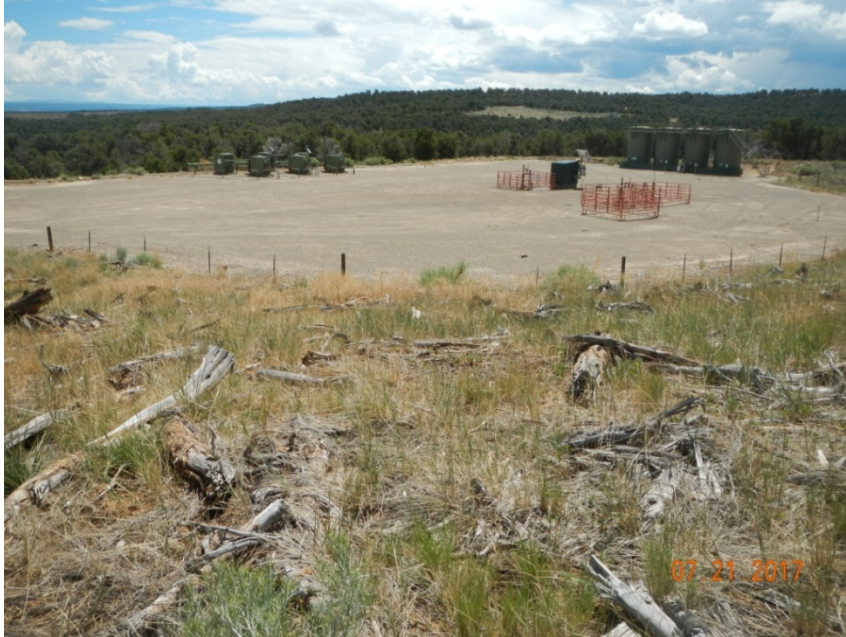
Photo 1: View of the project area from the northwestern corner facing center.

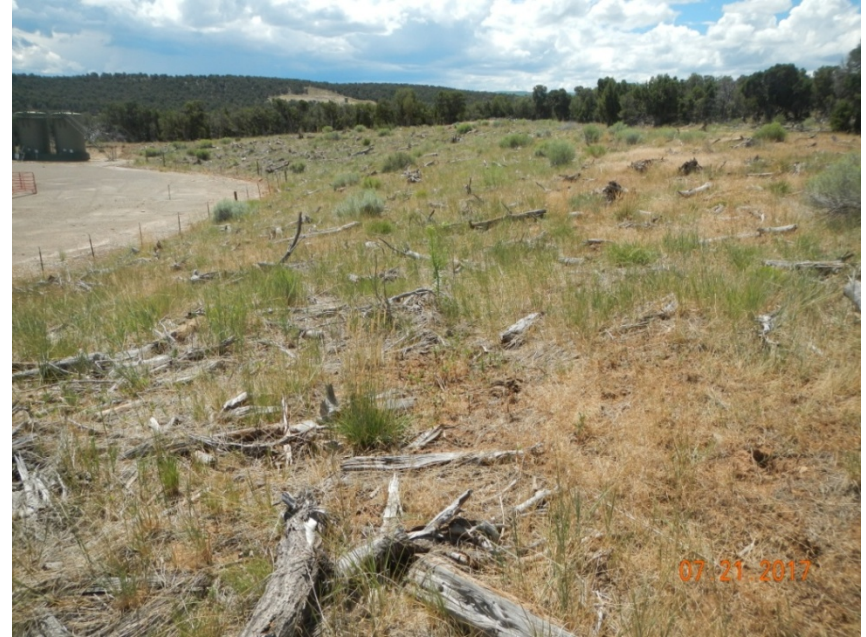
Photo 2: View of the western portion of the project area from the northwestern corner facing southward. Revegetation is progressing with grasses such as crested wheatgrass (*Agropyron cristatum*) and western wheatgrass (*Pascopyrum smithii*).

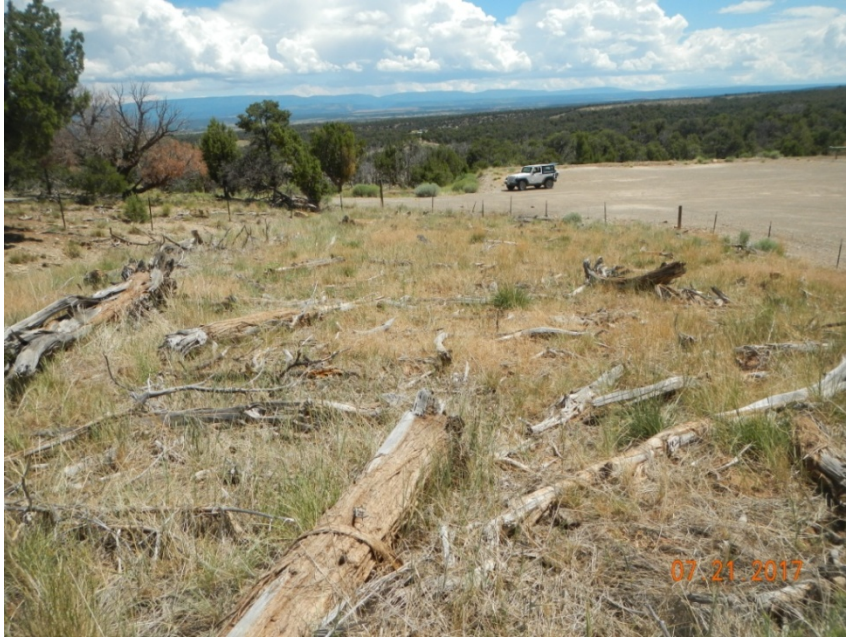
Photo 3: View of the northwestern portion of the project area from the northwestern corner facing eastward.

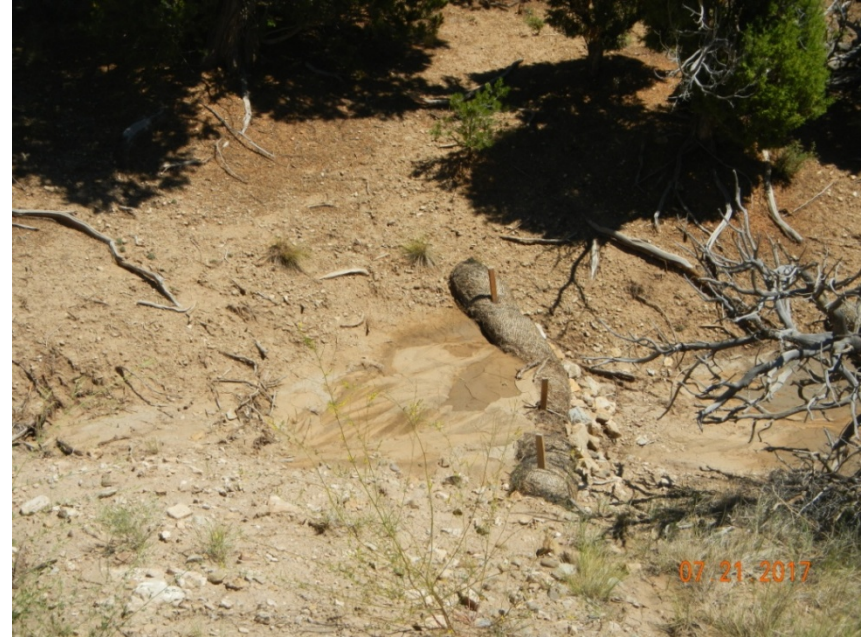
Photo 4: View of wattle on the northeastern edge full of sediment that needs maintenance.

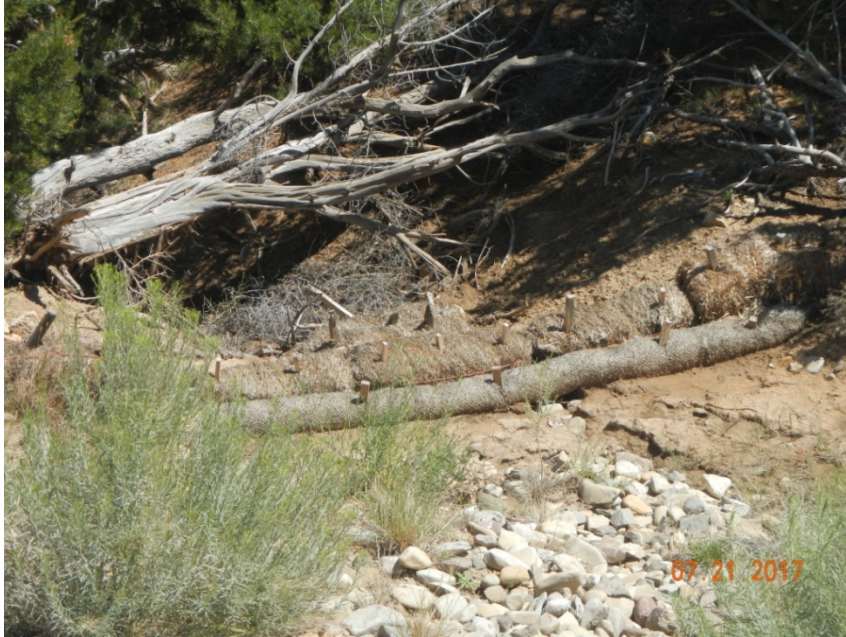
Photo 5: View of wattles along the eastern edge of the well pad where stormwater is flowing beneath the wattle and needs maintenance.

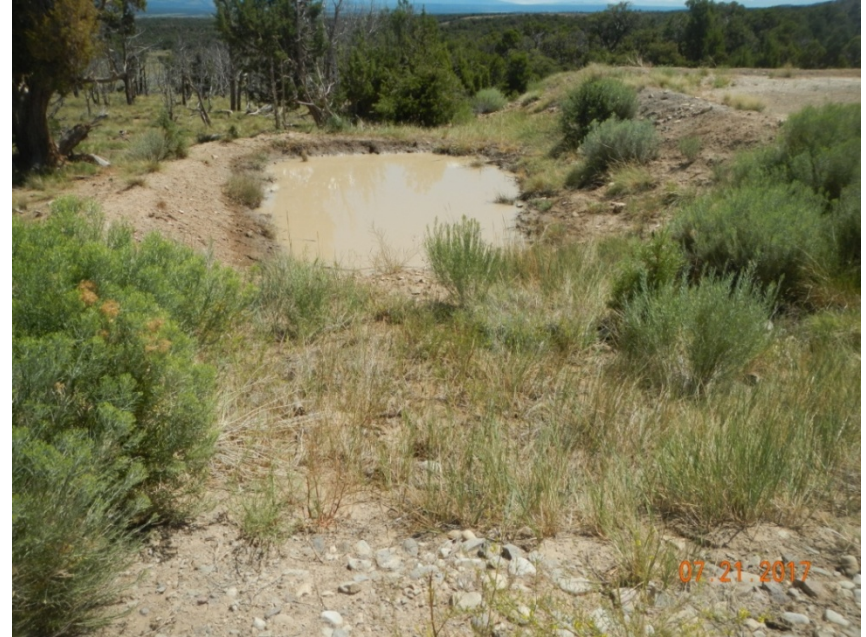
Photo 6: View of sediment trap east of the well pad entrance.
