Interim Reclamation Inspection

Operator: KERR MCGEE OIL & GAS ONSHORE LP #47120

Location ID: 438023

Location Name: DEJANE STATE TANK BATTERY /2N-36HZ

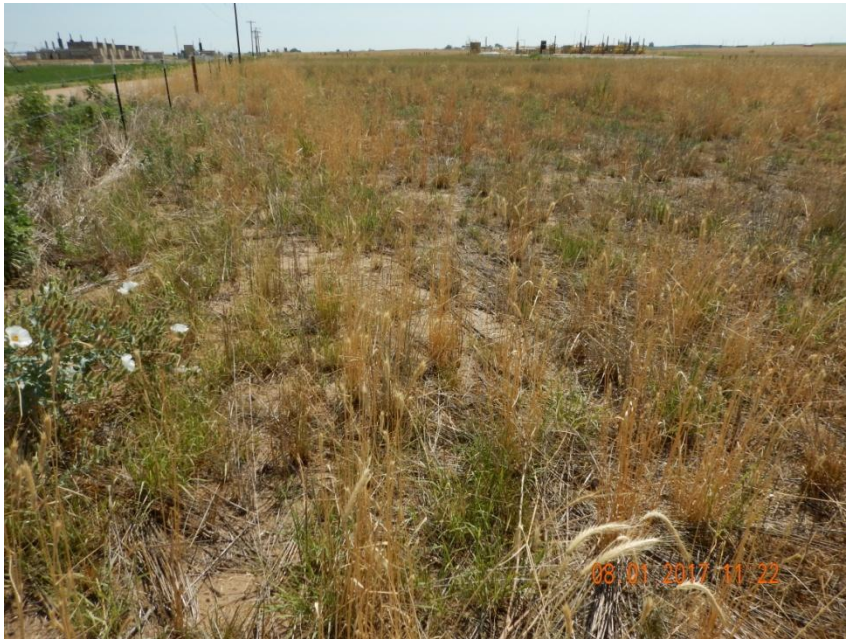
Photo 1. Photo taken from the northwest, east flowline area, facing East. Desirable plant species establishment is evident throughout most of the flowline area.

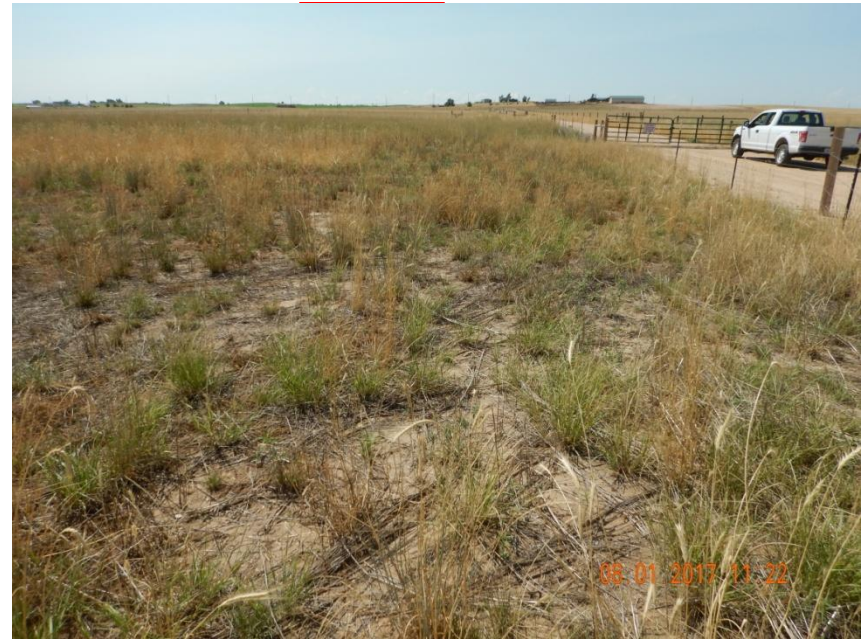
Photo 2. Photo taken from the northwest, east flowline area, facing South. Desirable plant species establishment is evident throughout most of the flowline area. The western portion of the east flowline area has vegetative gaps and is not uniform. Longspine sandbur (*Cenchrus longispinus*) was observed along portions of this area.

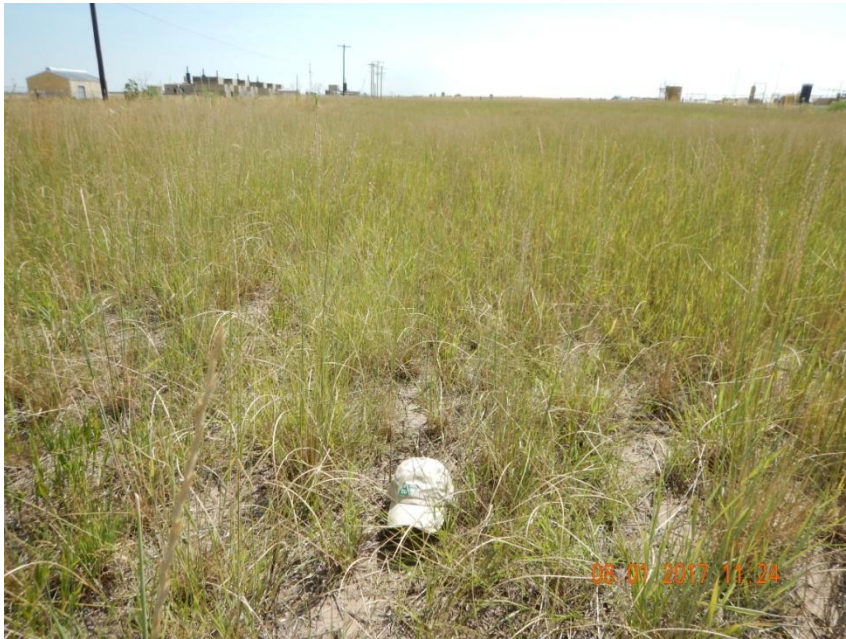
Photo 3. Photo taken from the central, east flowline area, facing East. Desirable plant species establishment is evident throughout this area.

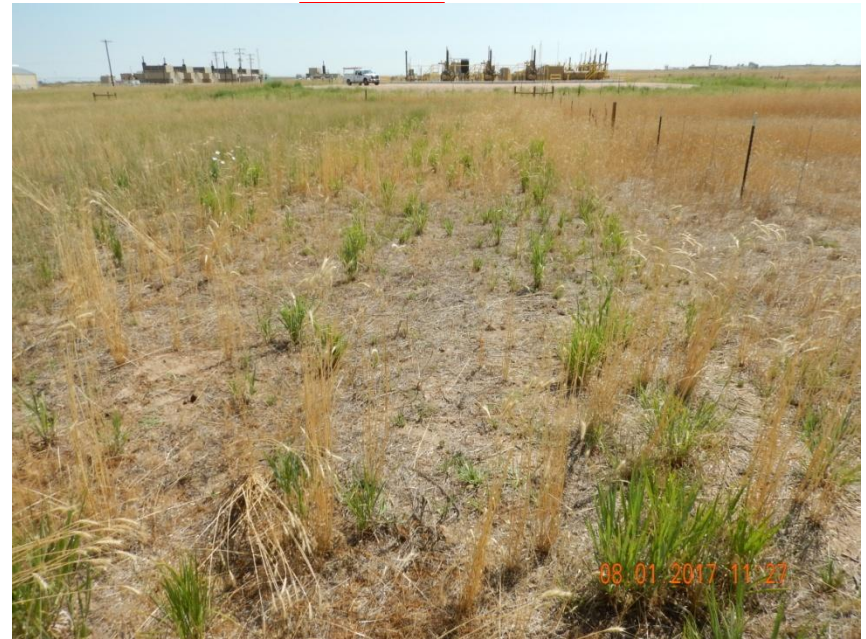
Photo 4. Photo taken from the south central, east flowline area, facing East. This area has vegetative gaps and is not uniform. Longspine sandbur (*Cenchrus longispinus*) was observed along portions of this area.

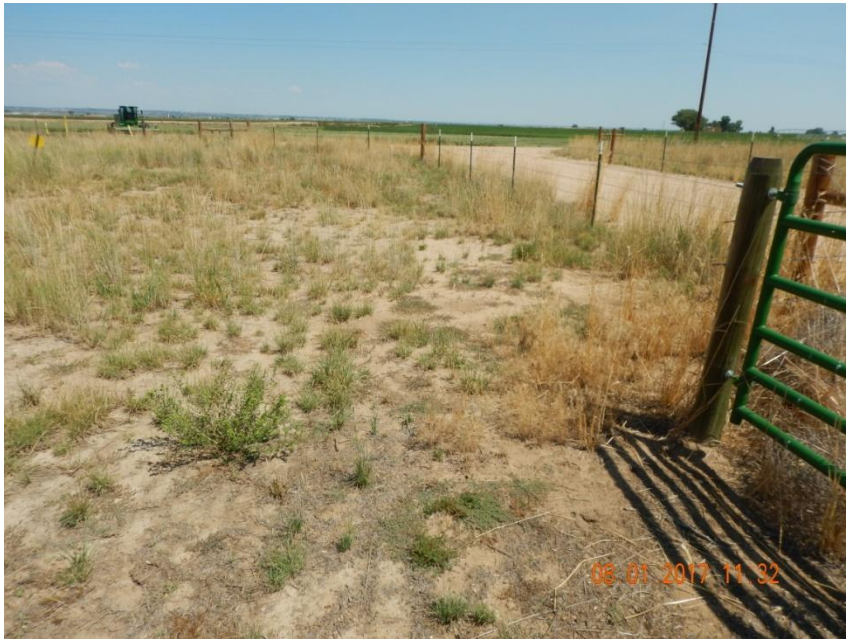
Photo 5. Photo taken from the east, west flowline area, facing North. This area has vegetative gaps and is not uniform. Longspine sandbur (*Cenchrus longispinus*) was observed along portions of this area.

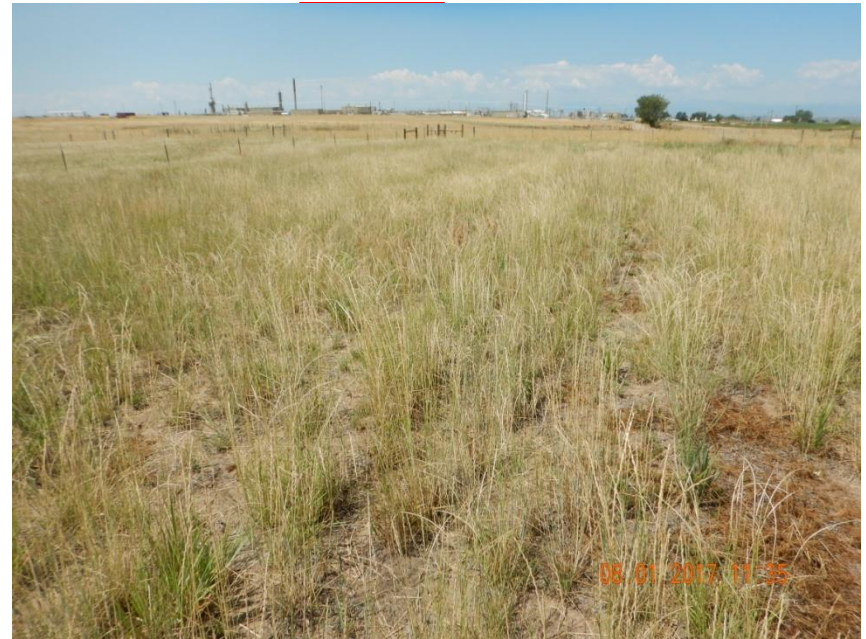
Photo 6. Photo taken from the central, west flowline area, facing West. Desirable plant species establishment is evident throughout this area.

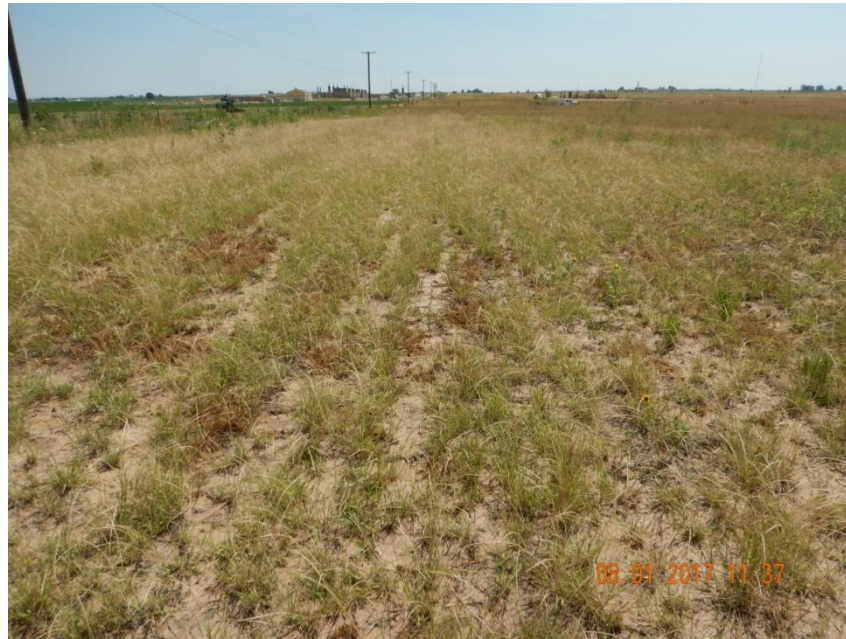
Photo 7. Photo taken from the north central, west flowline area, facing East. Desirable plant species establishment is evident throughout most of this area.
