- Davis 2-5 05-067-08150

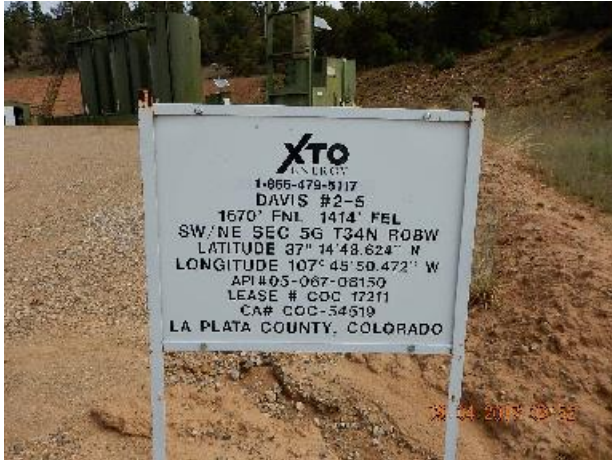
Photo 1: Wellhead sign.

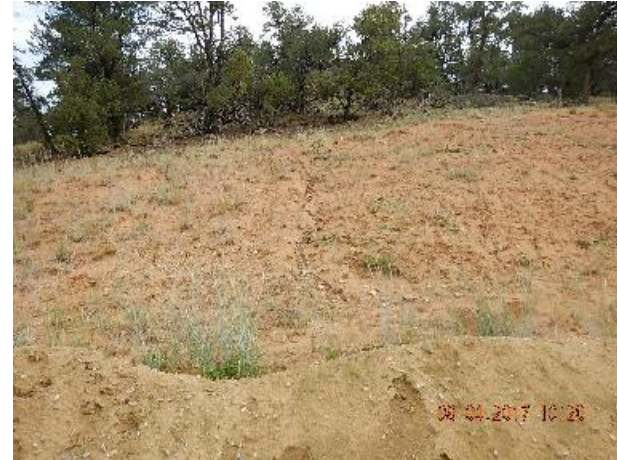
Photo 2: Rilling on cut slope.

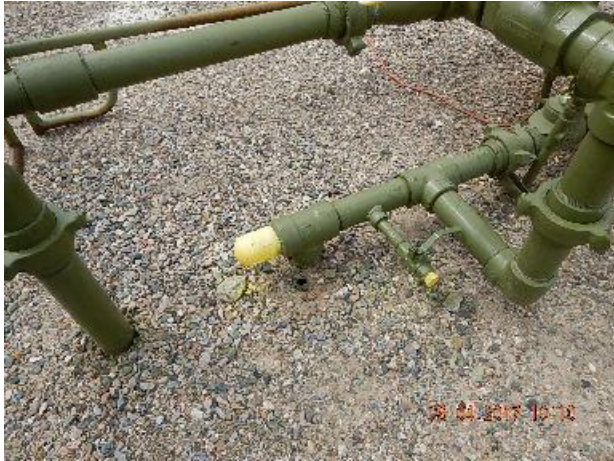
Photo 3: 1" poly line at wellhead.

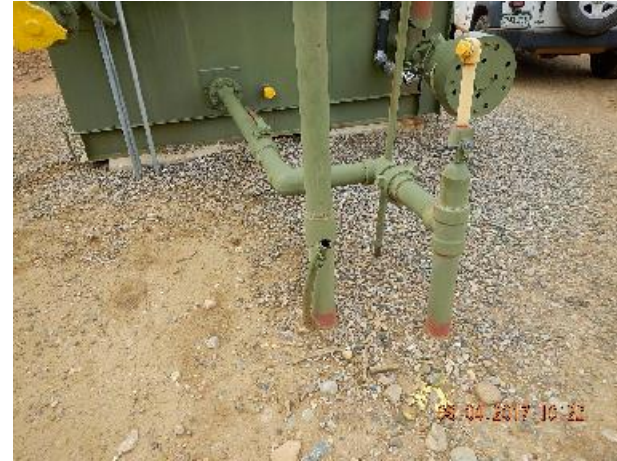
Photo 4: 1" poly line at separator.

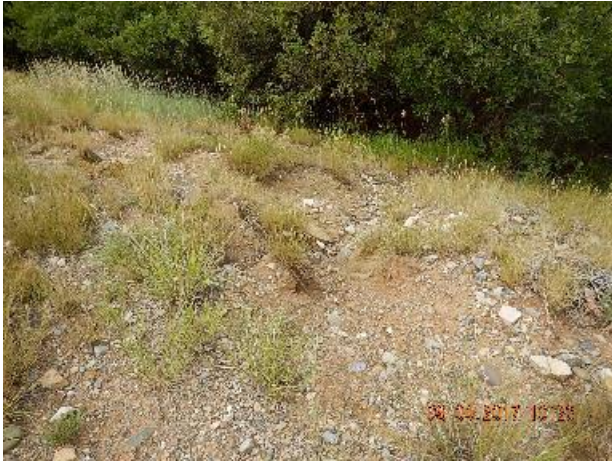
Photo 5: Erosion developing on fill slope.

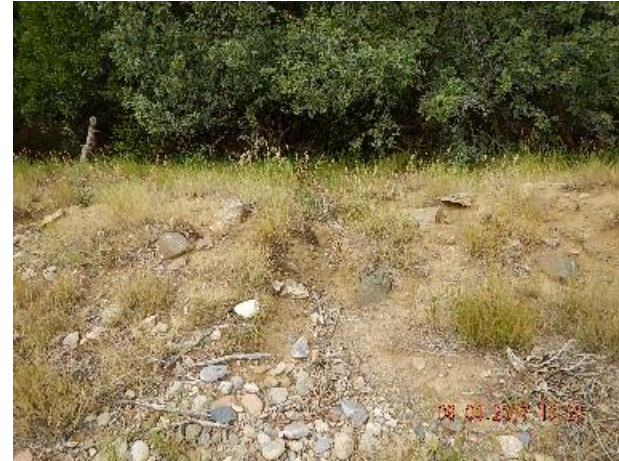
Photo 6: Erosion developing on fill slope.
