# Inspection Photos

Operator: DIVERSIFIED OPERATING  
CORPORATION - 24461

Location ID: 305414

Inspection Doc. Number: 675103796  
Weld County, CO

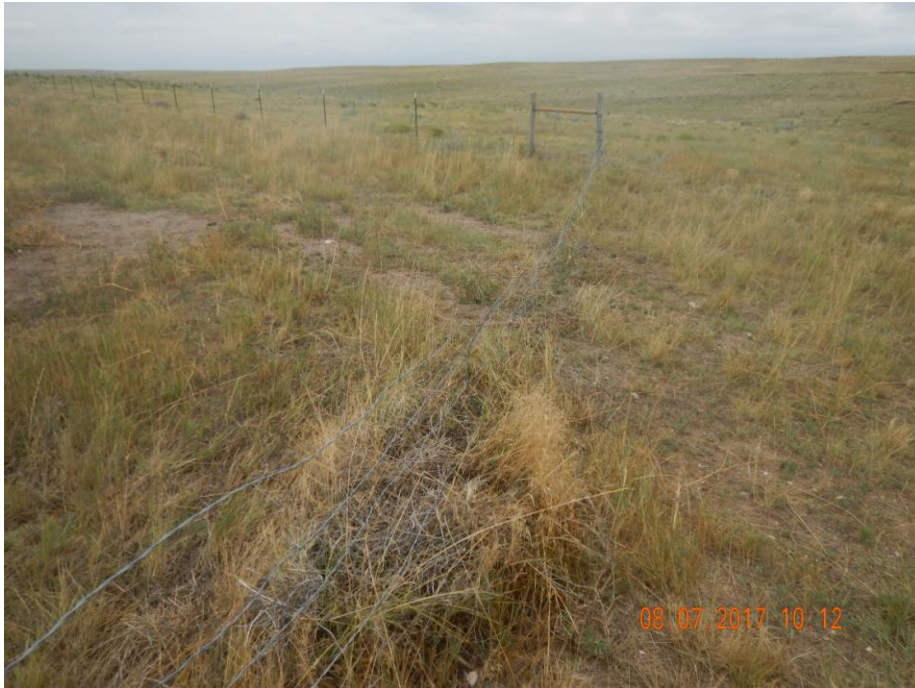
**Photo 1:** Photo taken from the southwest end of the location. Photo shows fence gate in disrepair. Advise maintenance.

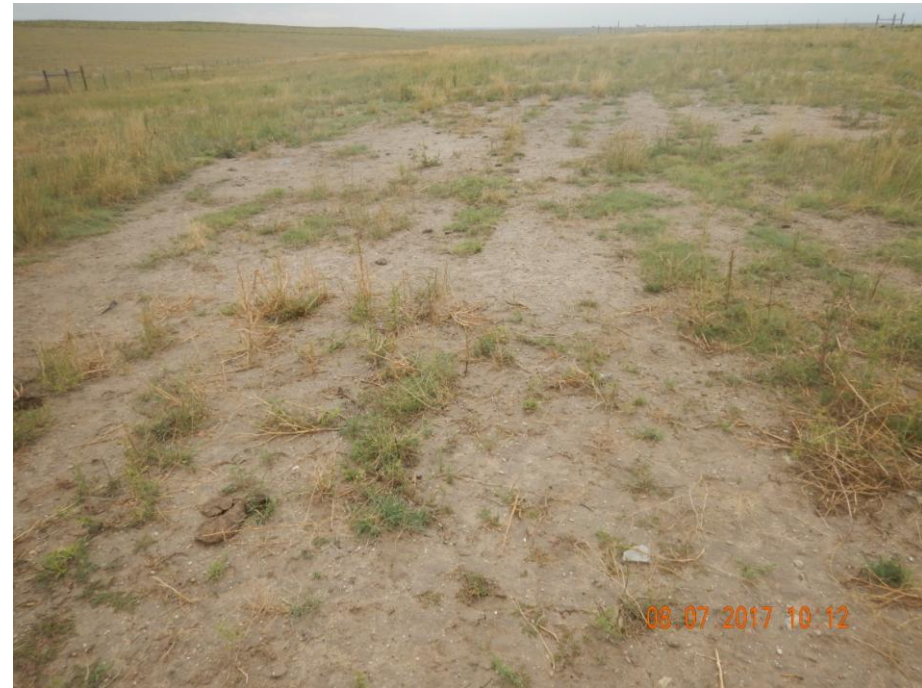
**Photo 2:** Photo taken from the south end of the location, facing east. Photo shows areas of the location that remain unvegetated with little desirable perennial growth evident. These areas will require additional reclamation work.

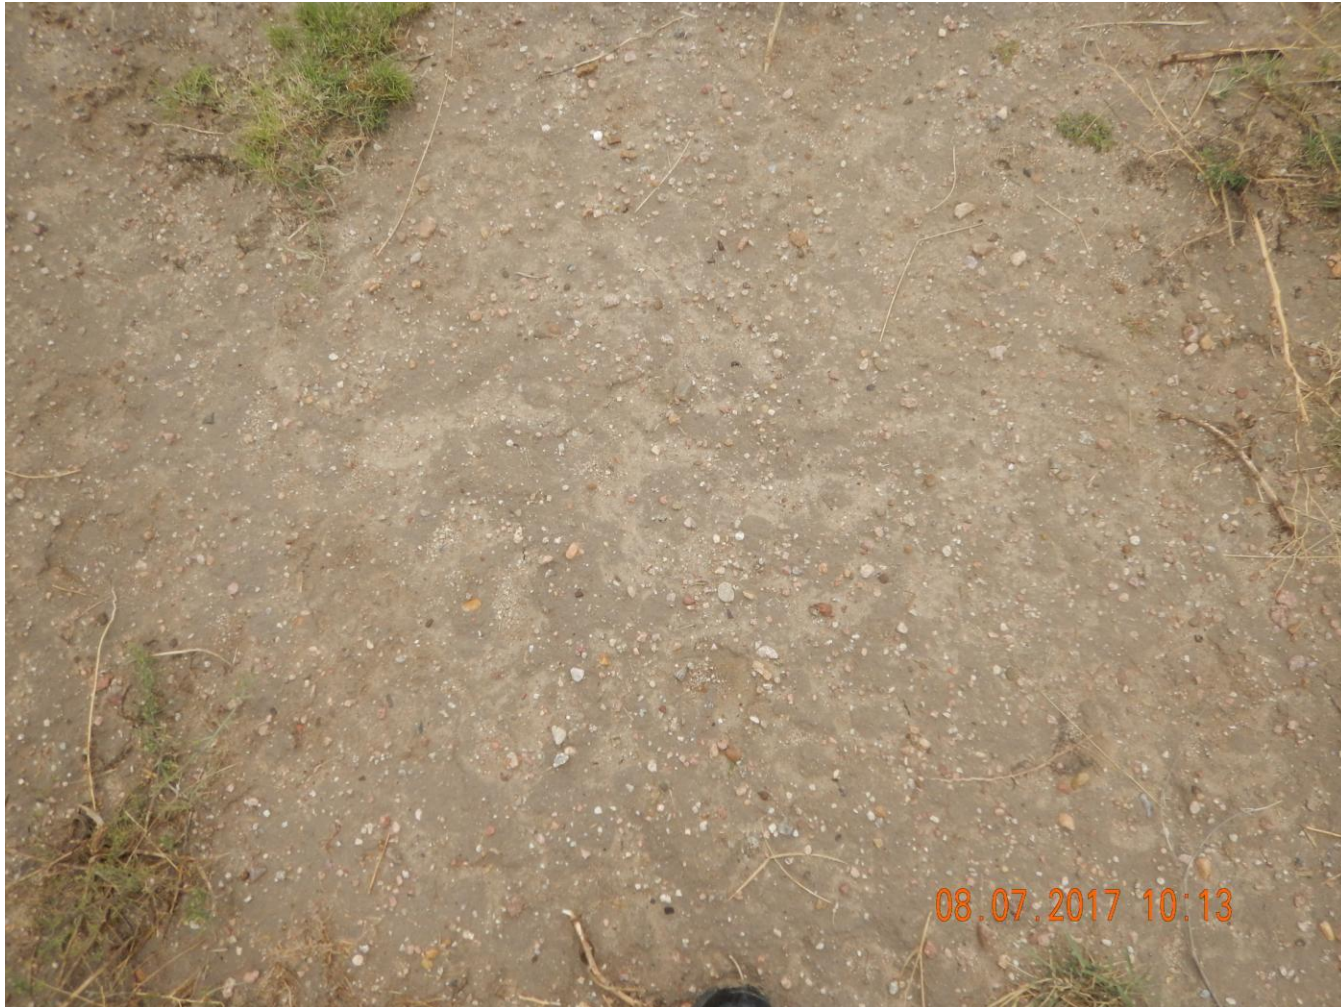
**Photo 3:** Photo taken from one of the large bare areas on the south end of the location. Photo shows large areas remain unvegetated with no sign of desirable perennial vegetative germination or growth and establishment.

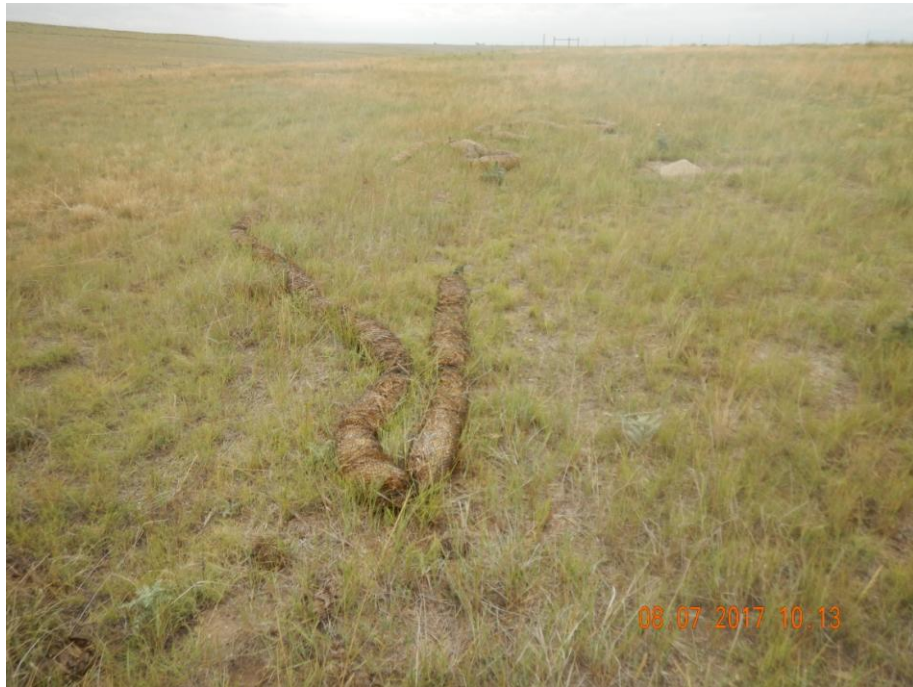
**Photo 4:** Photo taken from the location, facing east. Photo shows straw wattles on the location that remain in disrepair. Inspection doc. #682501867 required wattles to either be maintained or removed as wattles are considered debris in its current condition. Wattles have not been maintained or removed.

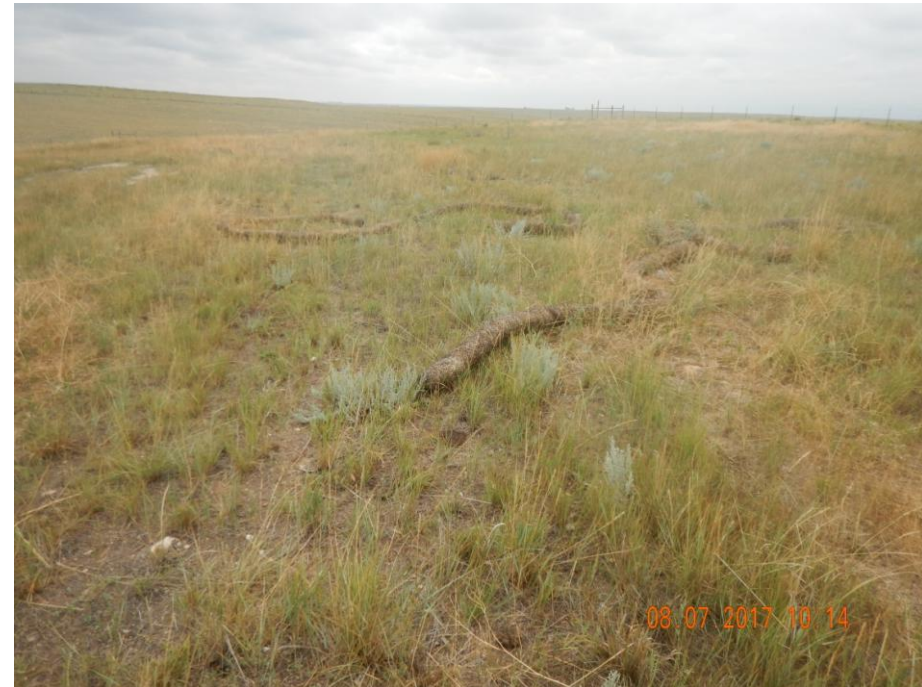
**Photo 5:** Photo taken from the location, facing east. Photo shows straw wattles on the location that remain in disrepair. Inspection doc. #682501867 required wattles to either be maintained or removed as wattles are considered debris in its current condition. Wattles have not been maintained or removed.

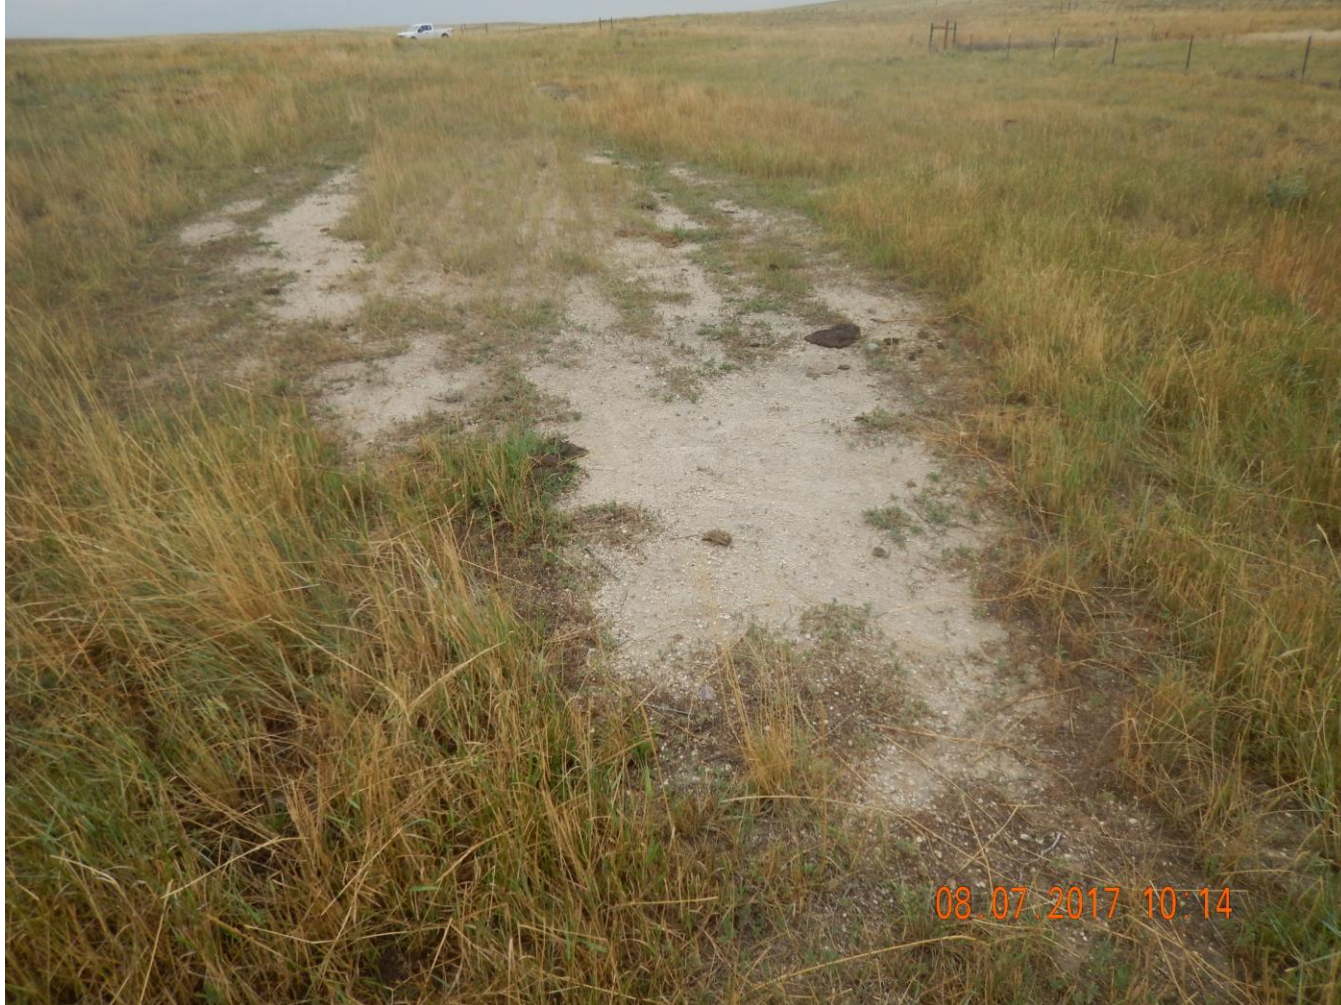
**Photo 6:** Photo taken from the southeast end of the location, facing west. Photo shows areas of the location that remain unvegetated with little desirable perennial growth evident. These areas will require additional reclamation work.

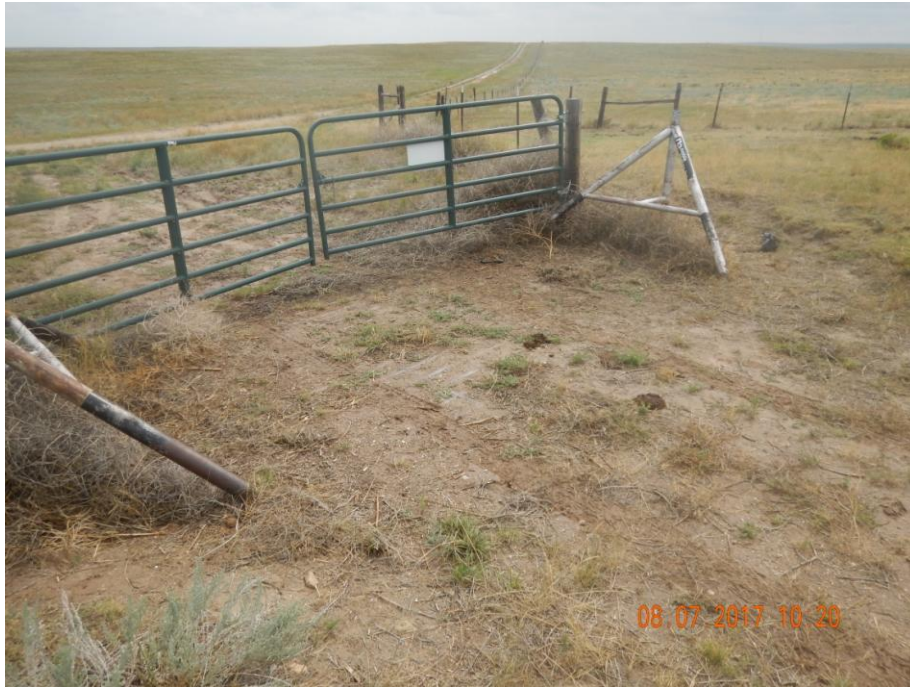
**Photo 7:** Photo taken from access road, east of the location. Inspection doc. #682501867 required operator to removed cattle guard. Photo shows cattle guard that has not been removed.

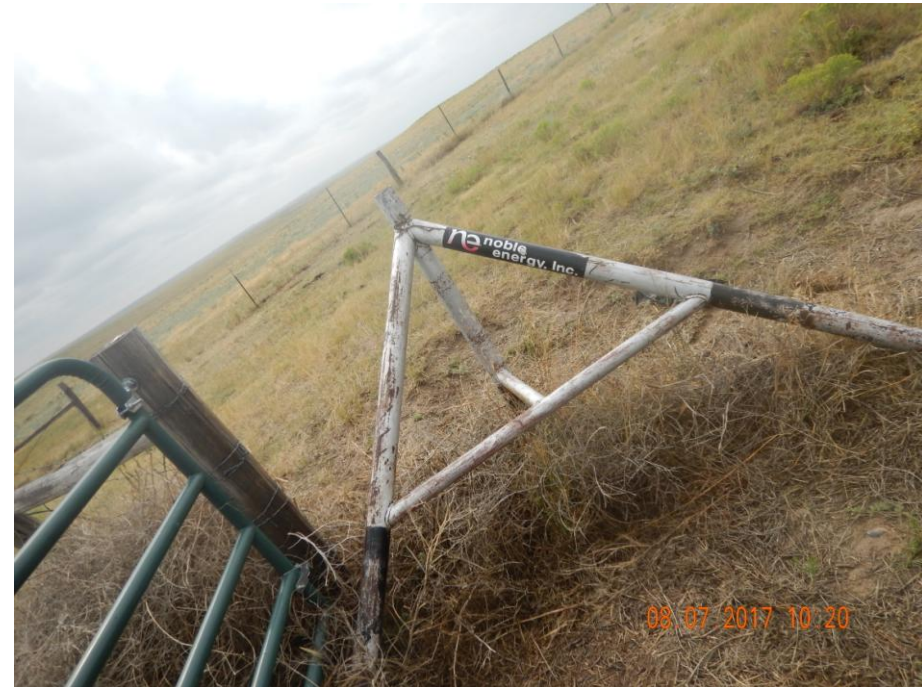
**Photo 8:** Photo taken from access road, east of the location. Inspection doc. #682501867 required operator to removed cattle guard. Photo shows cattle guard that has not been removed. Note label on cattle guard says "Noble Energy Inc.".
