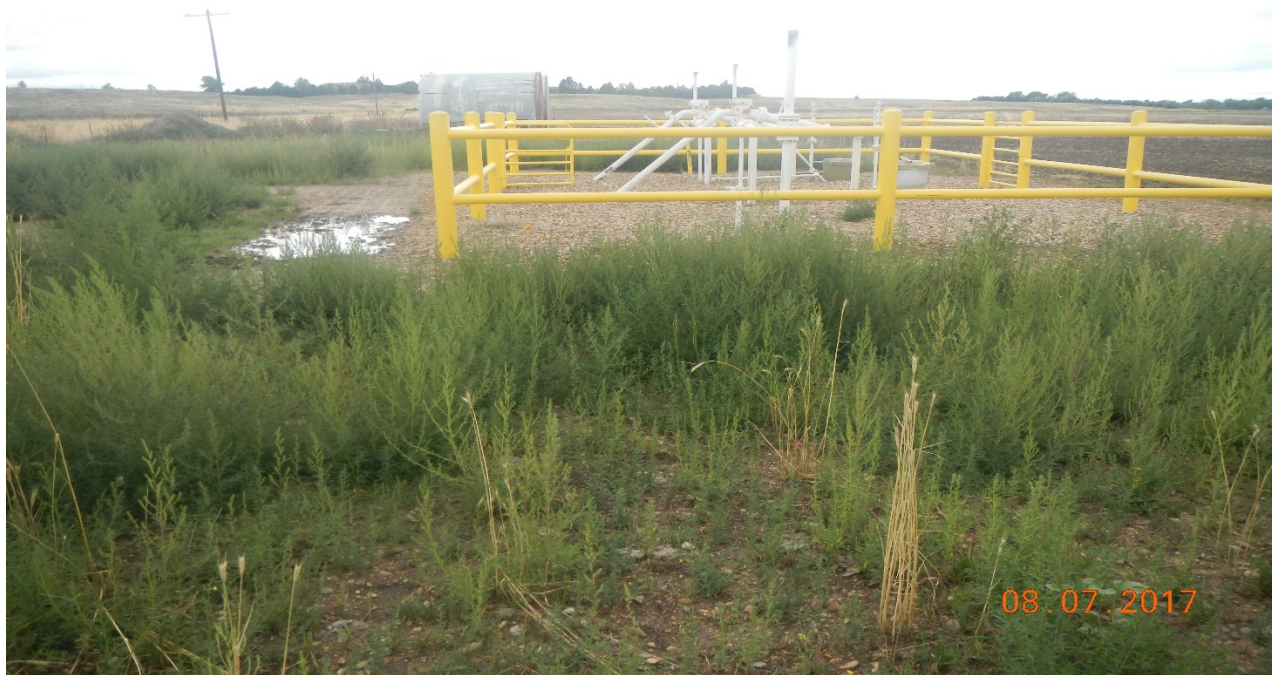
photo 1: Facing south toward the former tank battery site. It appears the pipeline infrastructure is midstream gathering.

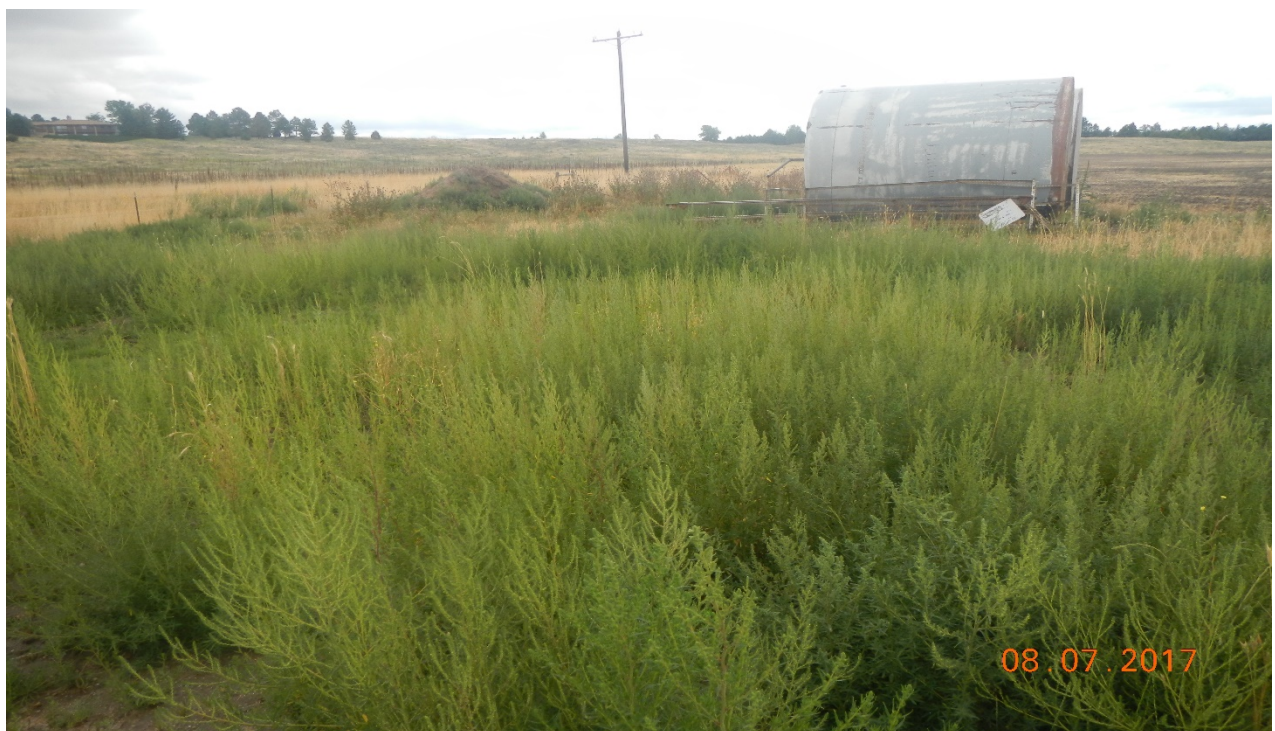
photo 2: Facing toward the south side of the former tank battery site. The tanks remain and there is undesirable vegetation growth throughout the site.

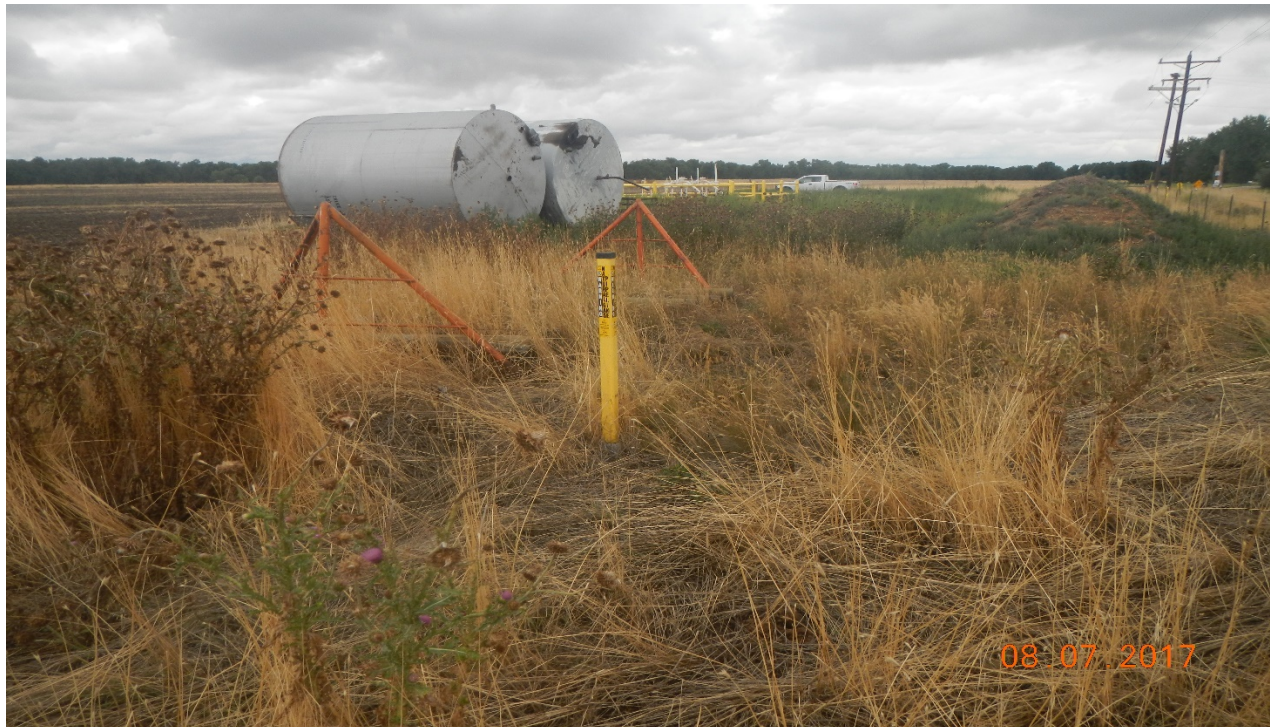
photo 3: South side of the former tank battery site. There is a cattle guard, soil pile, and tanks that remain.

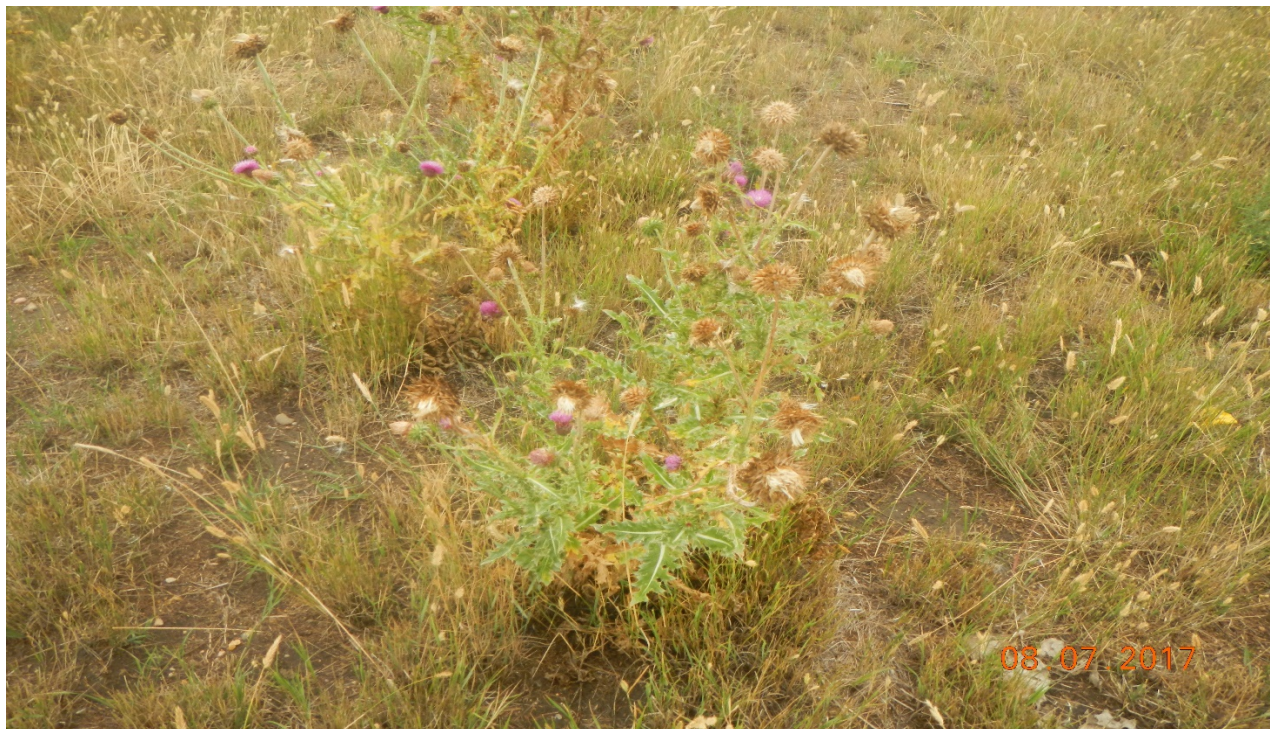
photo 4: There is List B noxious weeds (Musk thistle) throughout the tank battery site which are beginning to disperse seed.

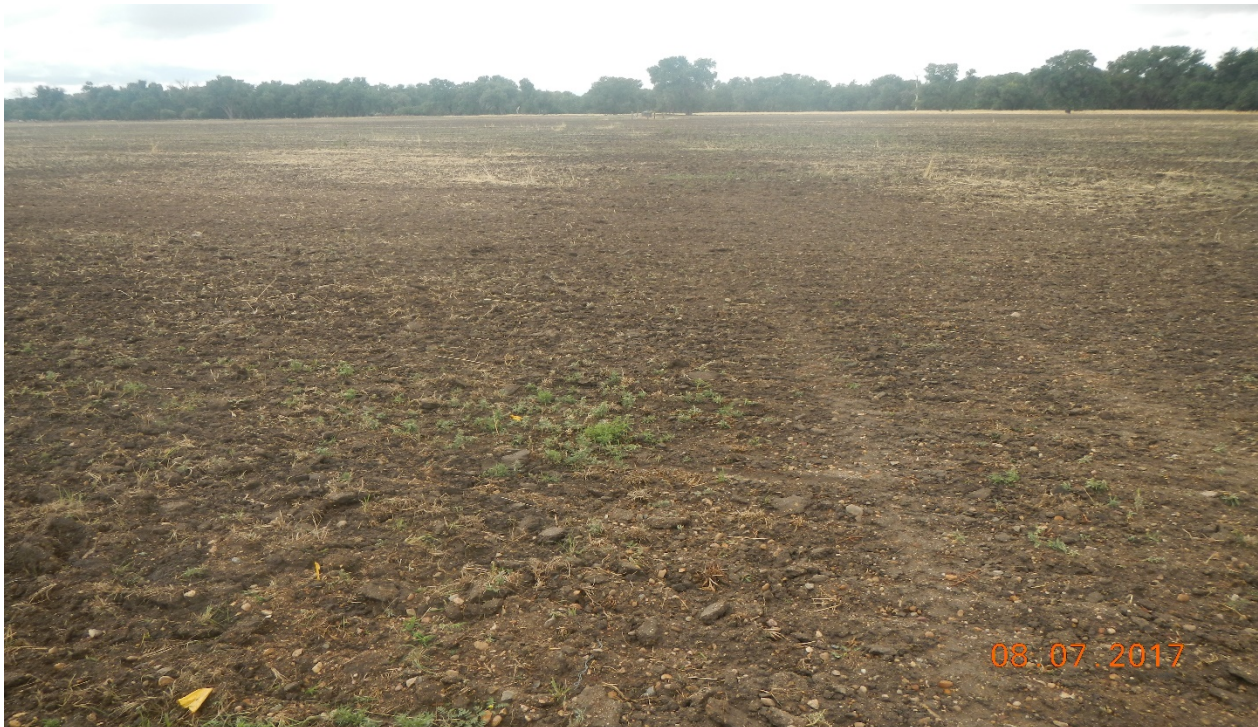
photo 5: Facing west toward the cultivated field where the site is located.

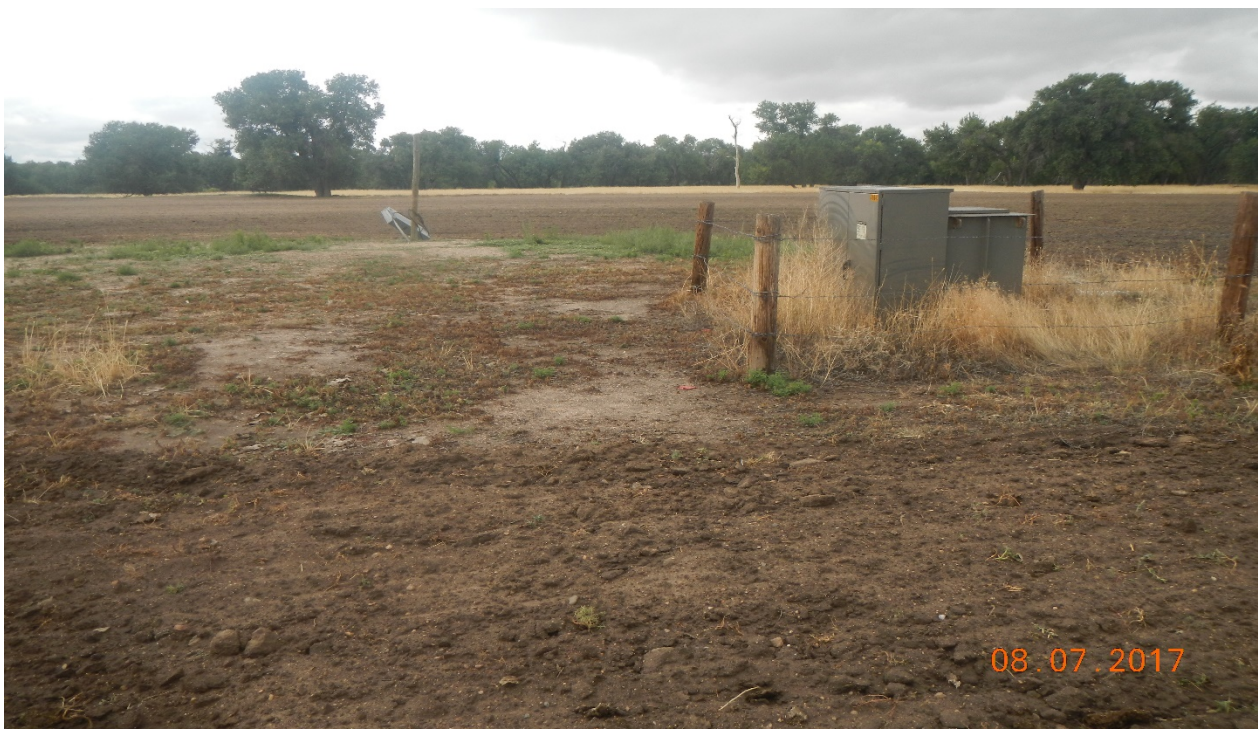
photo 6: The electric utilities remain at the location and the location has not been reclaimed per rule 1004.
