Inspection Photos  
Location Name: Bingman 1-14  
API: 05-081-06954

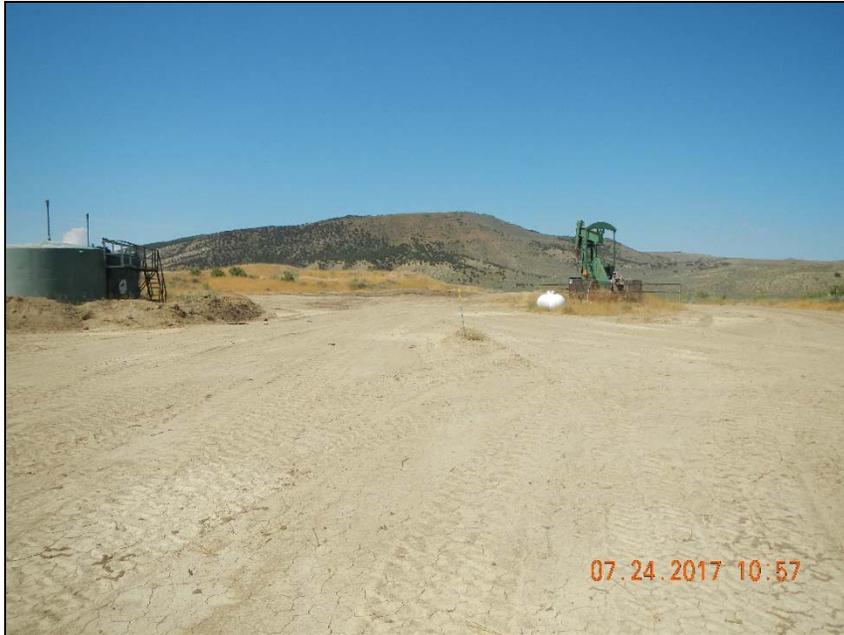
**Photo 1. Location overview taken at entrance facing west.**

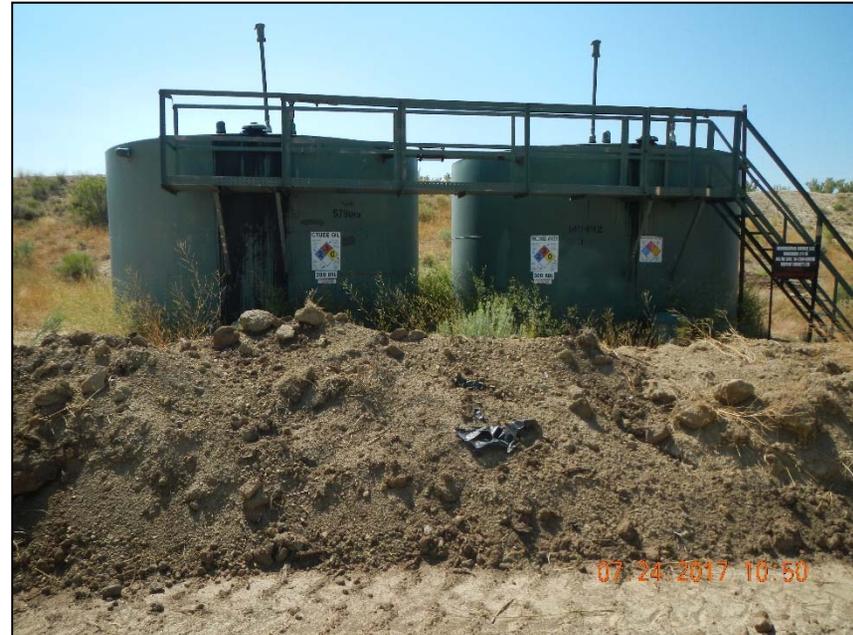
**Photo 2. Unconsolidated berm with plastic liner pieces mixed in. Weeds in berm.**

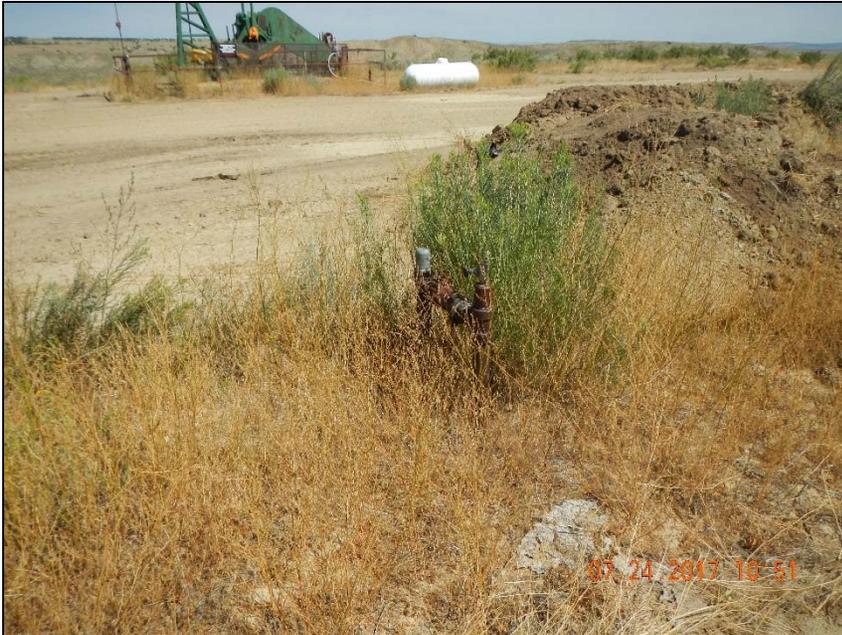
Photo 3. 2 – 2” steel risers at 40.38894, -108.13606.  
Weeds.

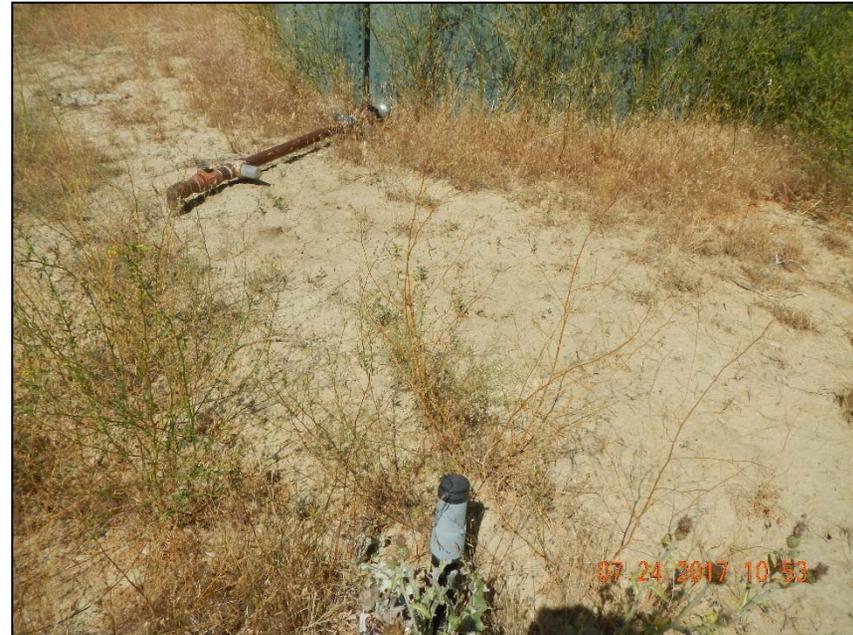
Photo 4. 1 – 2” steel riser in tank berm. Weeds.

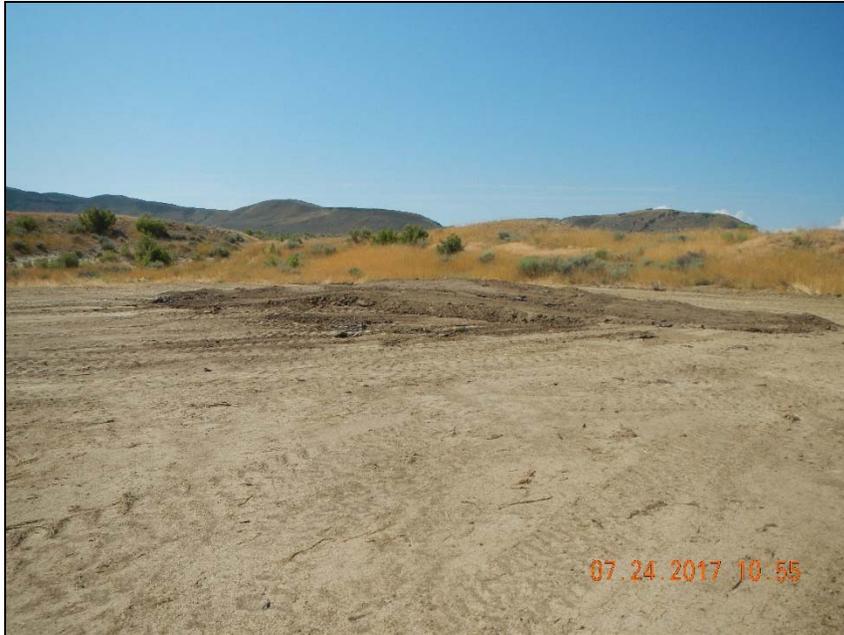
**Photo 5. Former land farm area with apparent recent work.**

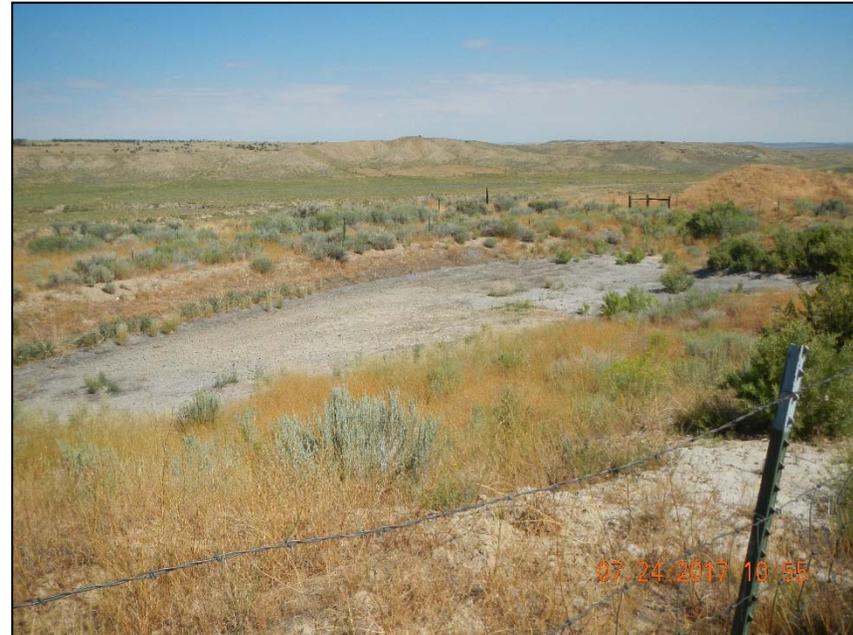
**Photo 6. View of pit taken at 40.38910, -108.13656 facing northwest.**
