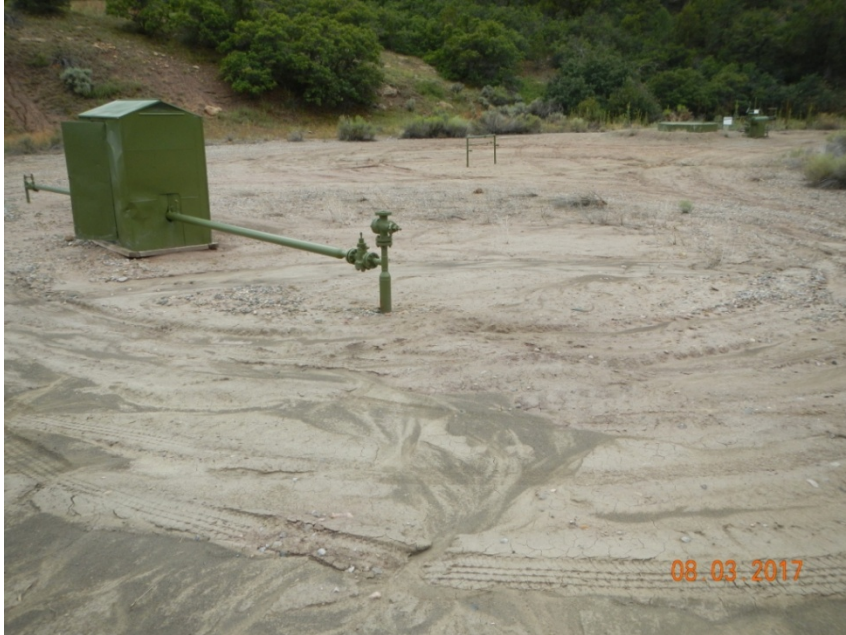
**Photo 1: View of the project area from the northeastern corner facing center.**

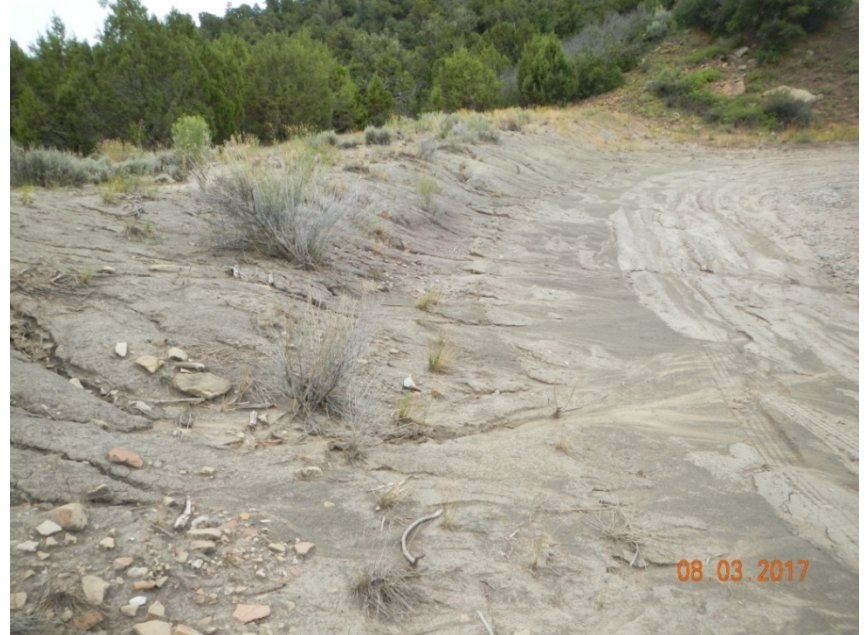
**Photo 2: View of the eastern portion of the project area from the northeastern corner of the well pad facing southward. This slope is not stabilized and is eroding.**

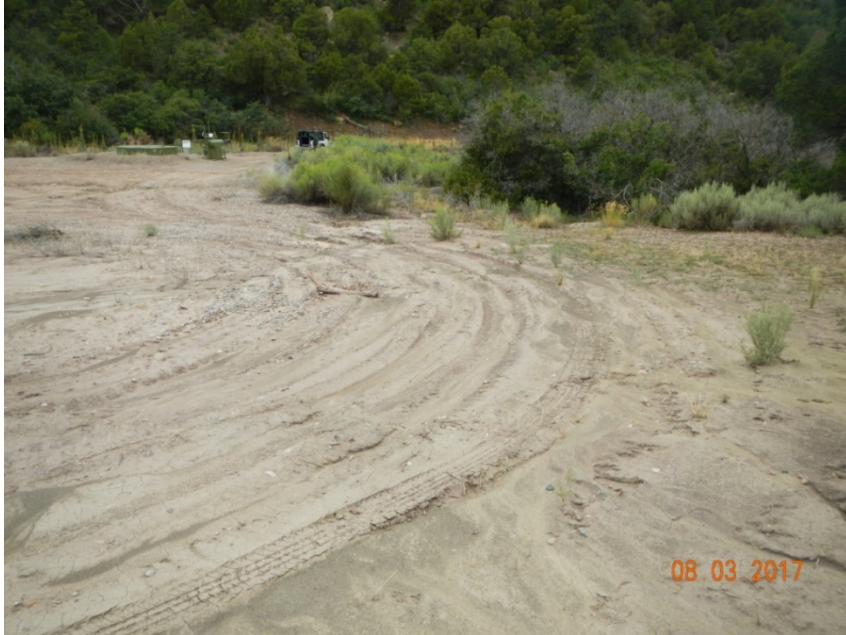
**Photo 3: View of the northern portion of the project area from the northeastern corner of the well pad facing westward.**

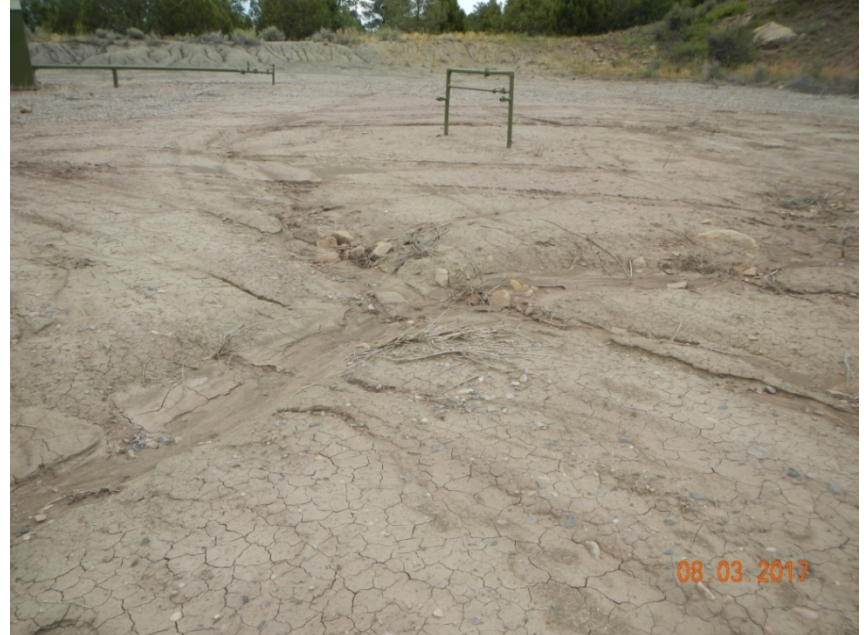
**Photo 4: View of erosional channel in the northern portion of the project area, approximately 2 feet wide and 8 to 12 inches deep, facing upstream onto the well pad.**

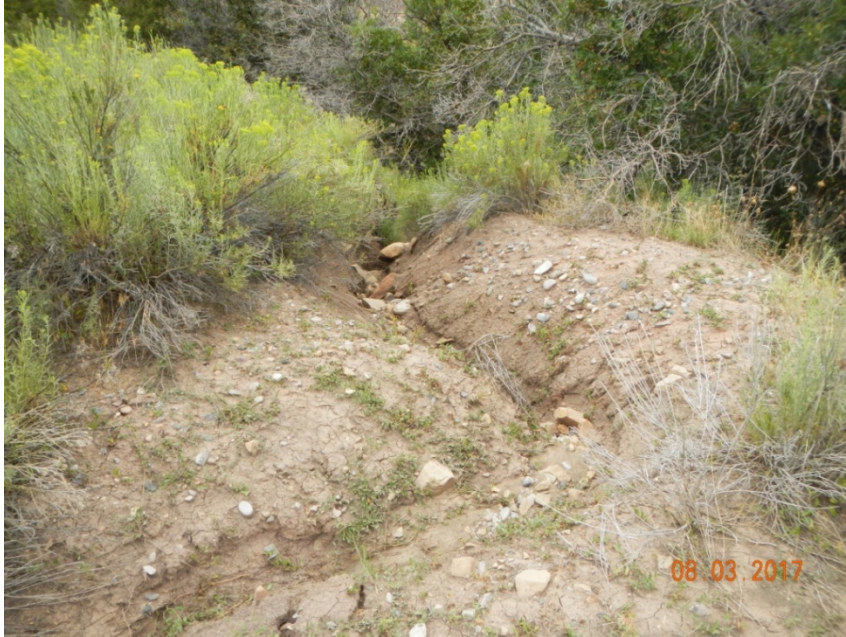
**Photo 5: View of erosional channel shown in Photo 4 facing downstream in the northern portion of the project area.**

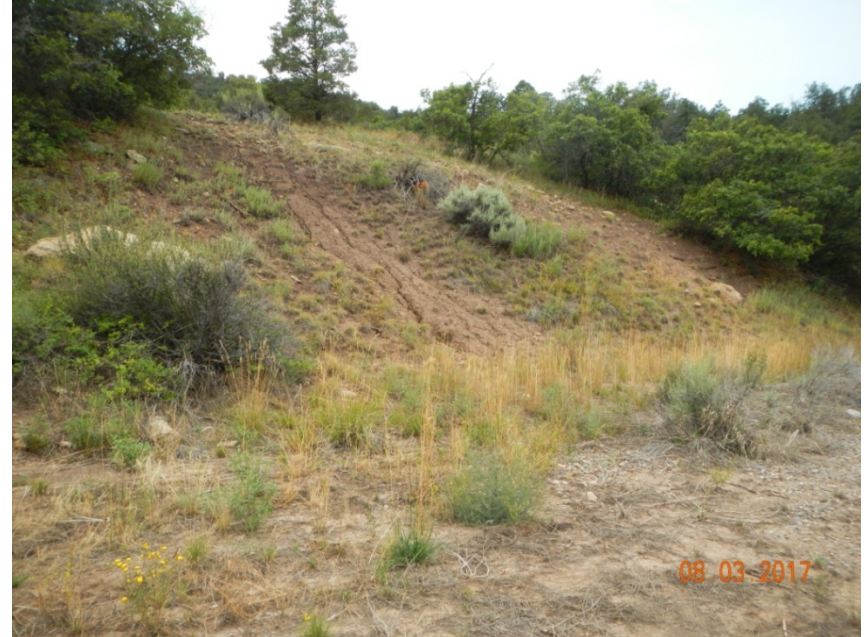
**Photo 6: View of the southern portion of the project area from the eastern edge facing southwestward. Rilling is occurring on the cut-slope.**
