Inspection Photos  
Location Name: Wolf Mountain 15-2-7-87  
API: 05-107-06222

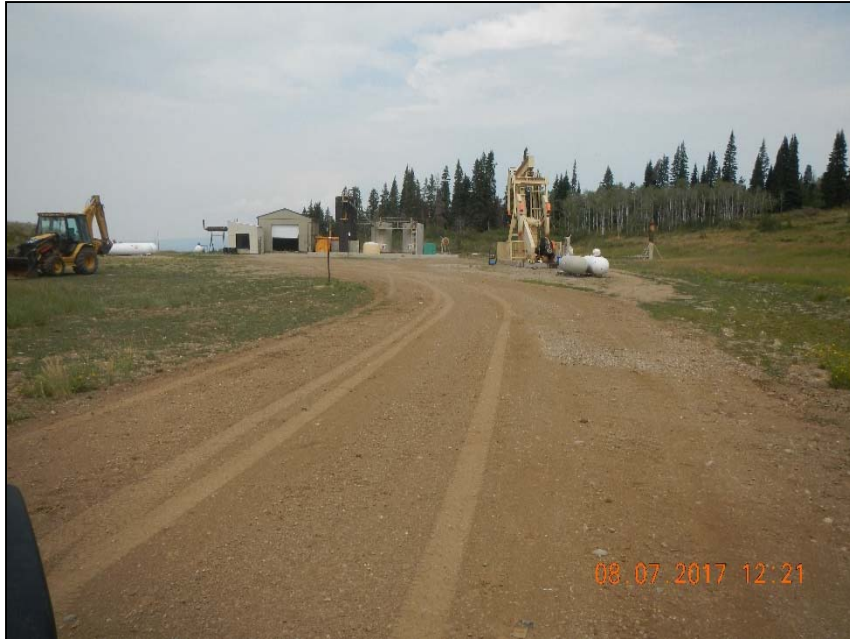
**Photo 1. Overview of location taken at entrance facing north.**

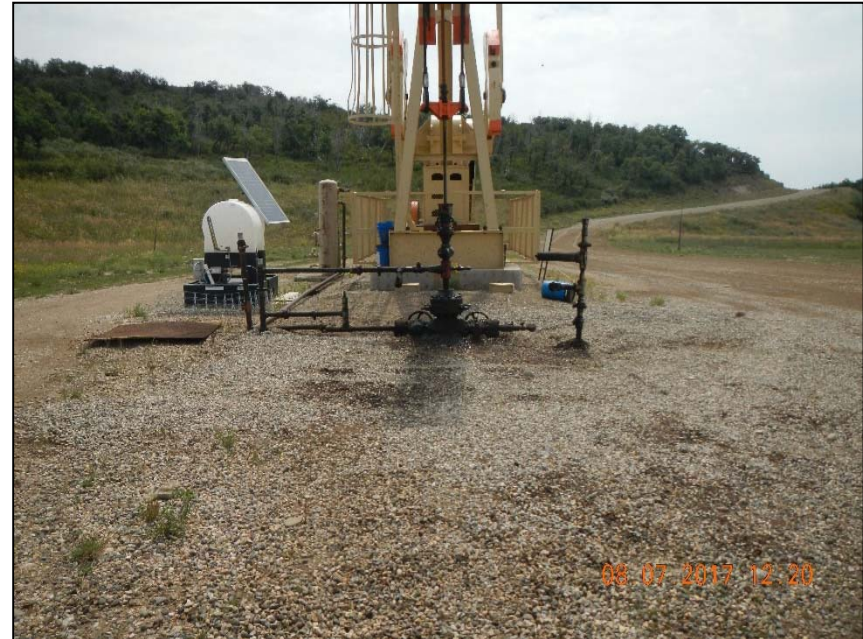
**Photo 2. Fresh gravel with staining visible underneath. Lube oil stored without containment on left side of pump jack.**

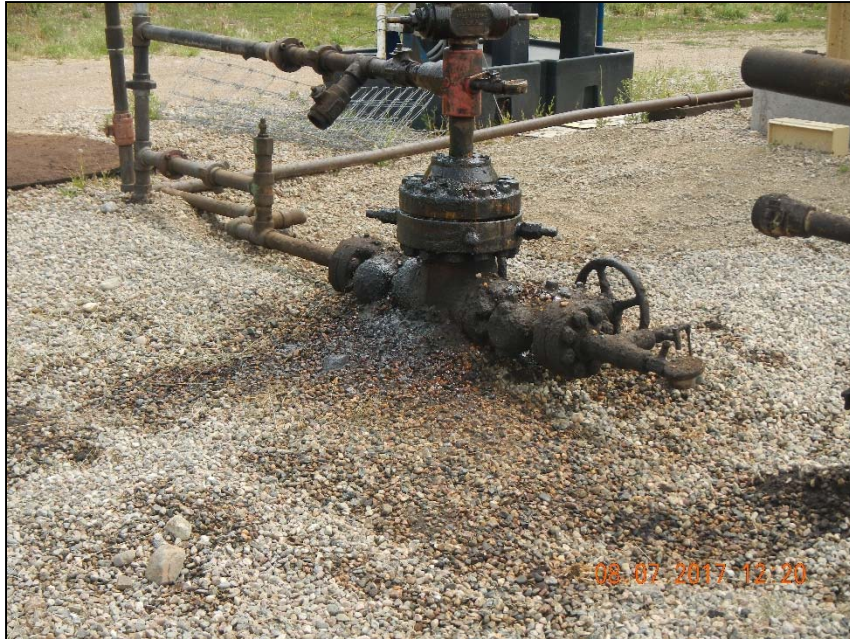
**Photo 3. Close-up of ongoing leak and staining at wellhead.**

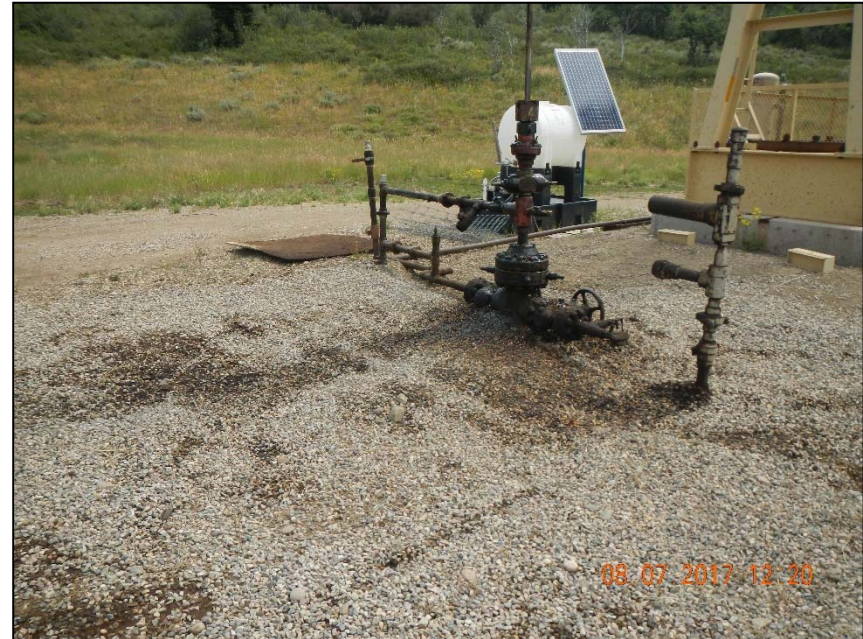
**Photo 4. 2" steel riser not in use. Stained soil covered by fresh gravel.**
