Inspection Photos
Location FARM RANCH EXP 2
API:05-001-07672

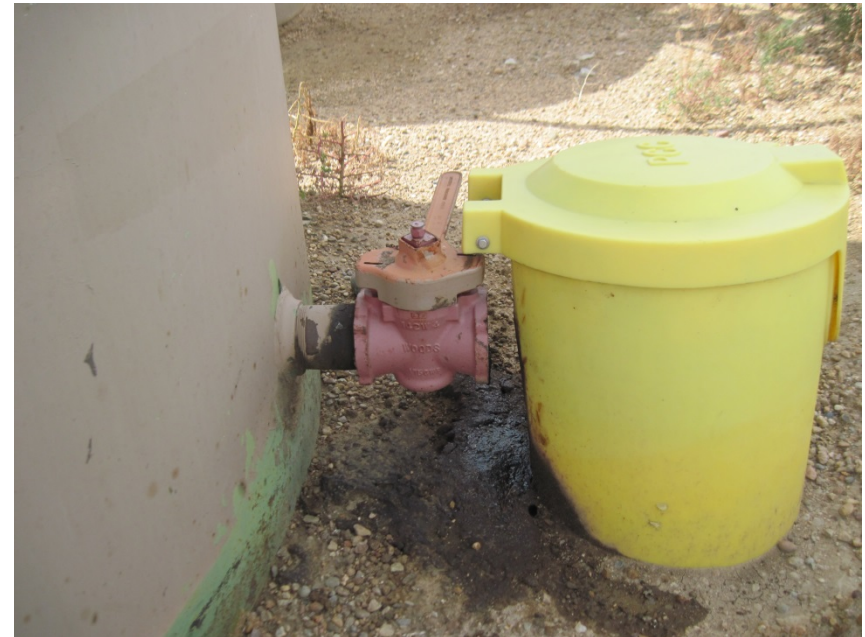
LOAD LINE VALVE NO CAP ON VALVE and stained soil
