- Annala Federal A 1 05-067-07741

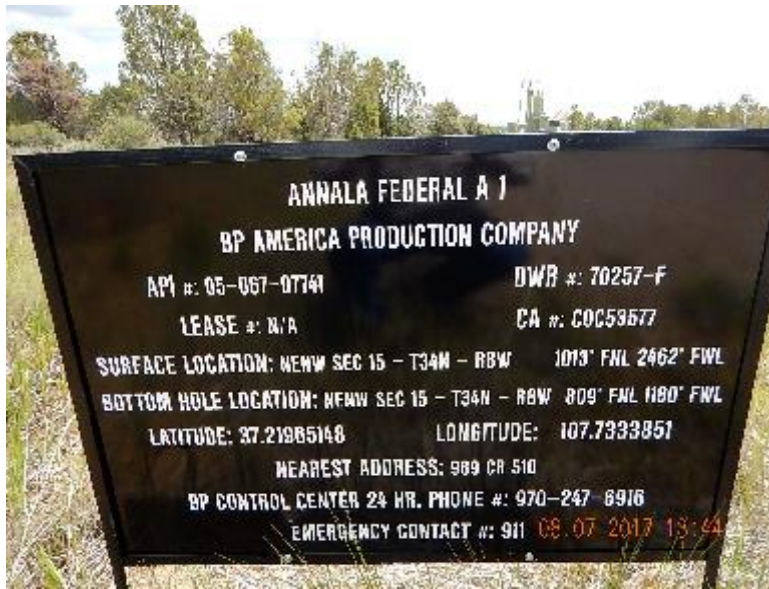
Photo 1: Wellhead sign.

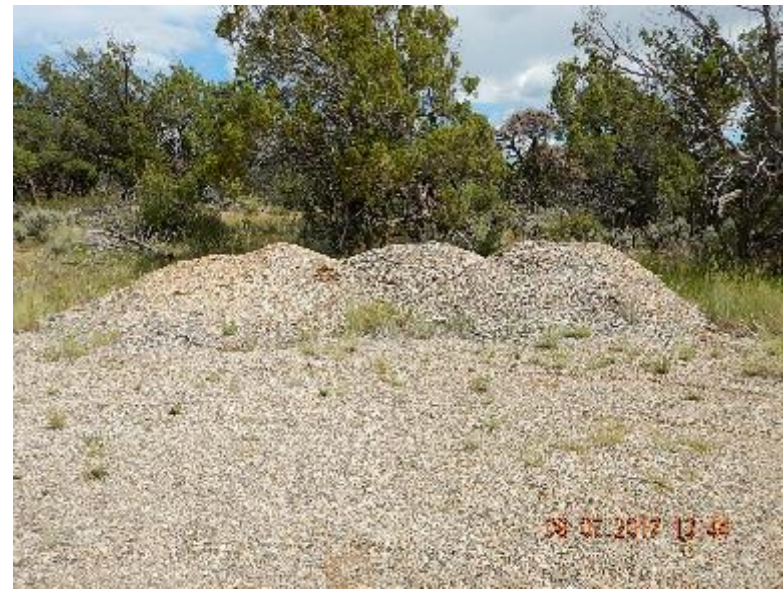
Photo 2: Mulch piles on SE corner.

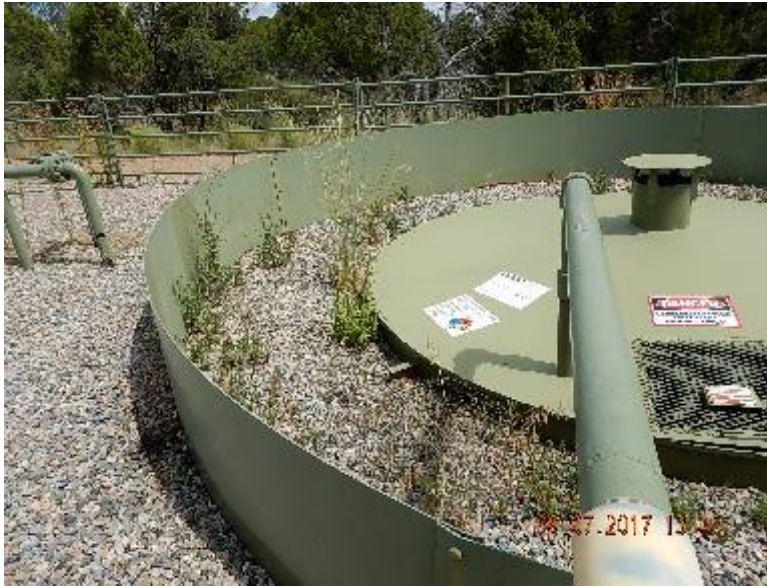
Photo 3: Right side view of weeds and grass in produced water tank base area.

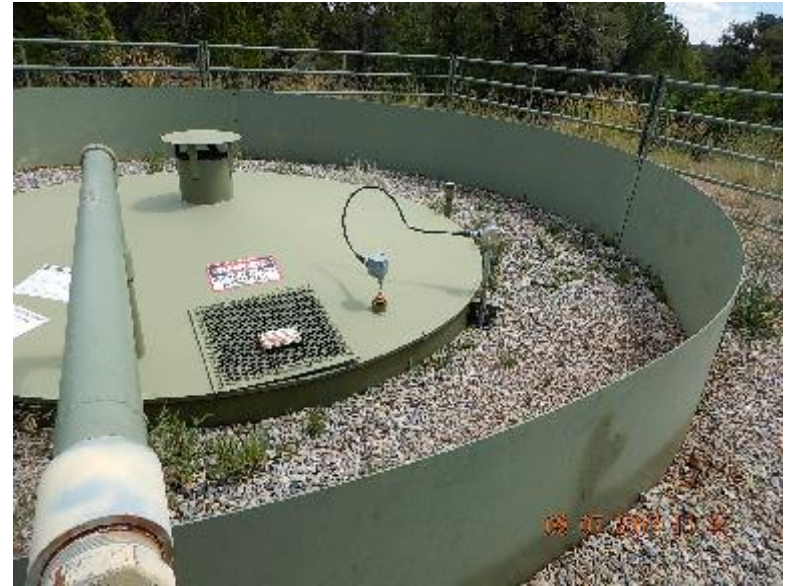
Photo 4: Left side view of weeds and grass in produced water tank base area.

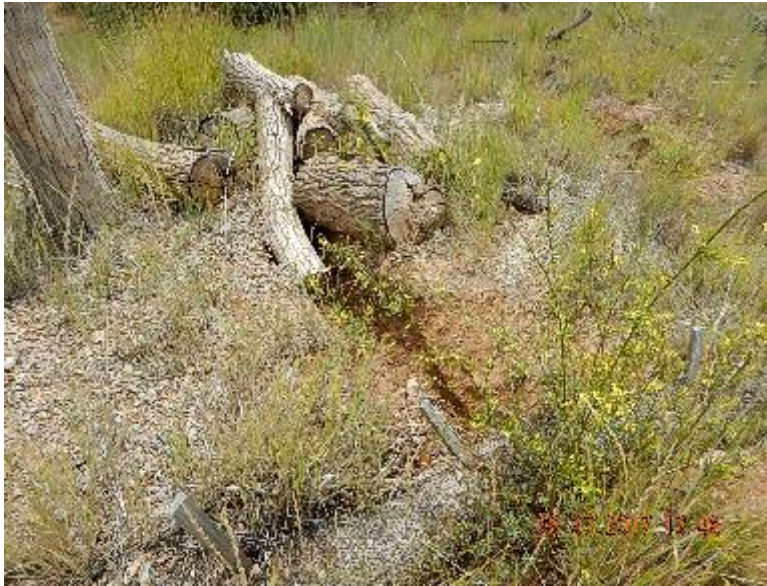
Photo 5: Failed waddle, erosion channel, and dumped wood.

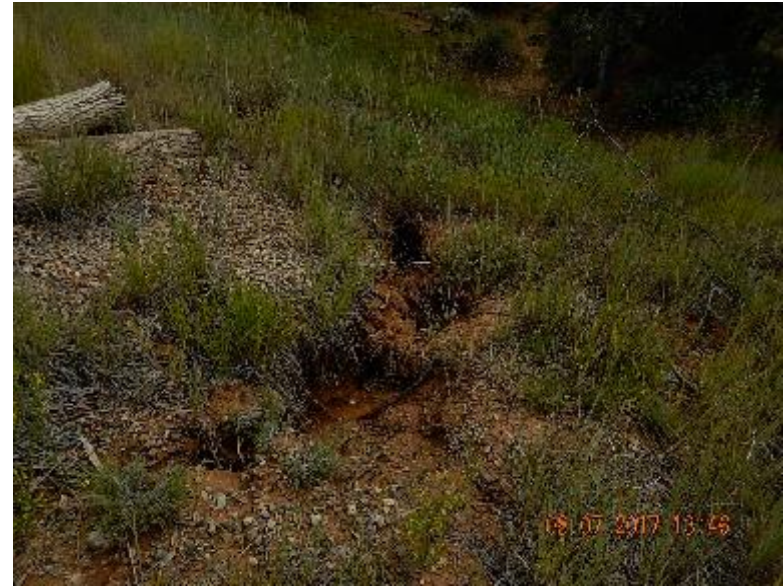
Photo 6: Erosion channel and additional wood on W perimeter.

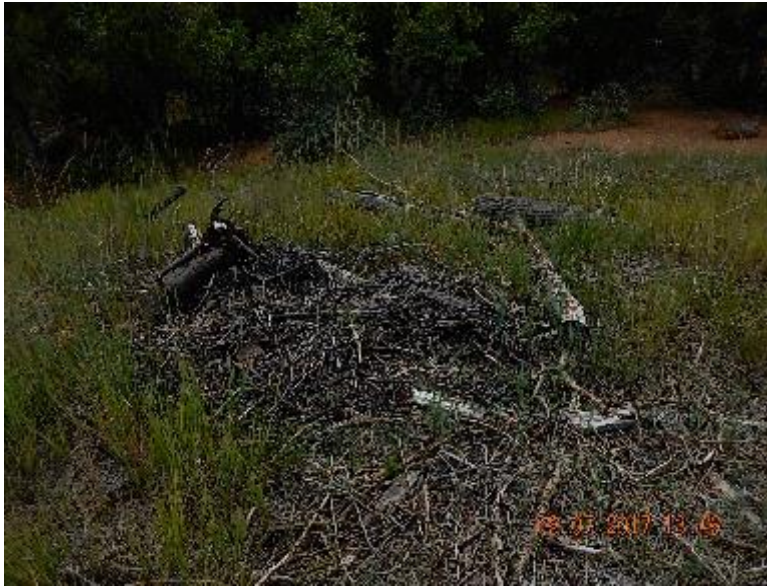
Photo 7: Wood debris.

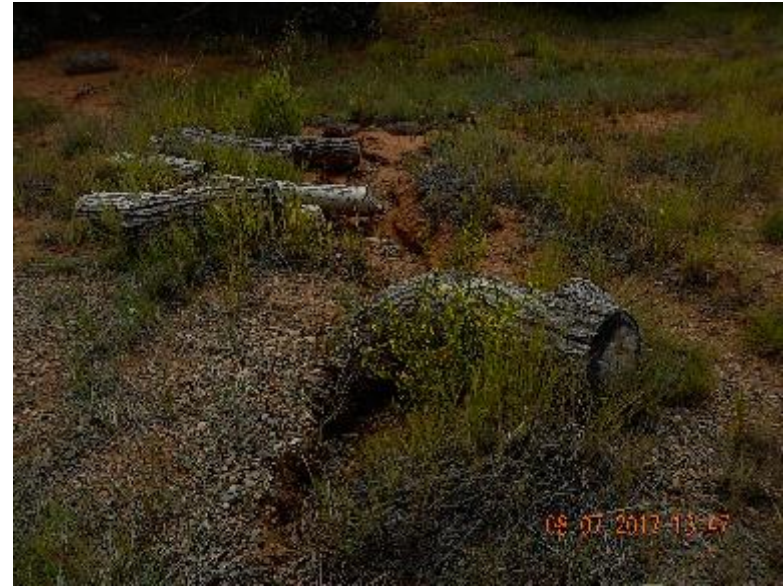
Photo 8: Erosion channel and additional cut wood dumped on location.

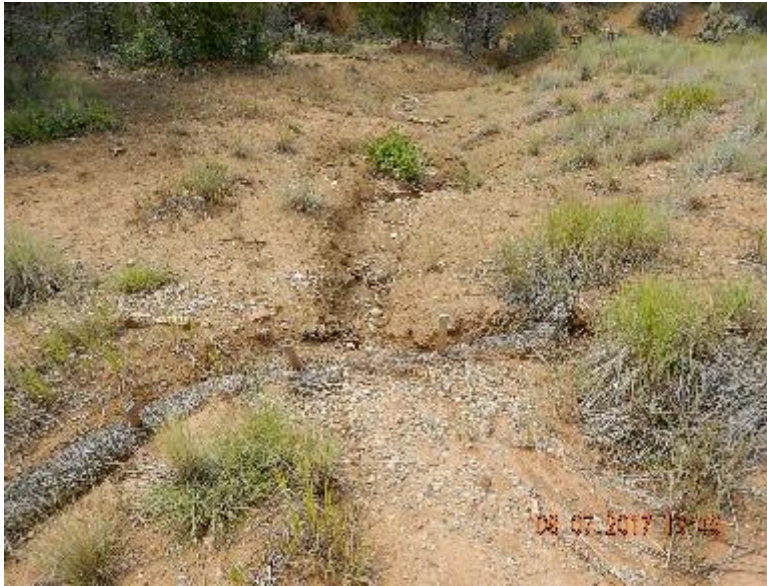
Photo 9: Full waddle and erosion channel.

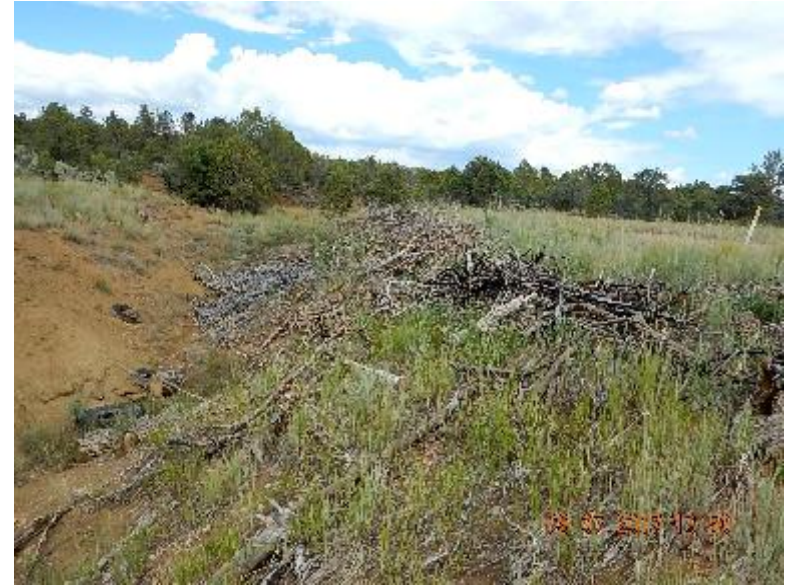
Photo 10: Dumped wood and debris in drainage on N perimeter.

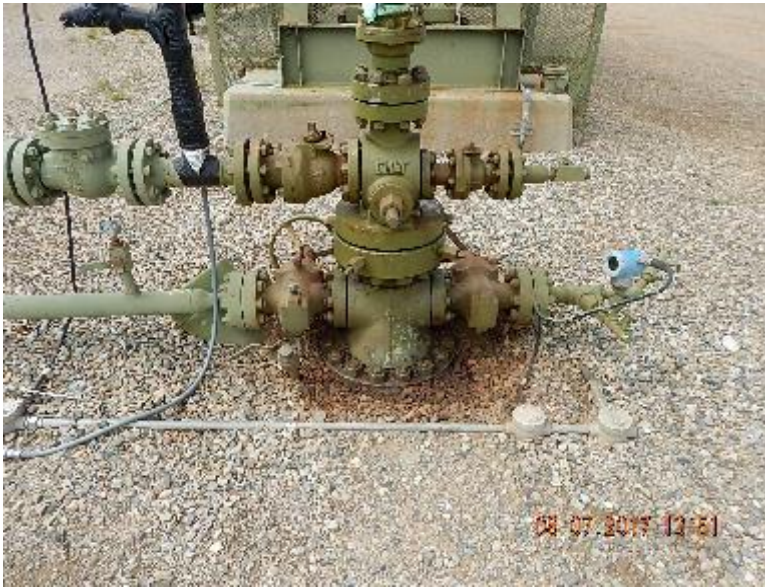
Photo 11: Impacted soil at wellhead.

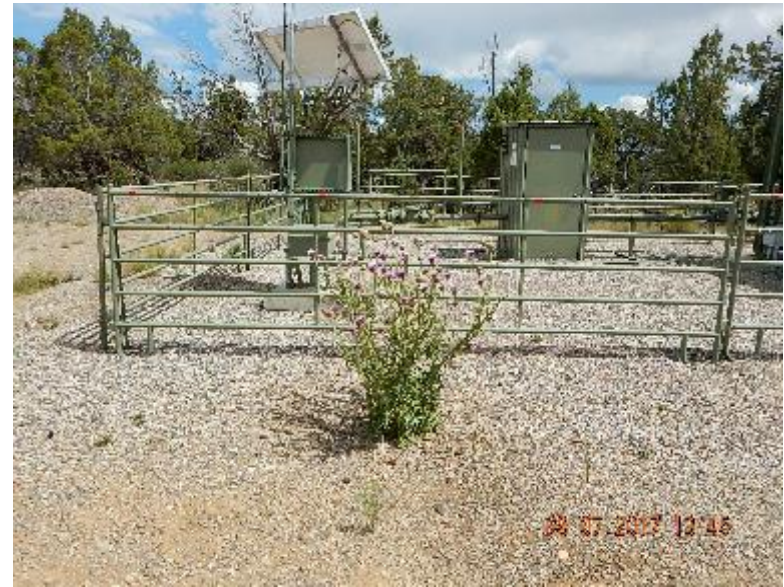
Photo 12: Canada Thistle on location.

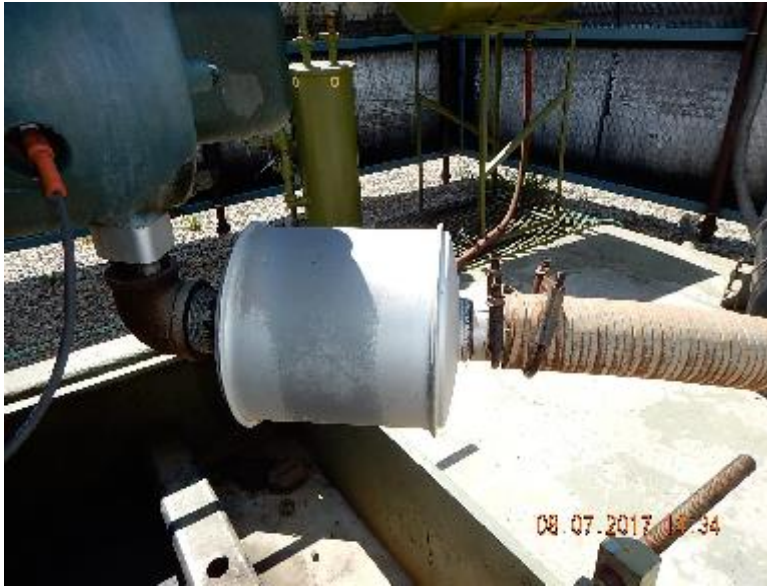
Photo 13: Muffler and connections at pump jack motor.

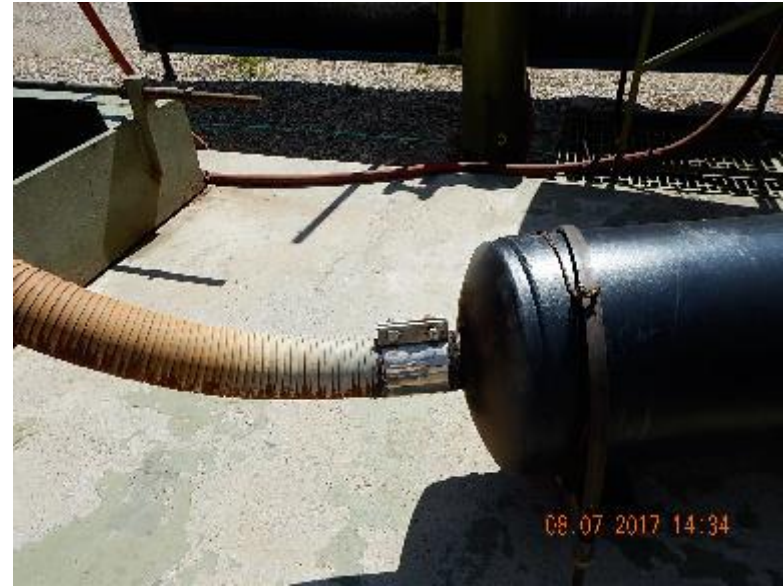
Photo 14: Flex pipe connection to in-line muffler.

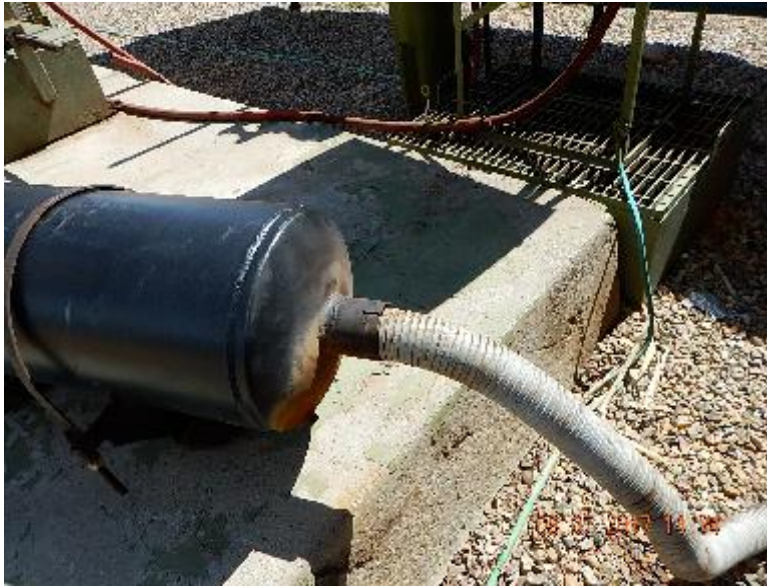
Photo 15: Flex pipe connection at back of in-line muffler.

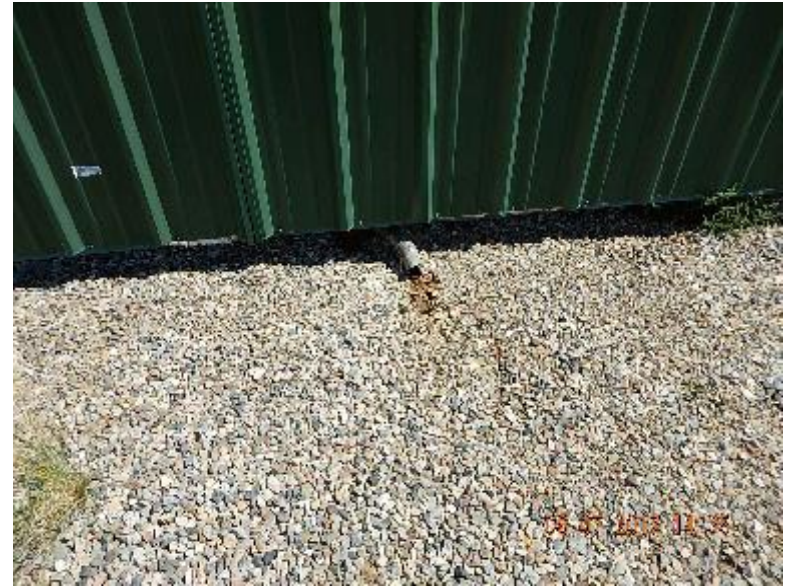
Photo 16: Flex pipe fed under sound wall.

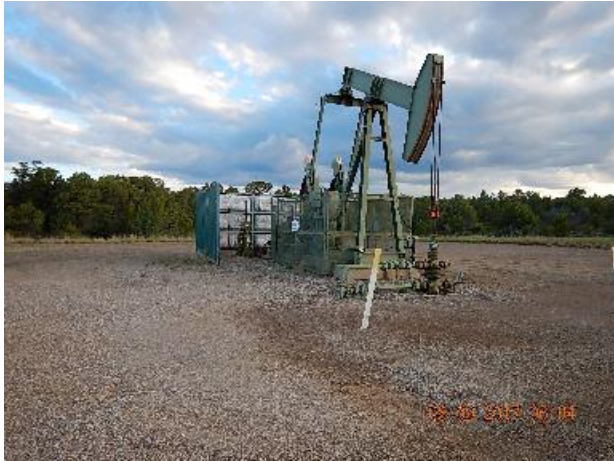
Photo 17: Photo of pump jack with sound walls taken from SE corner of location.

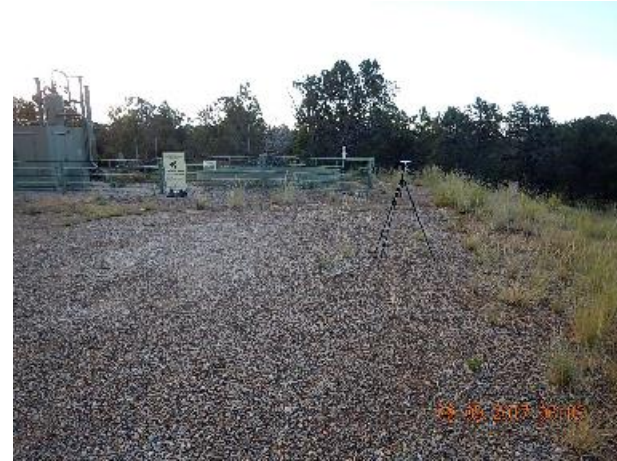
Photo 18: Sound meter set up just out from SE corner of location.
