Inspection Photos
Location Name: Raisley 21-34
API: 05-123-16741

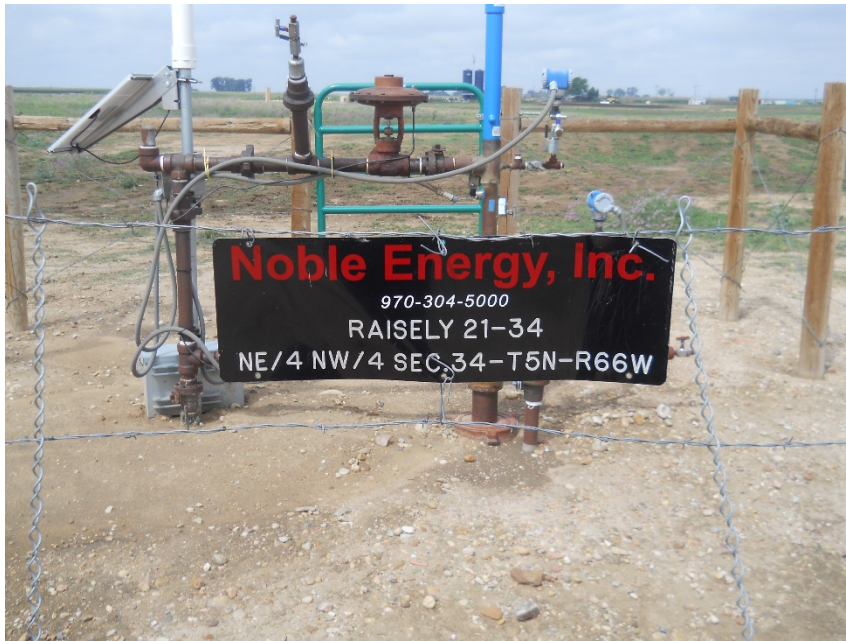
Wellhead sign looking west

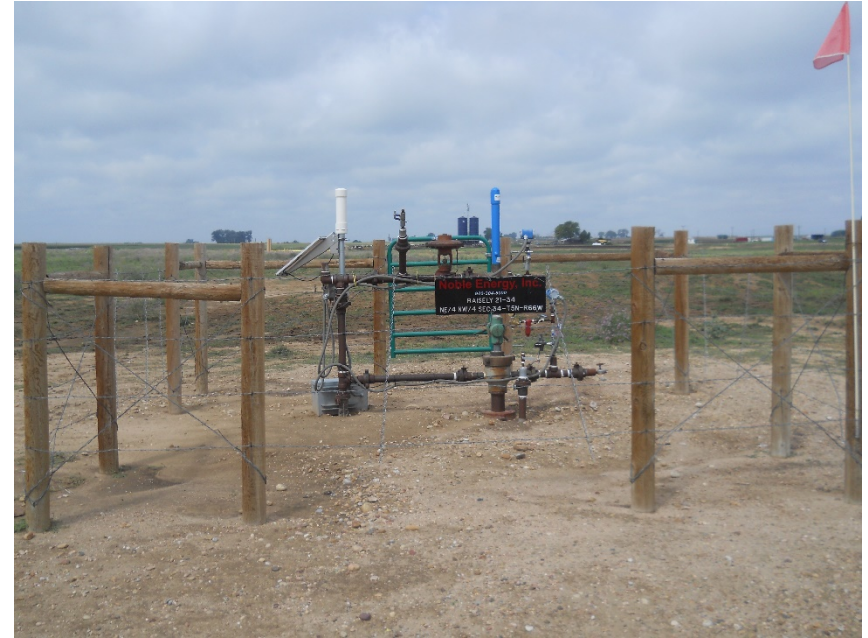
Wellhead looking west

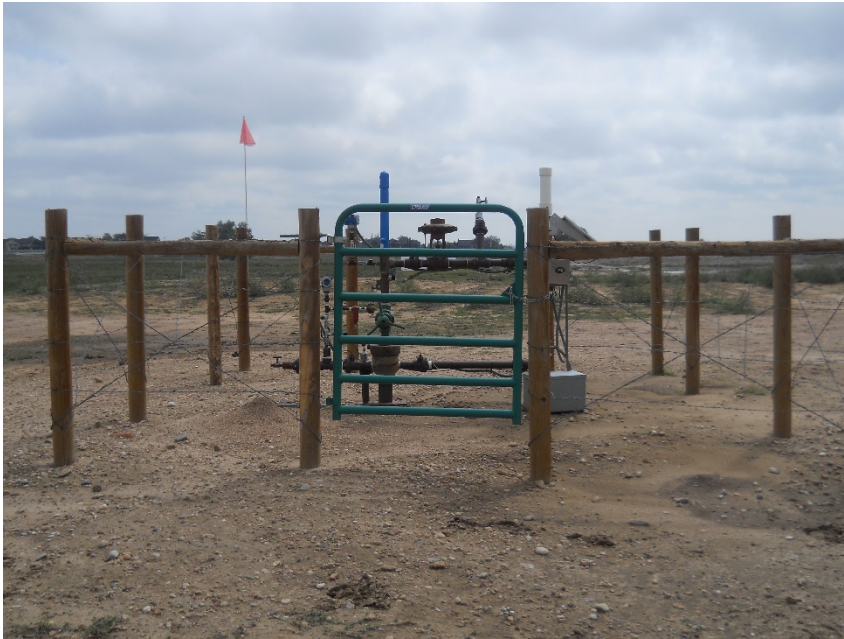
Wellhead looking east

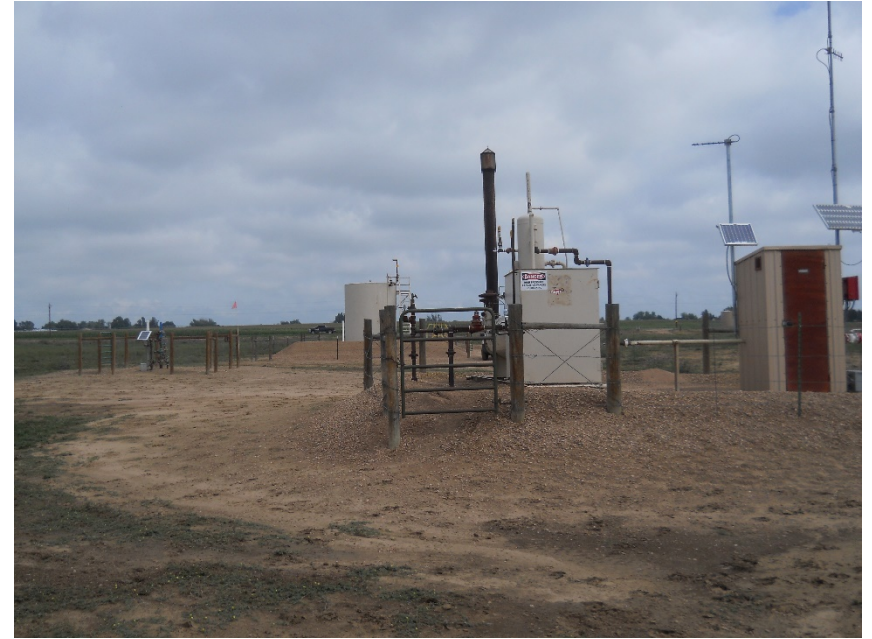
Battery looking north

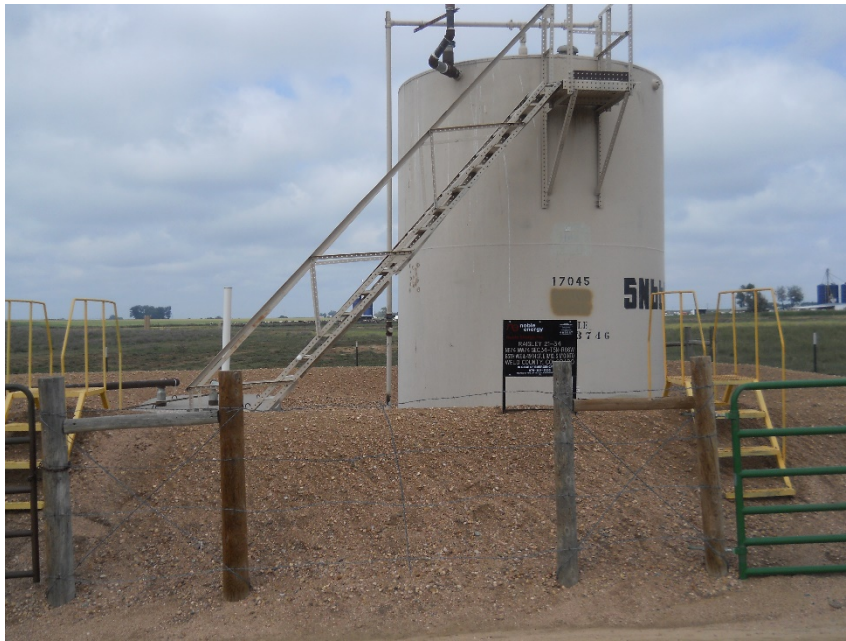
Tank battery looking north

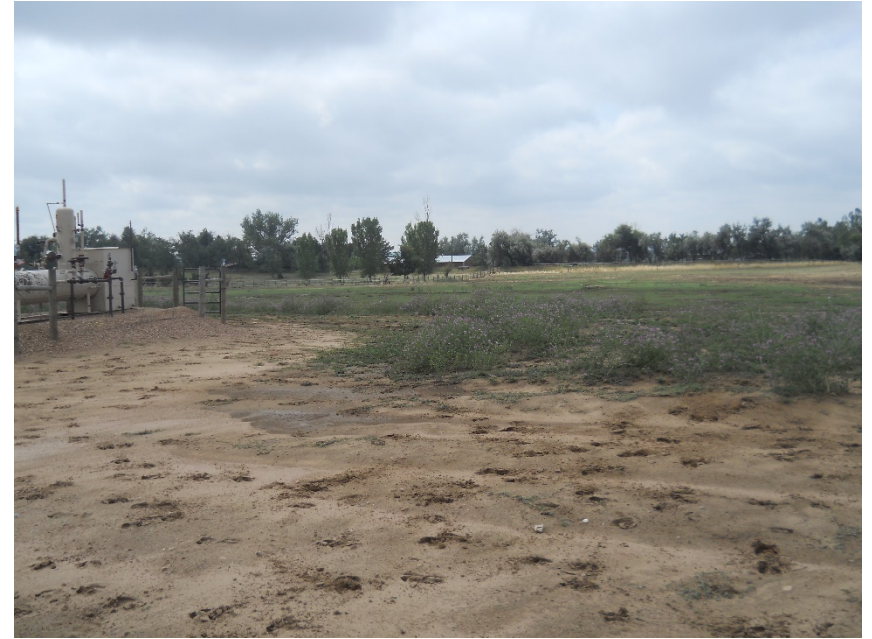
Actively growing weeds west side of separator

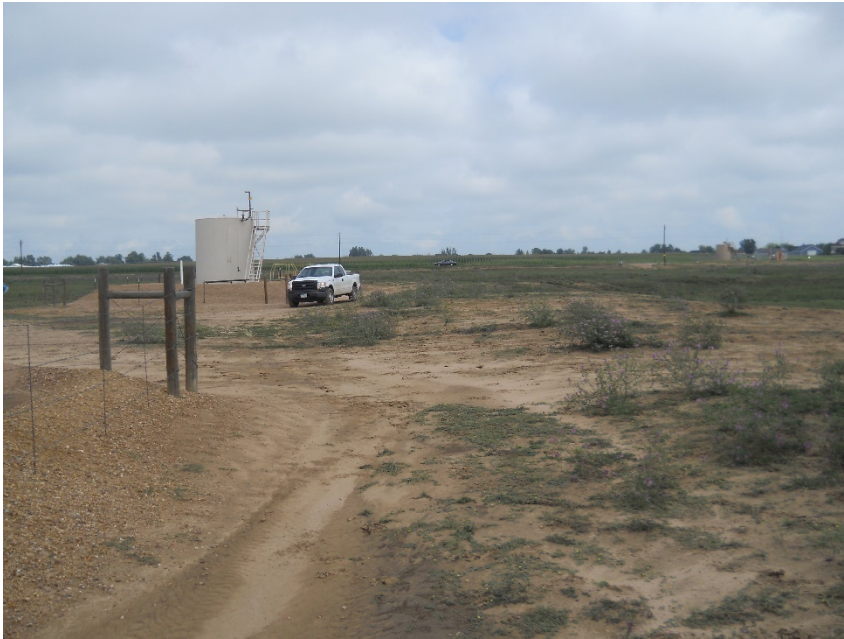
East side of separator looking north. Actively growing weeds

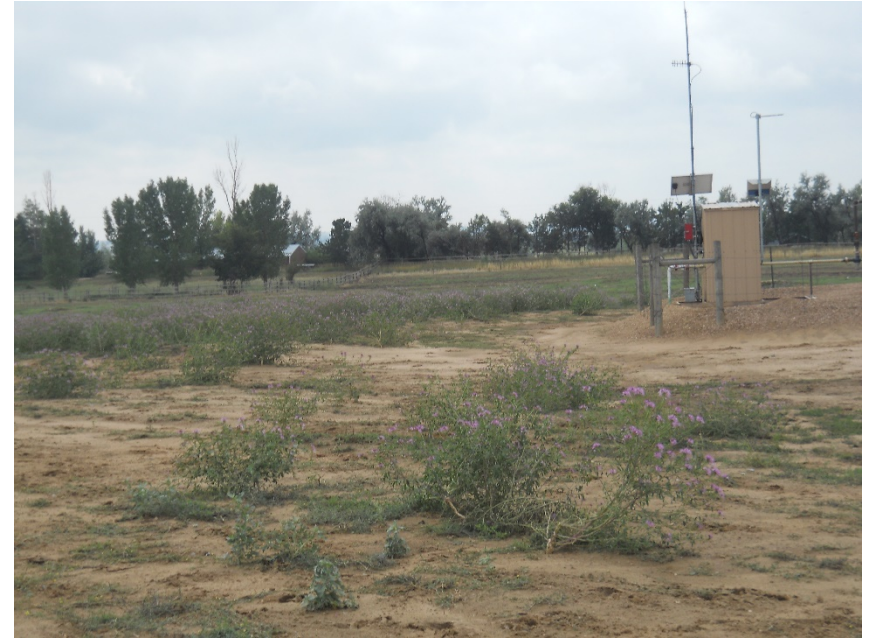
Southeast edge of location looking west. Actively growing weeds

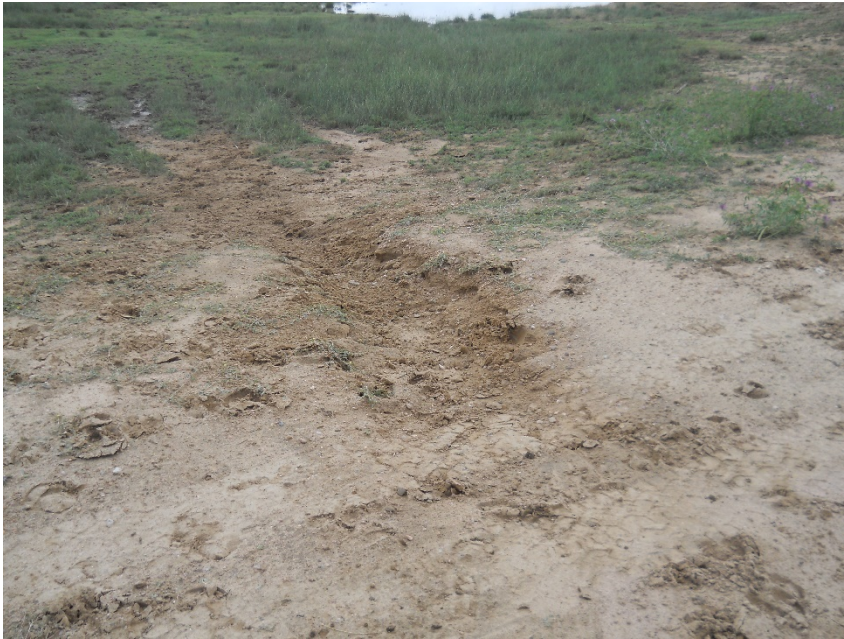
Location washing out northeast of tank battery (1/2 spots)

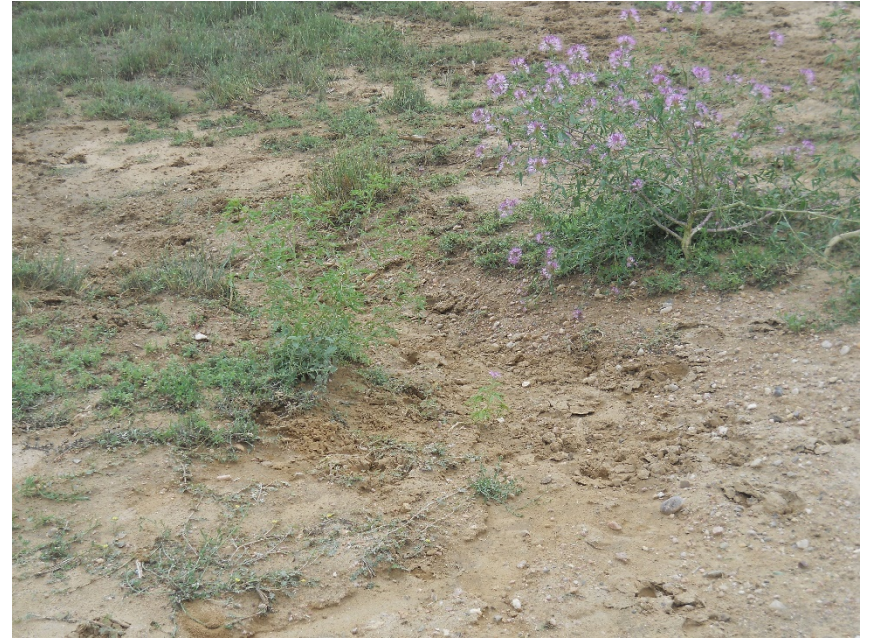
Location washing out northeast of tank battery (2/2 spots)

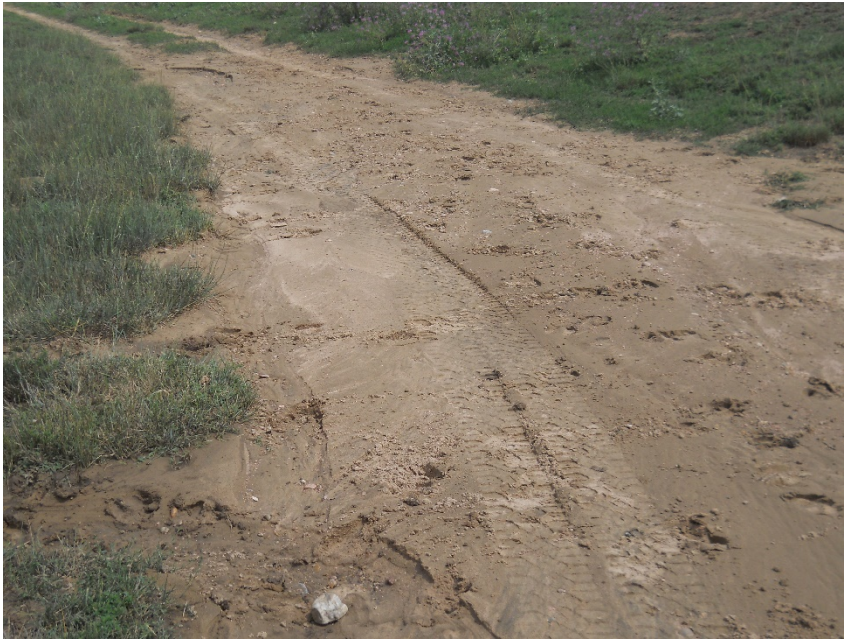
Lease road washing out headed northeast before curve

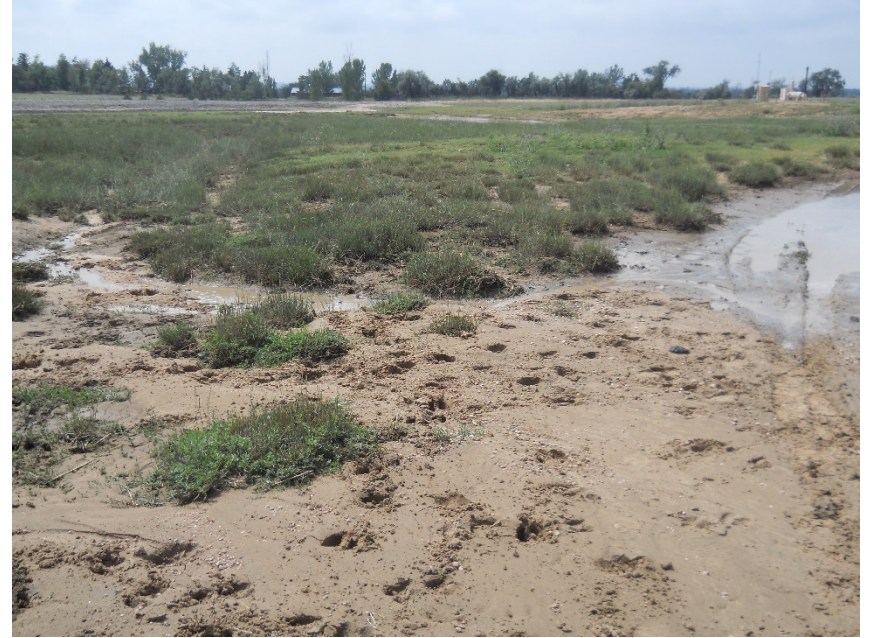
Lease road looking south before curve. Standing water actively draining through lease road to the east

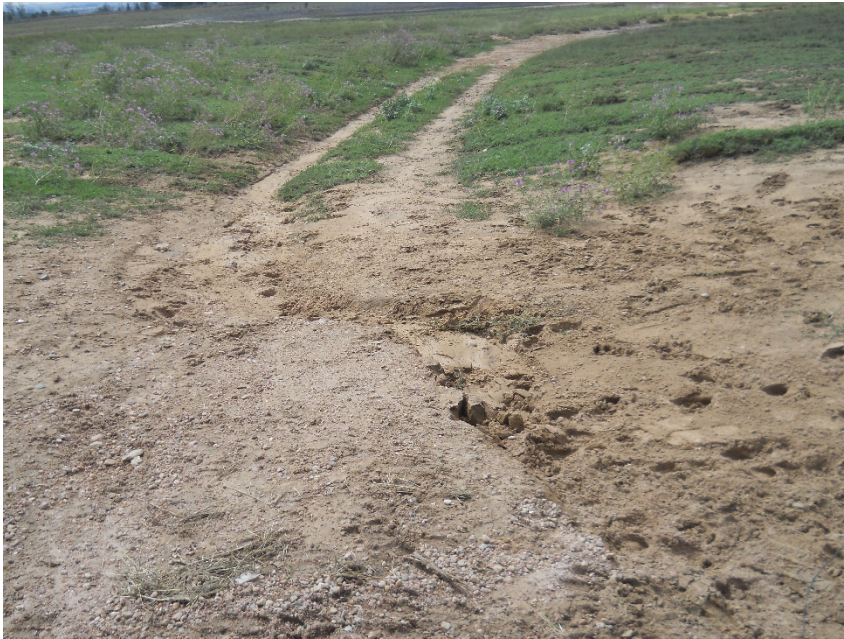
Battery entrance looking south. Lease road washing out, carrying sediment off.

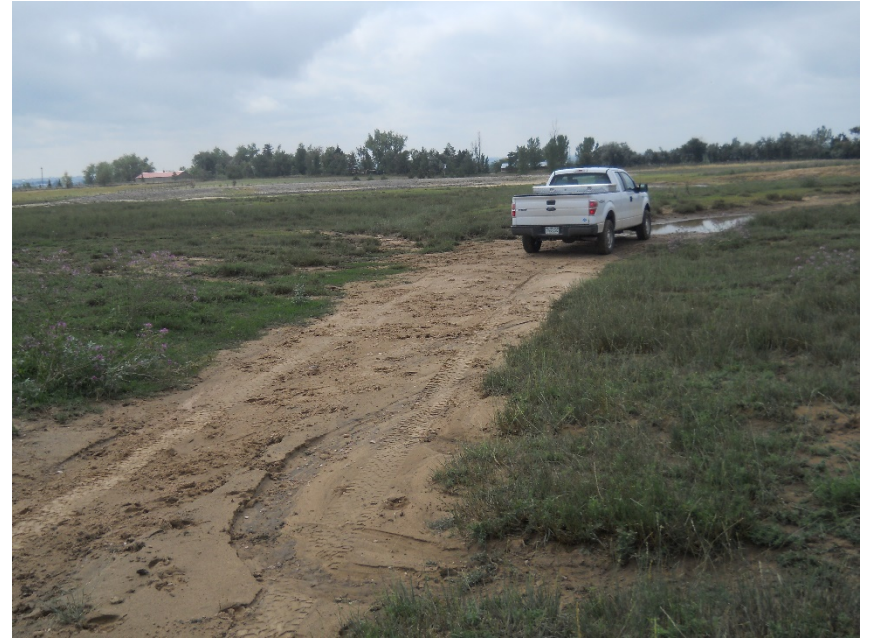
Lease road looking south before curve
