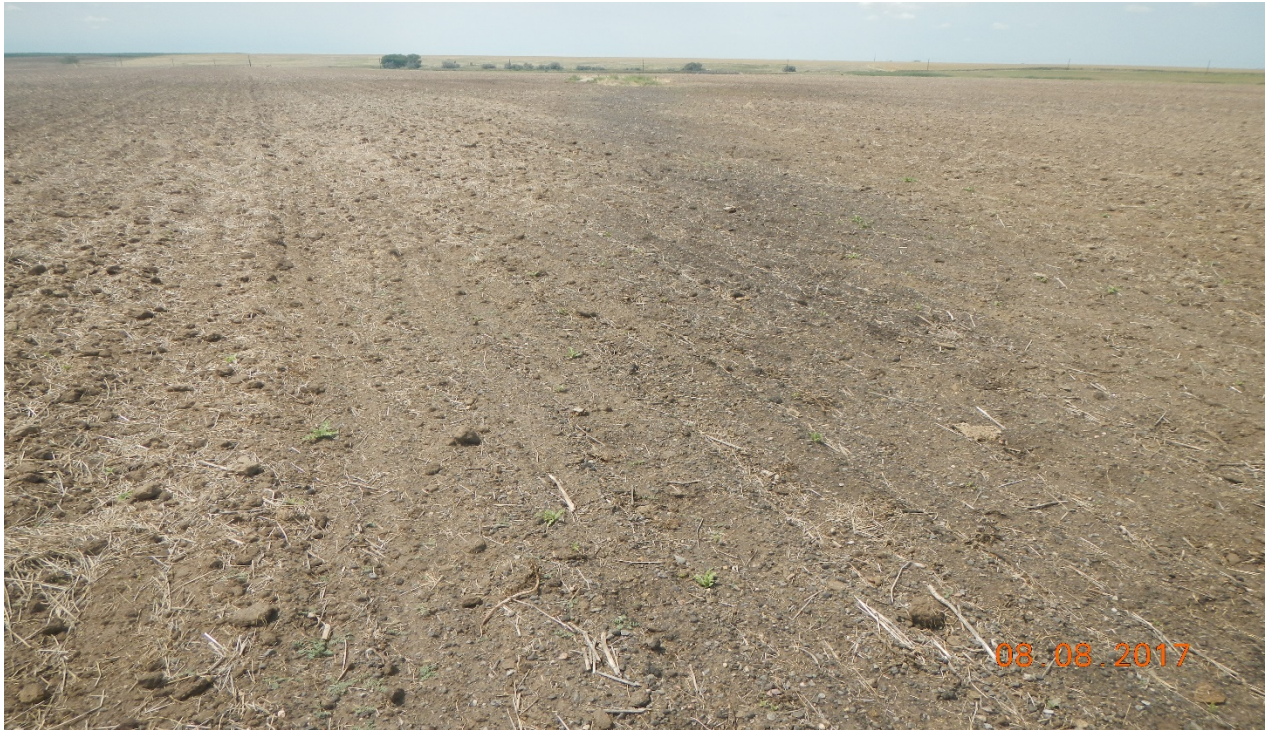
photo 1: Facing west along the former access road. The field has recently been plowed.

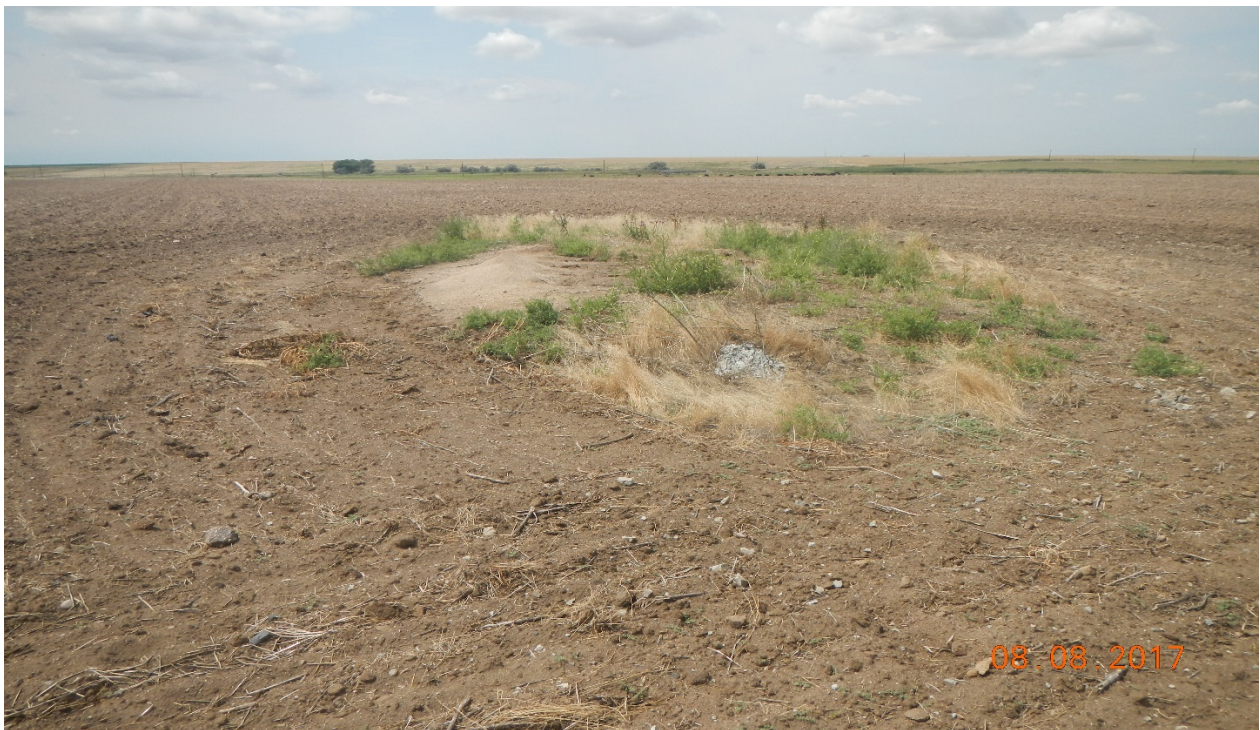
photo 2: The well site has not been plowed and properly decompacted.

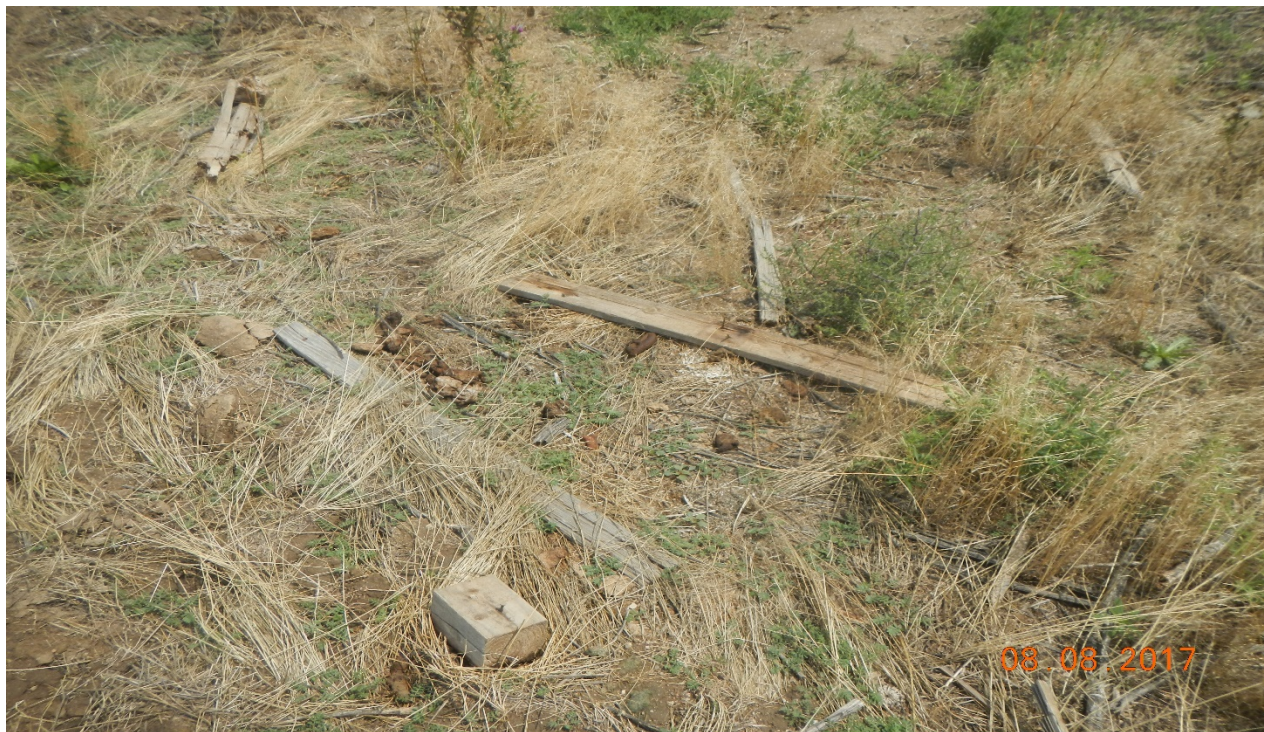
photo 3: There is wood boards and various debris that remains.

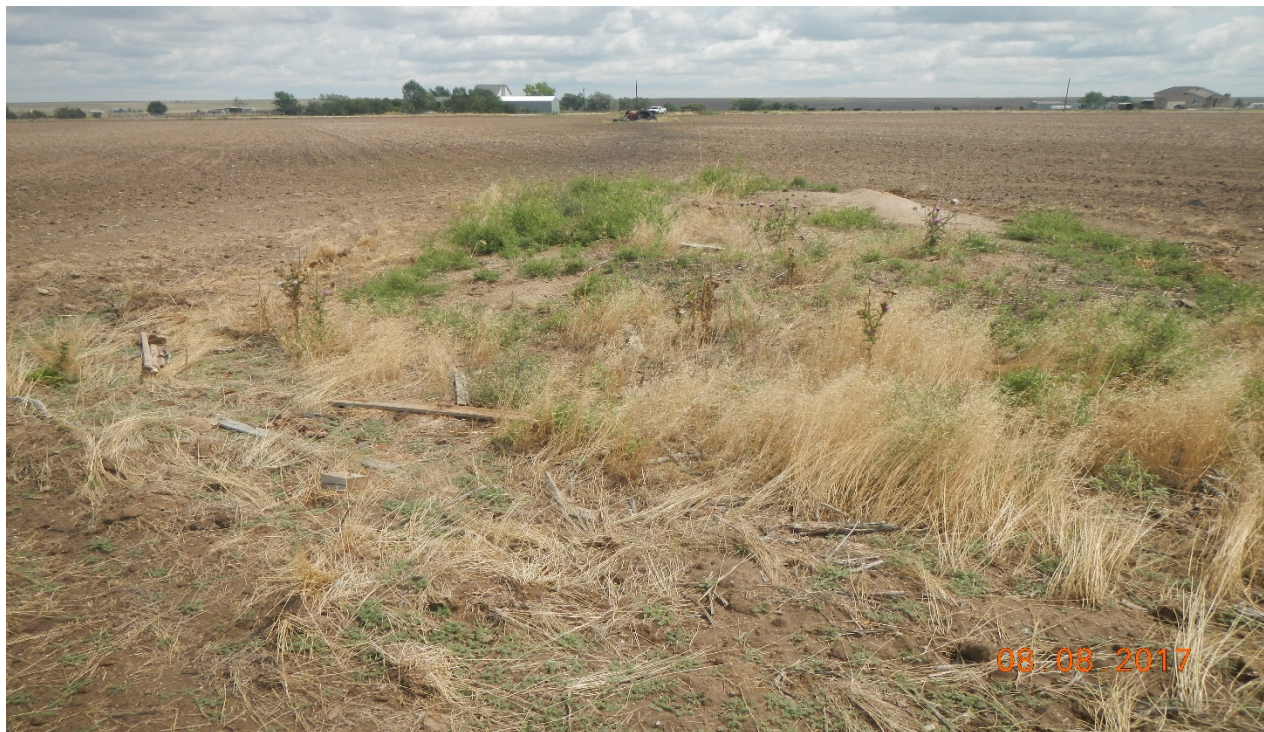
photo 4: Facing back east at the well site.
