Inspection Photos
Location Name: Susie 11-9
API: 05-123-10463

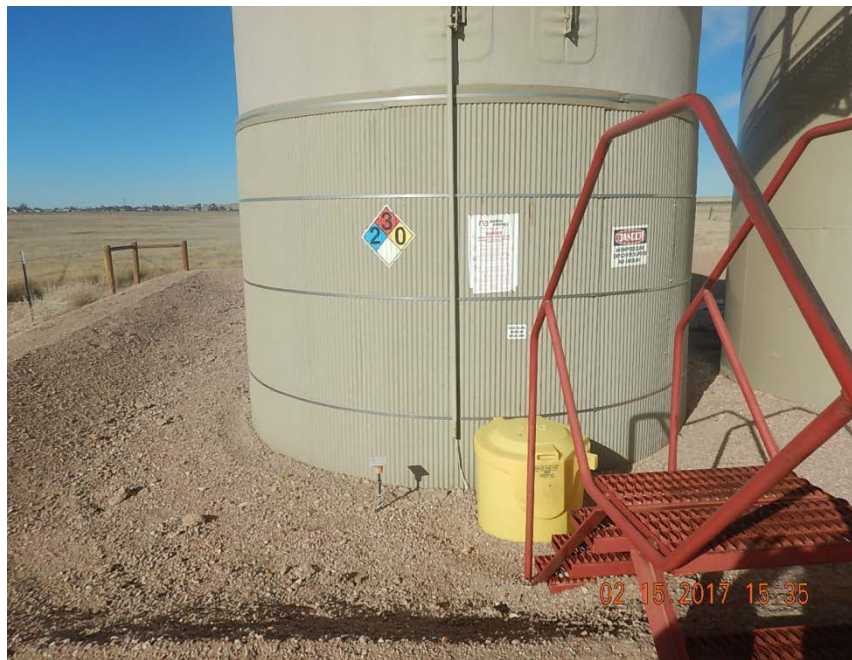
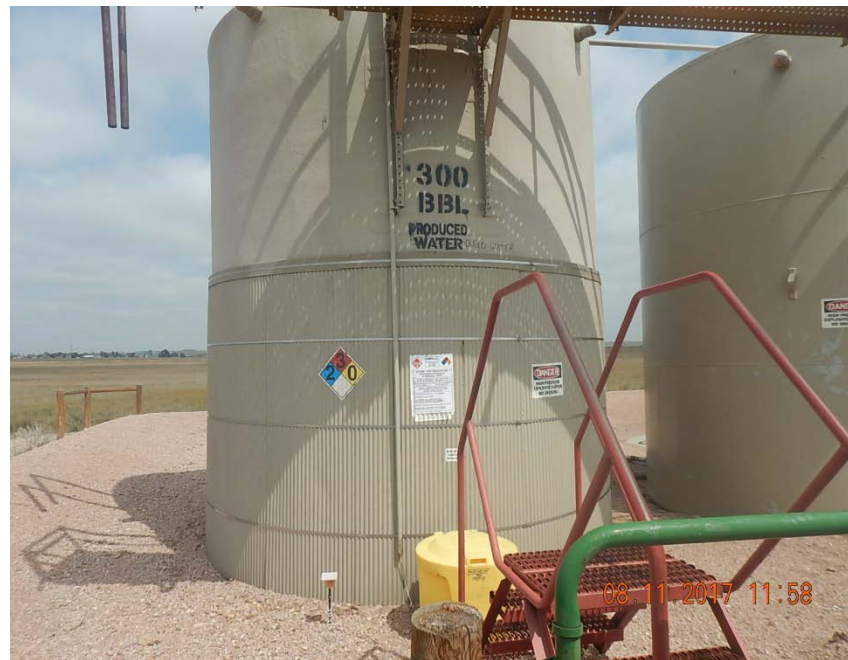
Photo 1: Produced water tank has capacity and contents

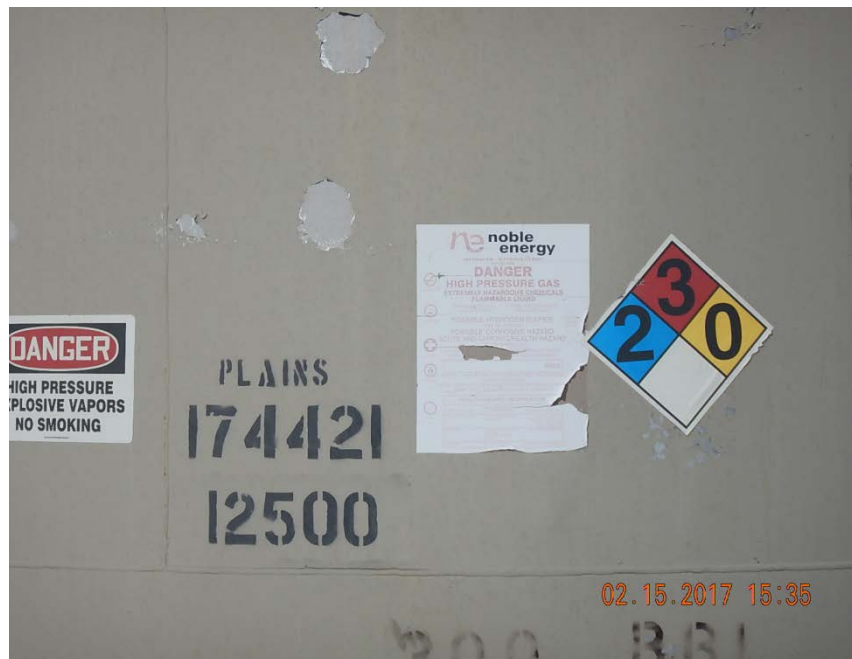
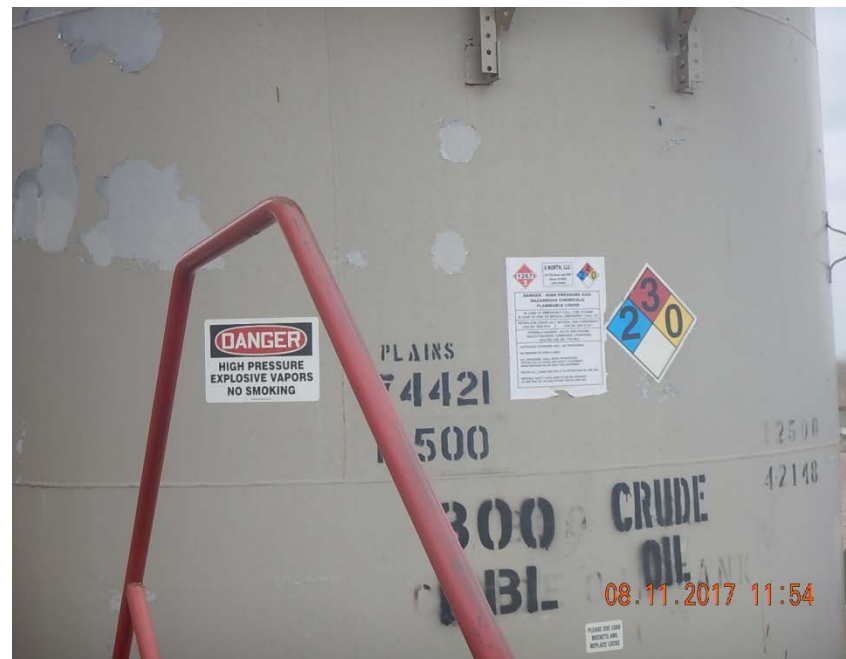
Photo 2: Decals from prior operator have been obscured

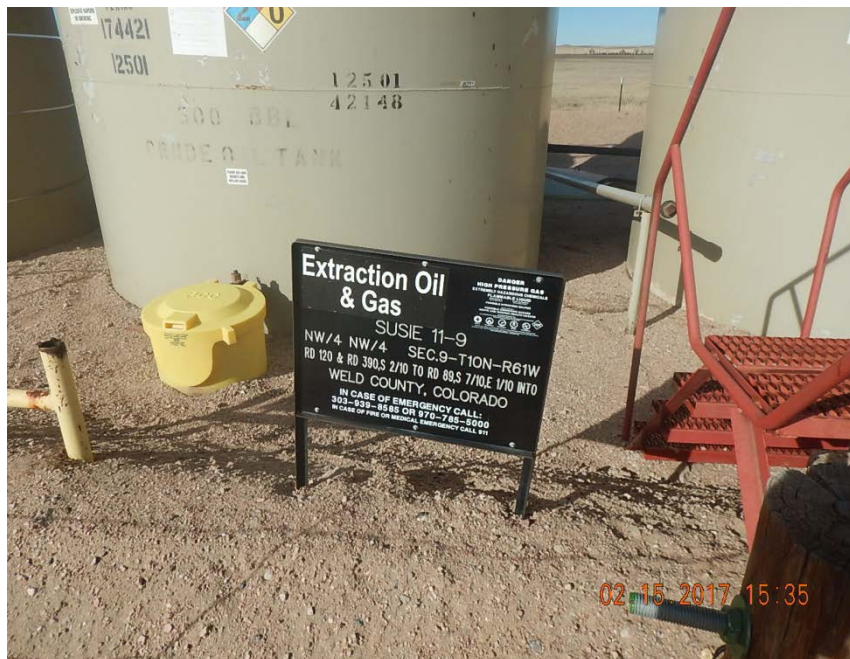
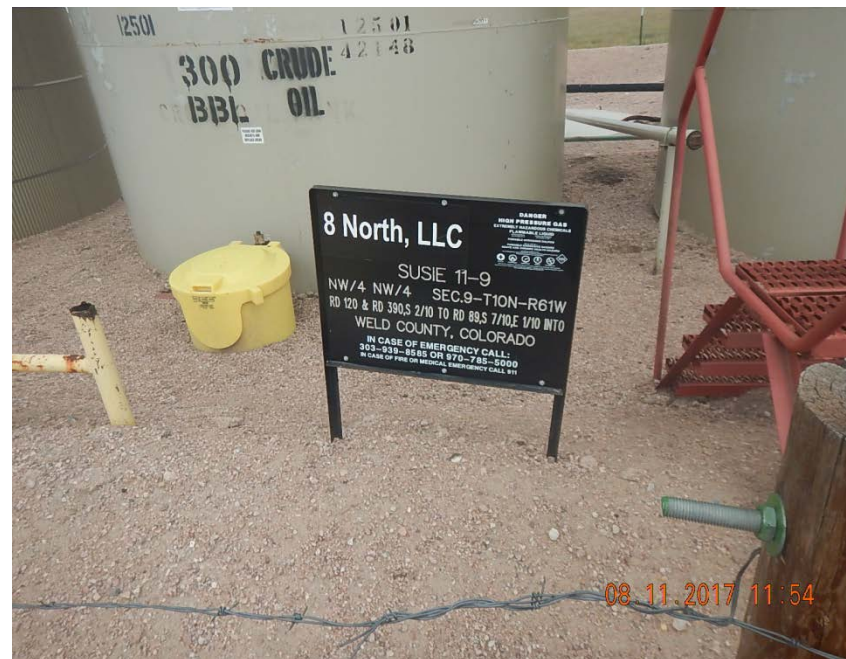
Photo 3: Battery sign is for current operator

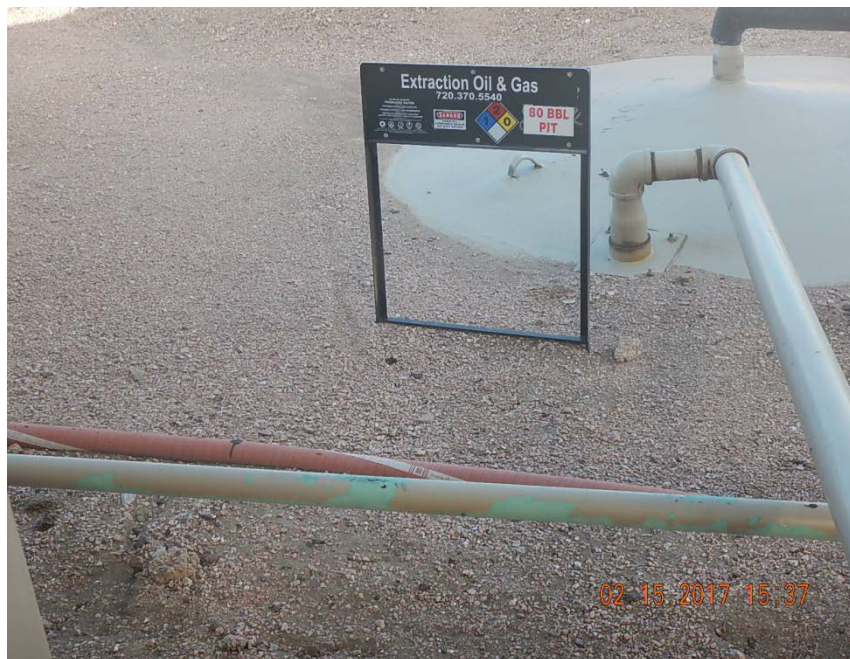
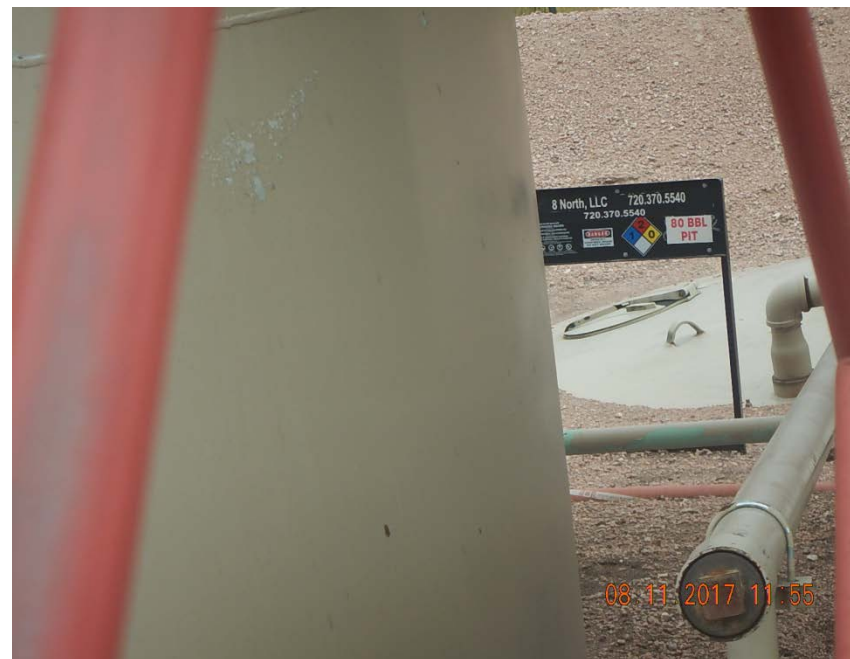
Photo 4: Sign at produced water vault is for current operator

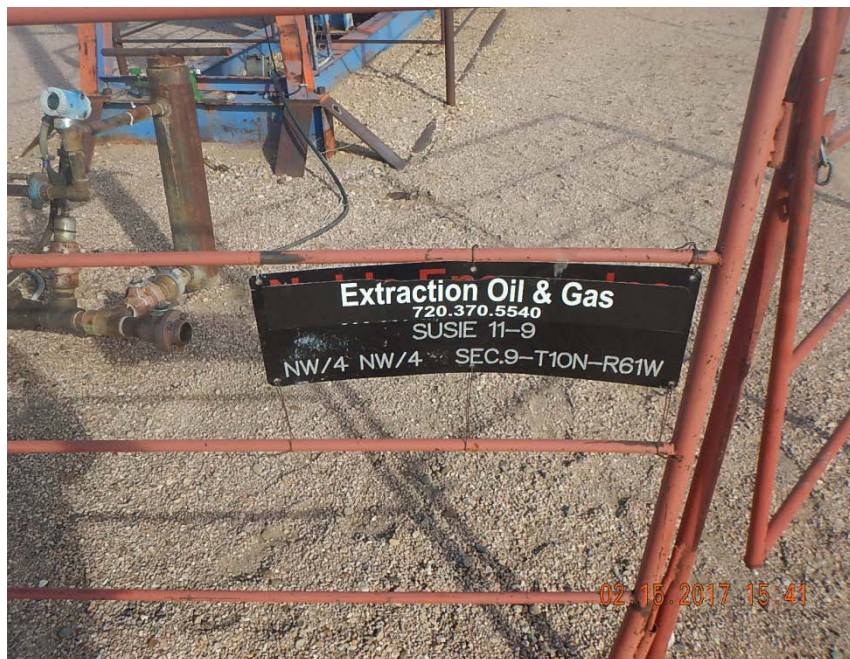
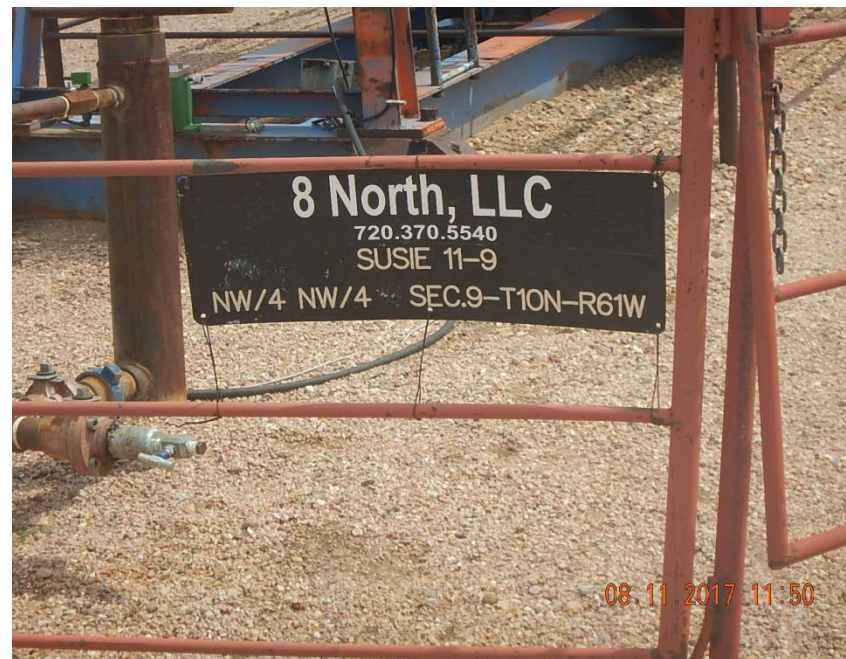
Photo 5: Wellhead sign is for current operator

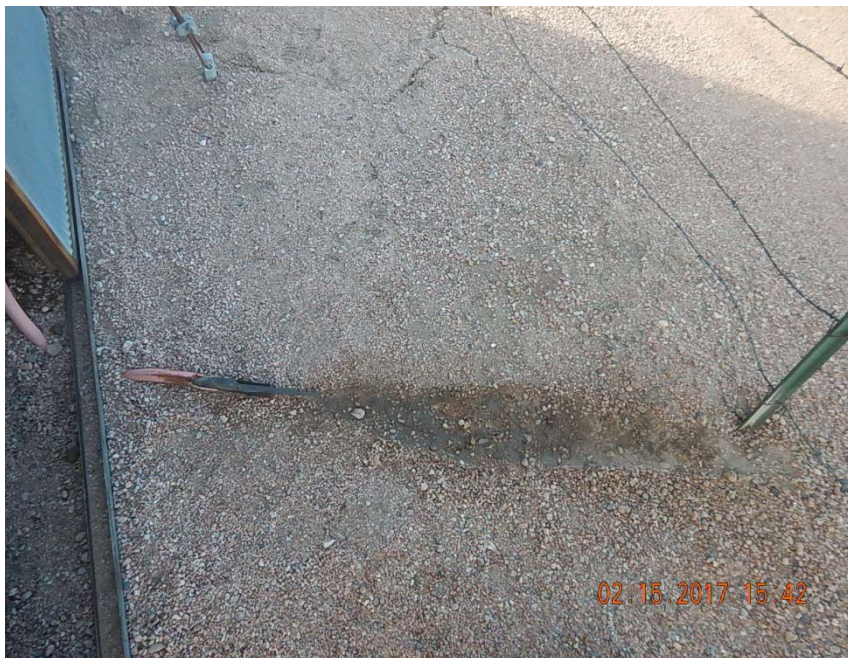
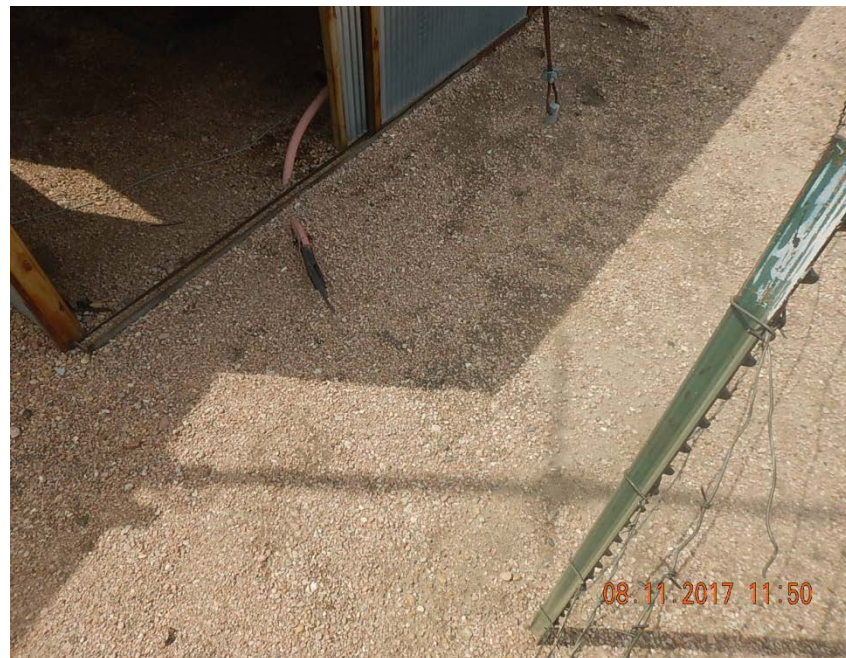
Photo 6: Stained soil at drain has been removed or remediated

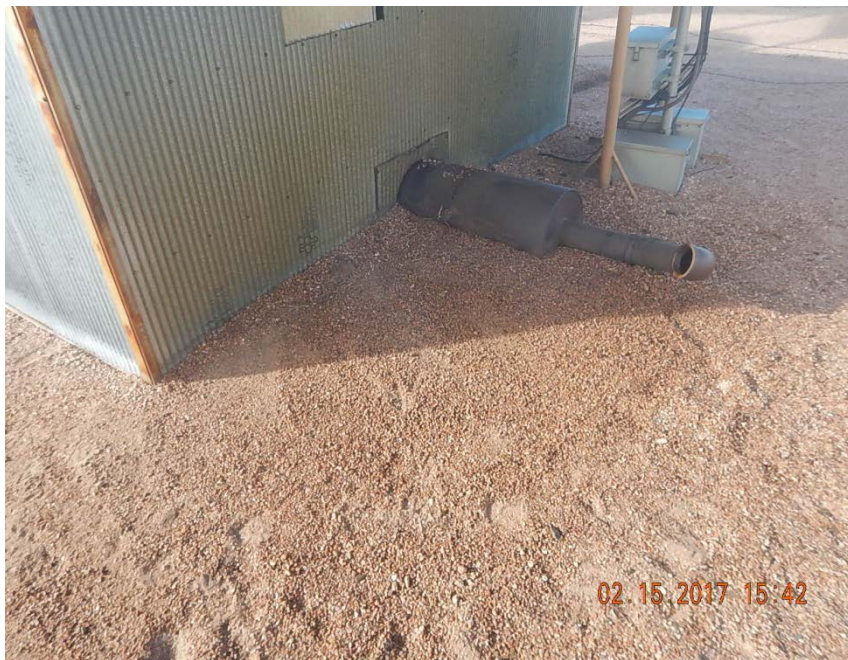
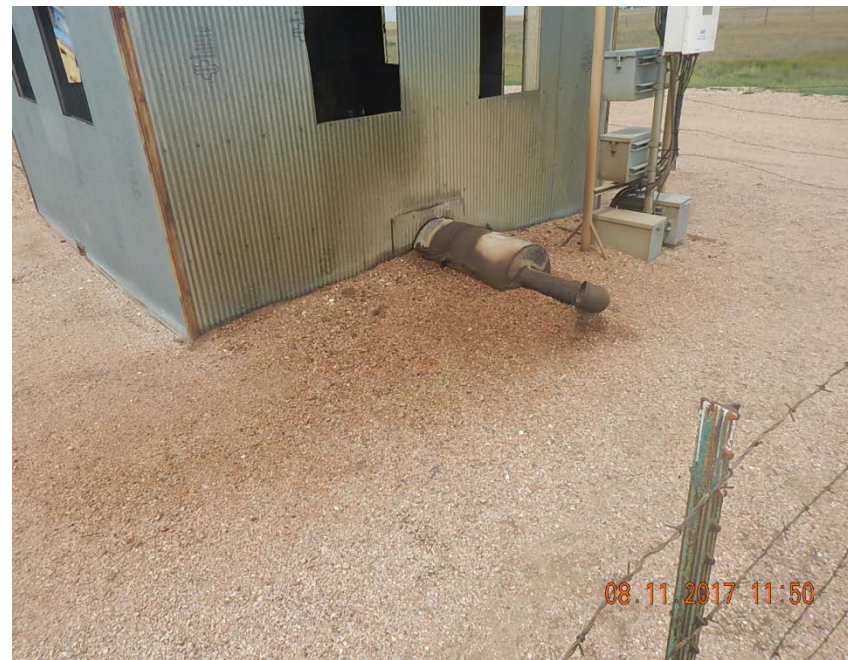
Photo 7: Stained soil at exhaust

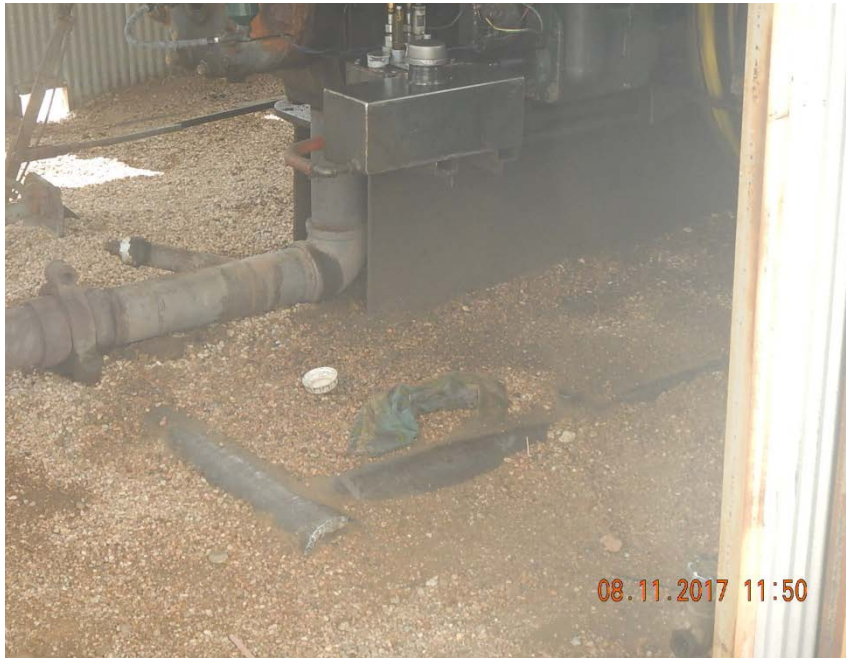
Photo 8: Stained soil in engine house
