**Inspection Photos**  
**Location Name: Mustang Resources LLC**  
**API05-045-06557**

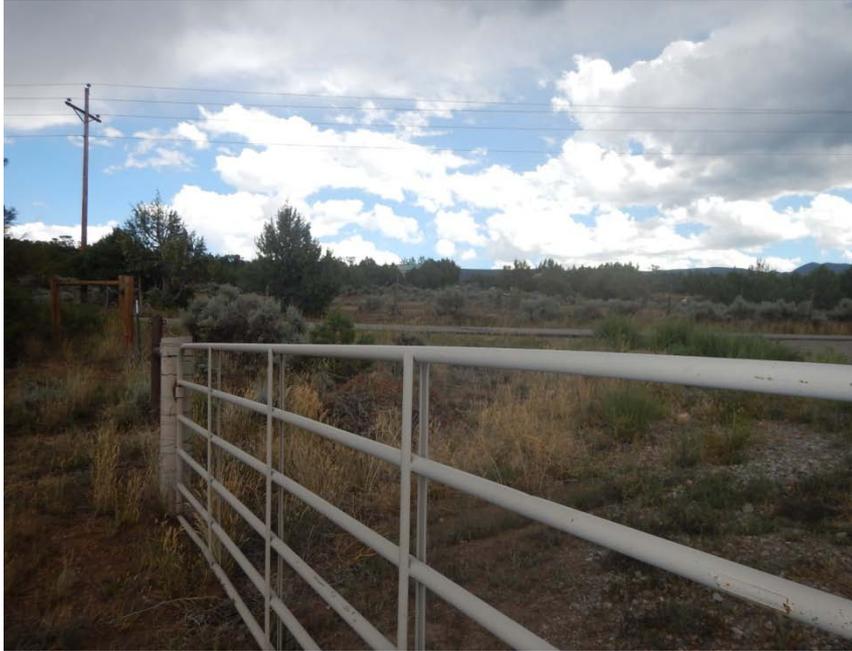
**Entrance looking south towards residence**

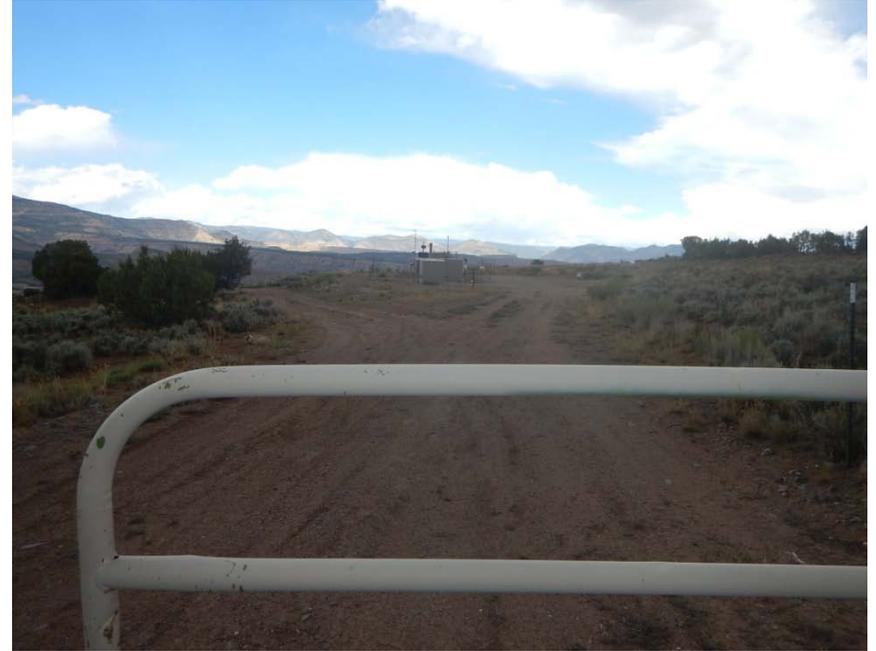
**Entrance looking northeast towards location**

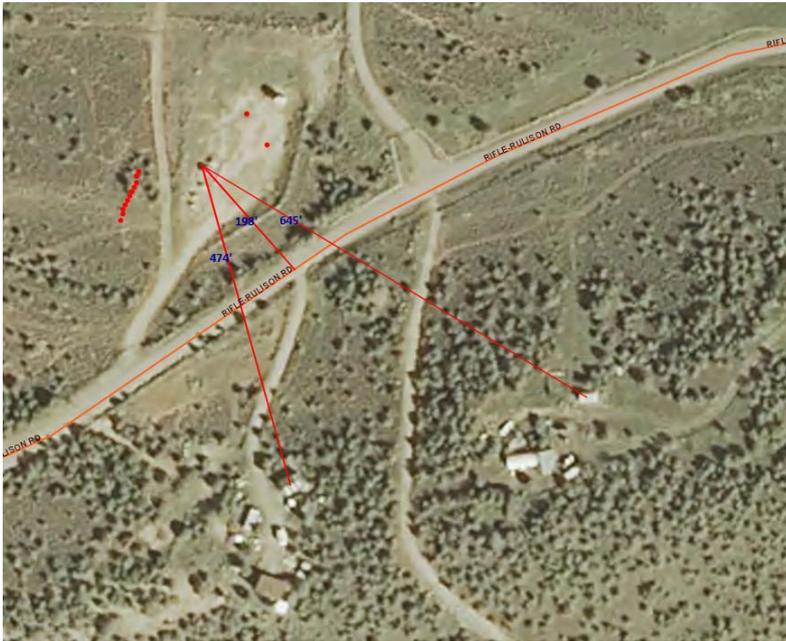
**Distance from tank relief valve**

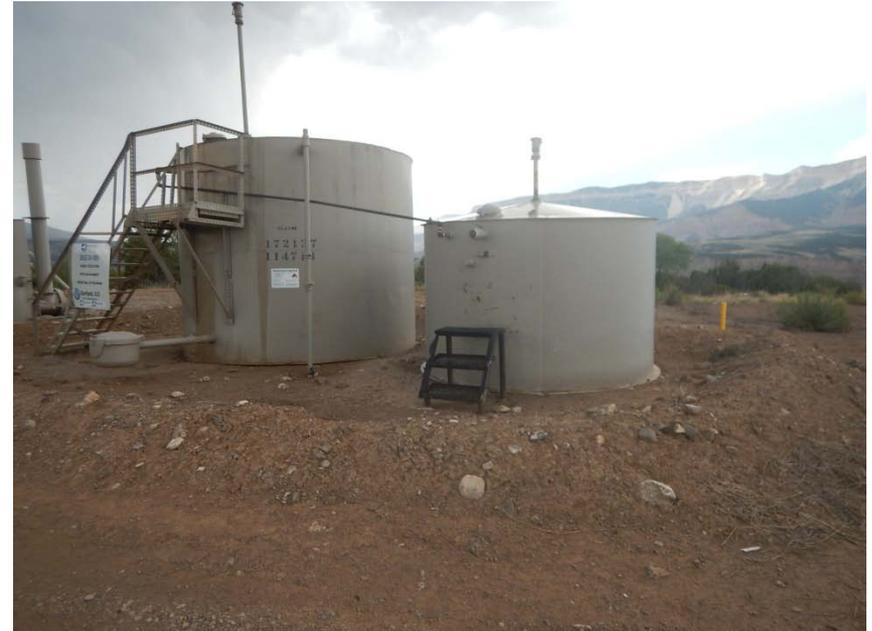
**Small tank with no labels or placards noted in previous inspection as Corrective actions needed**

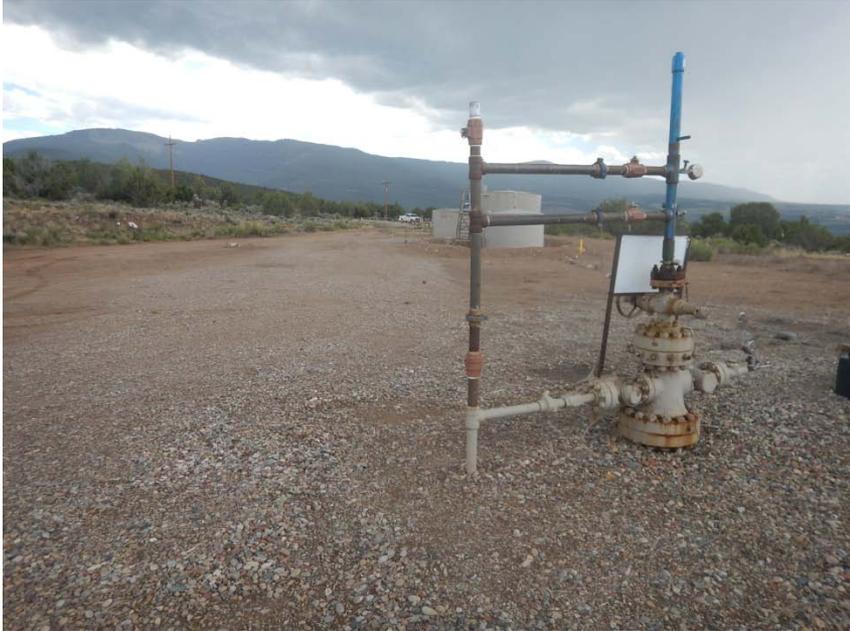
**Wellhead looking back to entrance**
