**Inspection Photos**  
**Location Name: Dolan Ranches #13-27**  
**API: 05-123-07364**

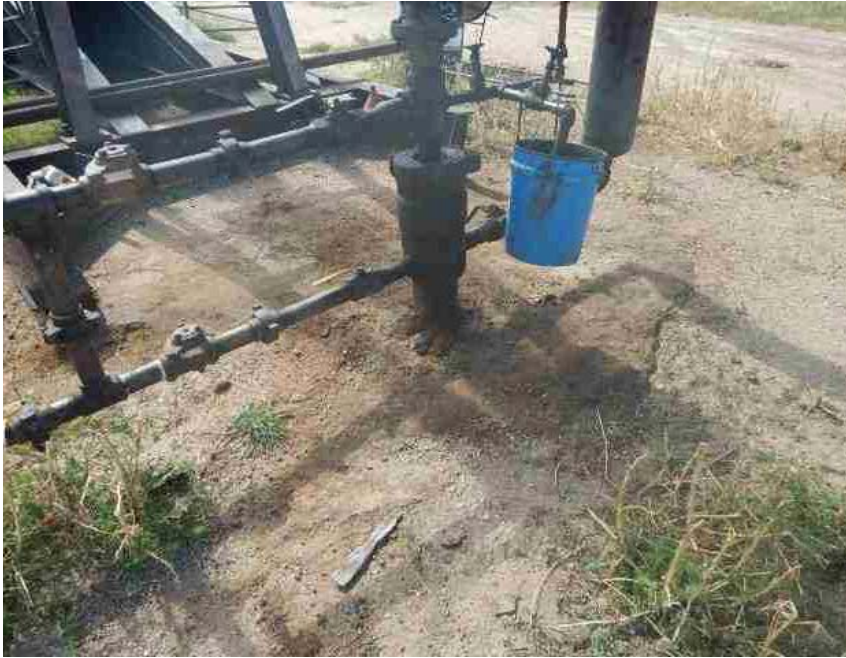
**Photo 1: Weeds around wellhead and engine. Cannot determine soil status around wellhead.**

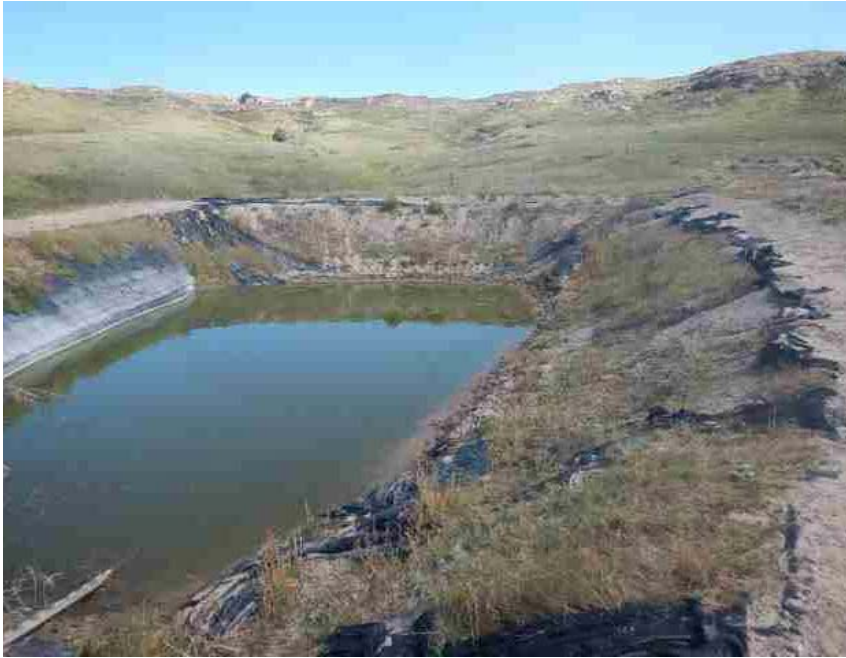
**Photo 2: Pit liner sagging**

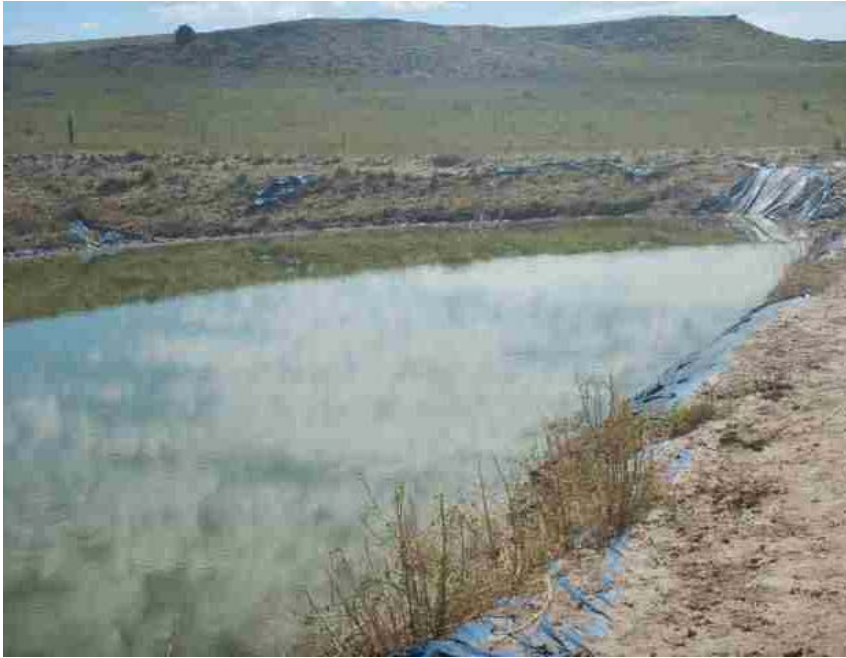
**Photo 3: Pit liner sagging**

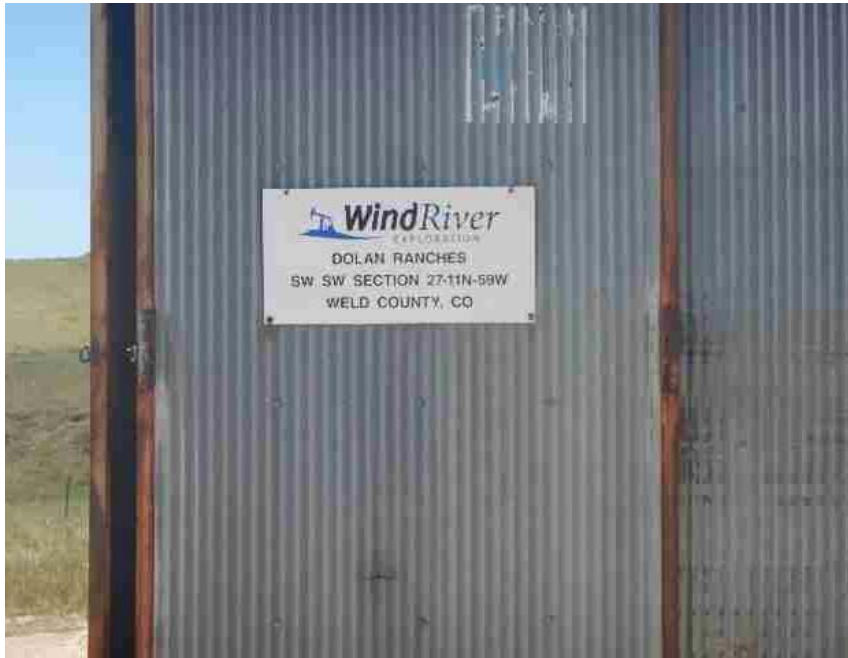
**Photo 4: Prior operator signage removed**

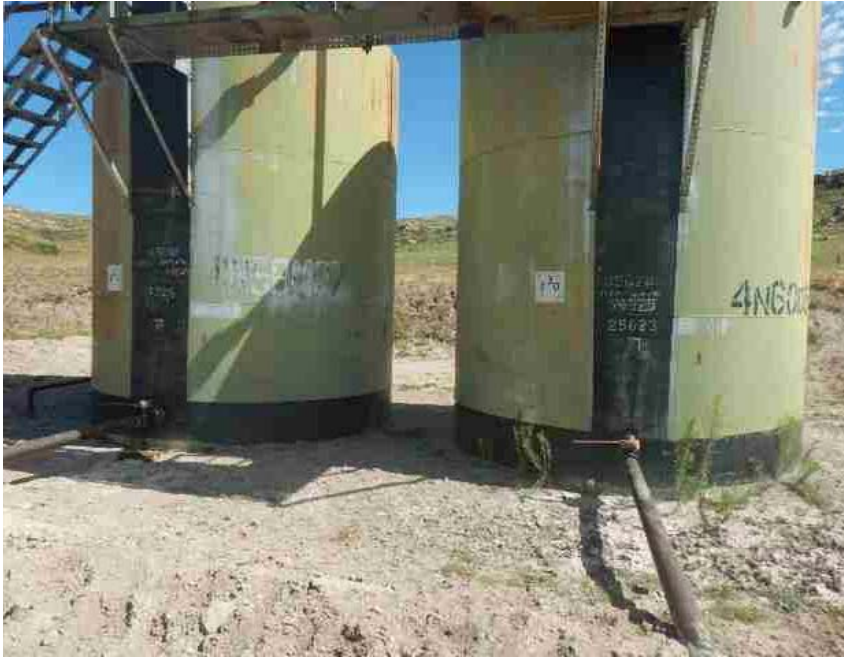
Photo 5: Tanks have placarding, contents, capacities. Operator signage and emergency number at battery. Weeds in berms
