Inspection Photos
Location Name: Spetter 5-8
API: 05-081-06548

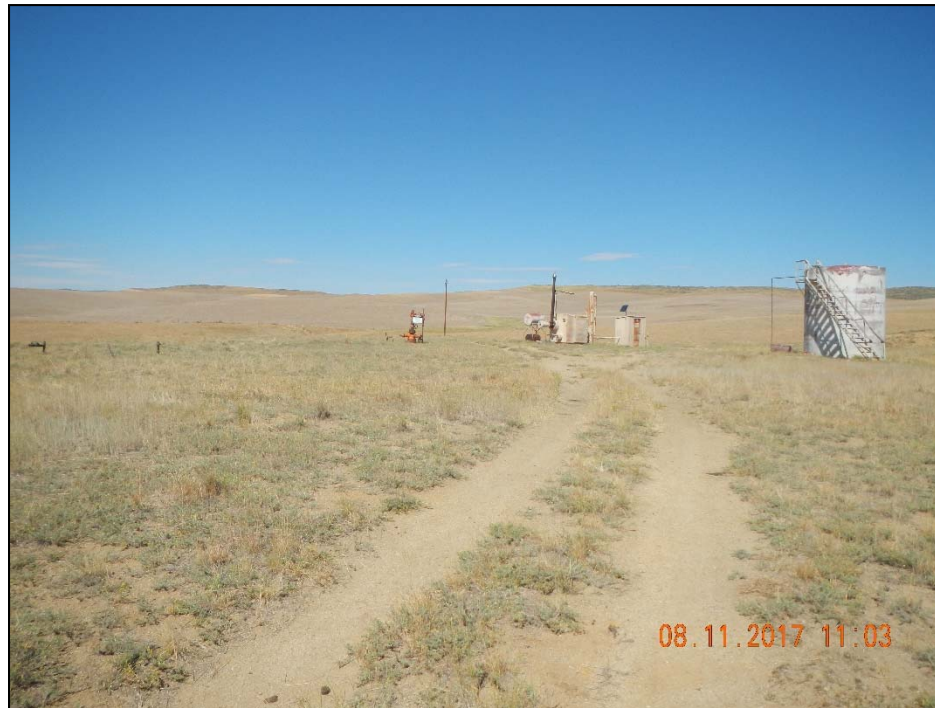
Photo 1. Overview of location taken at entrance facing north.

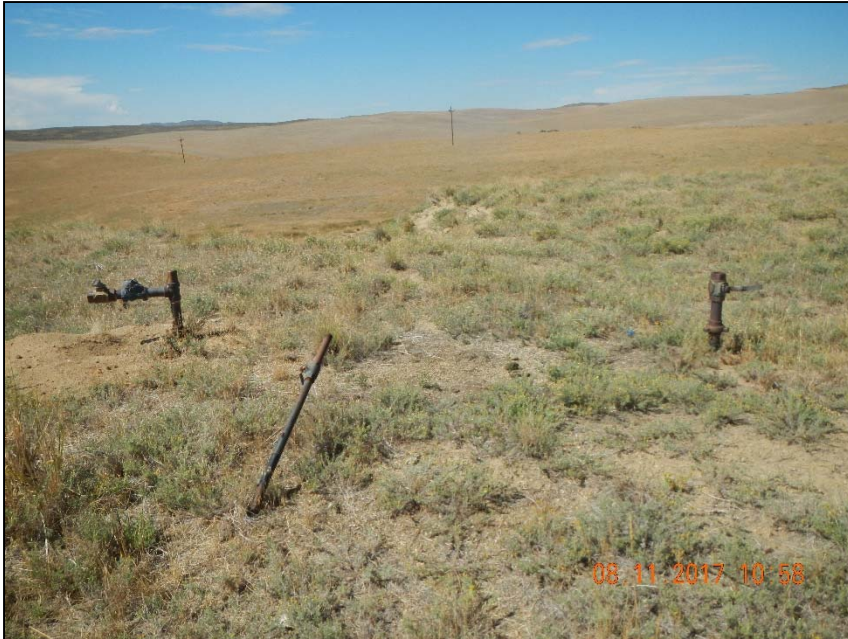
Photo 2. 2 -2" steel risers and 1 – 1" steel riser.

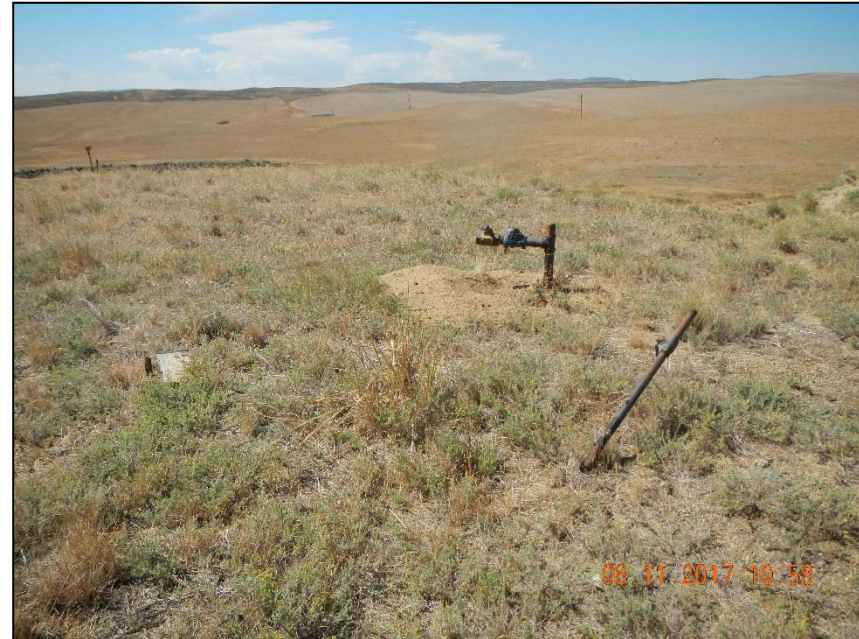
Photo 3. 2 – 1" steel risers and 1 – 2" steel riser.

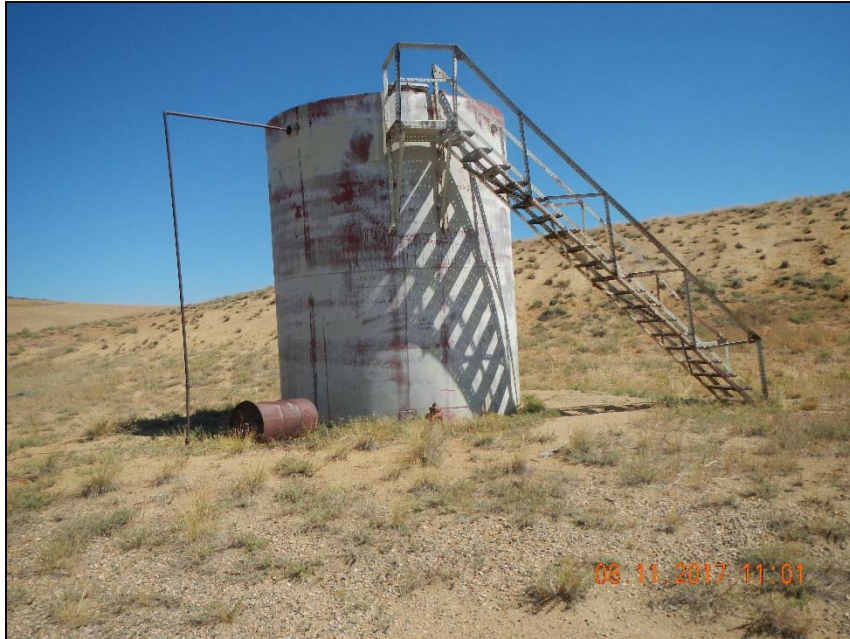
Photo 4. Tank with no label and no berm. Container with no secondary containment next to tank.

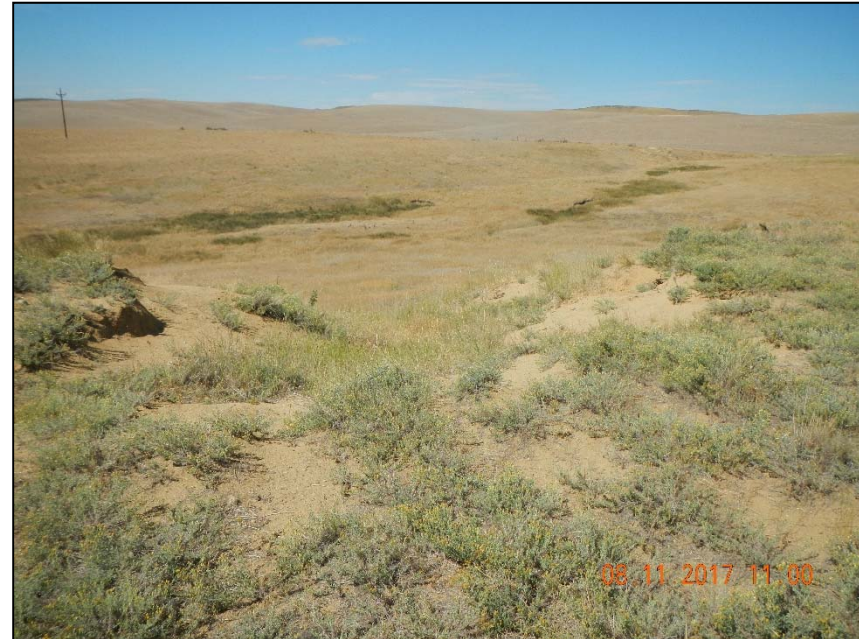
Photo 5. Example of erosion occurring on west side of location.
