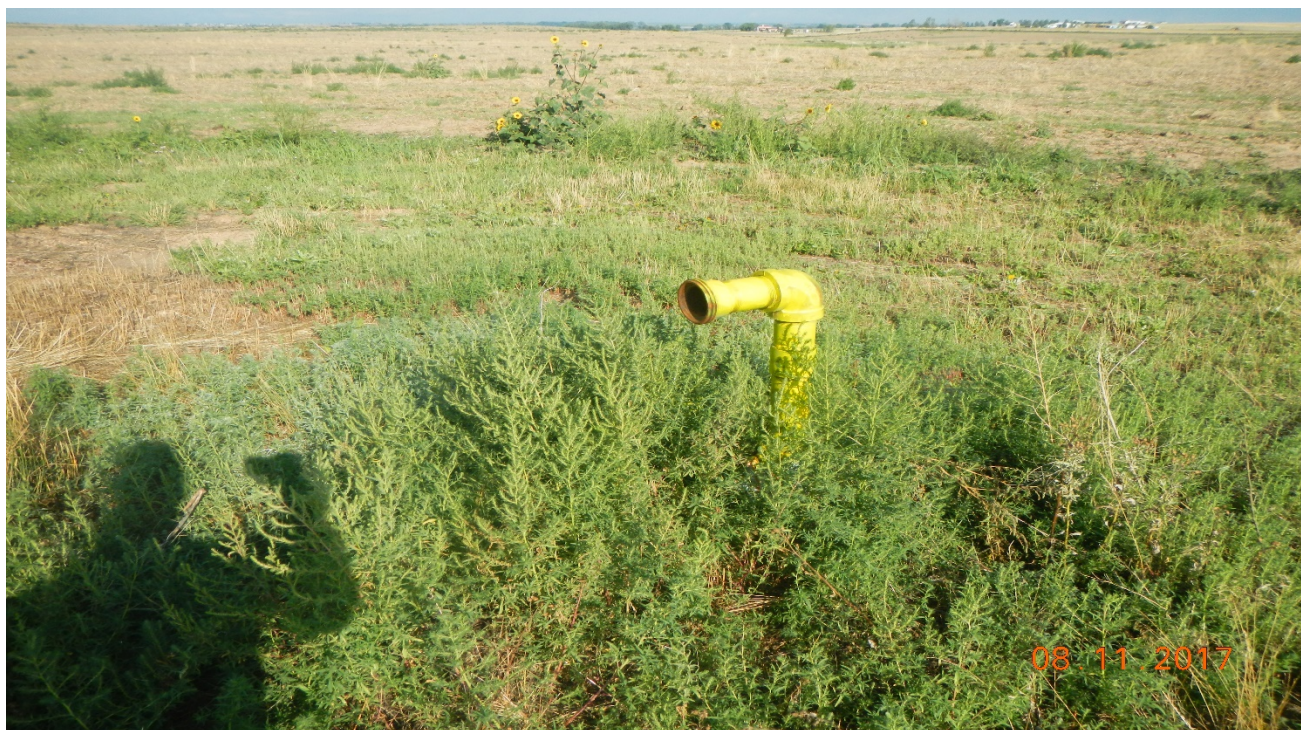
photo 1: A section of the pipe riser has been removed since the previous inspection. The remaining riser has been painted fluorescent. Lat/Long:39.98959,-104.54693

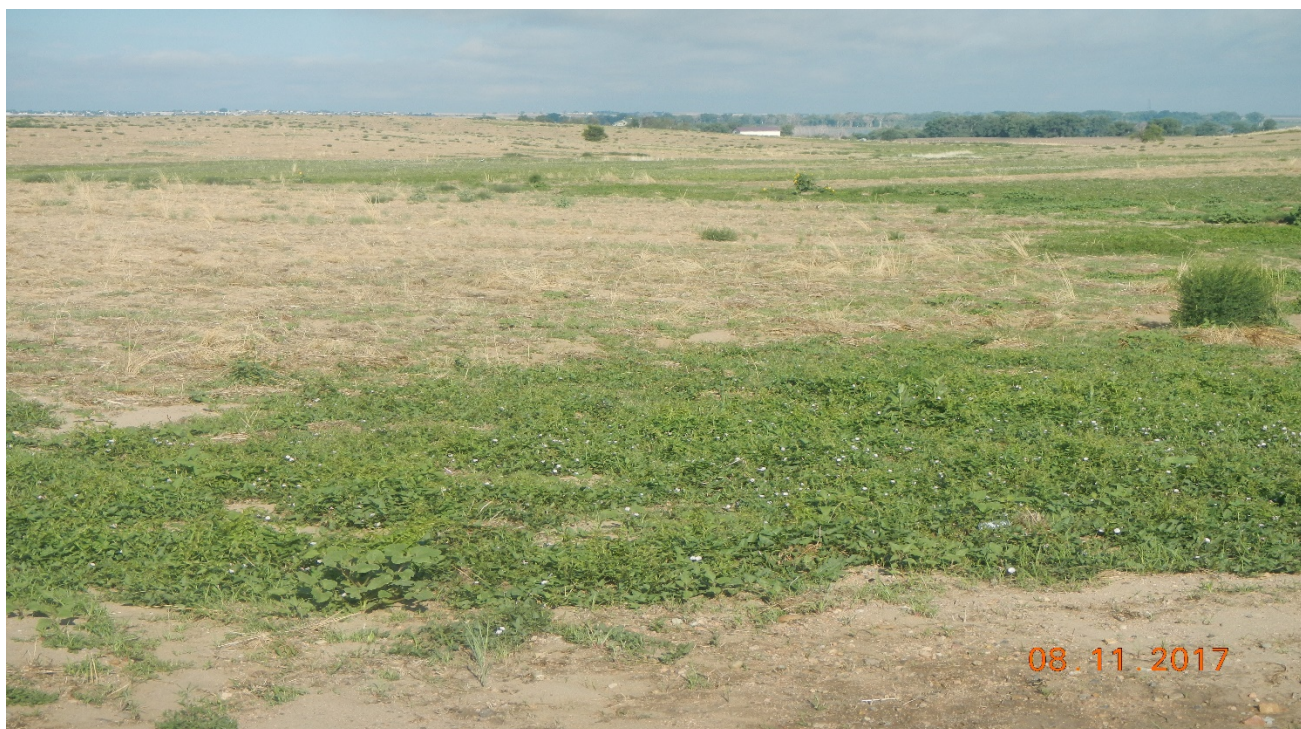
photo 2: Facing west toward the area of the well site. A crop has not been planted this season.
