Interim Reclamation and Stormwater Inspection

Operator: LONGS PEAK RESOURCES LLC- #10611

Location ID: 418125

Inspection Photos
Location Name: LAZY D ZN #03-09
Location ID: 418125

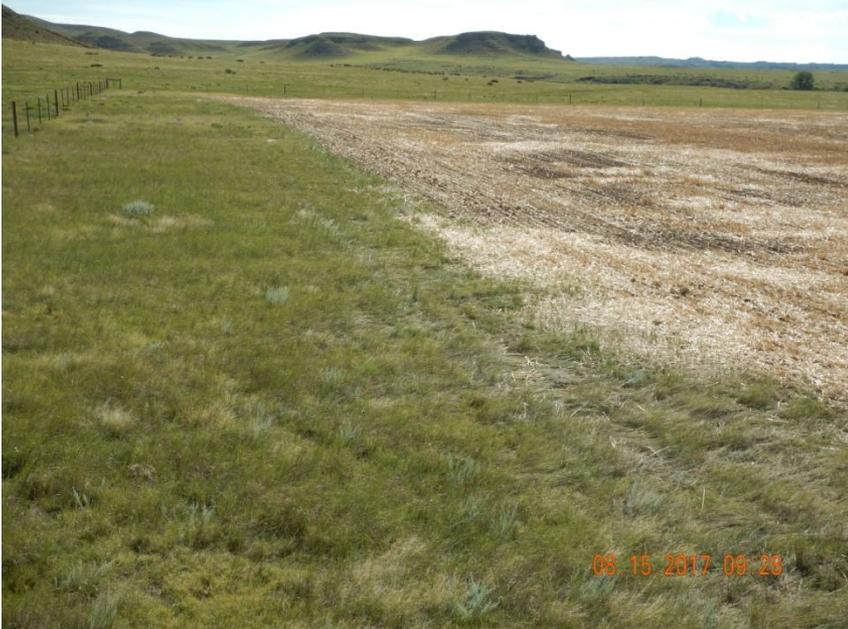
Photo 1. Photo taken from the entrance of location, facing East. Interim reclamation activities have been performed and are in process. Appears erosion controls have been installed to stabilize the seeded soil. Did not observe any germination throughout the interim area.

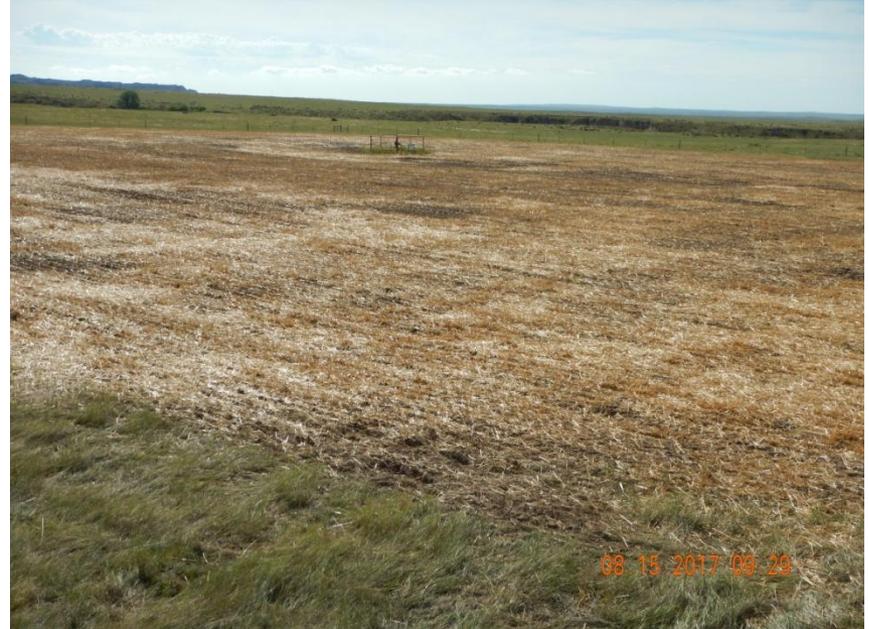
Photo 2. Photo taken from the entrance of location, facing Southeast. Interim reclamation activities have been performed and are in process. Appears erosion controls have been installed to stabilize the seeded soil. Did not observe any germination throughout the interim area.

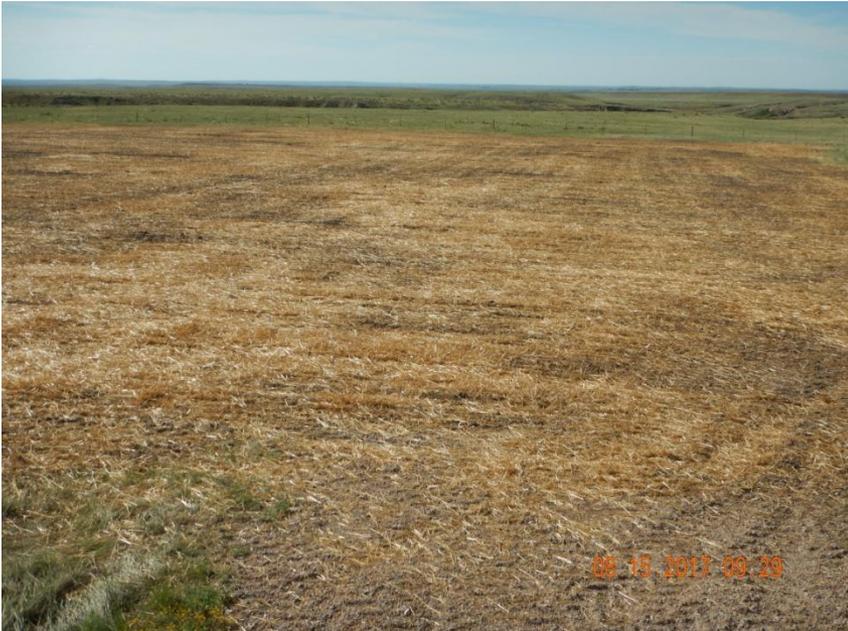
Photo 3. Photo taken from the entrance of location, facing South. Interim reclamation activities have been performed and are in process. Appears erosion controls have been installed to stabilize the seeded soil. Did not observe any germination throughout the interim area.

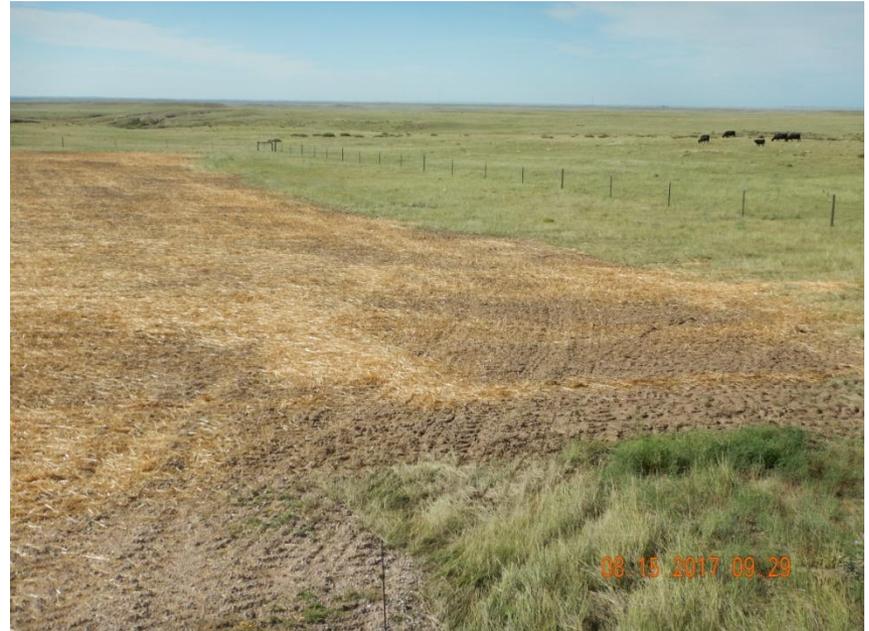
Photo 4. Photo taken from the entrance of location, facing Southwest. Interim reclamation activities have been performed and are in process. Appears erosion controls have been installed to stabilize the seeded soil. Did not observe any germination throughout the interim area.

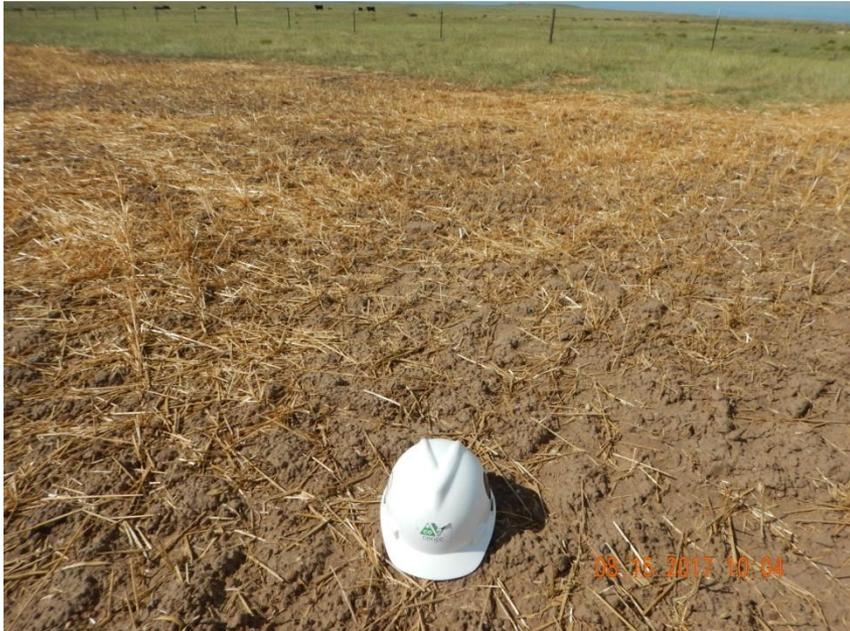
Photo 5. Photo taken from the western interim area, facing West. Appears erosion controls have been installed to stabilize the seeded soil. Did not observe any germination throughout the interim area.

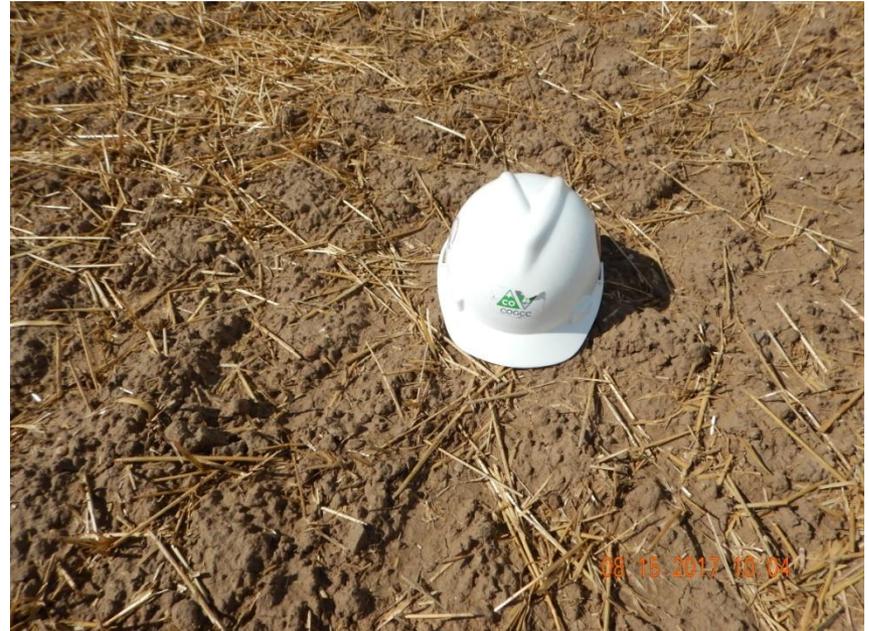
Photo 6. Close-up photo taken documenting that no germination was observed.
