Interim Reclamation and Stormwater Inspection

August 15, 2017

Operator: LONGS PEAK RESOURCES LLC- #10611

Location ID: 438066

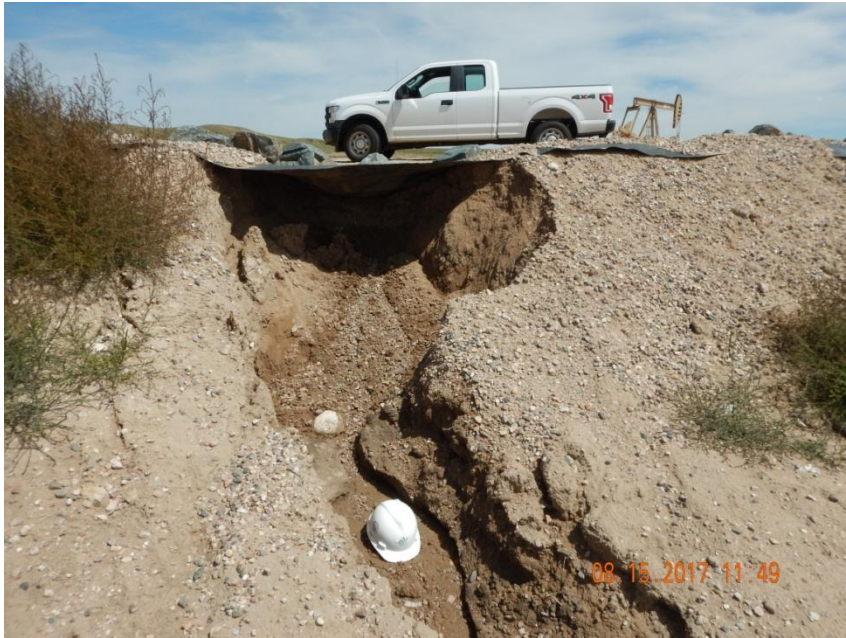
Photo 1. Photo taken from the southwestern location, facing North. Gully erosion observed along the fill slope.

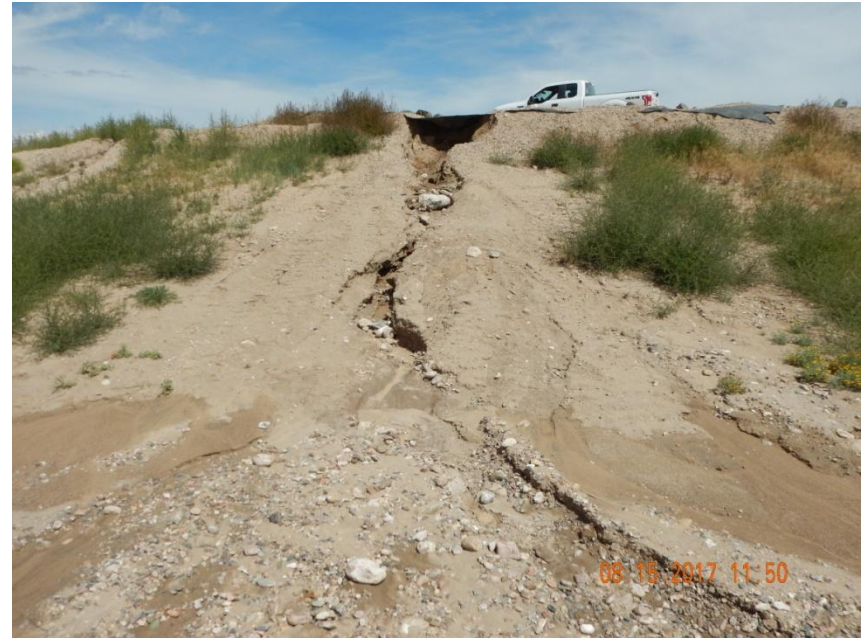
Photo 2. Photo taken from the southwestern location, facing North. Gully erosion observed along the fill slope. Photo illustrates sediment deposition accumulation.

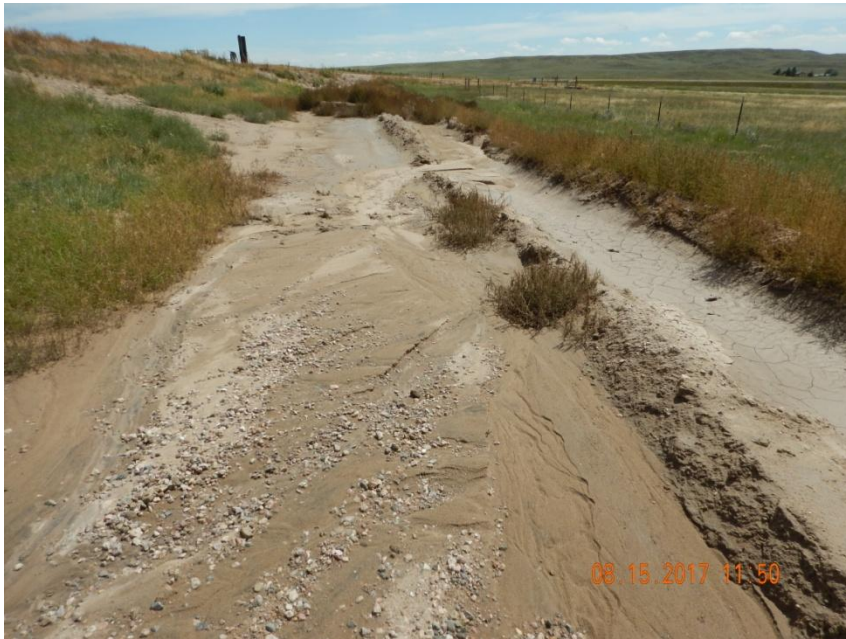
Photo 3. Photo taken from the southwestern stormwater management area, facing East. Photo illustrates sediment deposition accumulation and in need of maintenance.

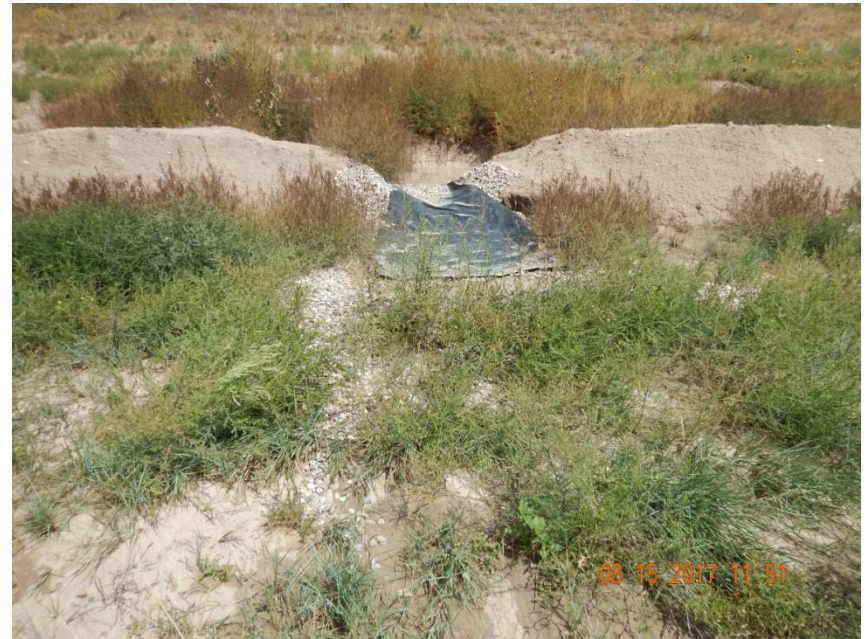
Photo 4. Photo taken from the southwest sediment trap outlet area, facing North. Sediment trap does not appear to have a sufficient stabilized outlet. Rock material does not appear to be the appropriate size and the plastic-like material only appears to allow stormwater flows to accelerate out of the sediment trap. A point of sediment discharge was observed south of the outlet area.

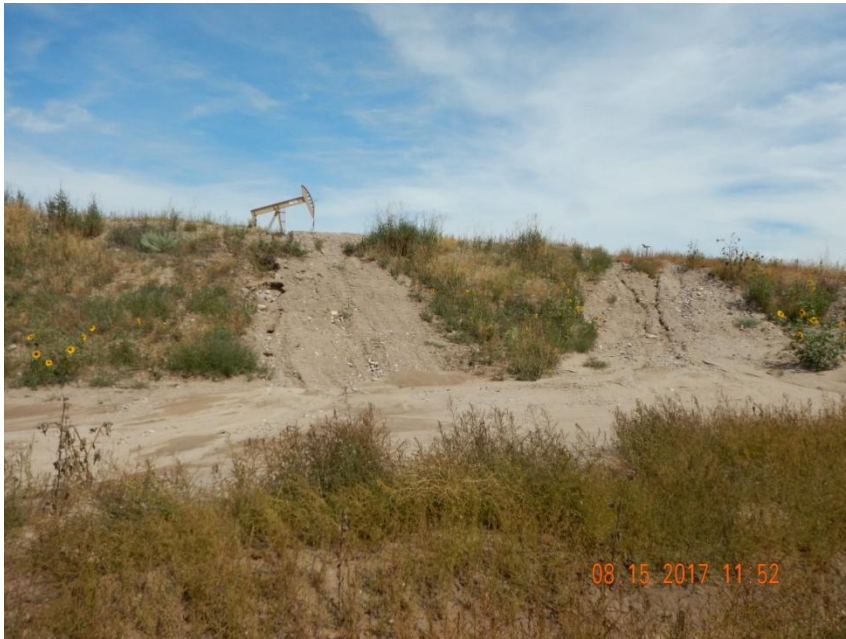
Photo 5. Photo taken west of the entrance to the location, facing North. Gully erosion is forming and rill erosion observed along the fill slope.

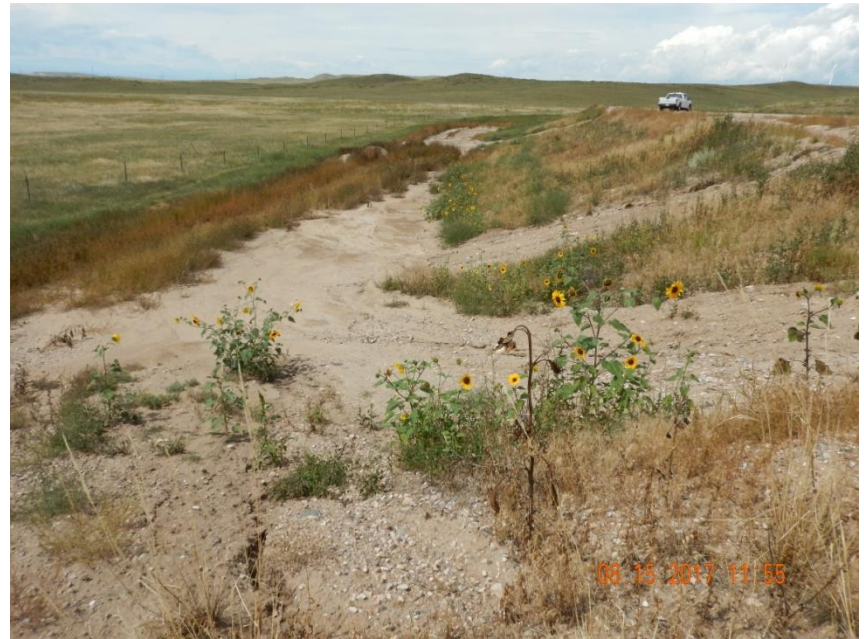
Photo 6. Photo taken from west of the entrance to the location, facing West. Photo illustrates sediment deposition accumulation and in need of maintenance.

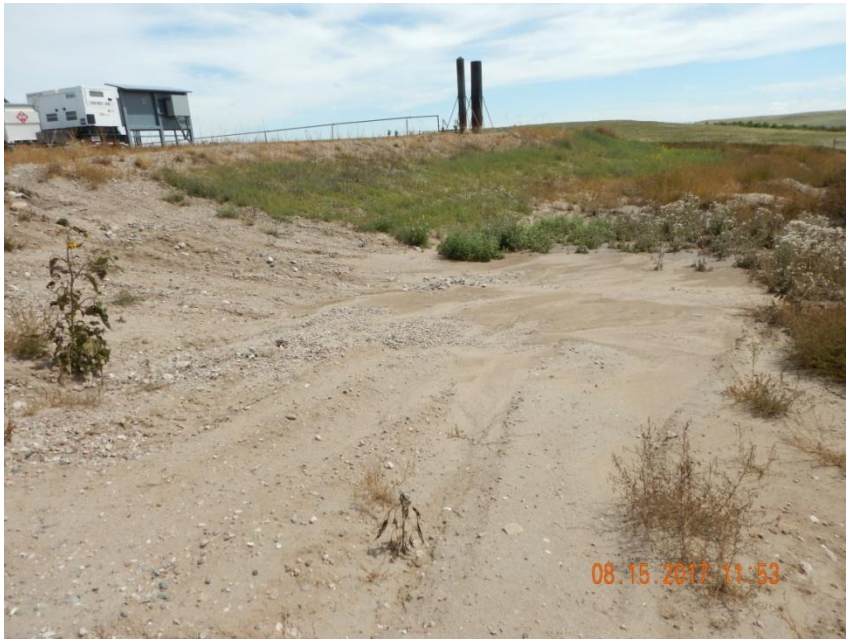
Photo 5. Photo taken east of the entrance to the location, facing East. Photo illustrates sediment deposition accumulation and in need of maintenance.

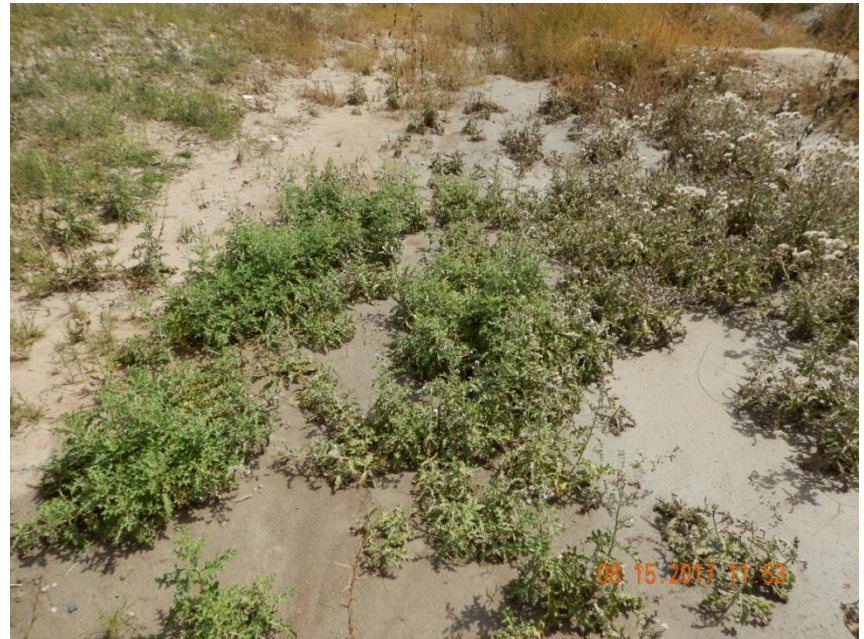
Photo 6. Photo taken from the sediment deposition accumulation area from the previous photo. Photo illustrates a List B Colorado Noxious weed, Canada thistle, that needs to be managed and controlled to prevent spreading off location onto adjacent lands.

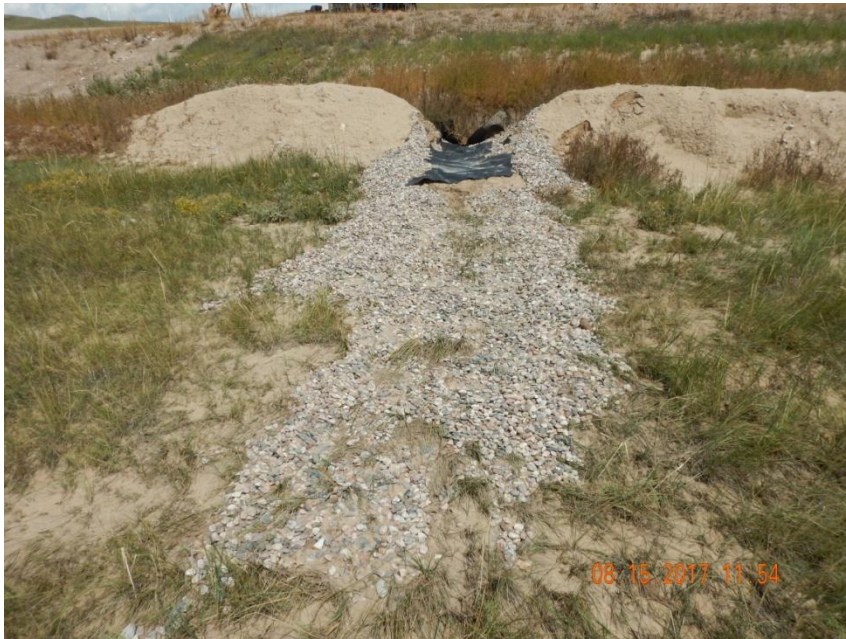
Photo 7. Photo taken from the southeast sediment trap outlet area, facing North. Sediment trap does not appear to have a sufficient stabilized outlet. Rock material does not appear to be the appropriate size and the plastic-like material only appears to allow stormwater flows to accelerate out of the sediment trap.

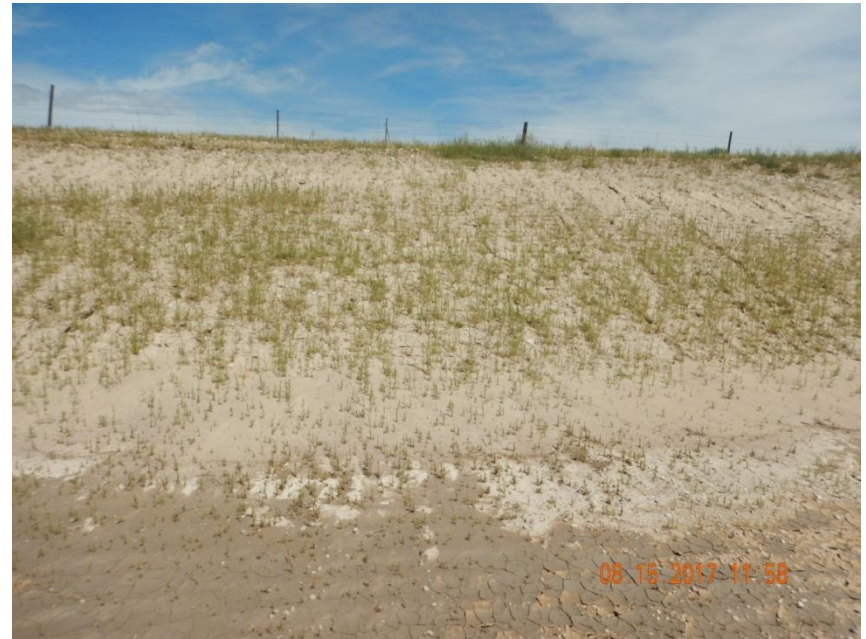
Photo 8. Photo taken from the northern cut slope, facing North. Rill erosion observed throughout the cut slope, except for the northeast corner where sediment blankets were installed.

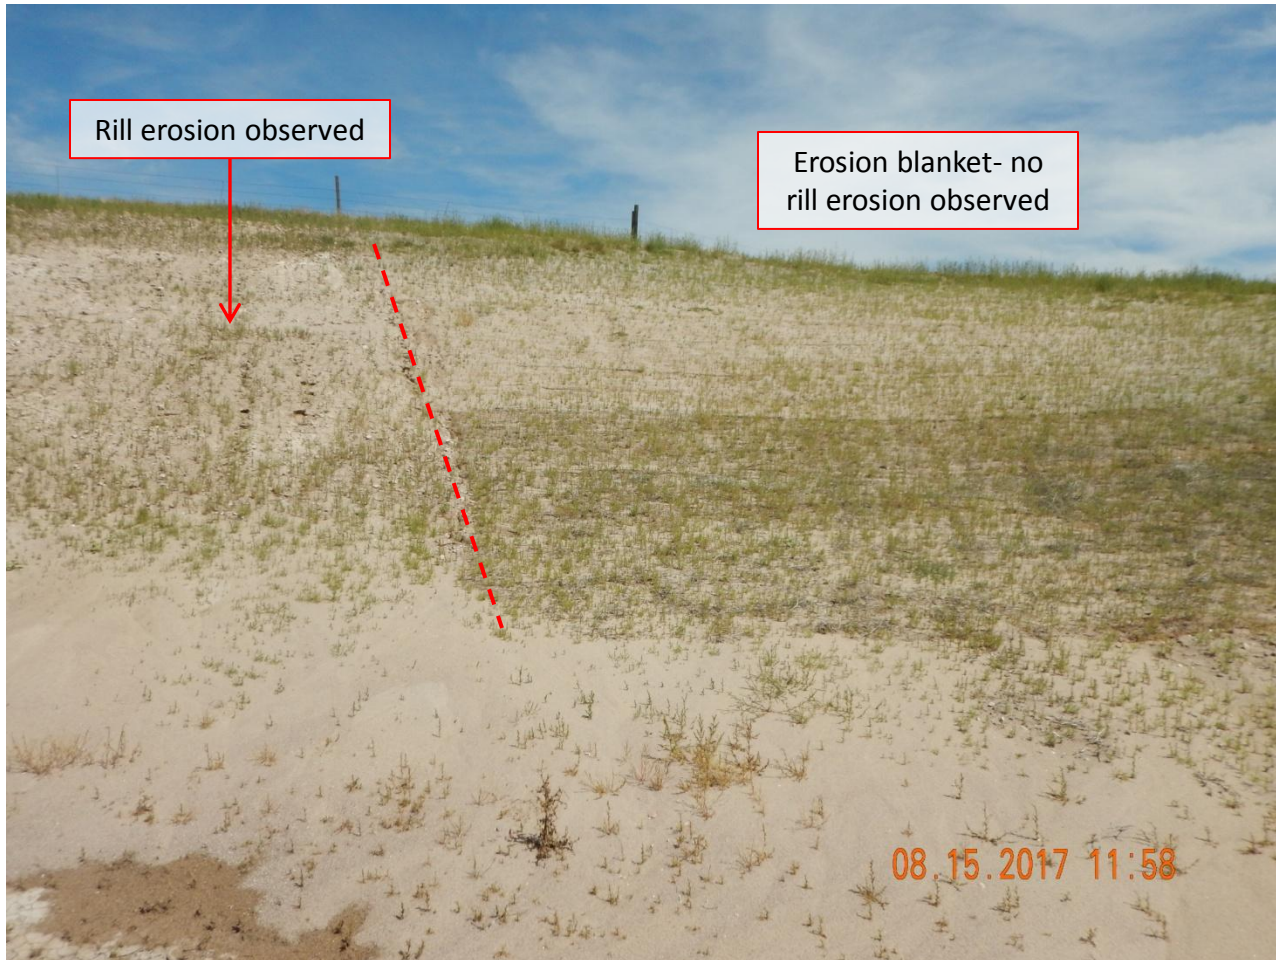
Photo 9. Photo taken from the northeast cut slope, facing North. Rill erosion observed throughout the cut slope, except for the northeast corner where sediment blankets were installed. Erosion blanket installed to the right of the red-dashed line.
