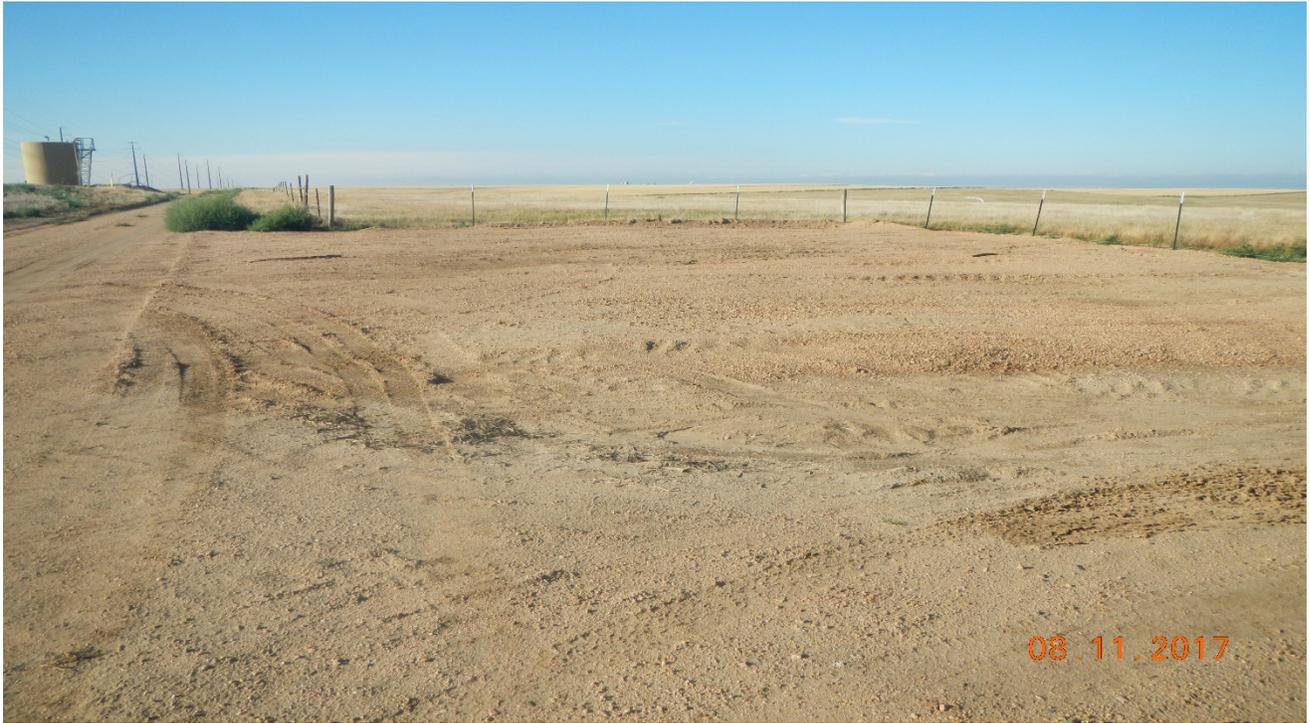
**photo 1:** Facing southwest toward the former tank battery site. The tank has been removed since the previous inspection.

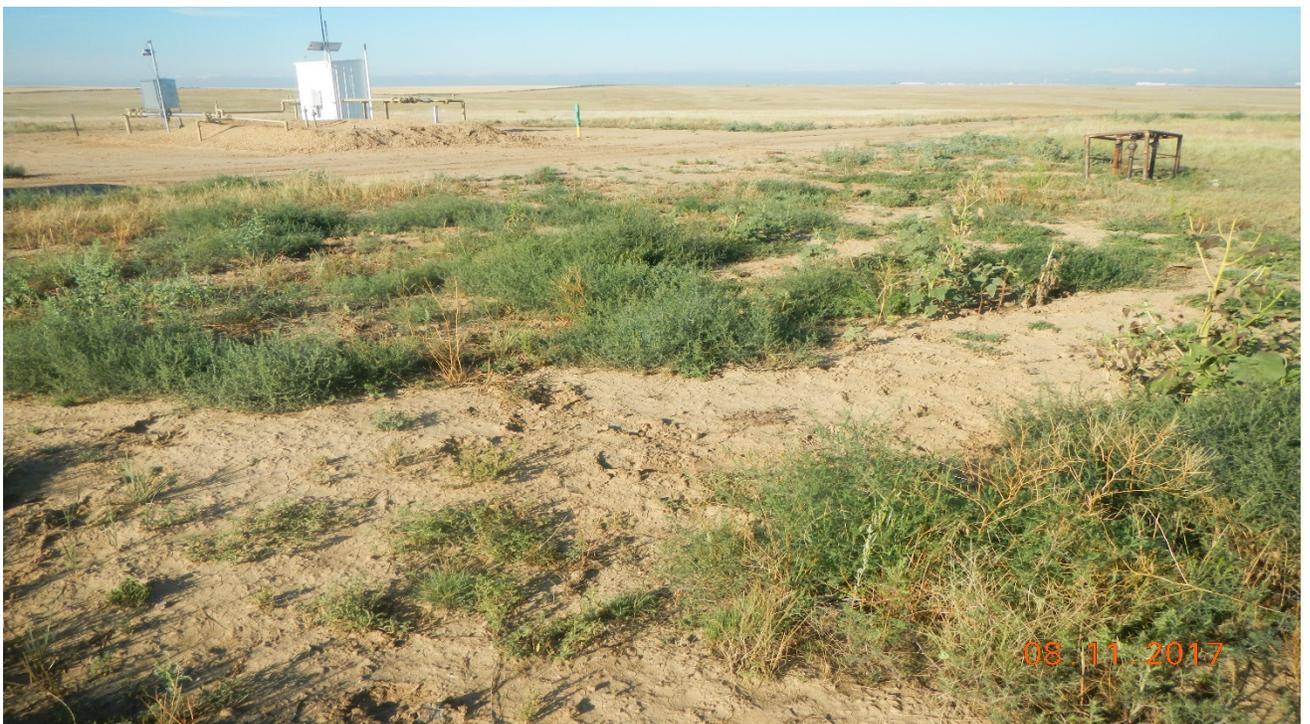
**photo 2:** Facing southwest toward the former well site.

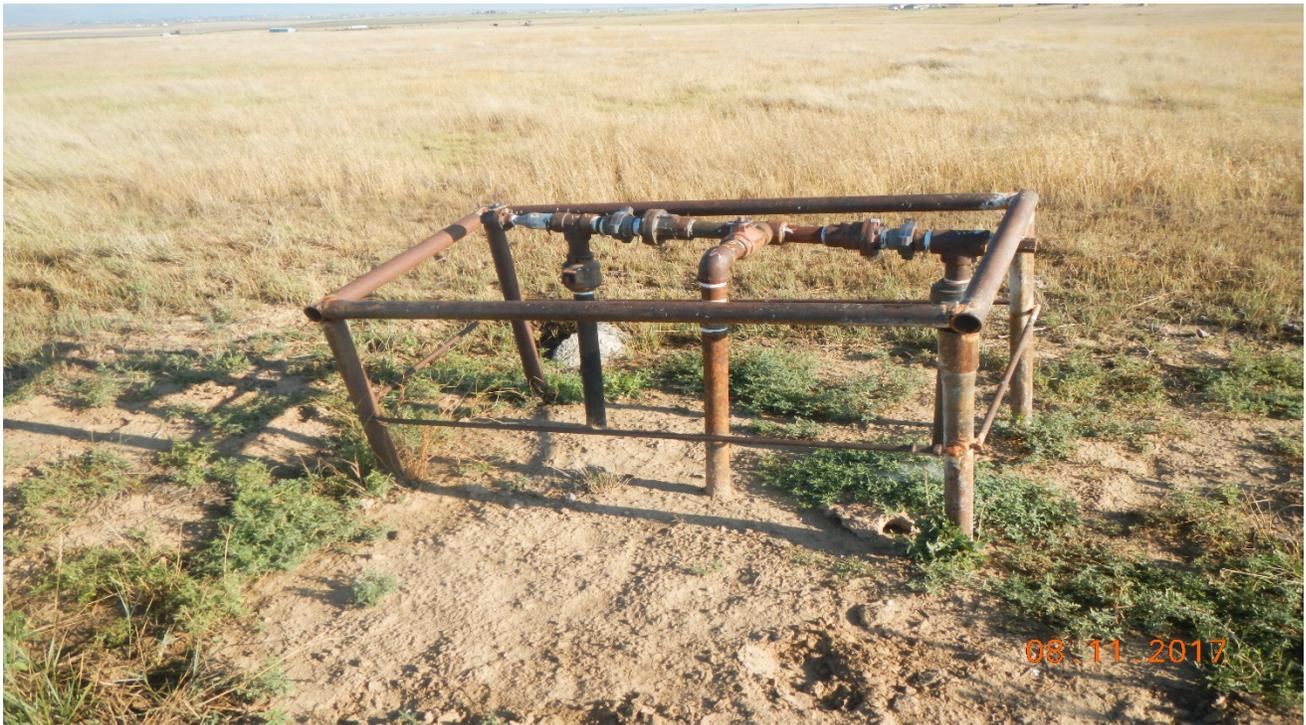
**photo 3:** This pipe riser still remains at the location Lat/Long:39.90421,-10454758.

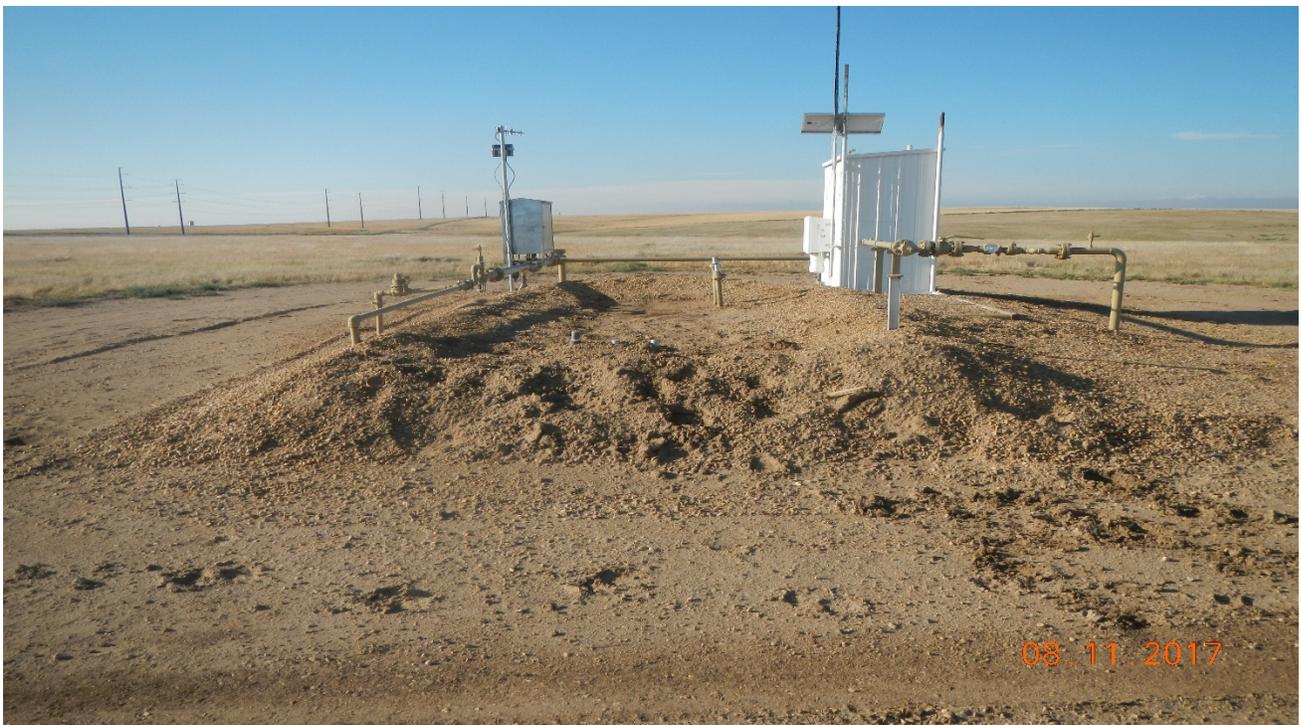
**photo 4:** The fence and some of the equipment appears to have been removed.

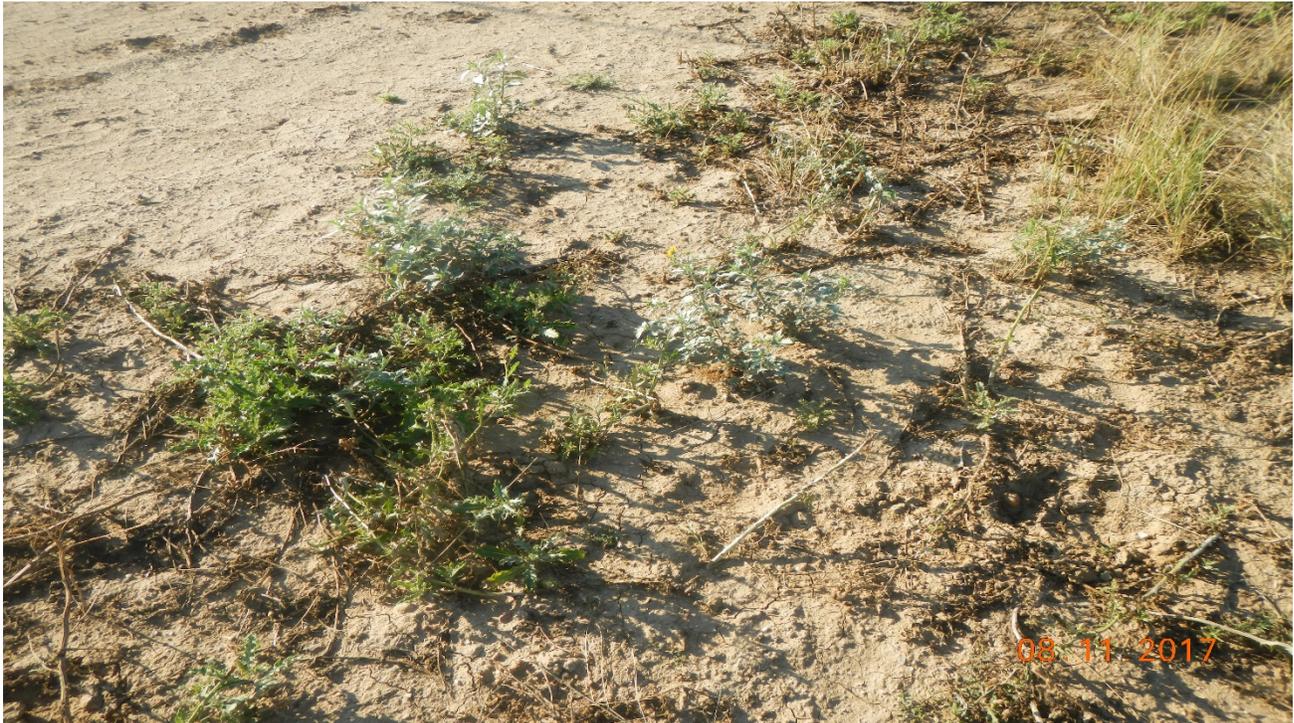
**photo 5:** It appears that the noxious weed control was performed however there is some weeds that are re-sprouting.

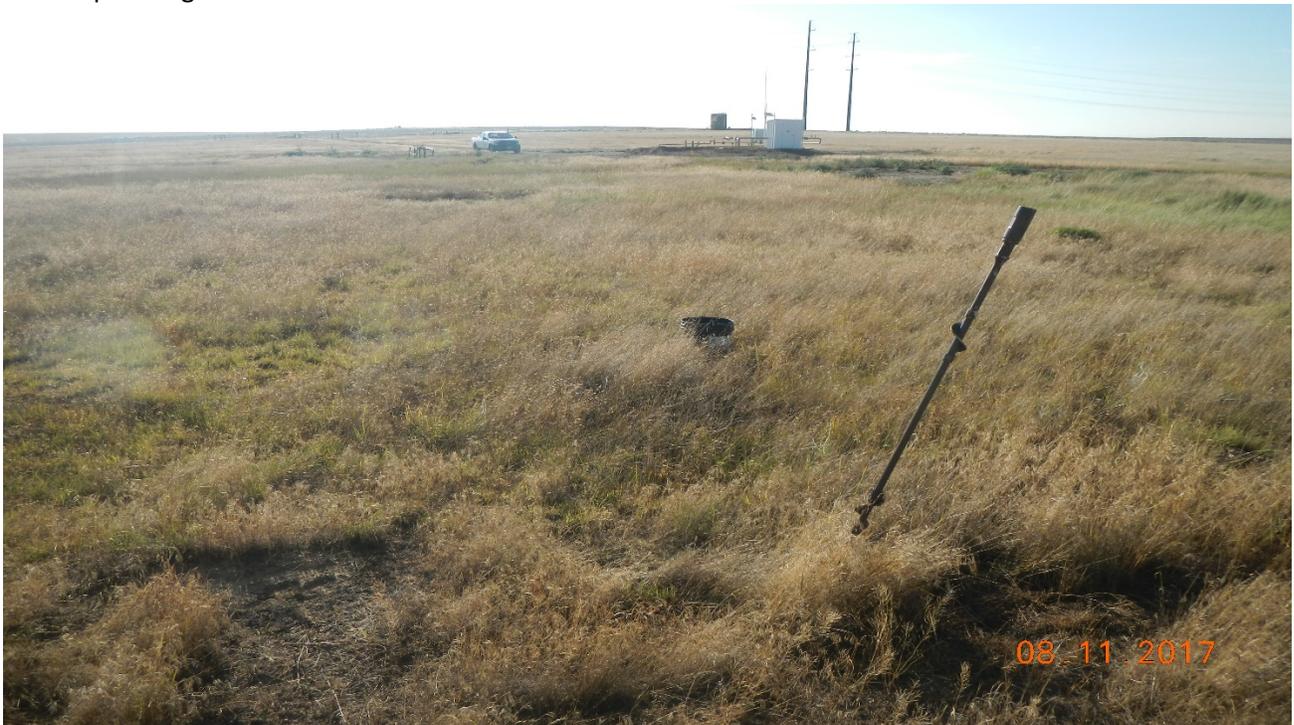
**photo 6:** Northwest side of the location facing southeast. There is a metal sticking out of the ground that needs to be removed.
