Inspection Photos

Operator: KERR NOBLE ENERGY INC - 100322

Location ID: 318182

Inspection Doc. Number: 675103824

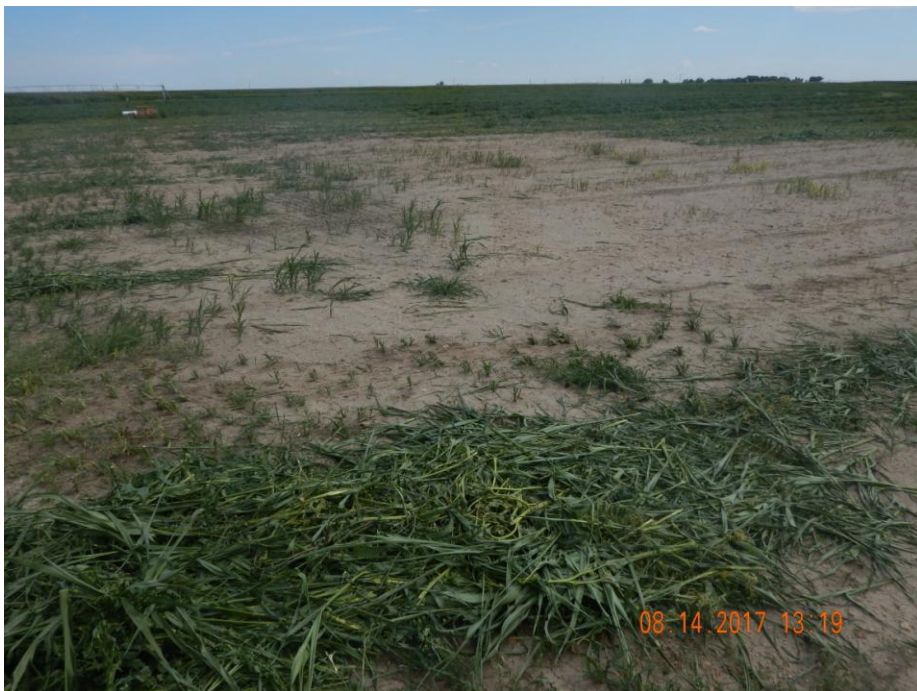
Photo 1: Photo taken from the west end of the battery location, facing east. Noble indicated surface owner seeded a “sudax grass” into the disturbance area after the previous inspection. Photo shows vegetation appears to have had difficulty establishing on large portions of the disturbance area, as establishment was not uniform and large areas of the location do not show sign that any germination had occurred, and remain predominantly bare and unvegetated.

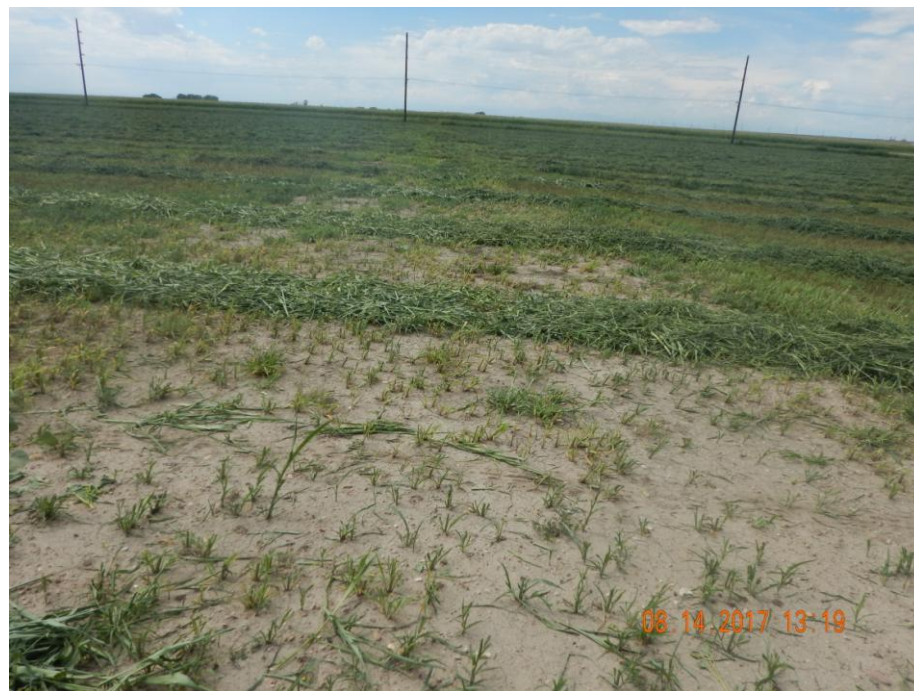
Photo 2: Photo taken from the west end of the location, facing east. Photo shows area where access road existed. Noble indicated surface owner seeded a “sudax grass” into the disturbance area after the previous inspection. Photo shows vegetation appears to have had difficulty establishing on large portions of the disturbance area, as establishment was not uniform and large areas of the location do not show sign that any germination had occurred, and remain predominantly bare and unvegetated.

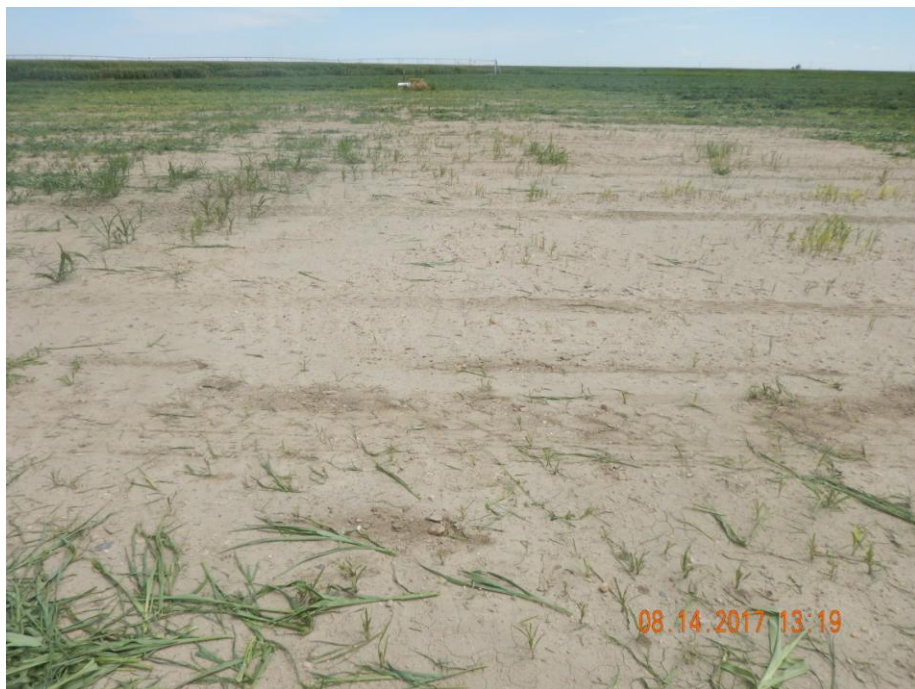
Photo 3: Photo taken from the west end of the battery location, facing east. Noble indicated surface owner seeded a “sudax grass” into the disturbance area after the previous inspection. Photo shows vegetation appears to have had difficulty establishing on large portions of the disturbance area, as establishment was not uniform and large areas of the location do not show sign that any germination had occurred, and remain predominantly bare and unvegetated.

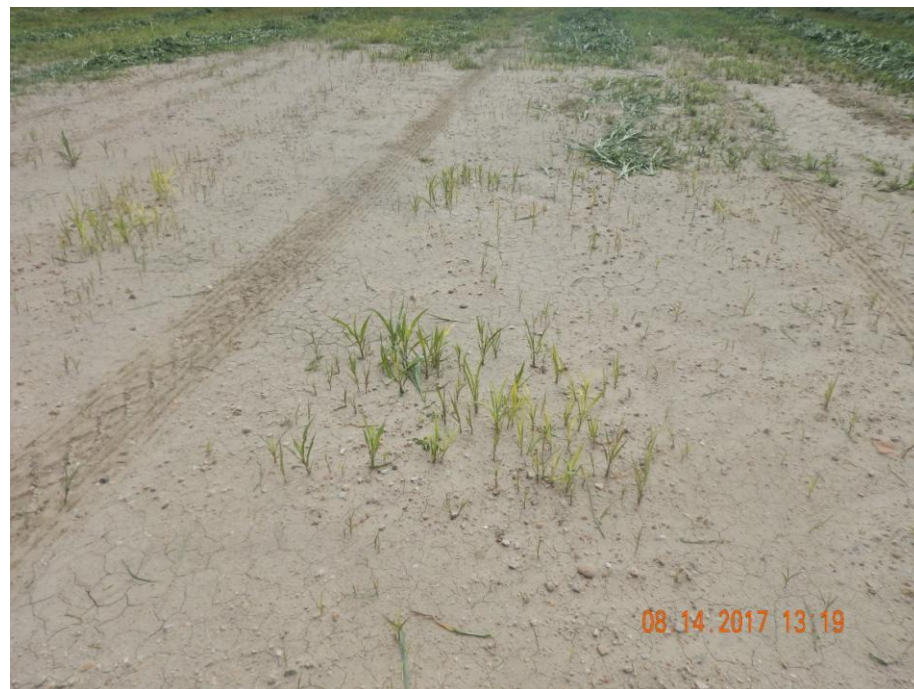
Photo 4: Photo taken from the battery location. Noble indicated surface owner seeded a “sudax grass” into the disturbance area after the previous inspection. Photo shows vegetation appears to have had difficulty establishing on large portions of the disturbance area, as establishment was not uniform and large areas of the location do not show sign that any germination had occurred, and remain predominantly bare and unvegetated.

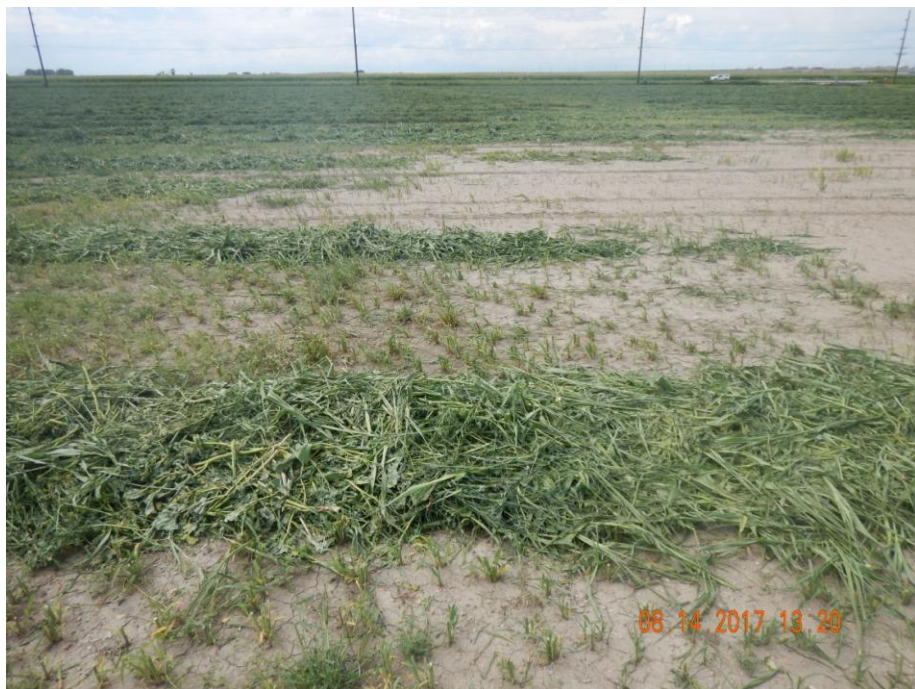
Photo 5: Photo taken from the south end of the battery location, facing west. Noble indicated surface owner seeded a “sudax grass” into the disturbance area after the previous inspection. Photo shows vegetation appears to have had difficulty establishing on large portions of the disturbance area, as establishment was not uniform and large areas of the location do not show sign that any germination had occurred, and remain predominantly bare and unvegetated.

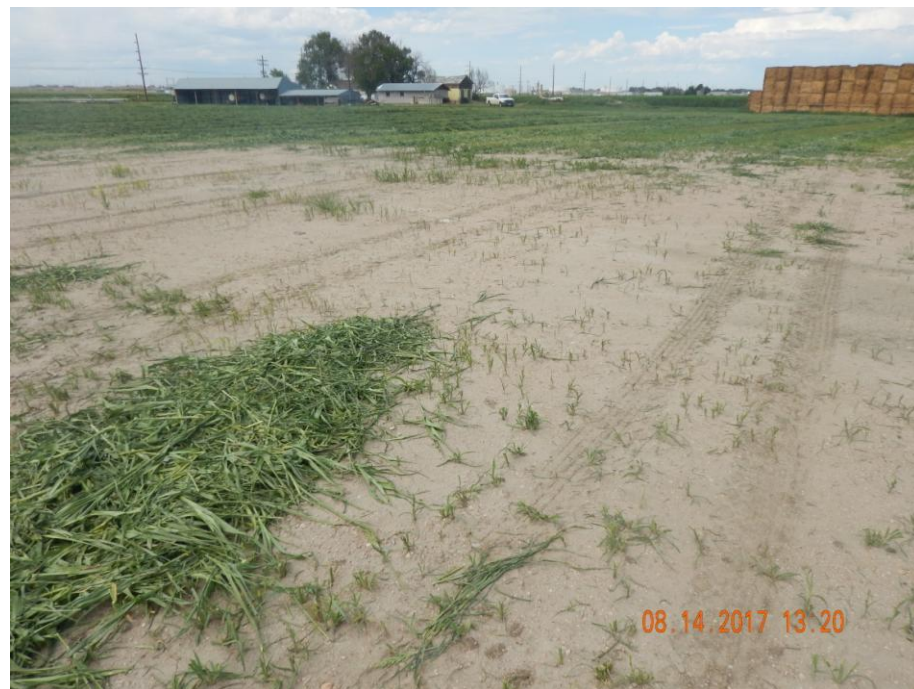
Photo 6: Photo taken from the south end of the battery location, facing northwest. Noble indicated surface owner seeded a “sudax grass” into the disturbance area after the previous inspection. Photo shows vegetation appears to have had difficulty establishing on large portions of the disturbance area, as establishment was not uniform and large areas of the location do not show sign that any germination had occurred, and remain predominantly bare and unvegetated.

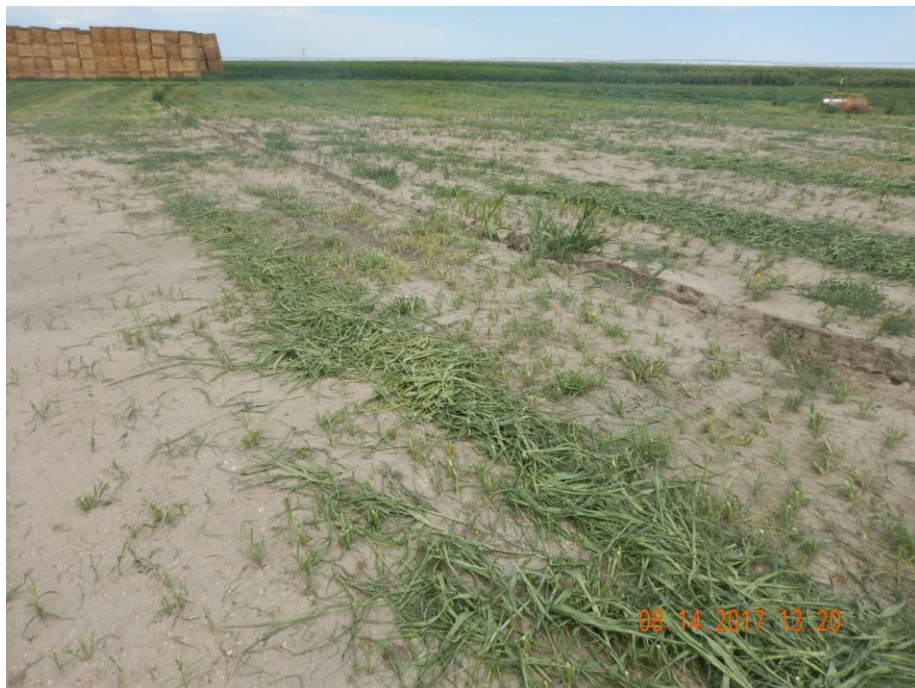
Photo 7: Photo taken from the south end of the battery location, facing northeast. Noble indicated surface owner seeded a “sudax grass” into the disturbance area after the previous inspection. Photo shows vegetation appears to have had difficulty establishing on large portions of the disturbance area, as establishment was not uniform and large areas of the location do not show sign that any germination had occurred, and remain predominantly bare and unvegetated.

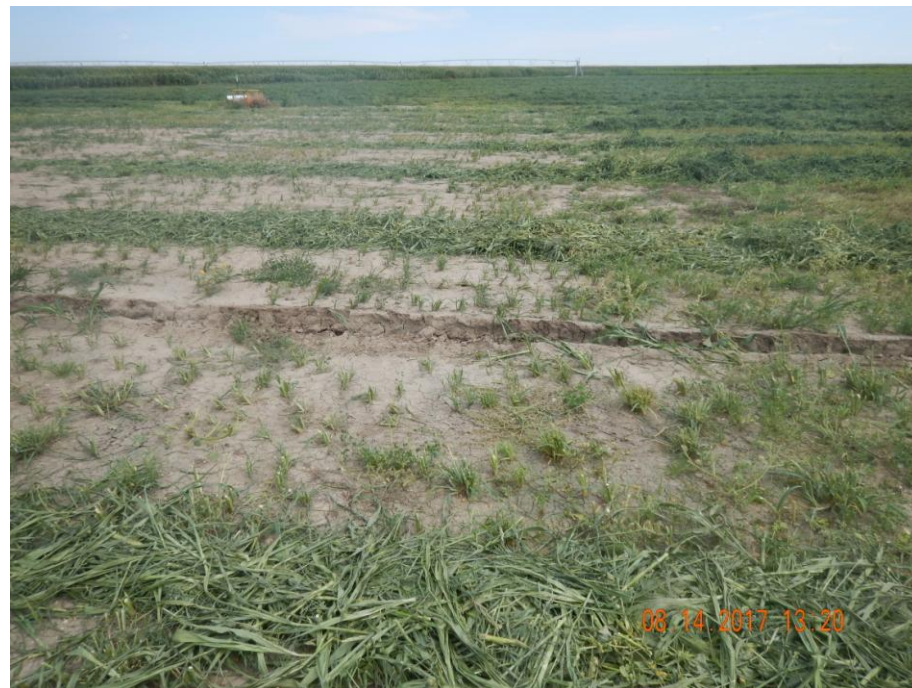
Photo 8: Photo taken from the south end of the battery location, facing east. Noble indicated surface owner seeded a “sudax grass” into the disturbance area after the previous inspection. Photo shows vegetation appears to have had difficulty establishing on large portions of the disturbance area, as establishment was not uniform and large areas of the location do not show sign that any germination had occurred, and remain predominantly bare and unvegetated.
