# Inspection Photos

Operator: SMITH OIL PROPERTIES INC - 79905

API: 123-08177

Inspection Doc. Number: 675103860

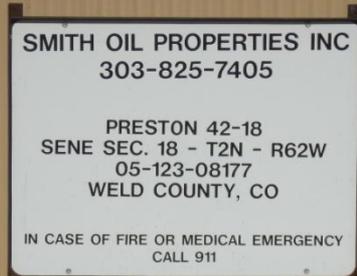
**Photo 1:** Photo taken from the east end of the battery facility. Photo of one of the two signs for an active well this battery serves.

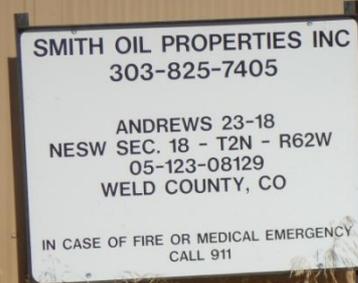
**Photo 2:** Photo taken from the east end of the battery facility. Photo shows the second sign for an active well this battery serves

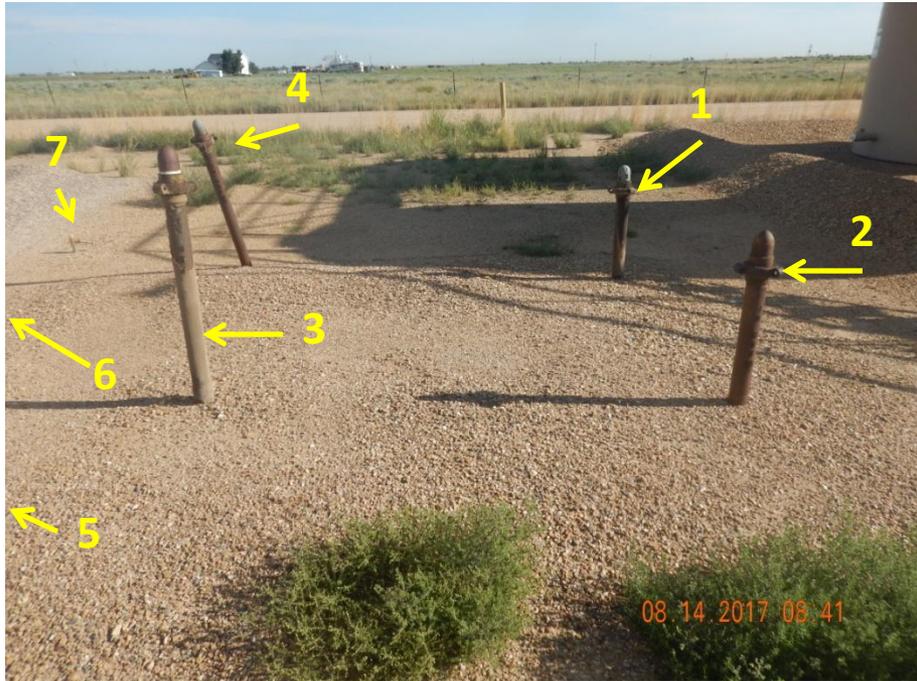
**Photo 3:** Photo taken from the central area of the battery facility, facing north. Photo shows risers at the battery. Inspection doc. #682502037 required operator to comply with reclamation requirements and the 2017 Flowline NTO to remove the risers. Operator appears to have only sprayed "In Use" on five (5) of the seven (7) risers visible (risers labeled 1-5). Risers labeled "In Use" will require pressure testing.

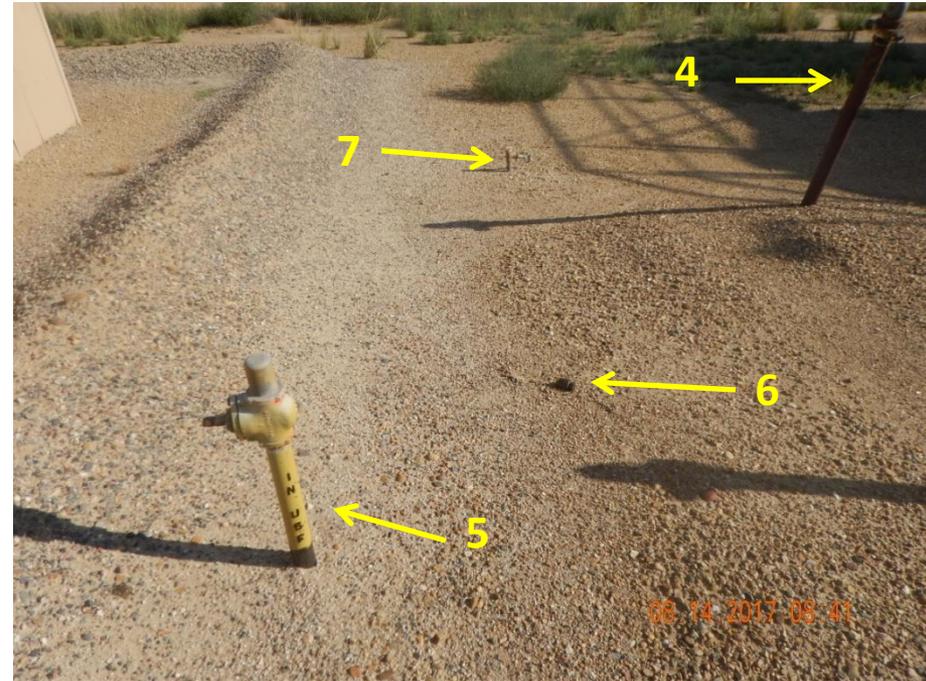
**Photo 4:** Photo taken from the central area of the battery facility, facing north. Photo shows risers at the battery. Inspection doc. #682502037 required operator to comply with reclamation requirements and the 2017 Flowline NTO to remove the risers. Operator appears to have only sprayed "In Use" on five (5) of the seven (7) risers visible (risers labeled 1-5). Risers labeled "In Use" will require pressure testing.

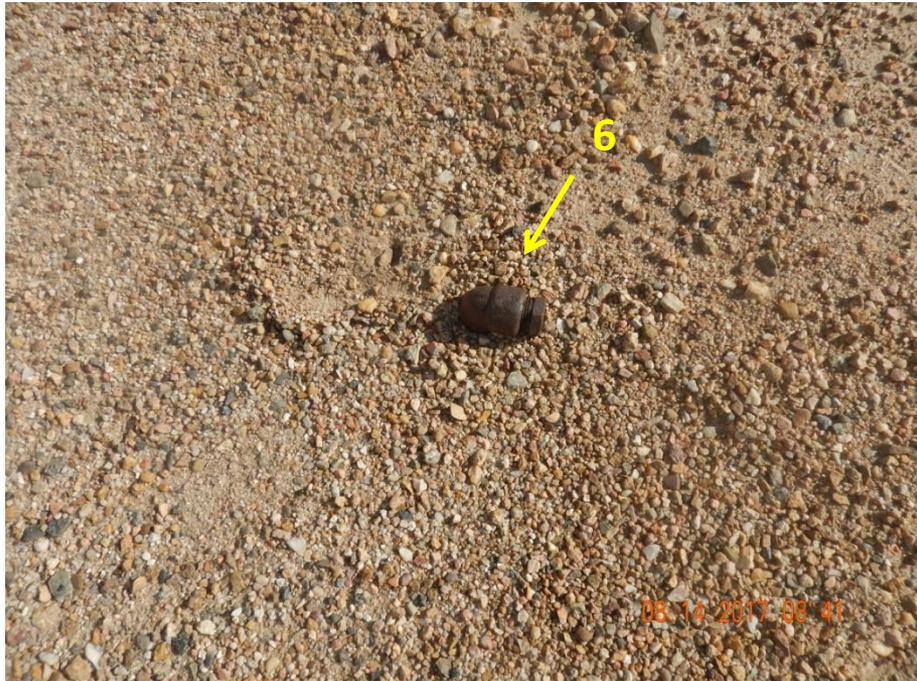
**Photo 5:** Photo taken from the central area of the battery facility. Photo shows risers at the battery. Inspection doc. #682502037 required operator to comply with reclamation requirements and the 2017 Flowline NTO to remove the risers. Riser seen here does not appear to be in use and will need to be removed.

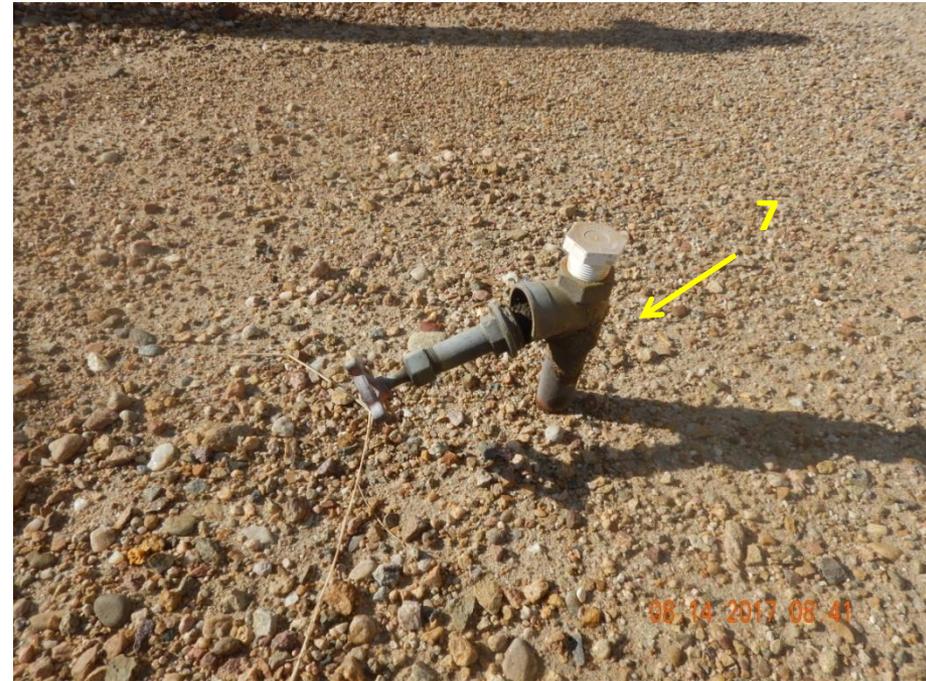
**Photo 6:** Photo taken from the central area of the battery facility. Photo shows risers at the battery. Inspection doc. #682502037 required operator to comply with reclamation requirements and the 2017 Flowline NTO to remove the risers. Riser seen here does not appear to be in proper function condition and needs to be removed.
