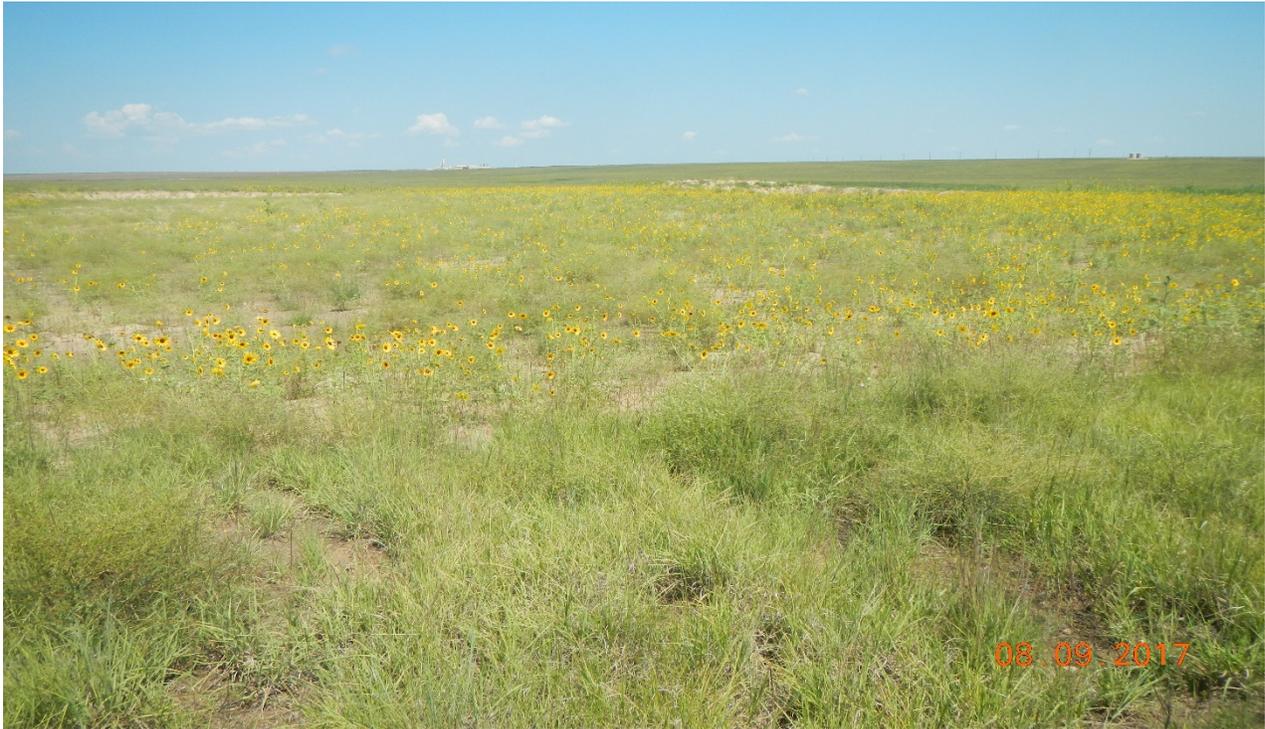
photo 1: Facing northeast toward the location. The location has been built and has not been reclaimed.

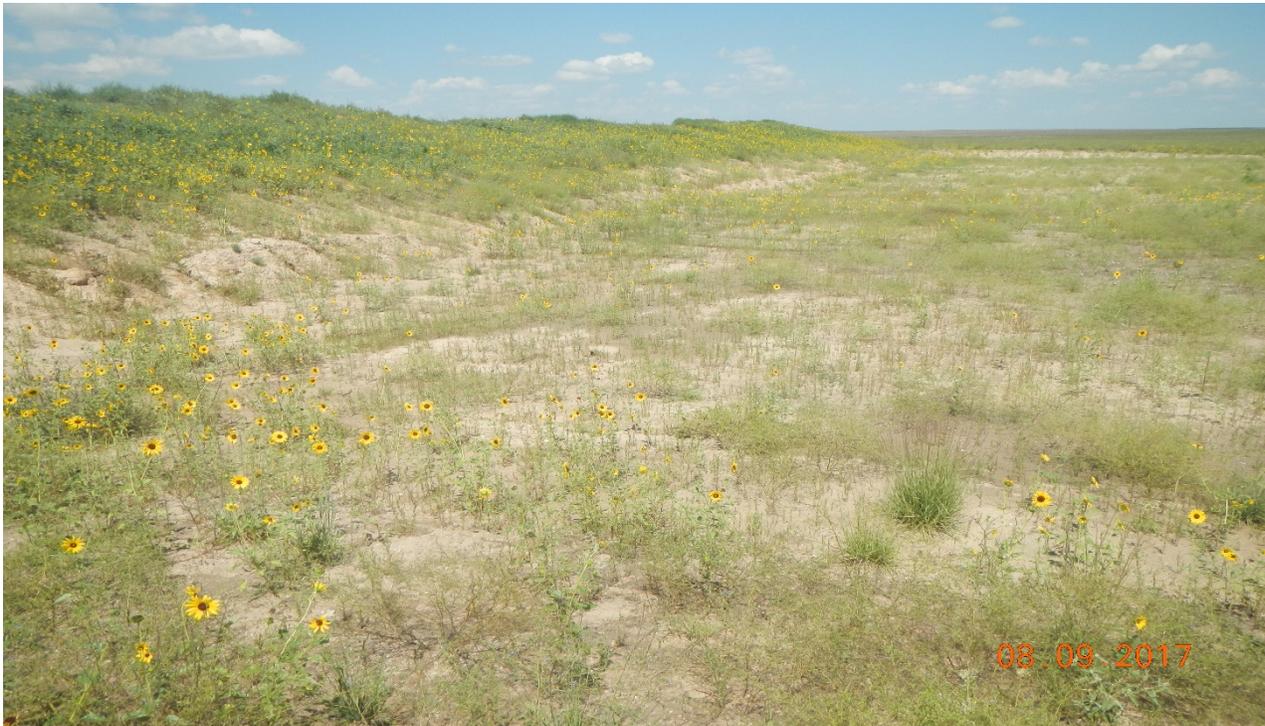
photo 2: Facing northwest along the topsoil pile at the west side of the location. There are weed issues and signs of erosion occurring along the topsoil pile.

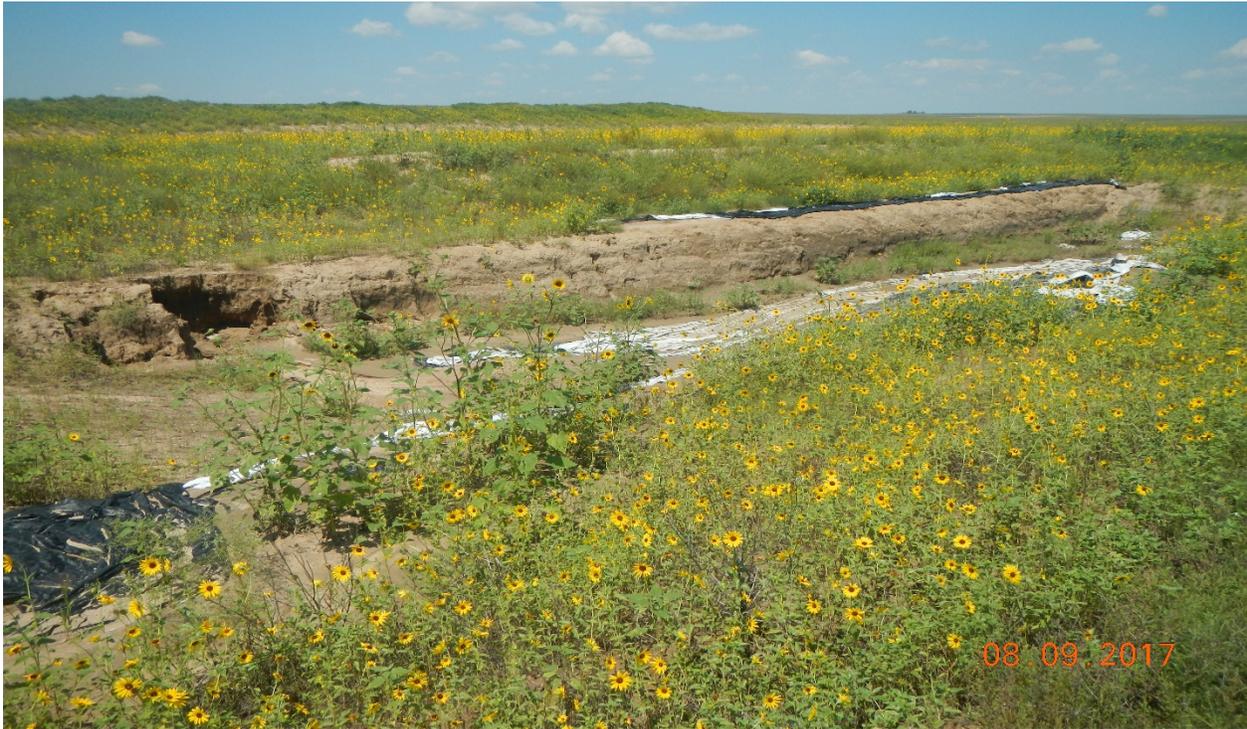
photo 3: There is a pit at the east side of the location which has torn liner debris.

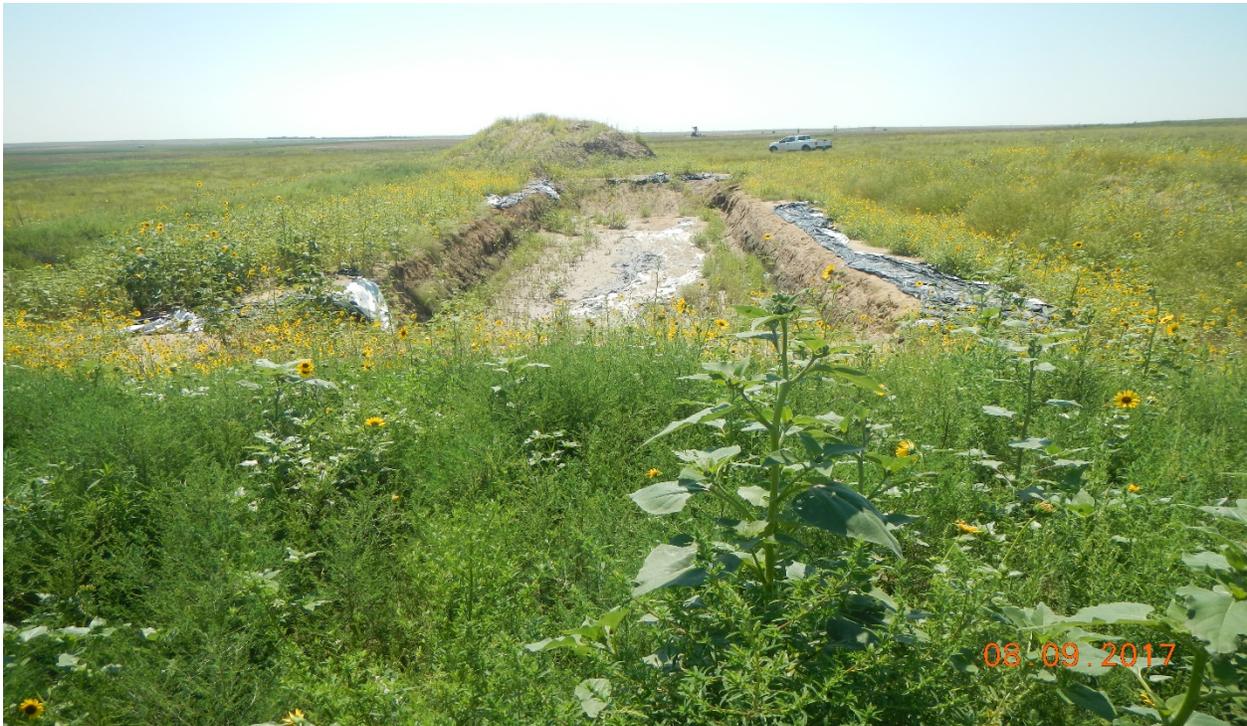
photo 4: Facing south at the east side of the location toward the pit.

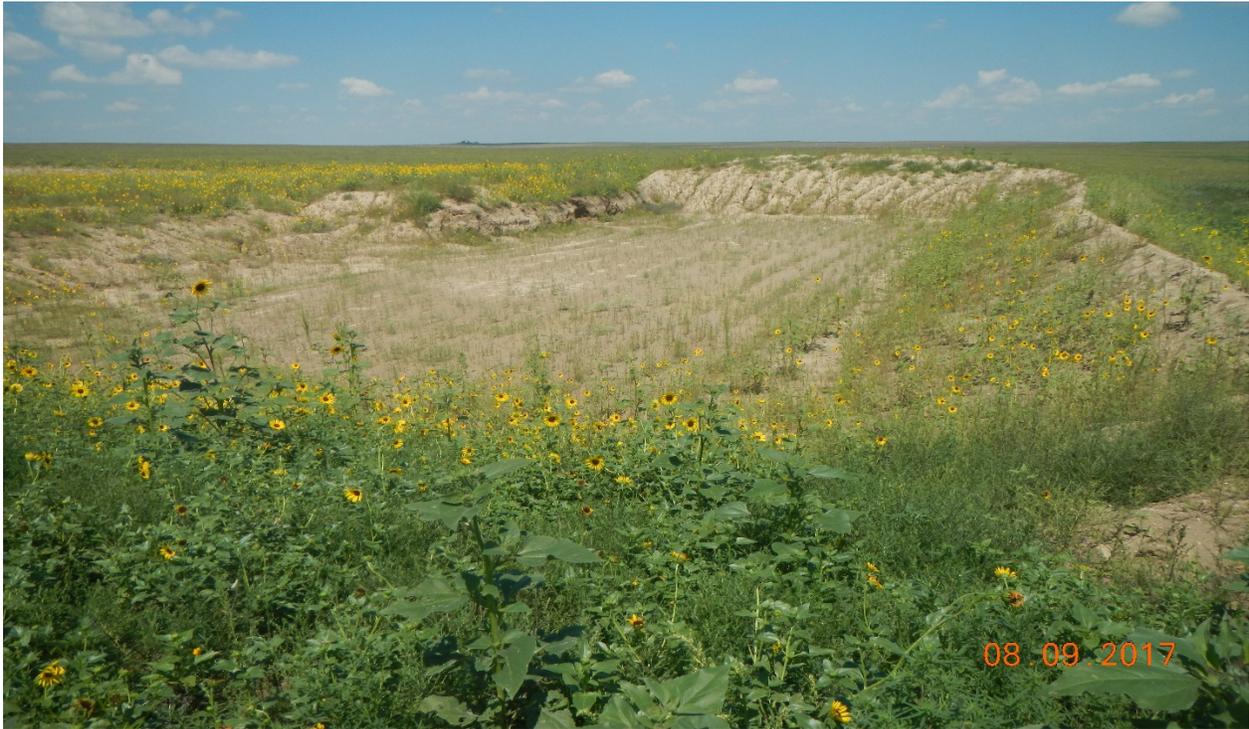
photo 5: A second pit remains open at the northeast side of the location.

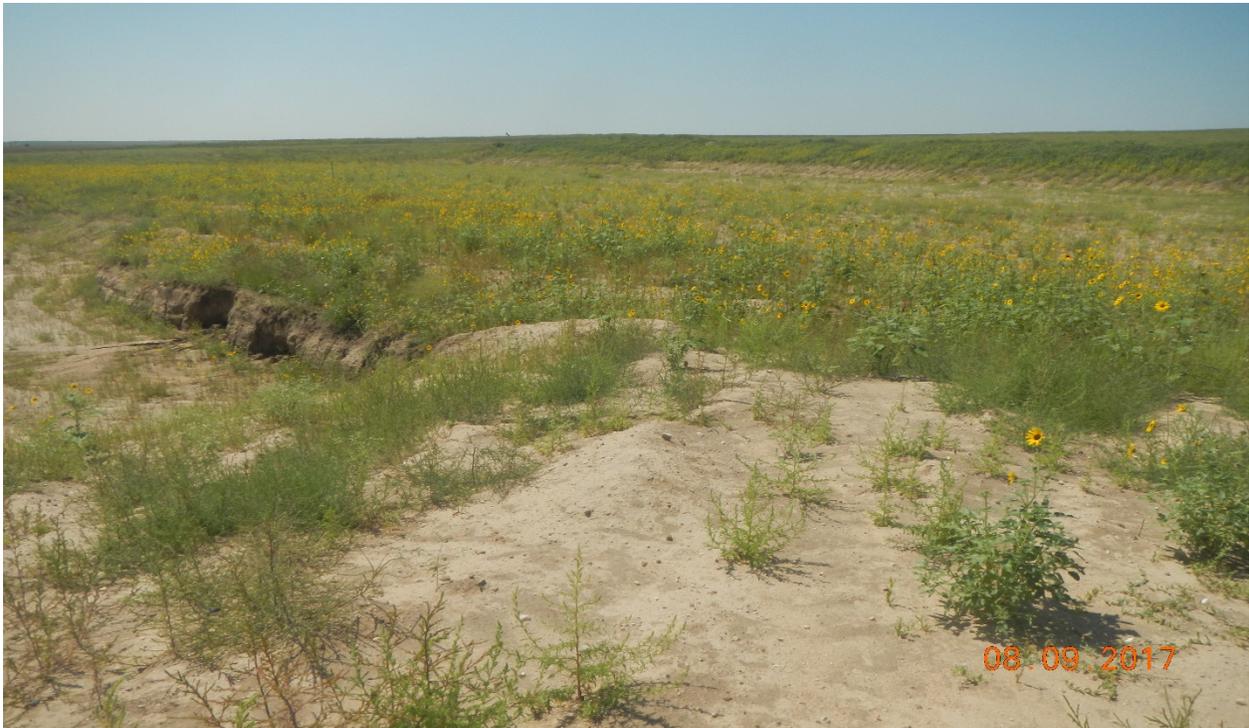
photo 6: Northeast side of the location facing southwest.

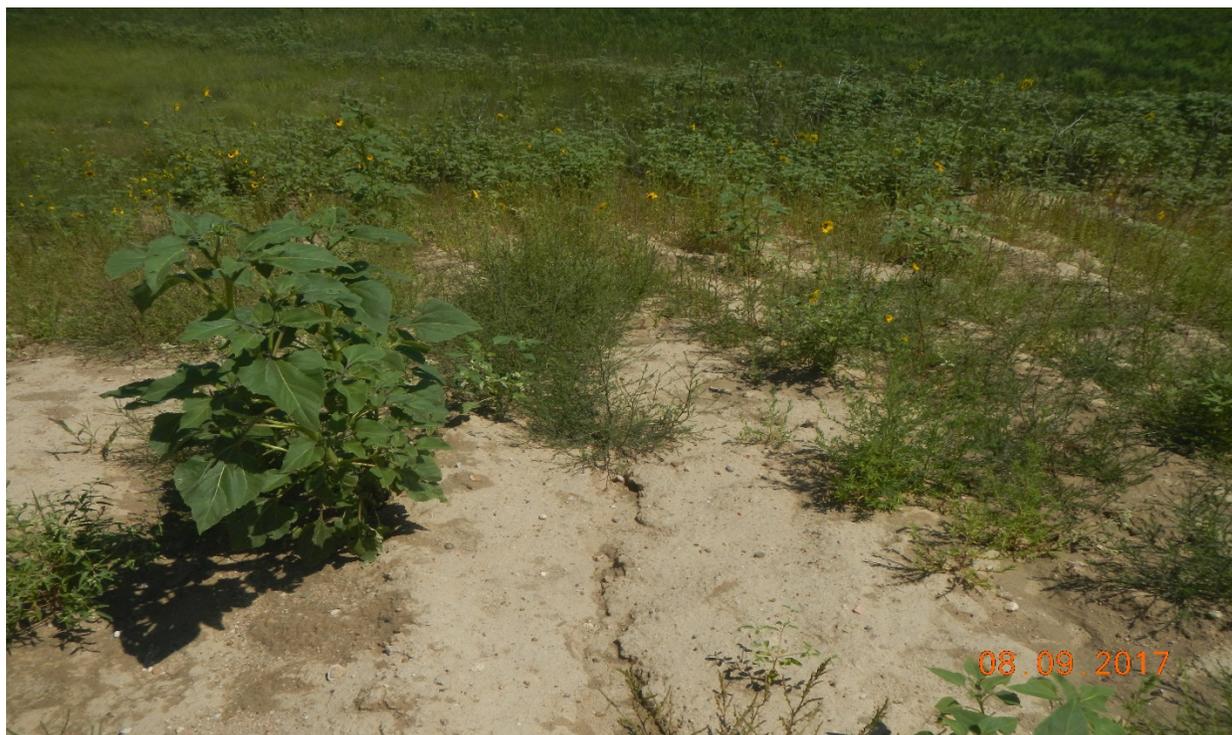
photo 7: There is signs of erosion occurring off the northeast side of the location

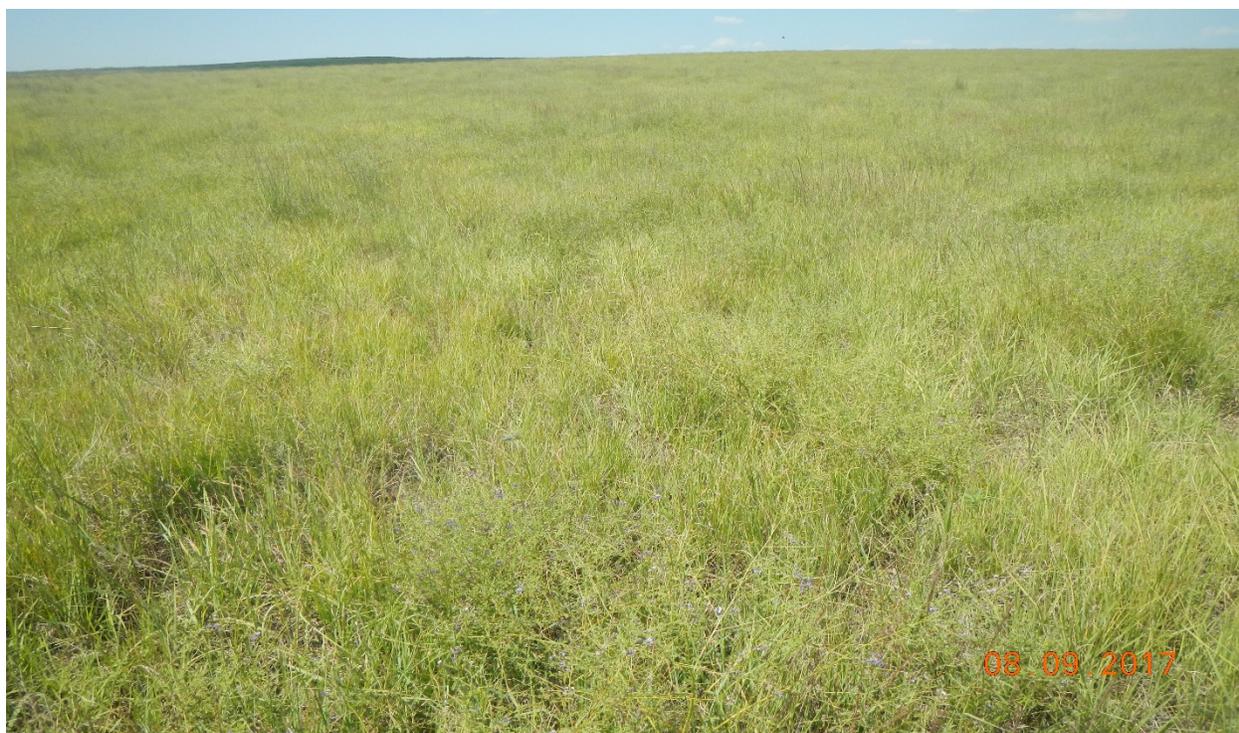
photo 8: Facing west at the surrounding undisturbed reference area.
