Inspection Photos
Location ROBBINS 24-11A
API:05-001-07577

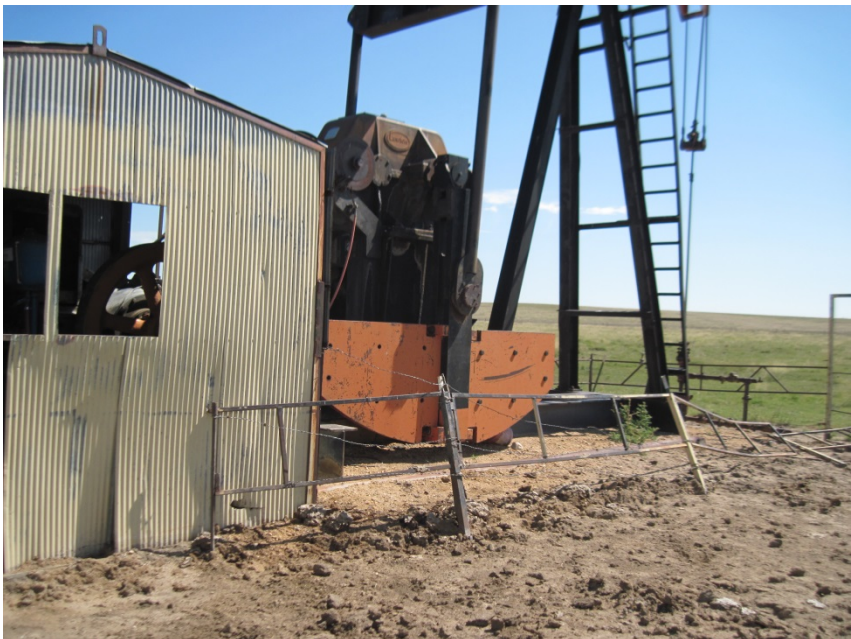
FENCE DOWN

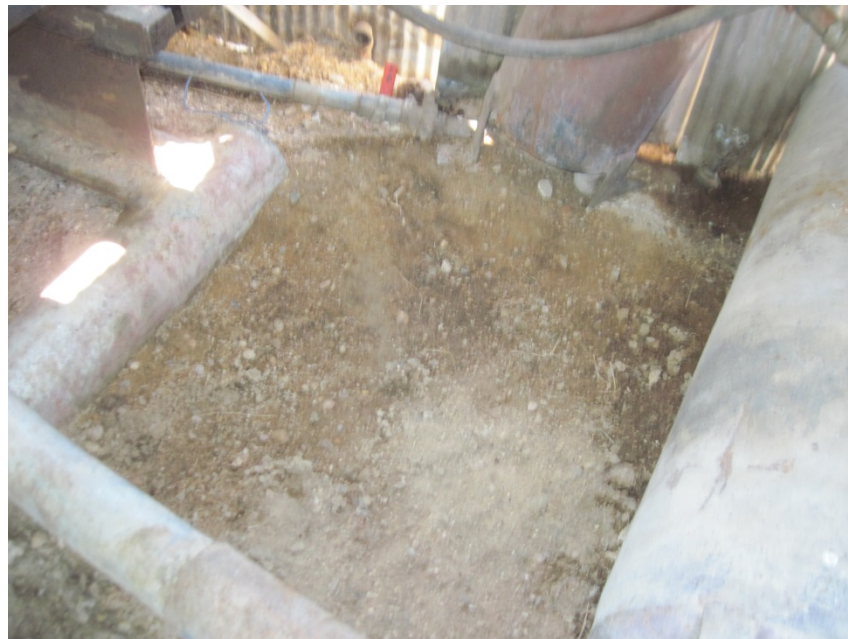
SOILED DIRT INSIDE PUMP JACK HOUSE
