Inspection Photos

Operator: NOBLE ENERGY INC - 100322

Location ID: 323052

Inspection Doc. Number: 675103879

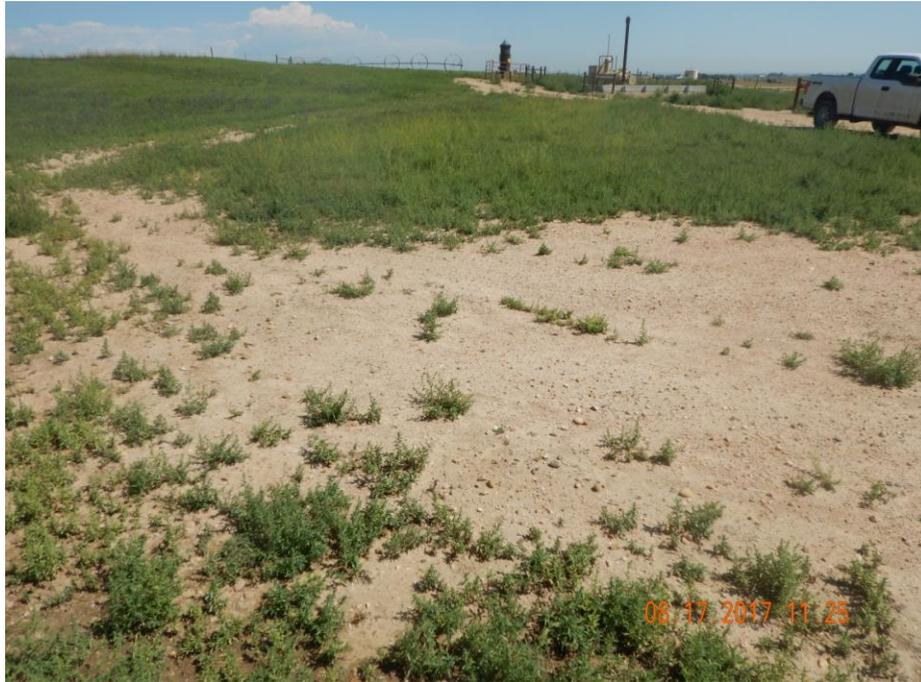
Photo 1: Photo taken from the south end of the well location, facing north. Photo shows no reclamation per corrective actions have been conducted; access road remains, location remains predominantly undesirable weedy plant species such as kochia.

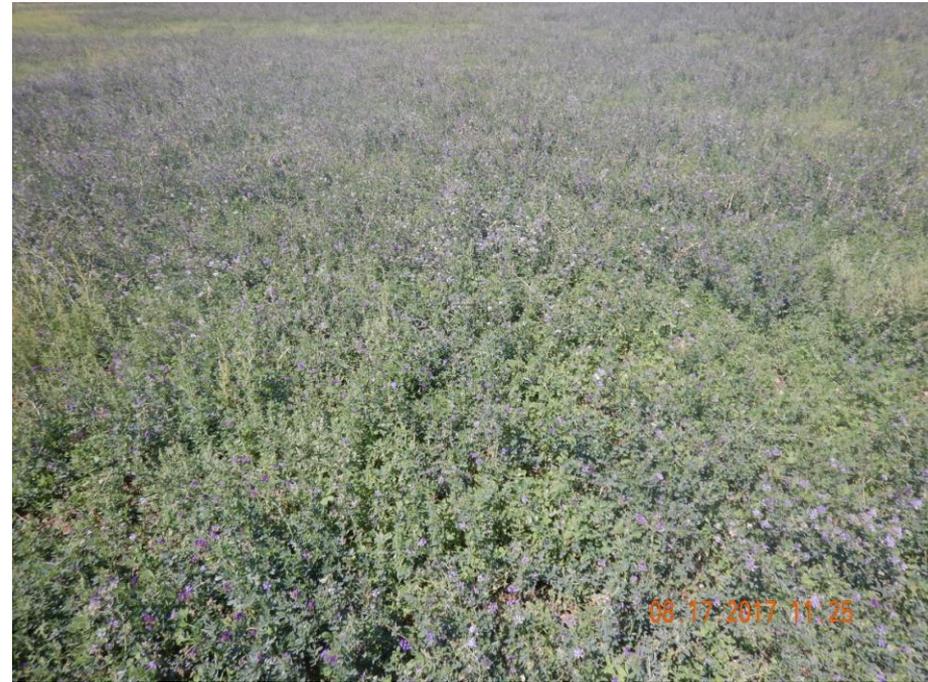
Photo 2: Photo taken from the adjacent reference area. Photo shows alfalfa crop growing in reference area.

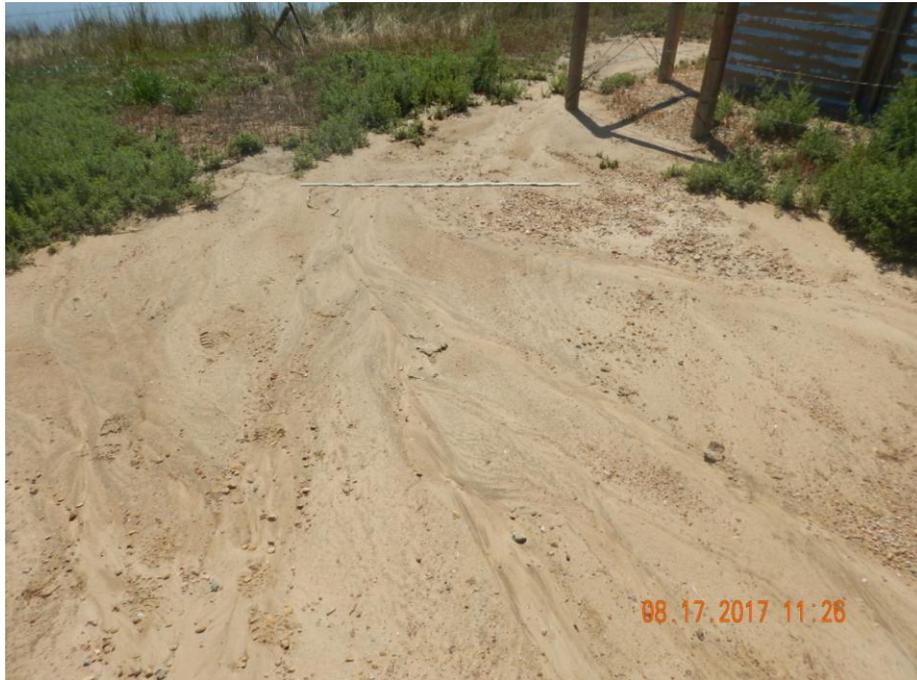
Photo 3: Photo taken from the battery location. Photo shows sediment deposition from sediment laden stormwater runoff degrading the location. 6 foot measuring stick for reference

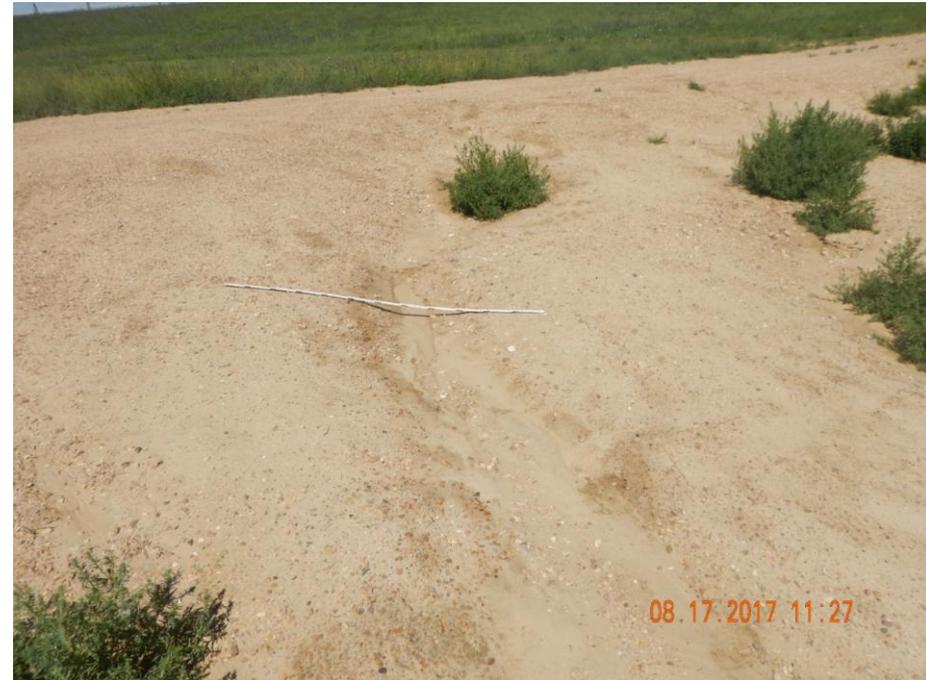
Photo 4: Photo shows gully erosion continuing to form and degrade the location and access road. Inspection doc. #682502370 required operator to repair erosion and install/repair required BMPs. CA has not been addressed. 6 foot measuring stock for reference.

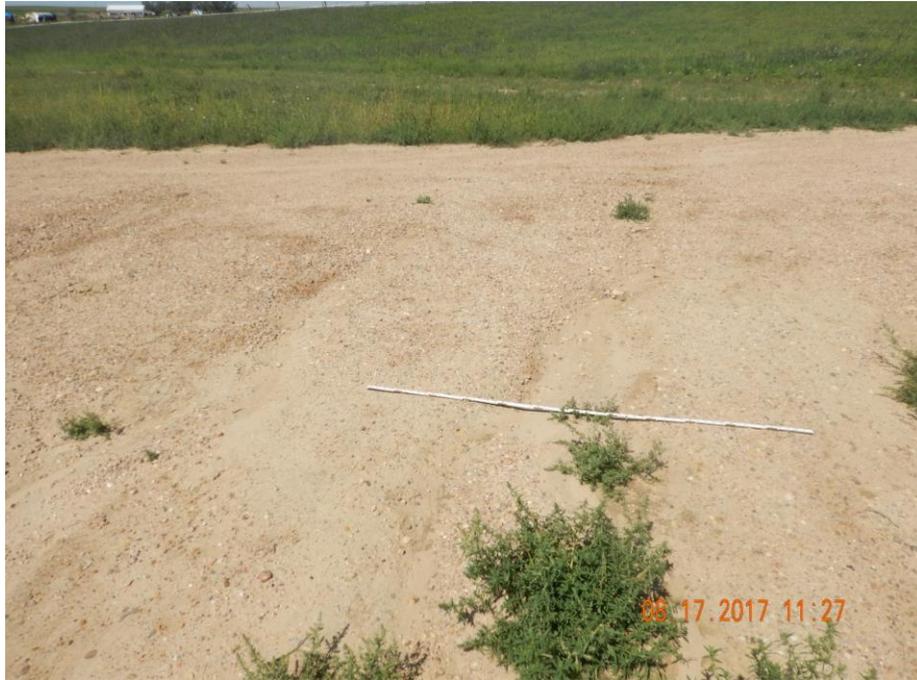
Photo 5: Photo shows gully erosion continuing to form and degrade the location and access road. Inspection doc. #682502370 required operator to repair erosion and install/repair required BMPs. CA has not been addressed. 6 foot measuring stock for reference.

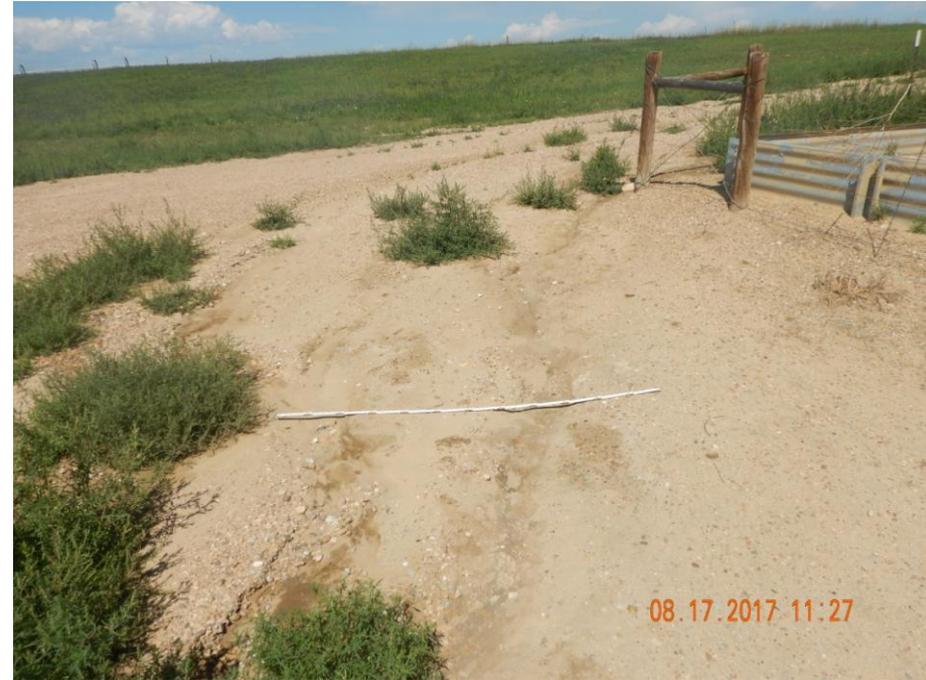
Photo 6: Photo shows gully erosion continuing to form and degrade the location and access road. Inspection doc. #682502370 required operator to repair erosion and install/repair required BMPs. CA has not been addressed. 6 foot measuring stock for reference.

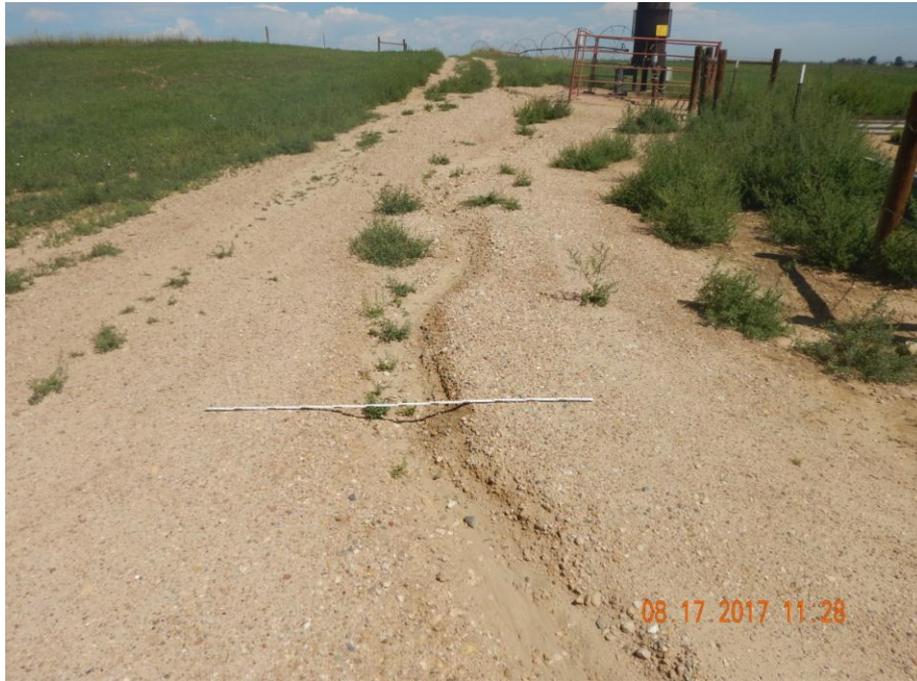
Photo 5: Photo shows gully erosion continuing to form and degrade the location and access road. Inspection doc. #682502370 required operator to repair erosion and install/repair required BMPs. CA has not been addressed. 6 foot measuring stock for reference.

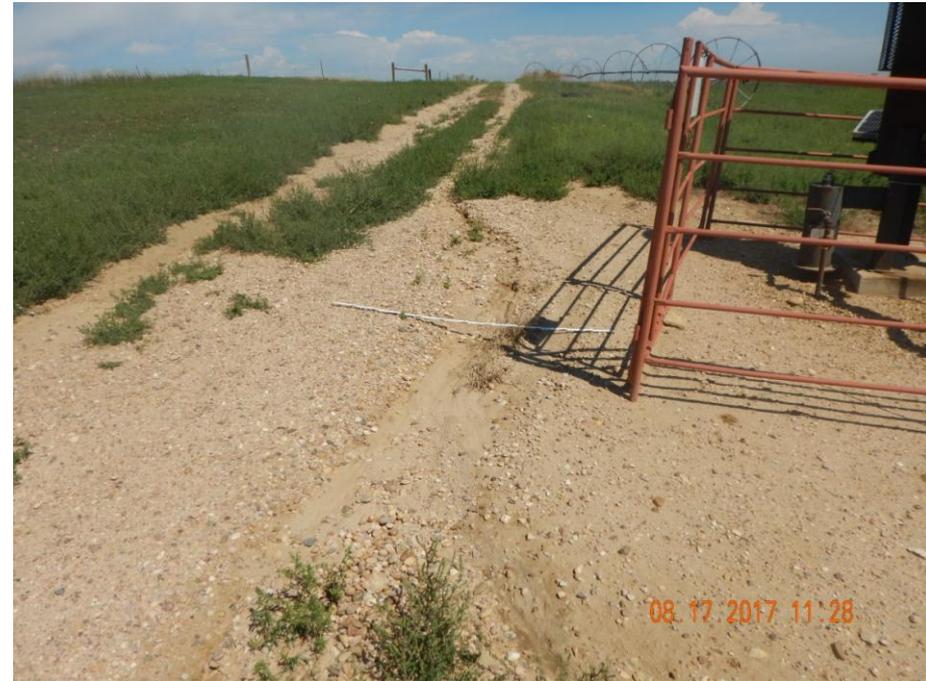
Photo 6: Photo shows gully erosion continuing to form and degrade the location and access road. Inspection doc. #682502370 required operator to repair erosion and install/repair required BMPs. CA has not been addressed. 6 foot measuring stock for reference.
