**Inspection Photos**  
**Location Name: Centennial 32-33**  
**API: 05-123-21239**

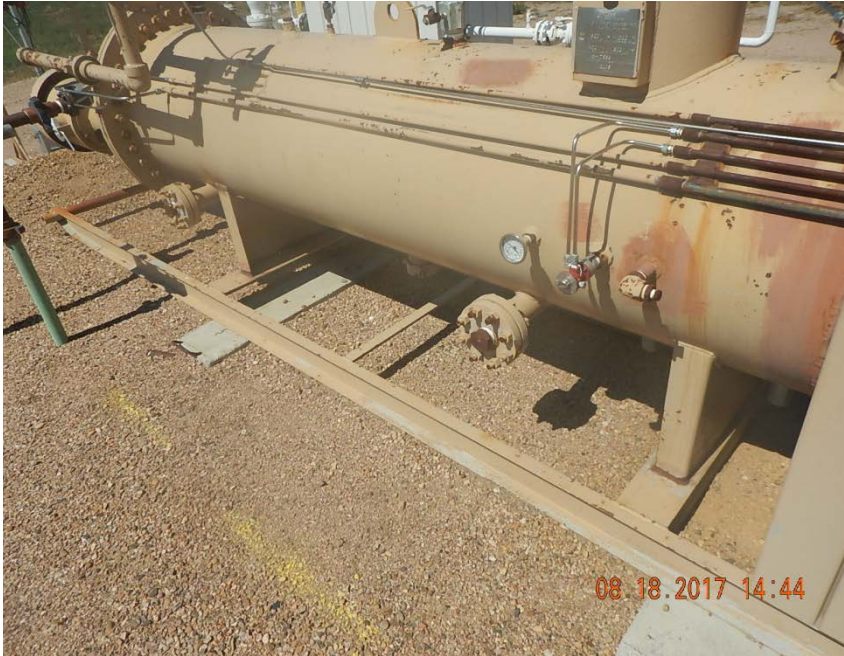
Photo 3: Separator not anchored

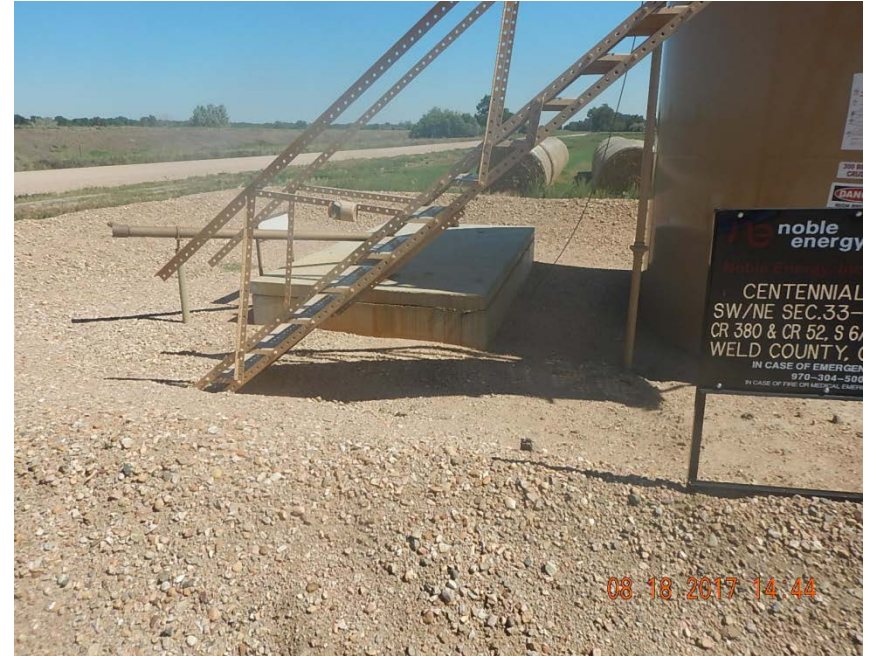
Photo 4: Concrete vault not anchored
