Inspection Photos
Location Name: Bucklin 9-36
API: 05-123-13590

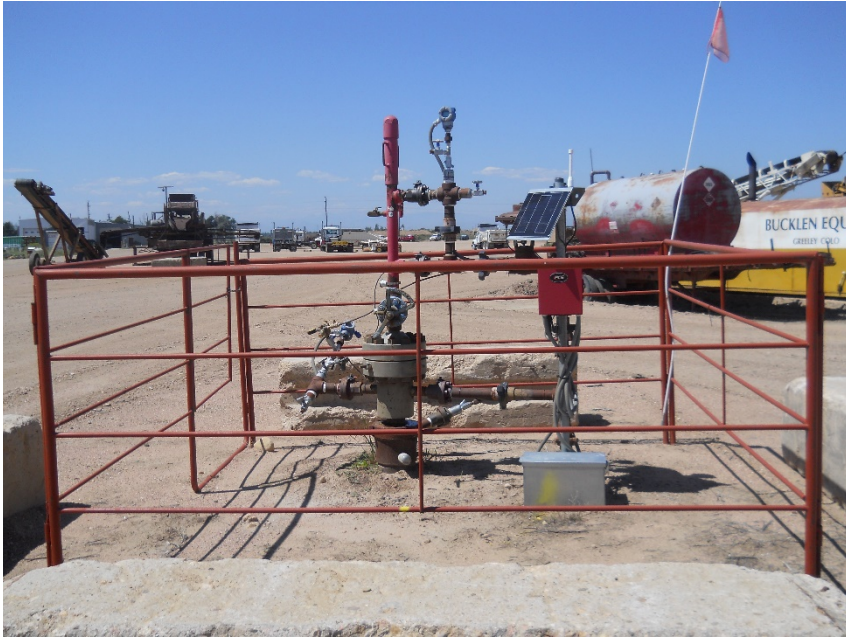
Wellhead looking west, no wellhead sign present

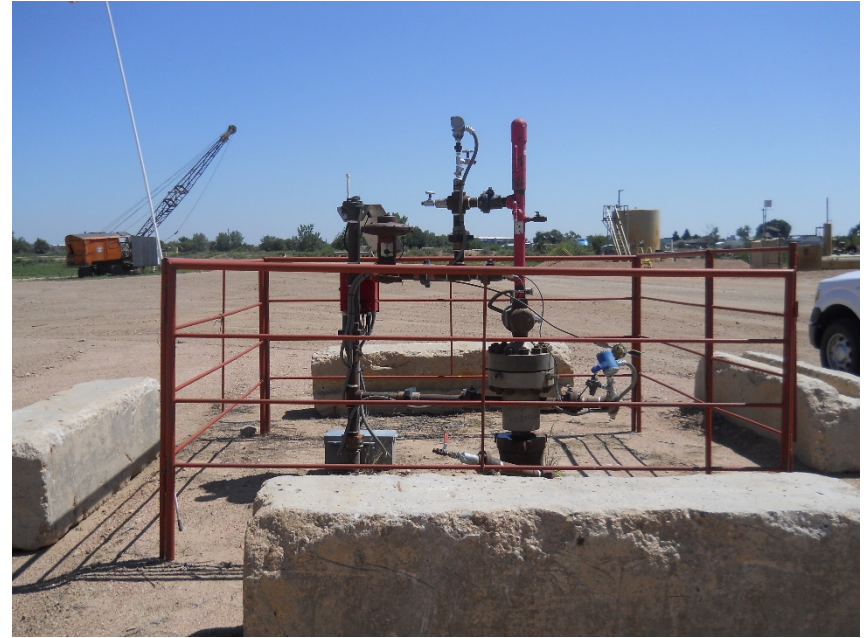
Wellhead looking east, no wellhead sign present

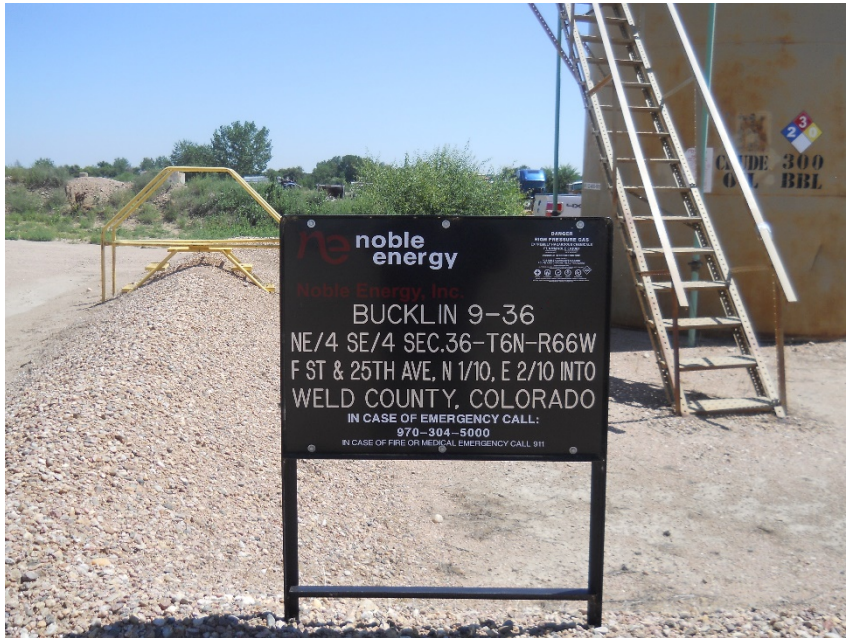
Tank battery sign looking east

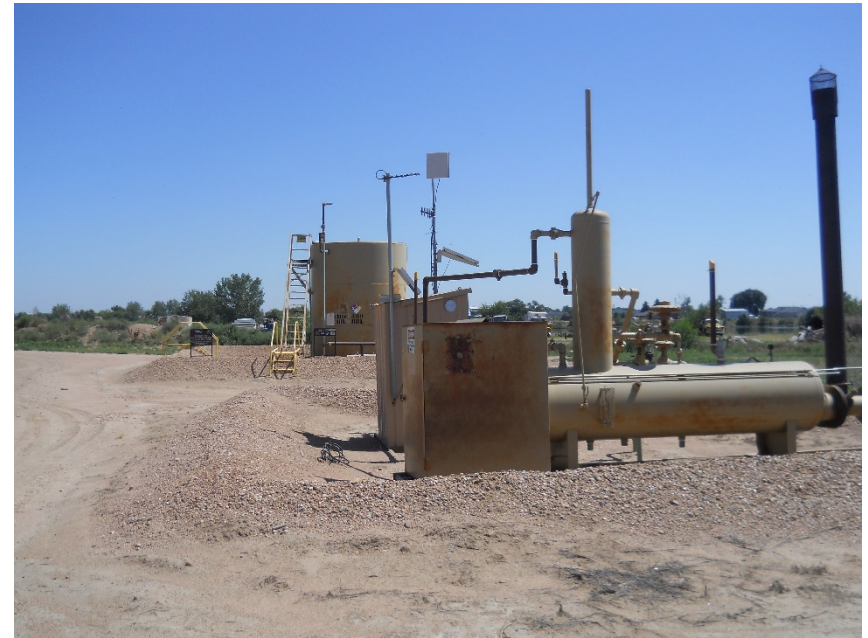
Battery looking east from west side of separator

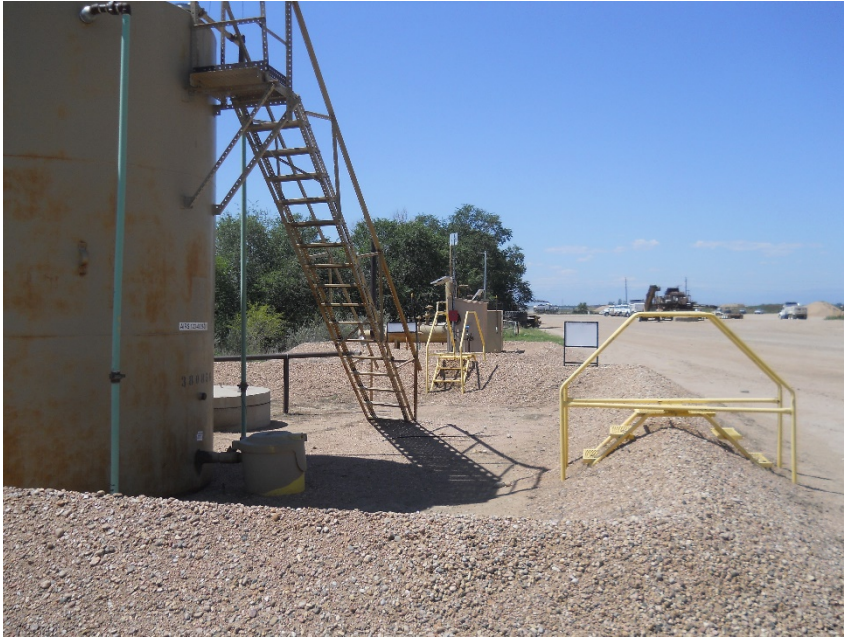
Battery looking west from northeast edge of tank berm
