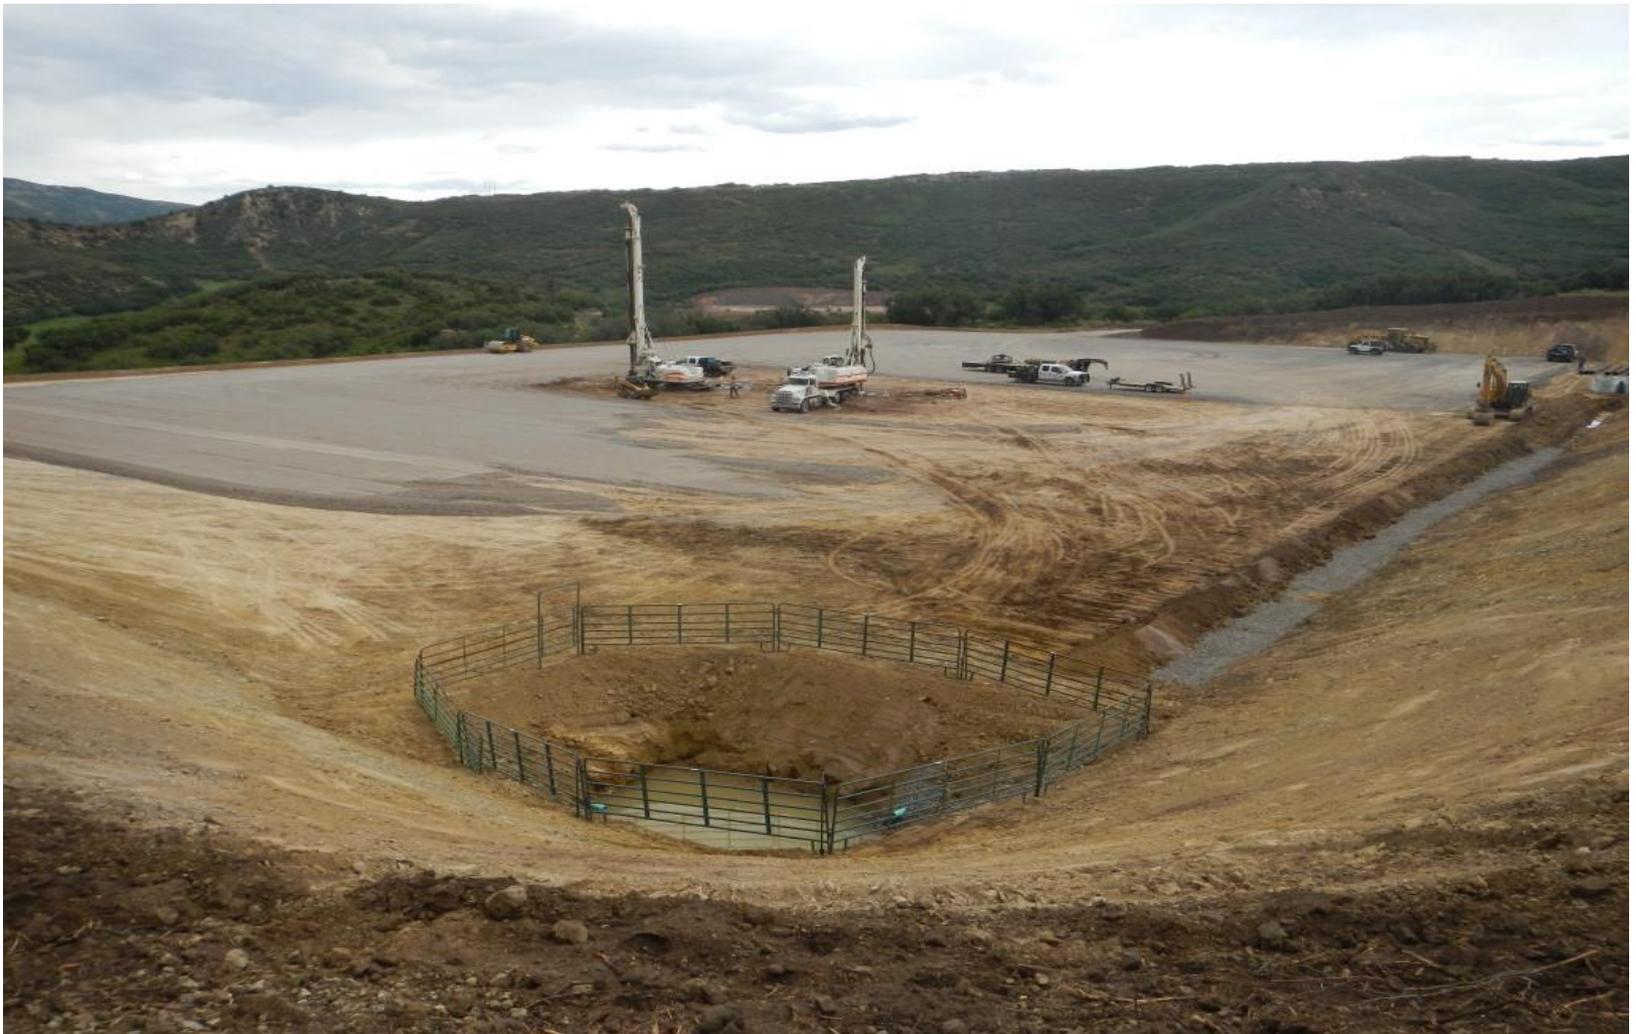
Photo#1:
Overview of Location looking East.

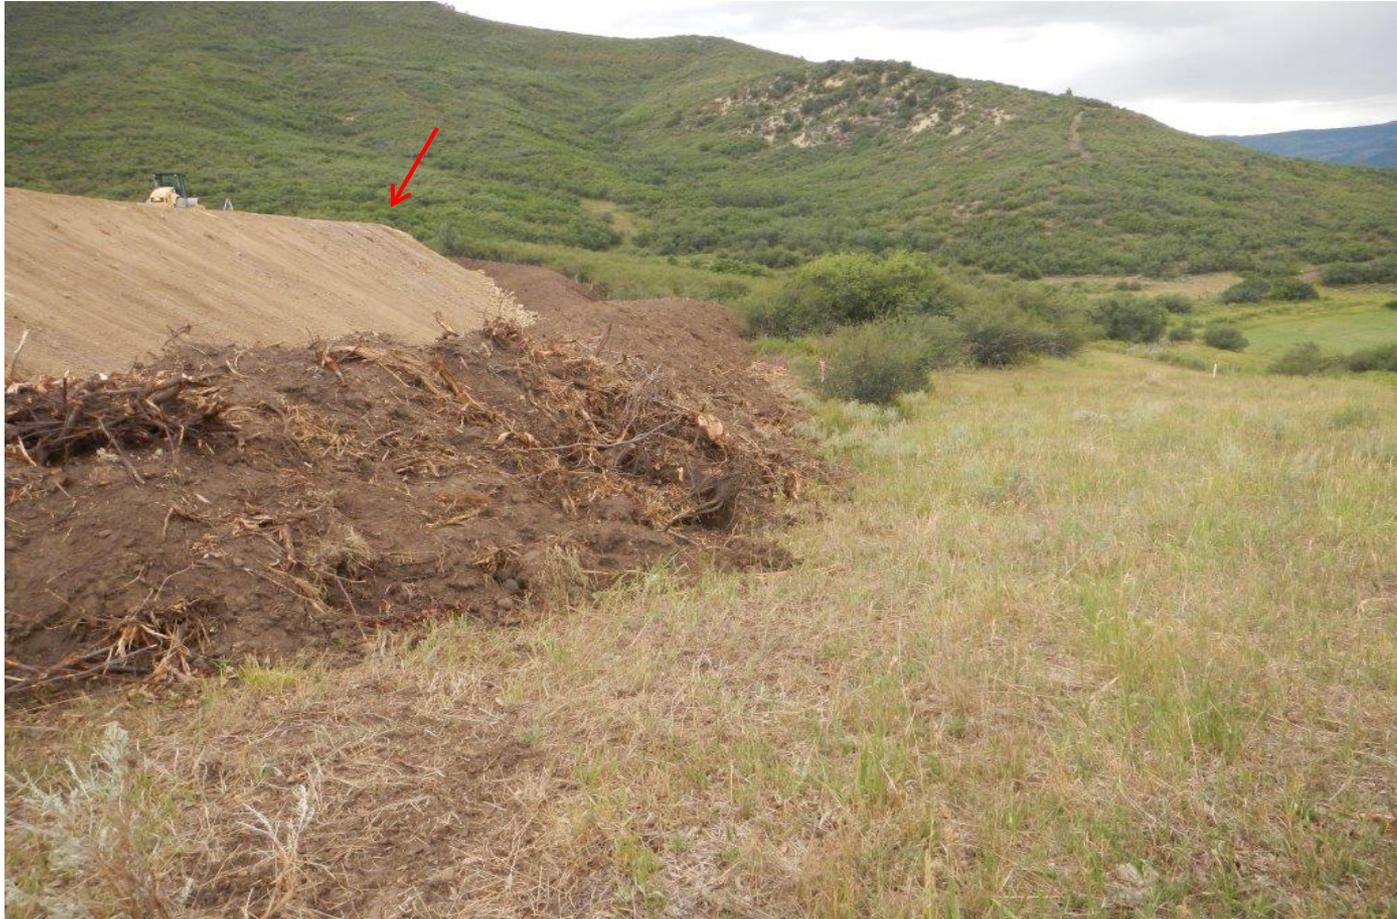
Photo#2:

View to North corner of pad (arrow indicates corner) showing topsoil stockpiled along base of fill slope with no perimeter BMPs installed.

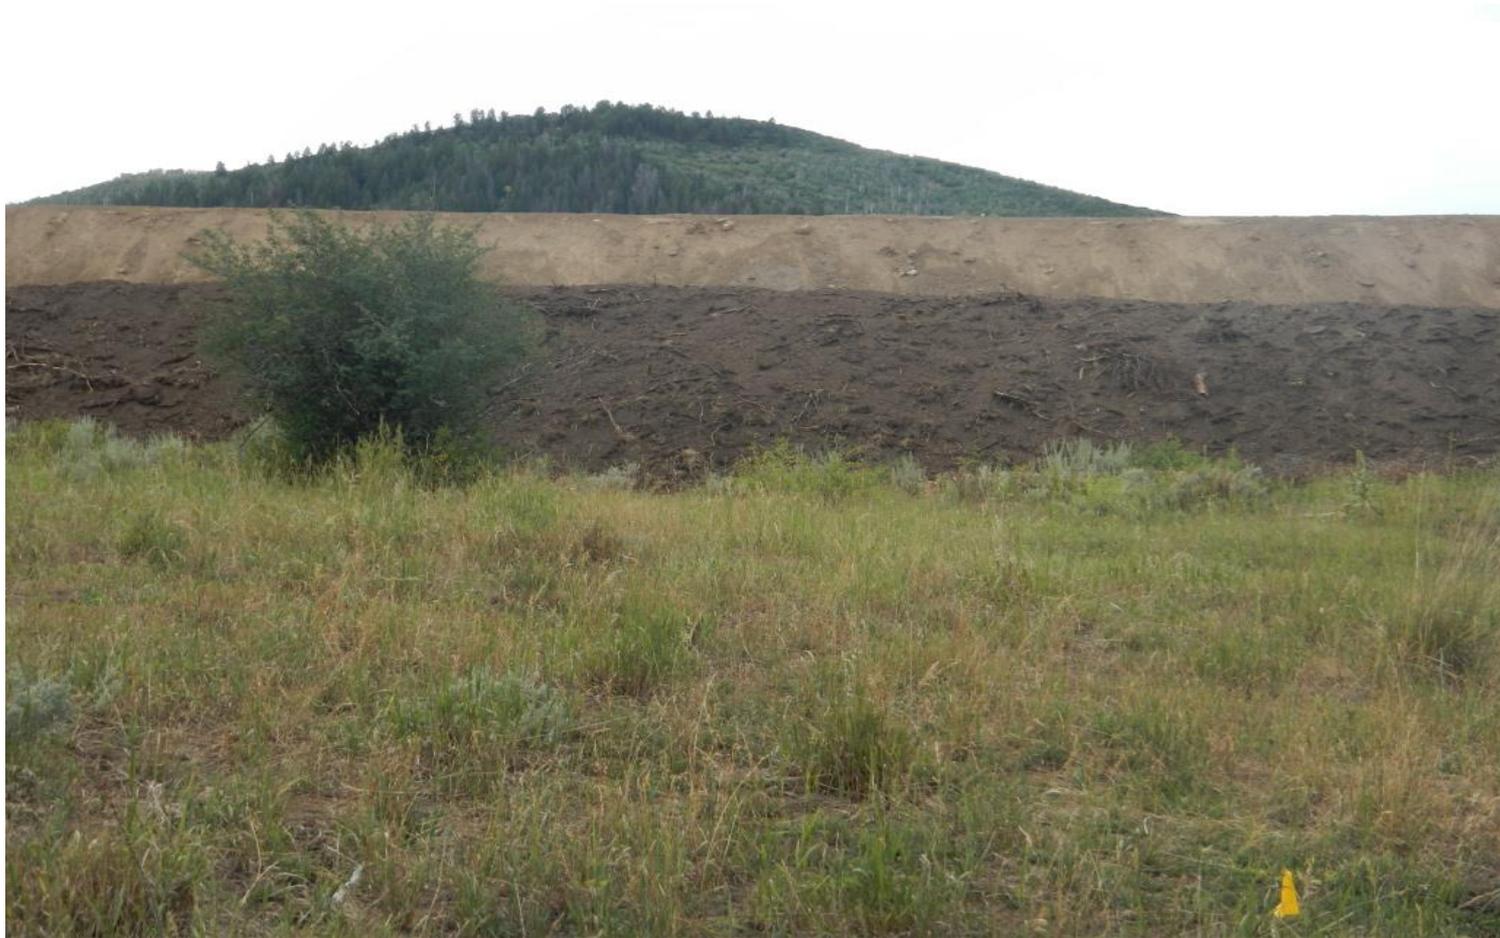
Photo#3:

View to Southwest to top of fill slope, from base of topsoil stockpiled around Location.

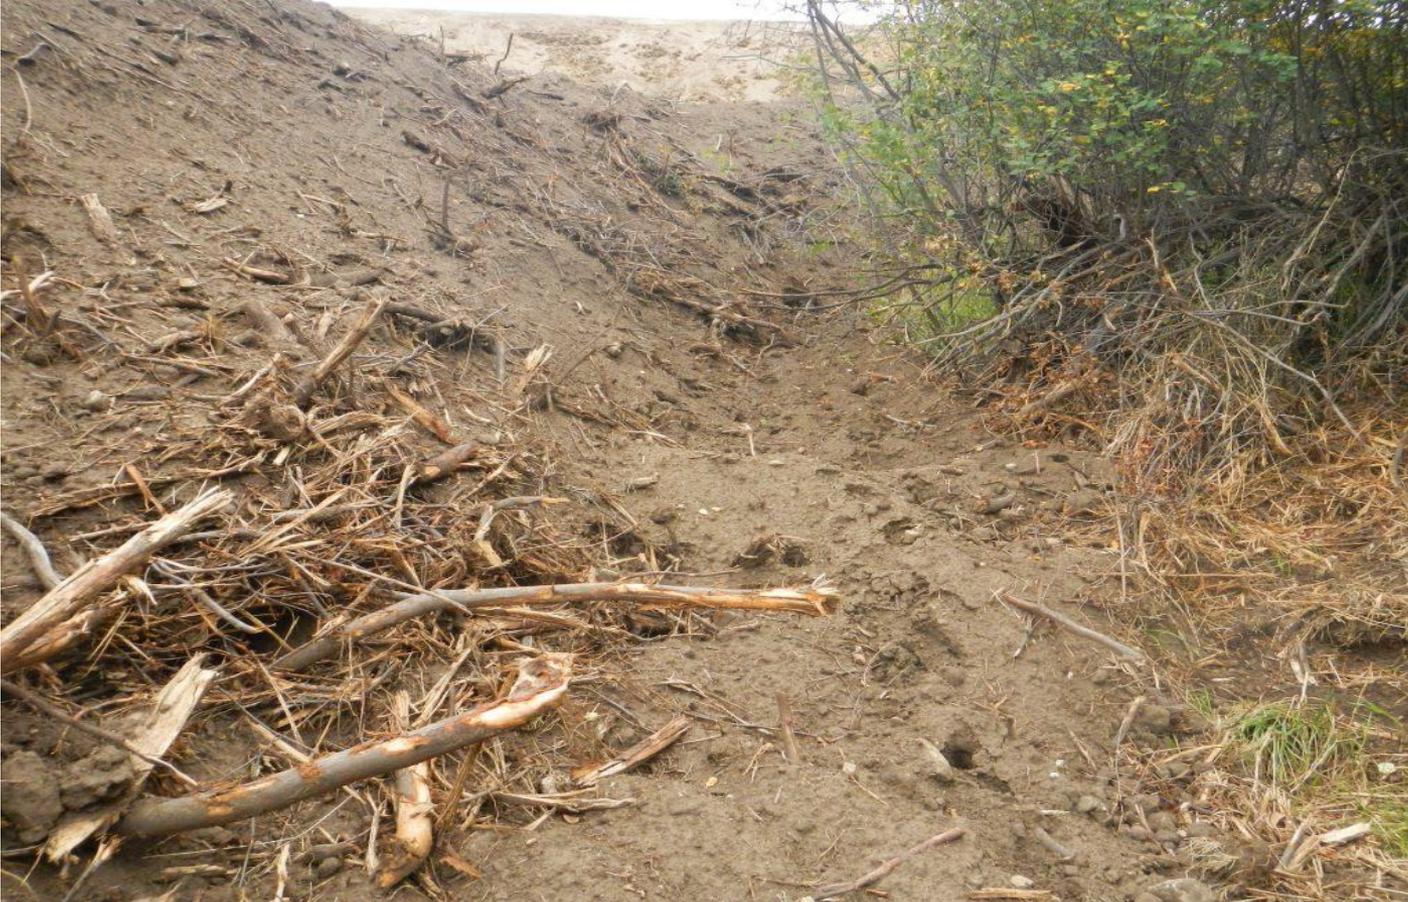
Photo#4:

Close up view of base of topsoil stockpile where edge of disturbance meets native vegetation showing no Perimeter Controls installed.

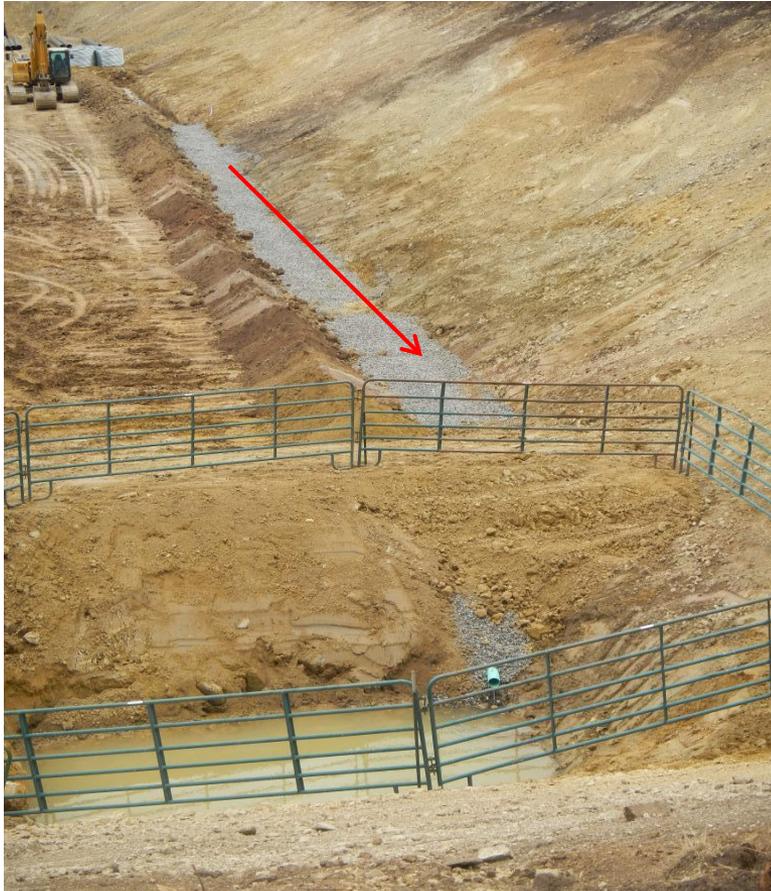
Photo#5:

Seep from cut slope is draining to pit which drains to sediment area at base of fill slope. Arrows indicate direction of flow. This area is shown as cuttings area in Location diagrams, probably calling for adjustment of cuttings site.

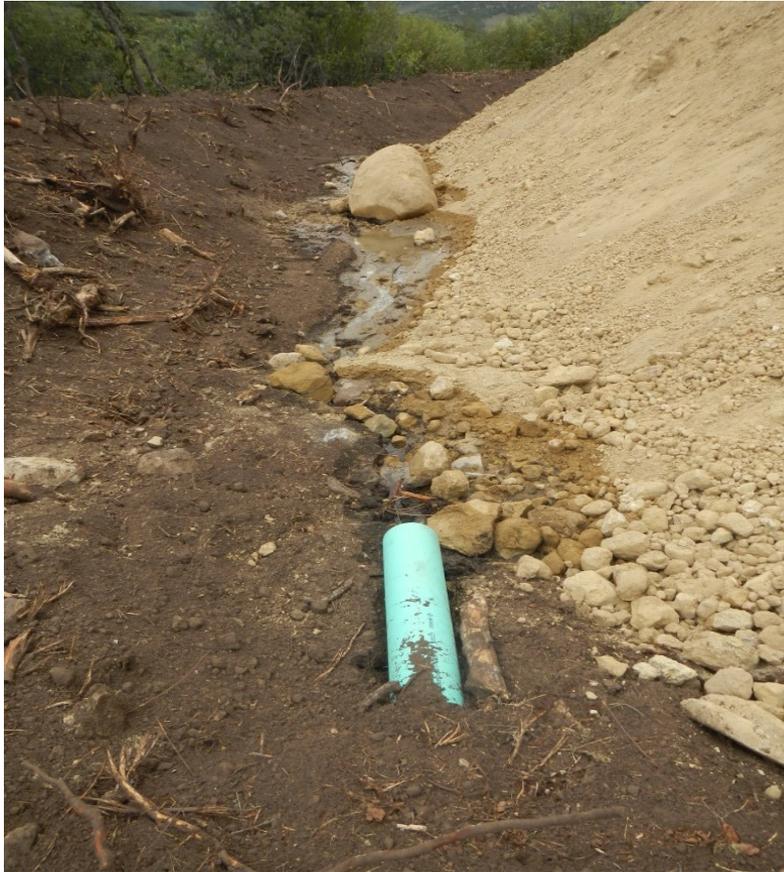
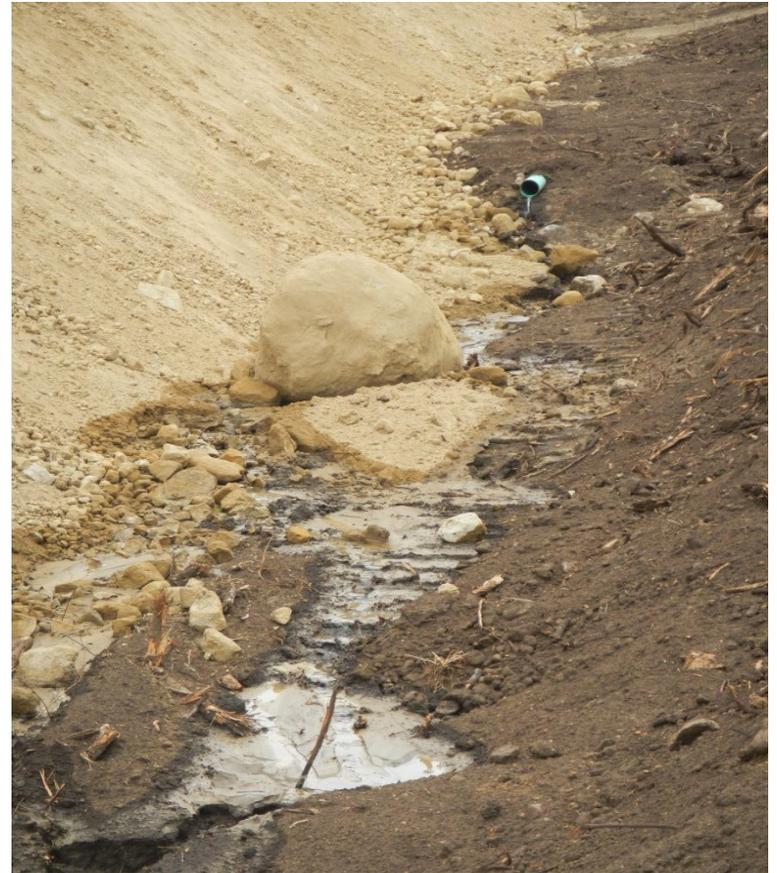
Photo#7 : *Facing down gradient*

Discharge point from Seep Pit in Photos #5&6. Unstabilized topsoil & subsoils are mixing & migrating downslope.

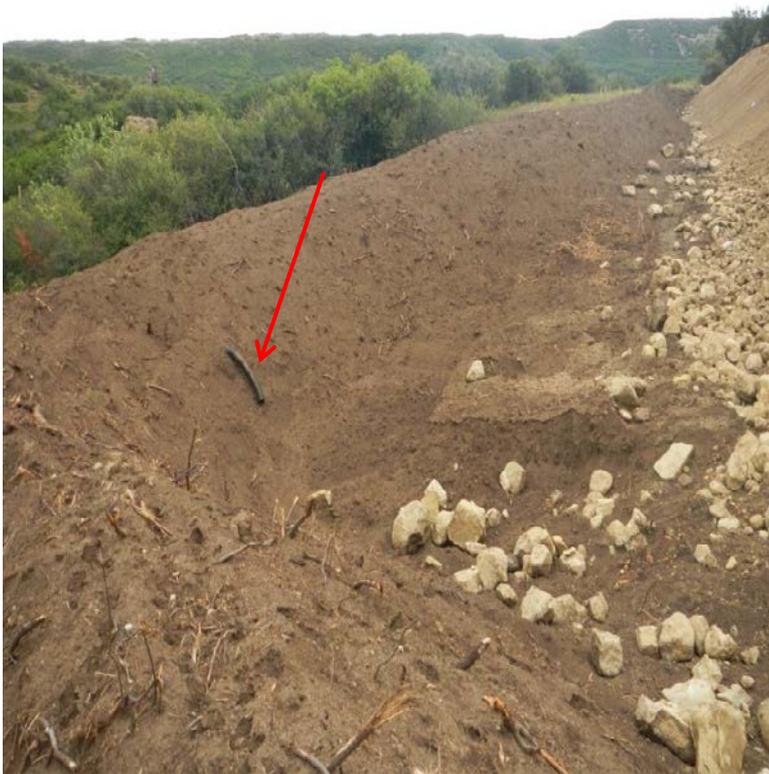
Photo#9:

Unstabilized sediment area (identified by Operator as sediment reservoir) does not appear to be installed with good engineering practices. Arrow indicates outlet discharge pipe.

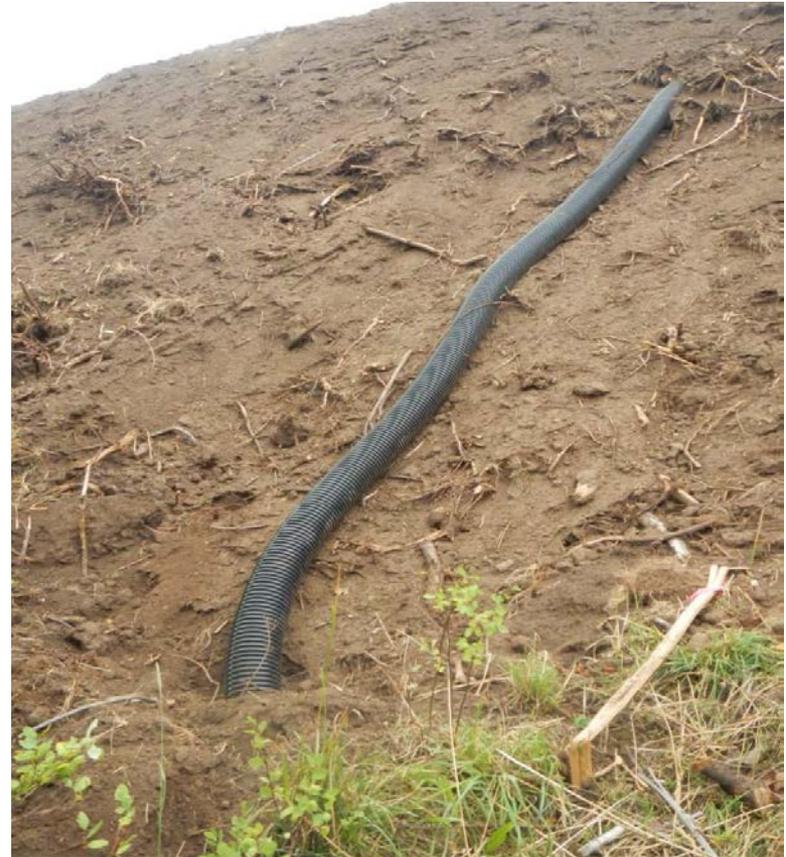
Photo#10

Outlet discharge pipe (identified with arrow in photo#9) outside of unstabilized topsoil stockpile.

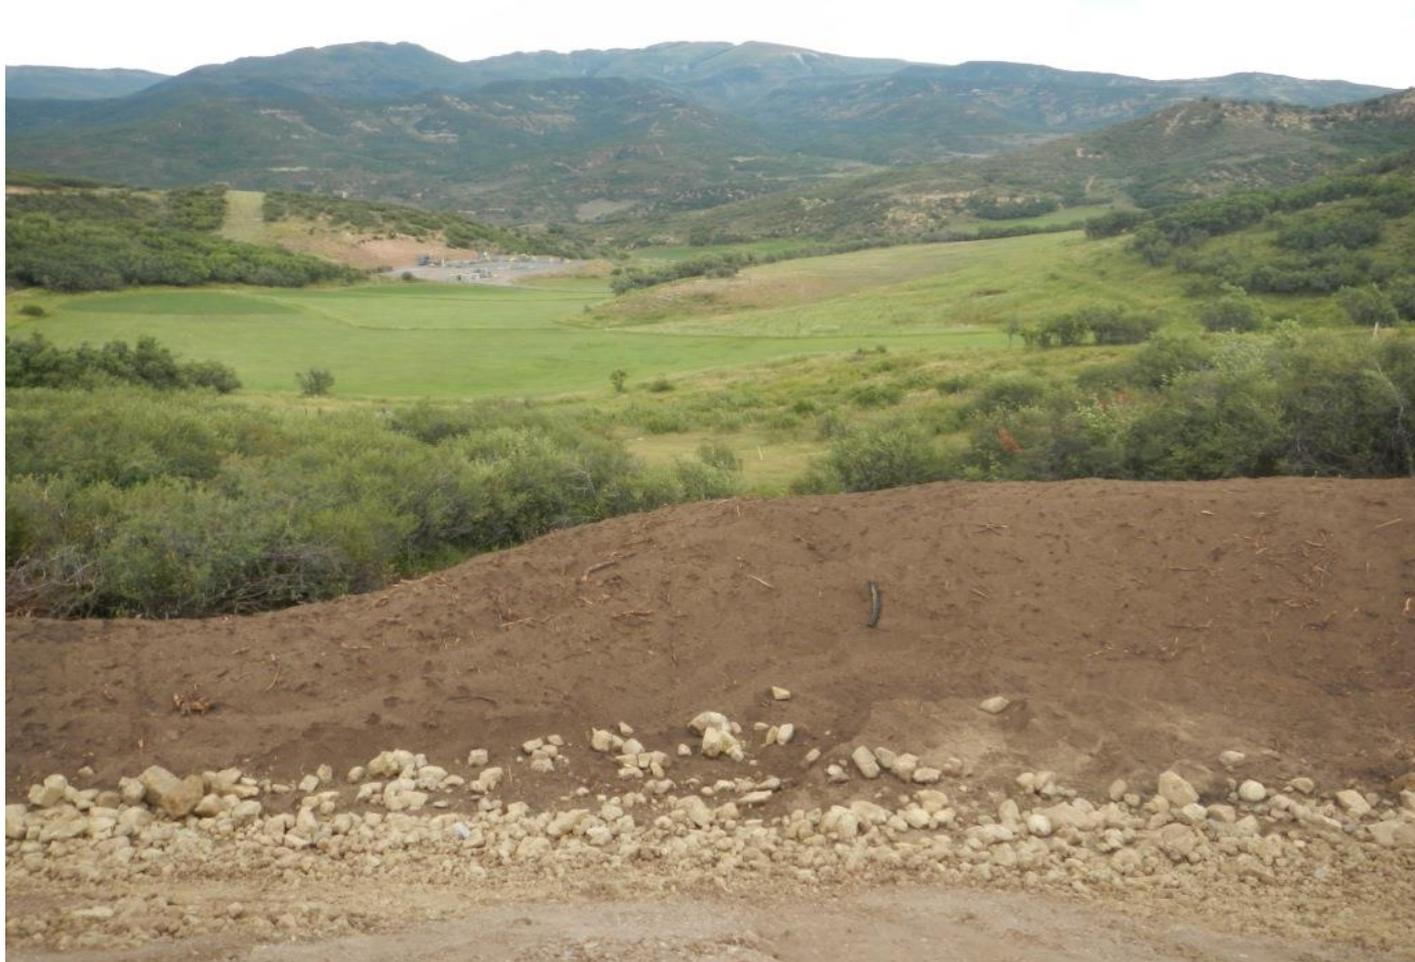
Photo#11:

Overview from top of fill slope looking to NE, showing unstabilized soils & mixing of soils at base of slope.
