Final Reclamation Inspection

August 16, 2017

Operator: TOP OPERATING COMPANY FDBA MURRAY J HERRING LTD - 39560

API: 05-123-08139

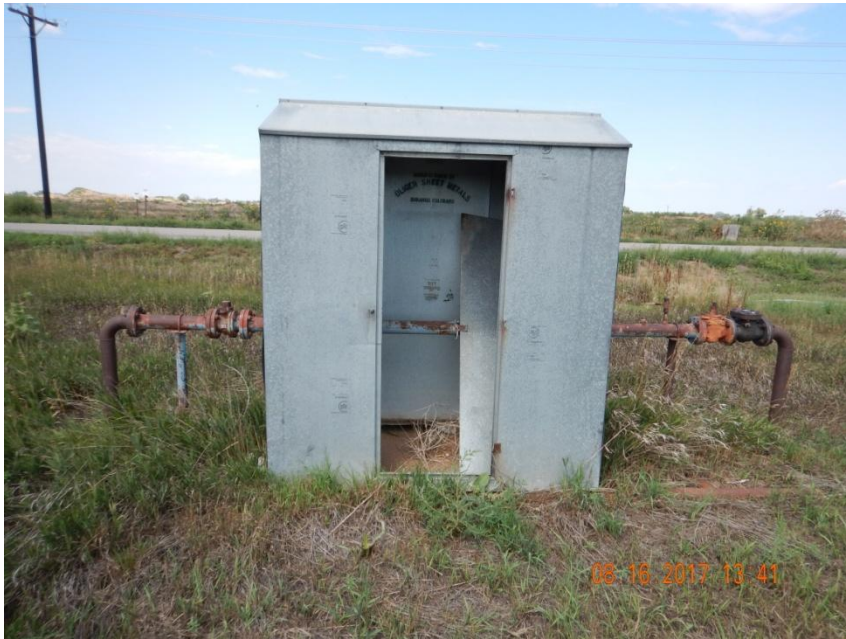
Photo 1. Photo taken from the eastern battery location, facing North, towards the meter shed. Comply with the Pipeline/Flowline NTO and/or the Reclamation Rule 1004.a to remove (regardless of ownership) all equipment.

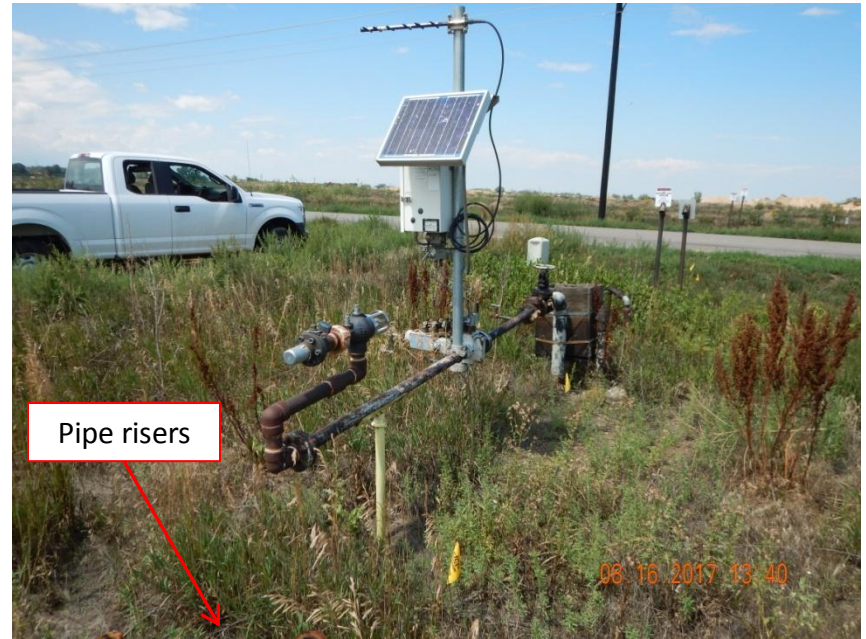
Photo 2. Photo taken just west of the meter shed, facing North. Comply with the Pipeline/Flowline NTO and/or the Reclamation Rule 1004.a to remove (regardless of ownership) all equipment. See Photo 3 regarding pipe risers.

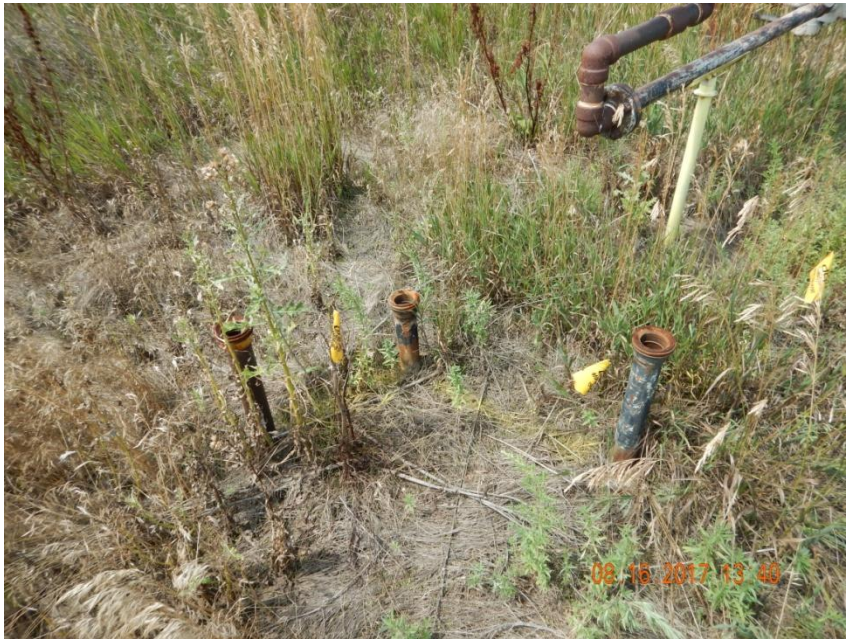
Photo 3. Photo taken of three (3) pipe risers that were previously mentioned in Photo 2.

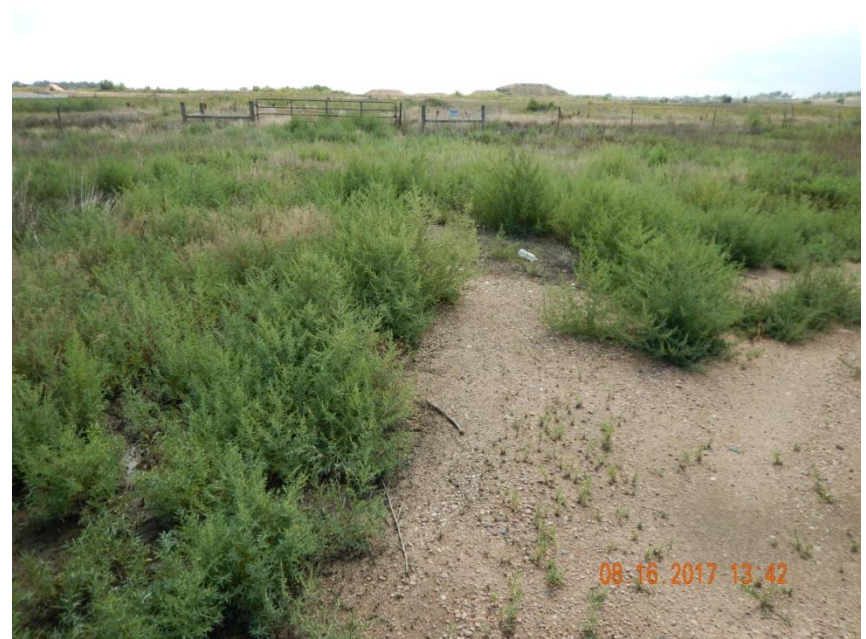
Photo 4. Photo taken from the eastern battery location, facing South. Weedy, annual vegetation (Kochia and Russian thistle) observed throughout the battery location. Photo further illustrates that reclamation activities have not been performed because gravel still remains.

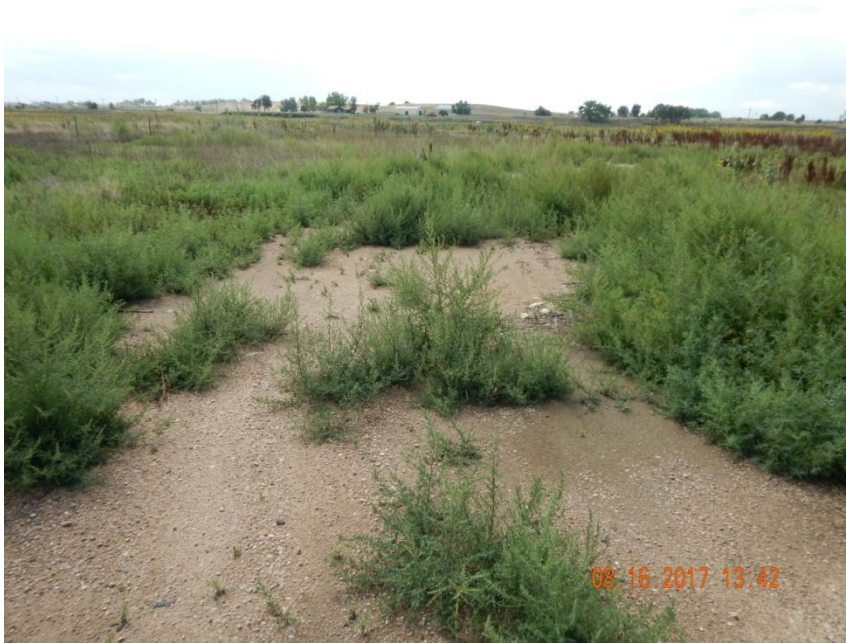
Photo 5. Photo taken from the eastern battery location, facing West. Weedy, annual vegetation (Kochia and Russian thistle) observed throughout the battery location. Photo further illustrates that reclamation activities have not been performed because gravel still remains.

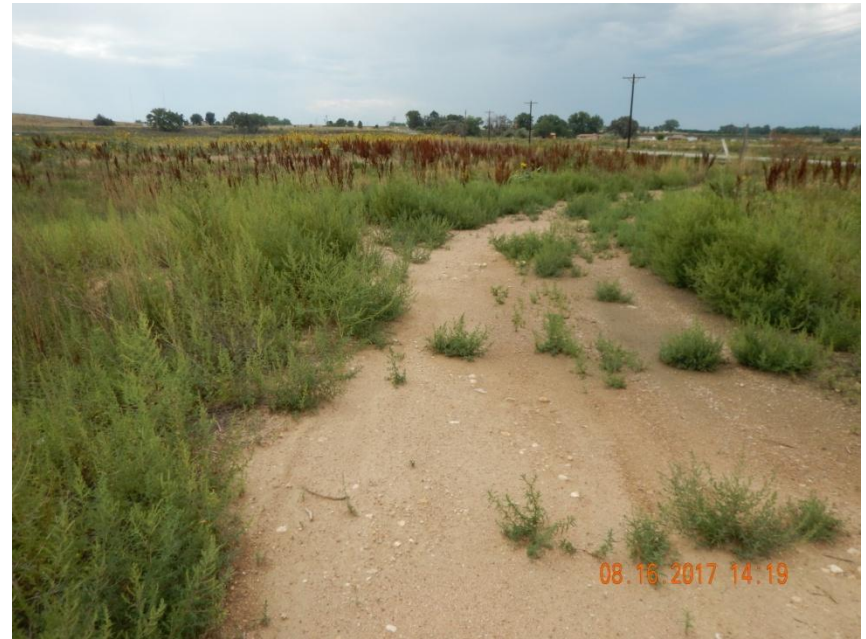
Photo 6. Photo taken from the central battery location, facing West. Weedy, annual vegetation (Kochia and Russian thistle) observed throughout the battery location. Photo further illustrates that reclamation activities have not been performed because gravel still remains from the access road.
