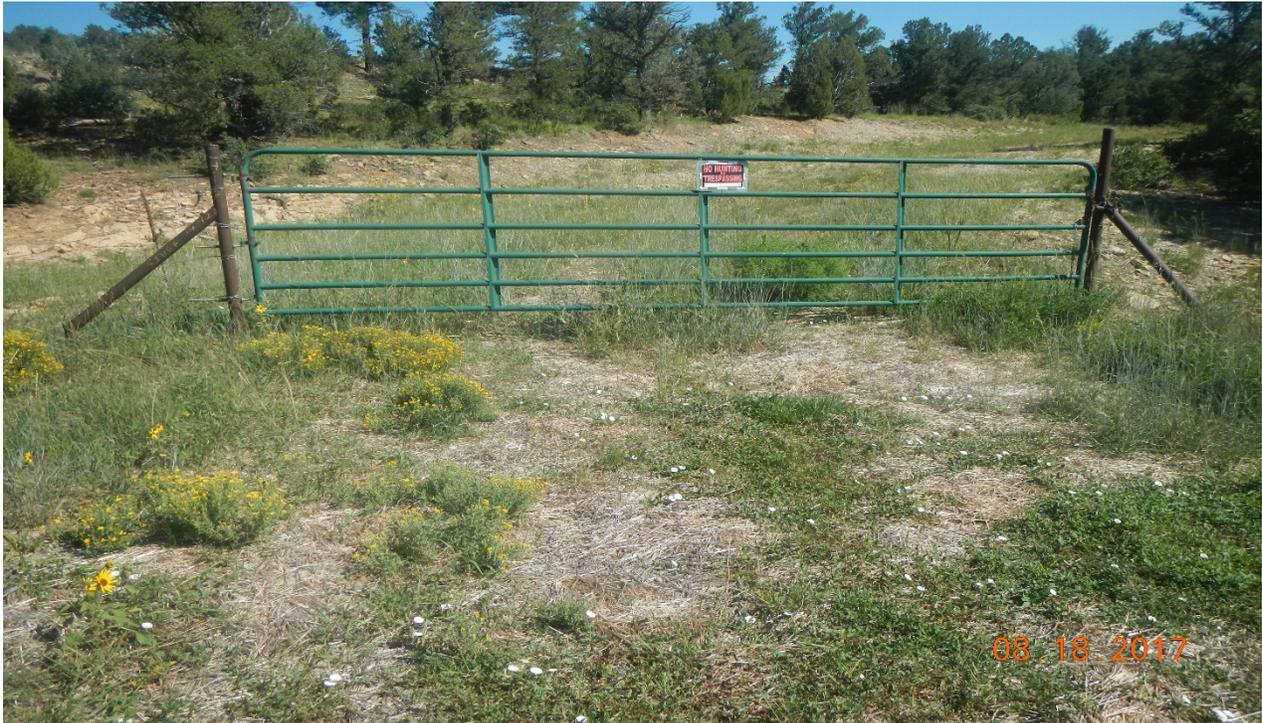
photo 1: Facing north at the beginning of the access road.

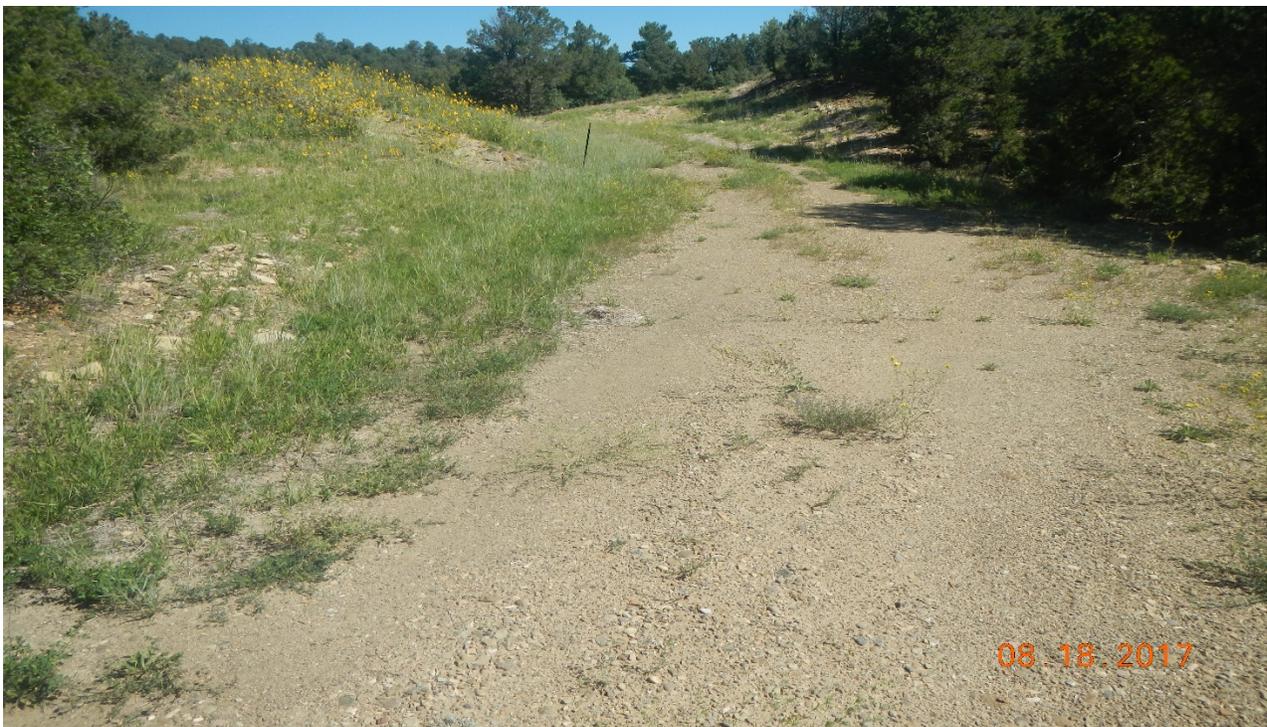
photo 2: Facing north along the access road. The location is toward the upper left side of the photo.

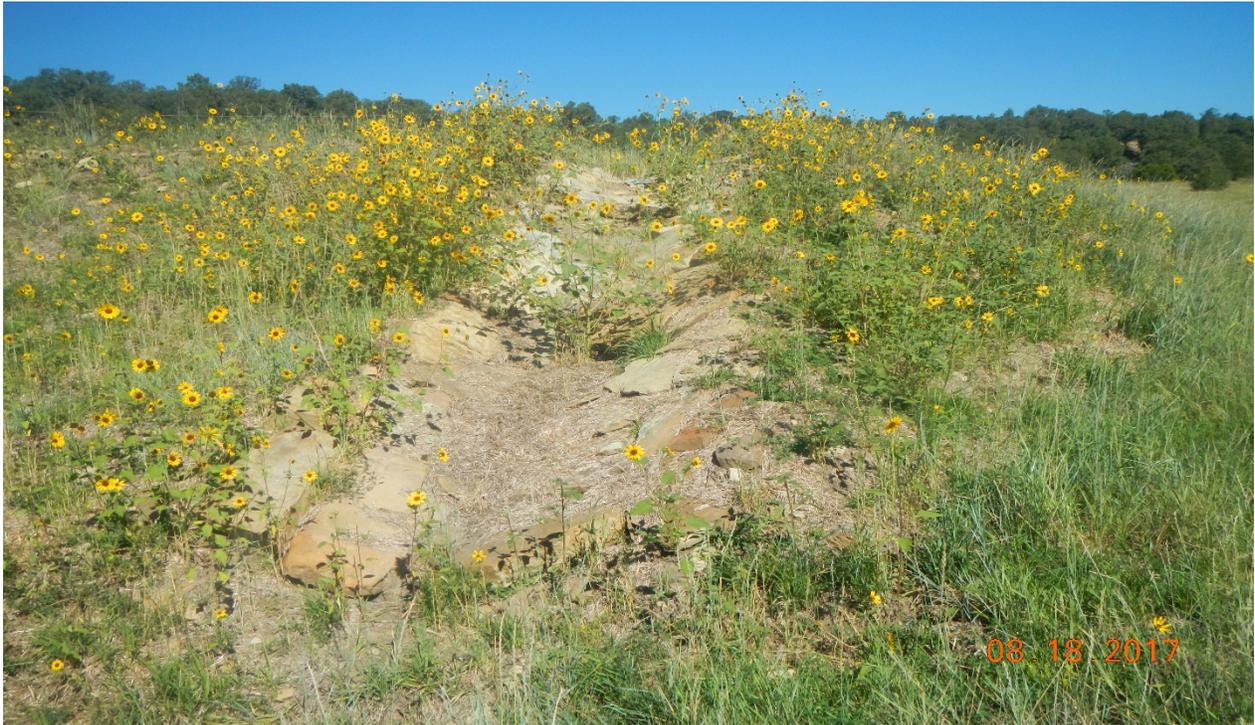
photo 3: There are stormwater BMP's in place at the east side of the location.

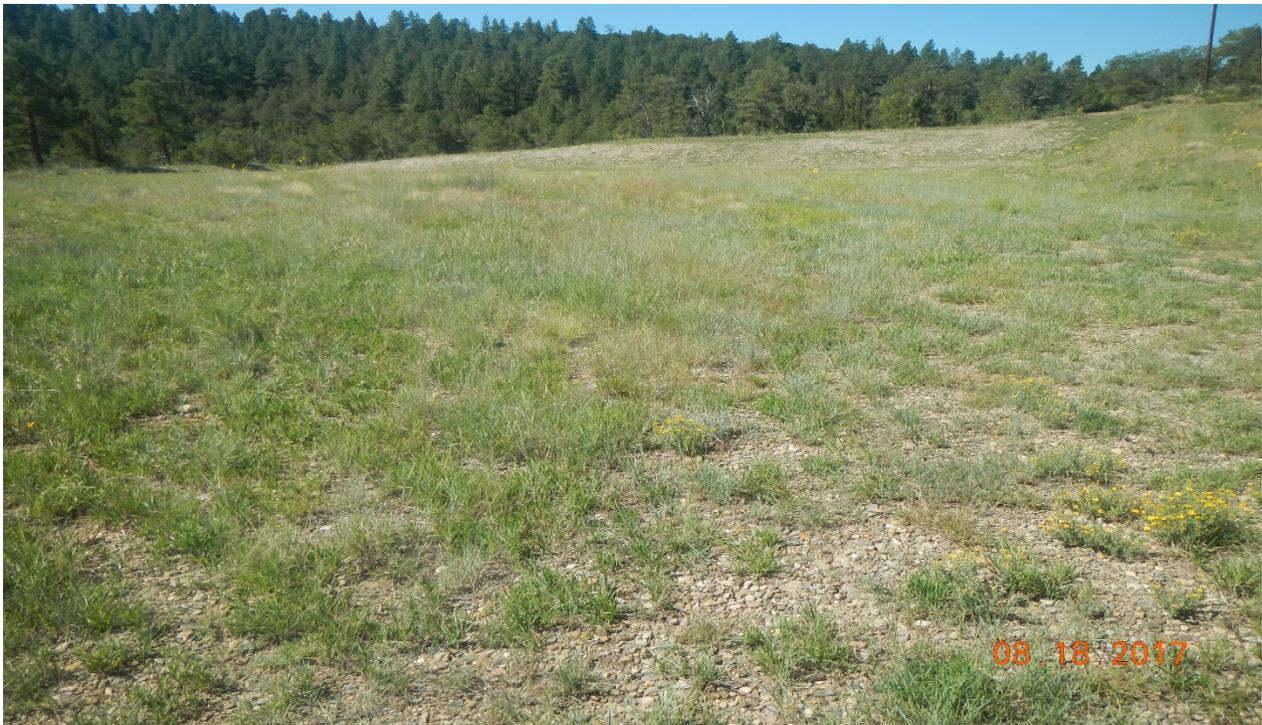
photo 4: Facing southwest toward the location.

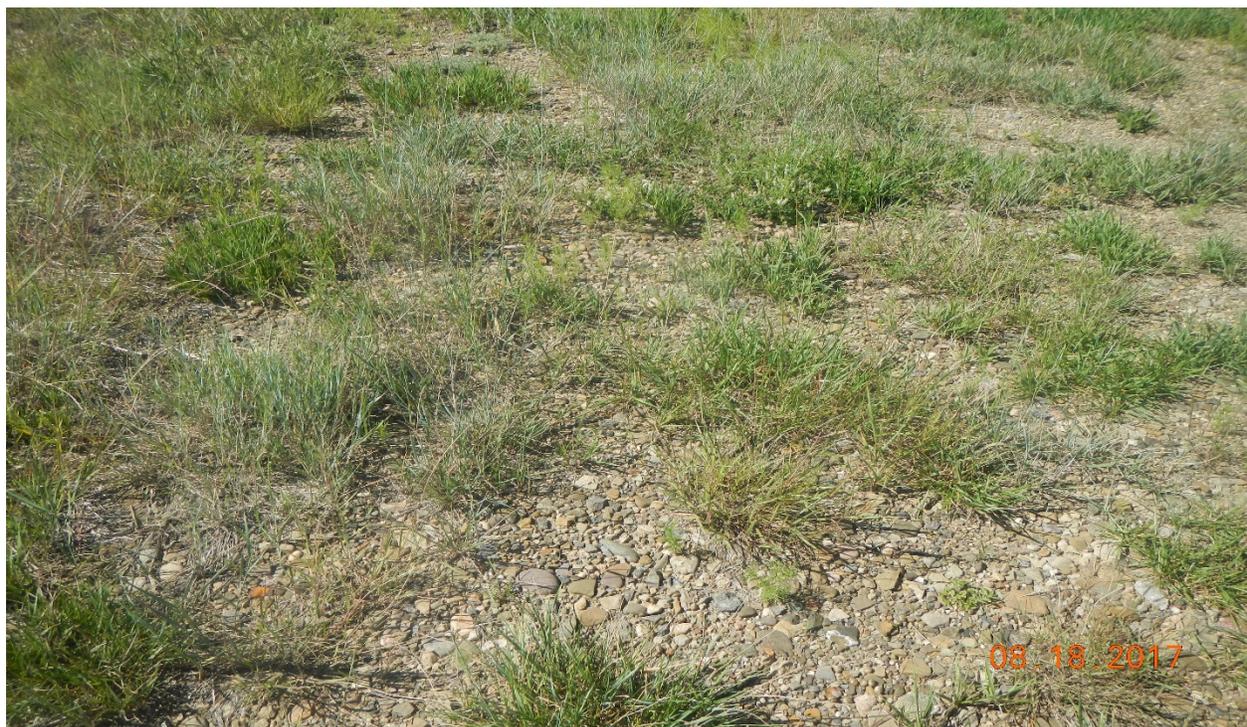
photo 5: There is gravel that remains at the location.

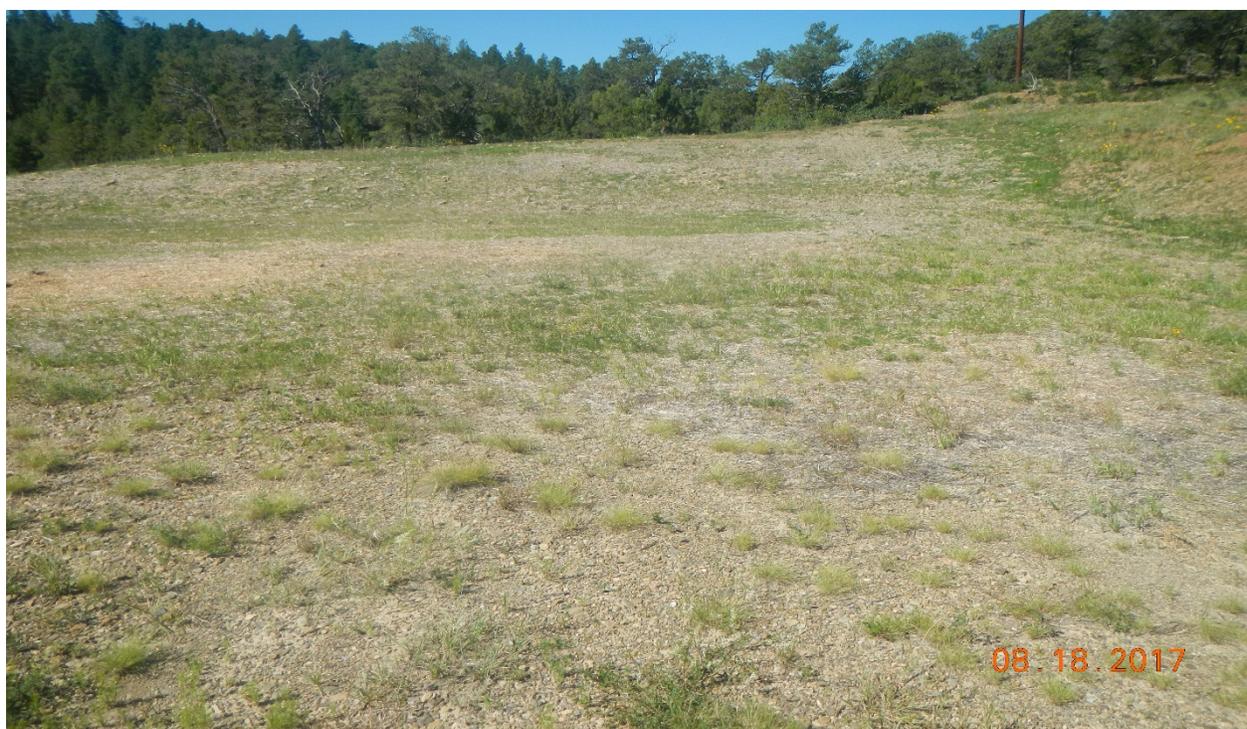
photo 6: Facing southwest toward the cut slope.

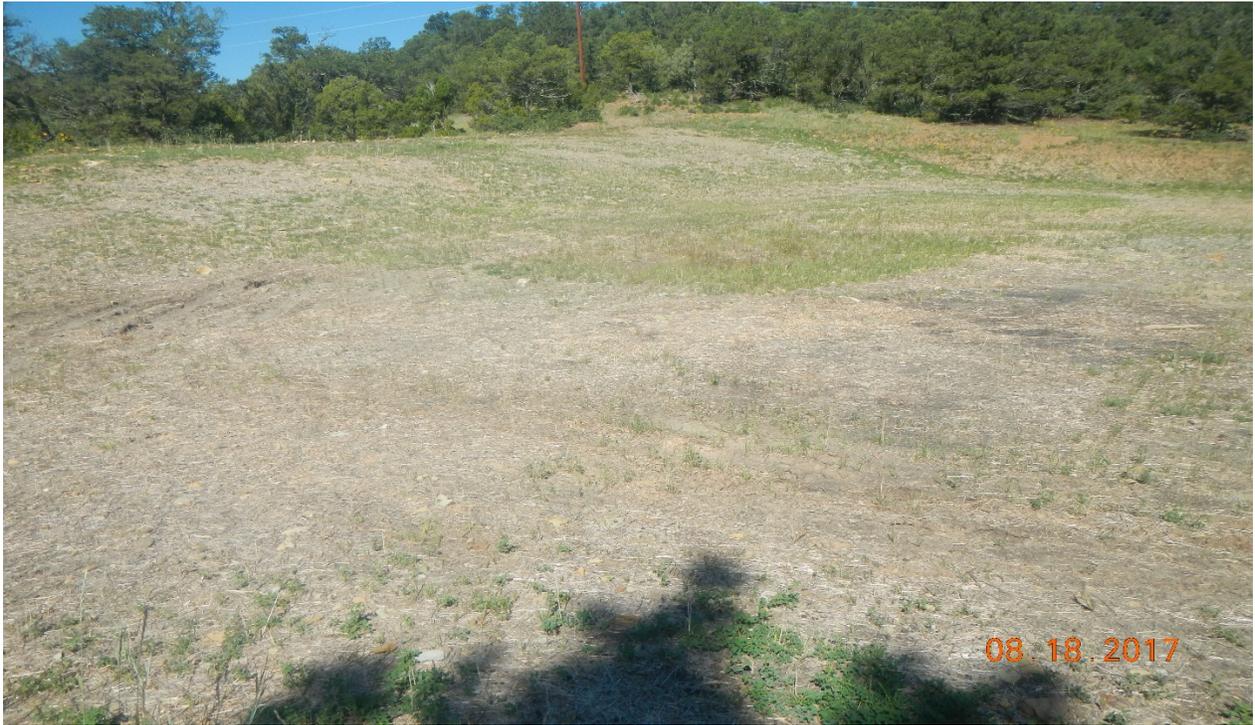
photo 7: Facing west toward the cut slope. The vegetation is beginning to establish in this area.

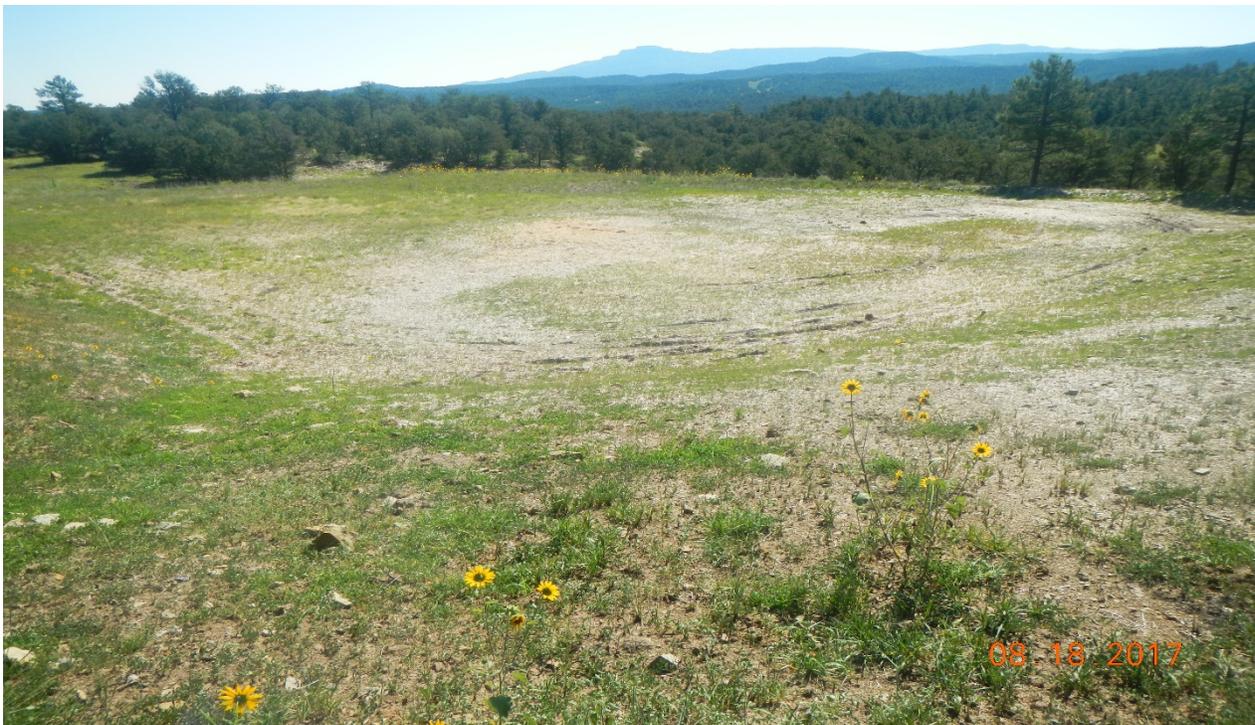
photo 8: West side of the location facing east overlooking the location.
