# Reclamation and Stormwater Inspection

August 17, 2017

Operator: NOBLE ENERGY INC- #100322

Location ID: 433936

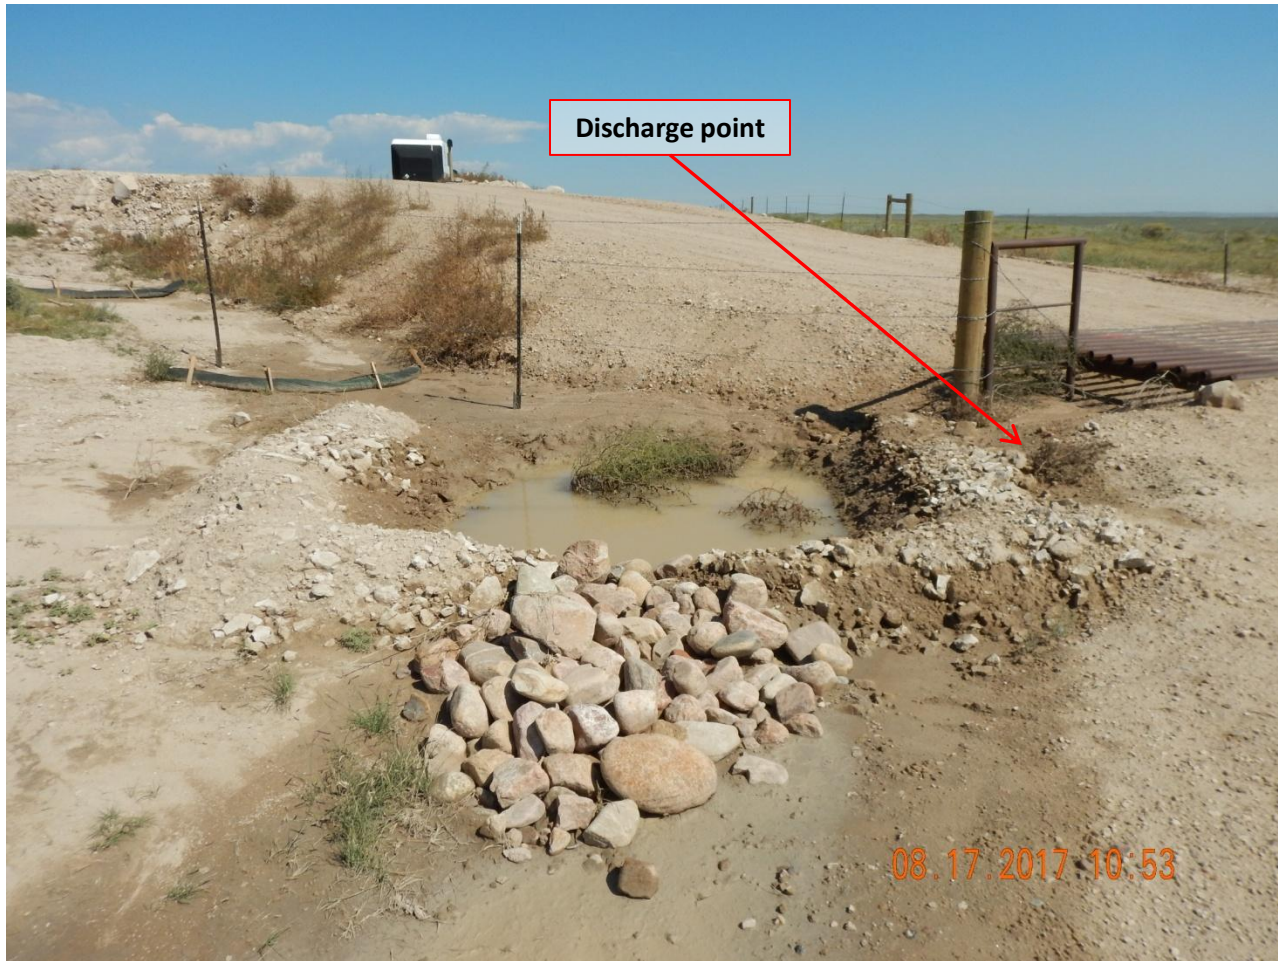
**Photo 1.** Photo taken from the east well pad, east entrance along the west side, facing Northeast. Operator has installed a second sediment trap near the entrance of the location. A discharge point was observed at the cattle guard as shown above. Embankment material and embankment construction does not appear to be sufficiently compacted, as it appears unconsolidated material could be contributing to sediment loss. Sediment trap outlet area does not appear to be properly constructed to capture outlet flows. Sediment trap size could be enlarged to help capture sediment laden stormwater runoff.

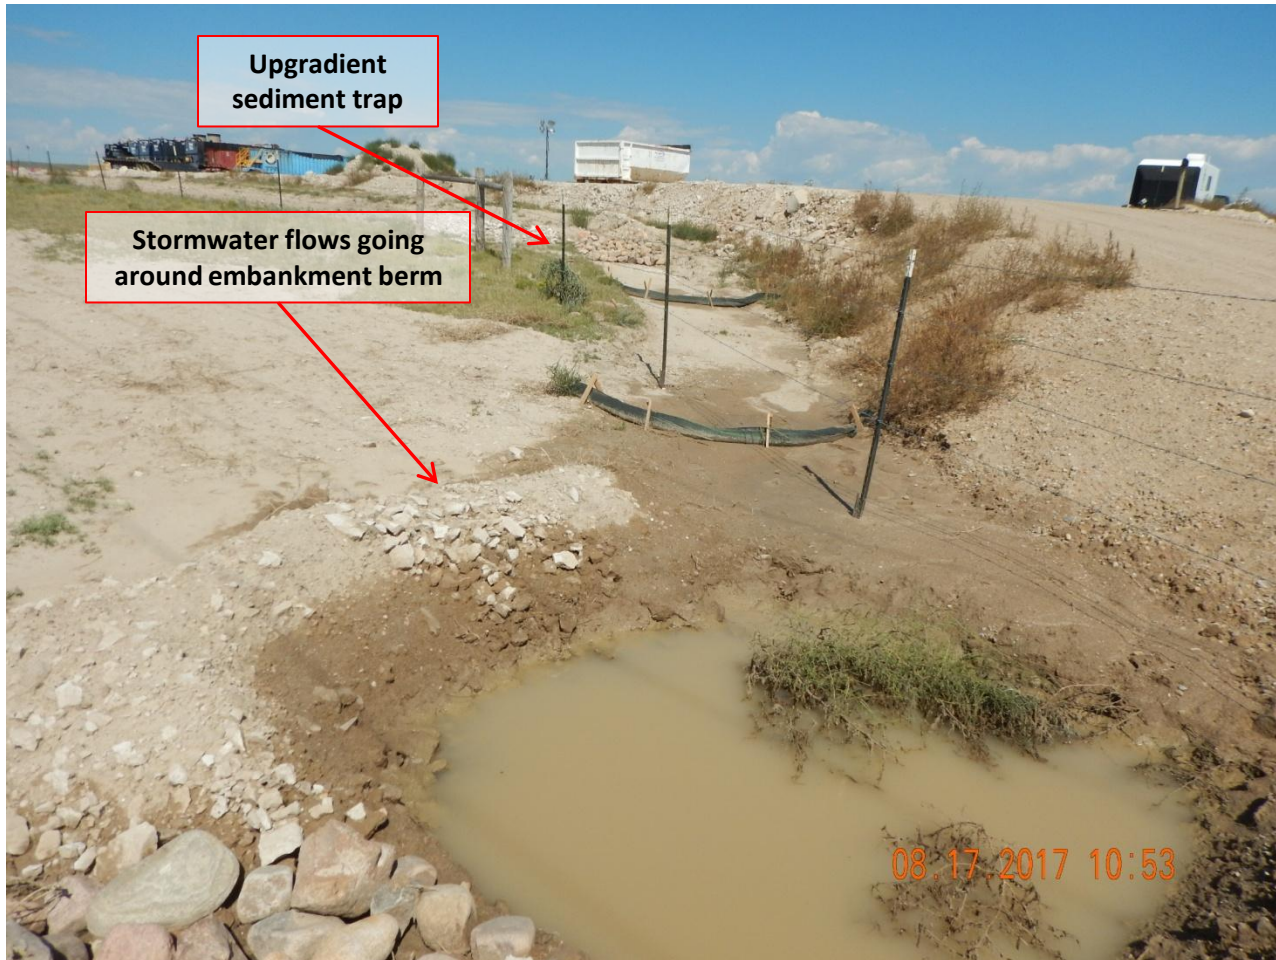
**Photo 2.** Photo taken from the previous sediment trap, facing North. Operator has installed a shallow ditch from the outlet area of the upgradient sediment trap to the inlet area of the downgradient sediment trap. Operator has installed filtrex wattles along the shallow ditch. Appears stormwater flows are going around the embankment berm of the downgradient sediment trap.

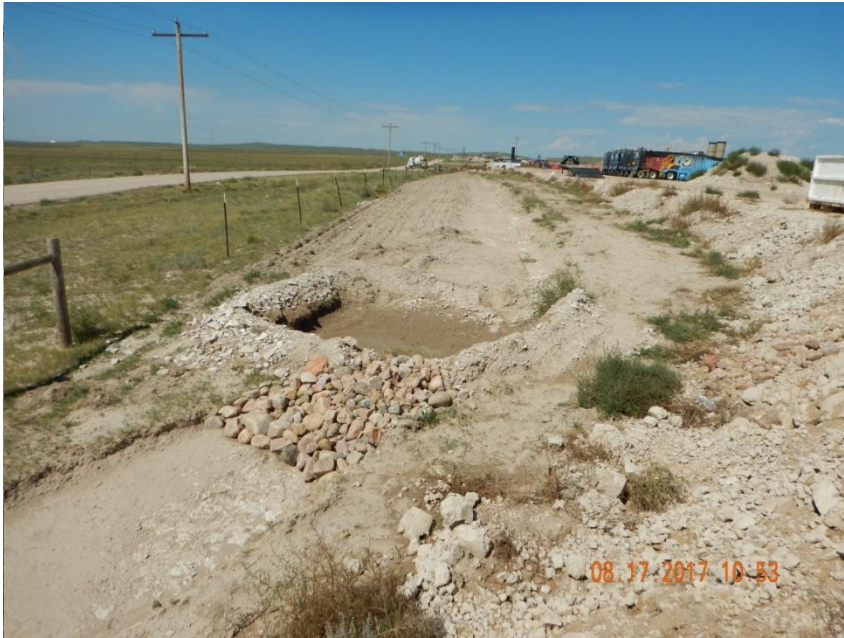
**Photo 3.** Photo taken from the previously mentioned upgradient sediment trap, facing West. Appears the Operator has enlarged the sediment trap size with a stabilized outlet area. Embankment material and embankment construction does not appear to be sufficient compacted, as it appears unconsolidated material could be contributing to sediment loss. Appears the Operator has re-installed surface roughening along the southern perimeter of the location. Refer to Photo 4 for a picture taken of the sediment trap from the July 11, 2017 inspection.

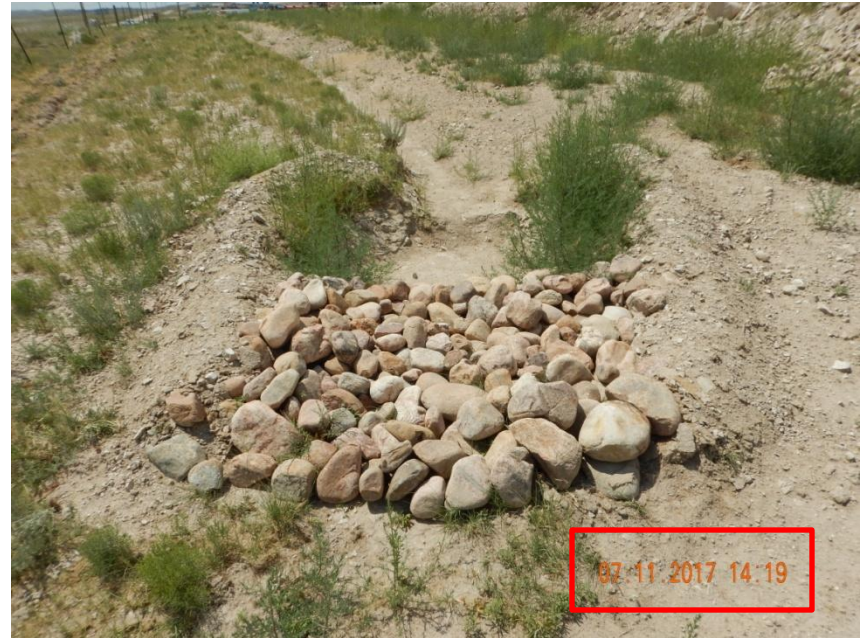
**Photo 4.** Photo taken of the sediment trap in Photo 3 from the July 11, 2017 inspection.

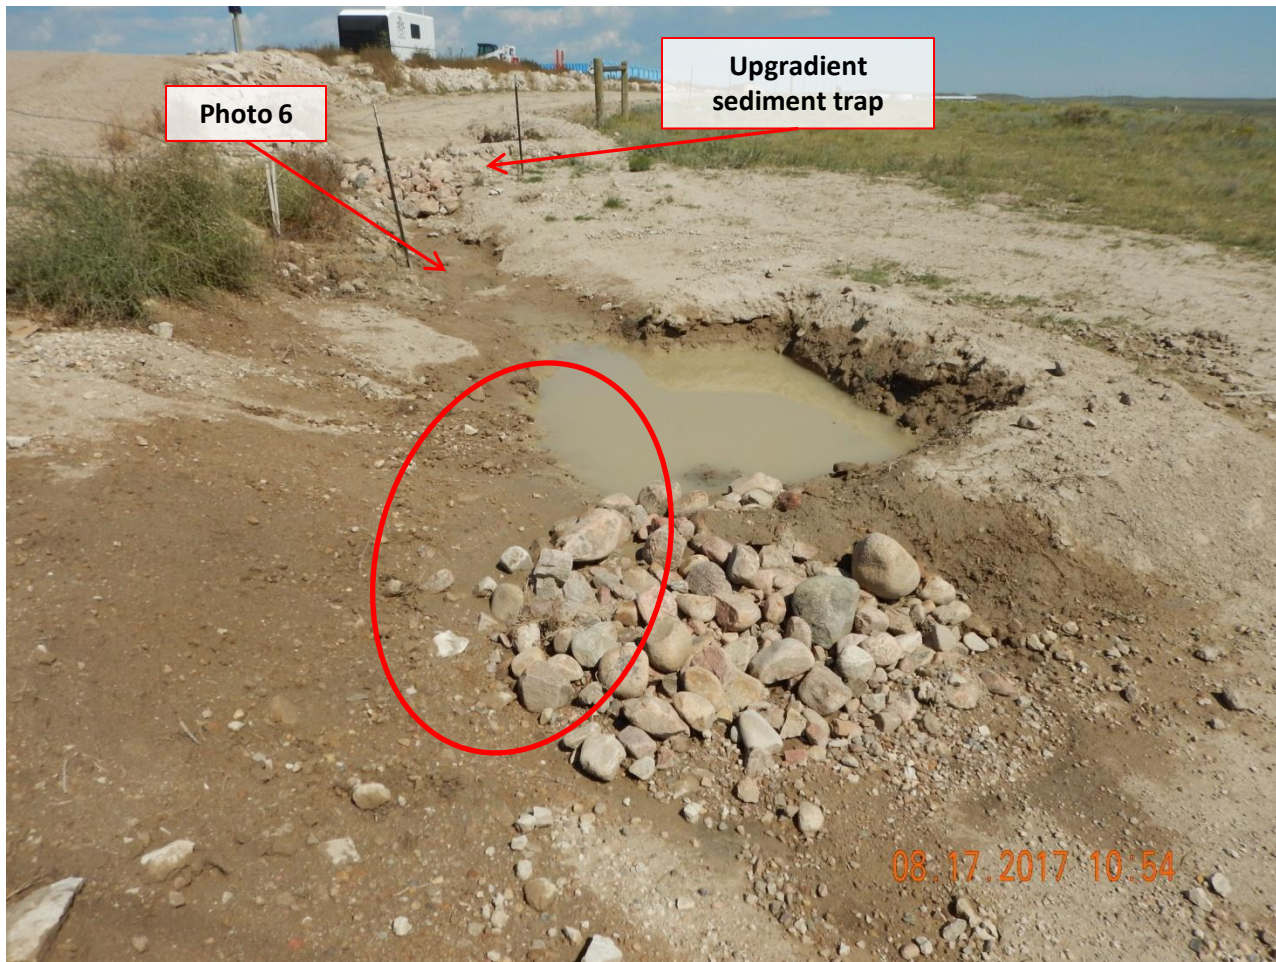
**Photo 5.** Photo taken from the east well pad, east entrance along the east side, facing Northwest. Operator has installed a second sediment trap near the entrance of the location. Embankment material and embankment construction does not appear to be sufficiently compacted, as it appears unconsolidated material could be contributing to sediment loss. Sediment trap outlet area does not appear to be properly constructed to capture outlet flows. Appears sediment laden stormwater is discharging from the western outlet area (red circle). Sediment trap size could be enlarged to help capture sediment laden stormwater runoff.

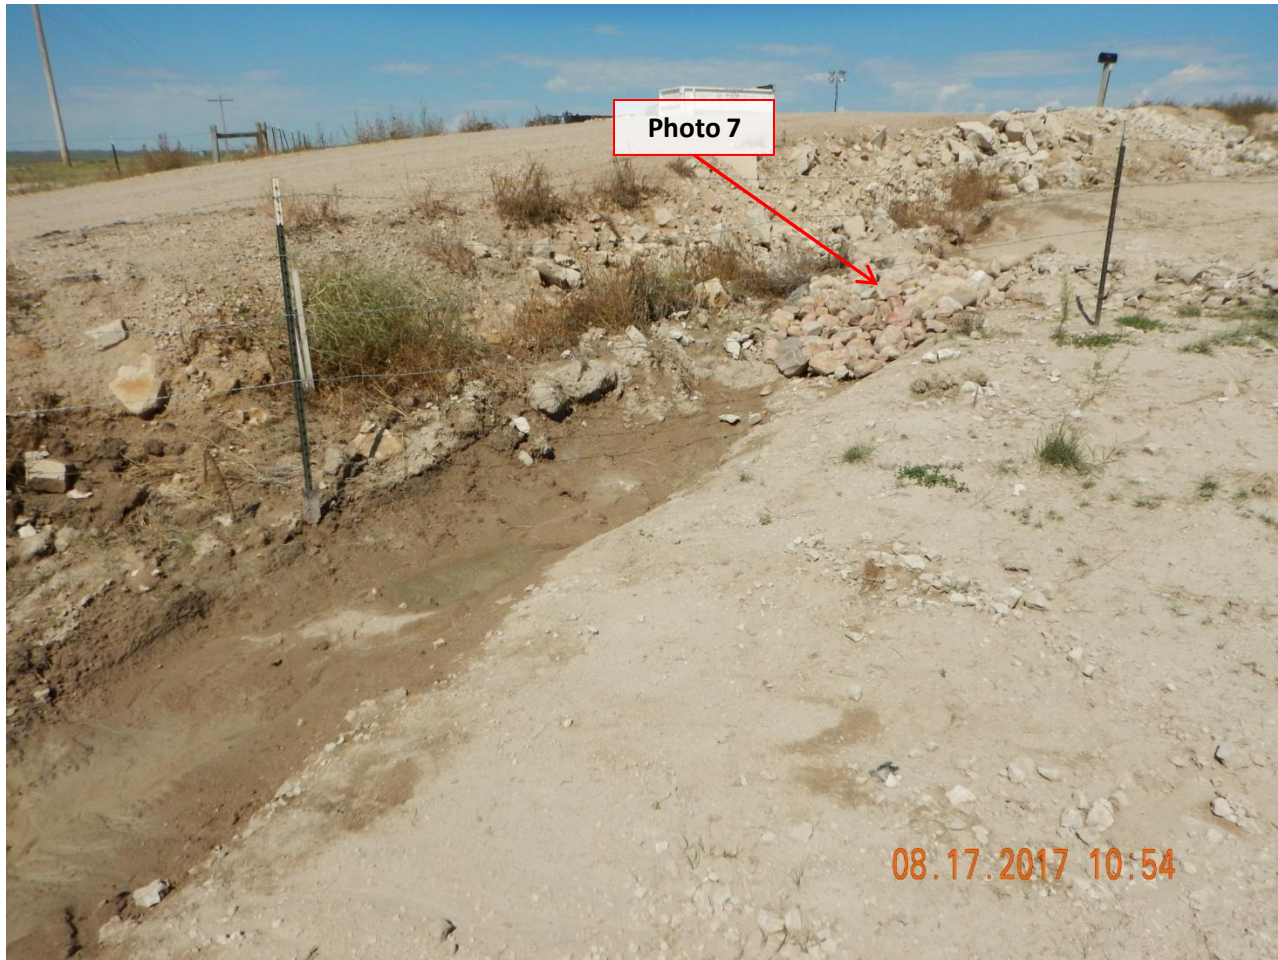
**Photo 6.** Photo taken from the ditch area between the two sediment traps, facing West. Operator has installed a shallow ditch from the outlet area of the upgradient sediment trap to the inlet area of the downgradient sediment trap. Ditch size may not be a sufficient depth to contain both outlet flows from the upgradient sediment trap and stormwater runoff from the access road.

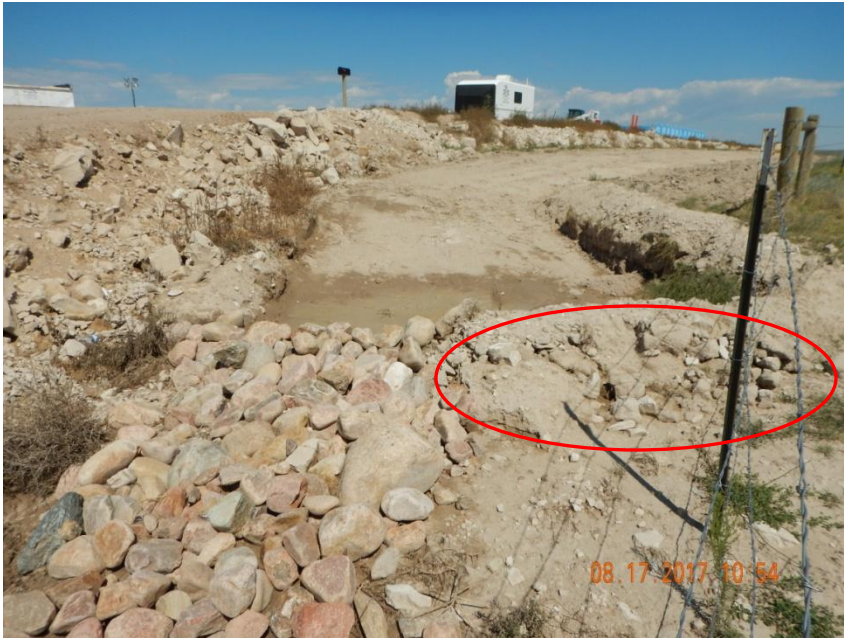
**Photo 7.** Photo taken from the previously mentioned upgradient sediment trap, facing Northwest. Appears the Operator has enlarged the sediment trap size with a stabilized outlet area. Embankment material and embankment construction does not appear to be sufficient compacted, as it appears unconsolidated material is contributing to sediment loss (red circle). Refer to Photo 8 for a picture taken of the sediment trap from the July 11, 2017 inspection.

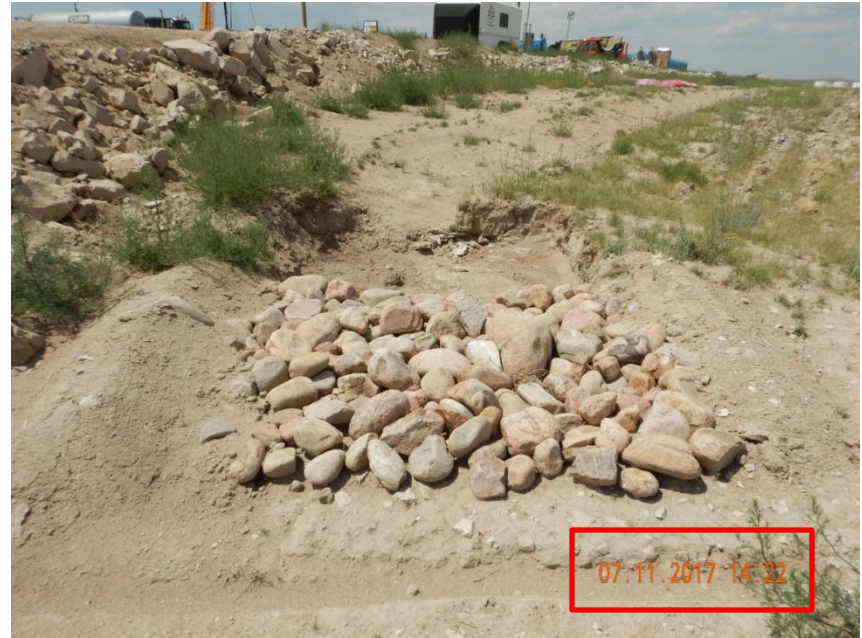
**Photo 8.** Photo taken of the sediment trap in Photo 7 from the July 11, 2017 inspection.

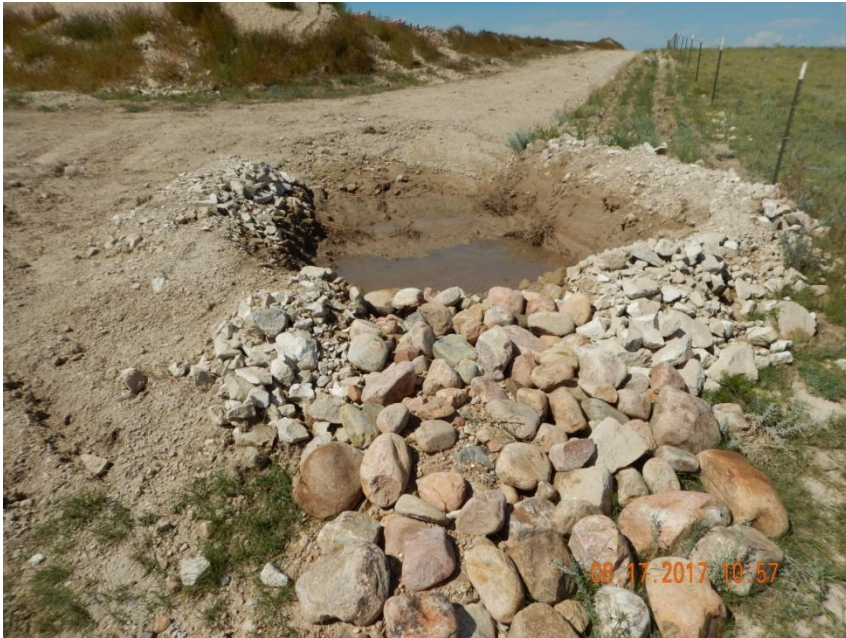
**Photo 9.** Photo taken from the northeast east well pad, facing West. Appears the Operator has enlarged the sediment trap size with a stabilized outlet area. Embankment material and embankment construction does not appear to be sufficient compacted, as it appears unconsolidated material could be contributing to sediment loss . Refer to Photo 10 for a picture taken of the sediment trap from the July 11, 2017 inspection.

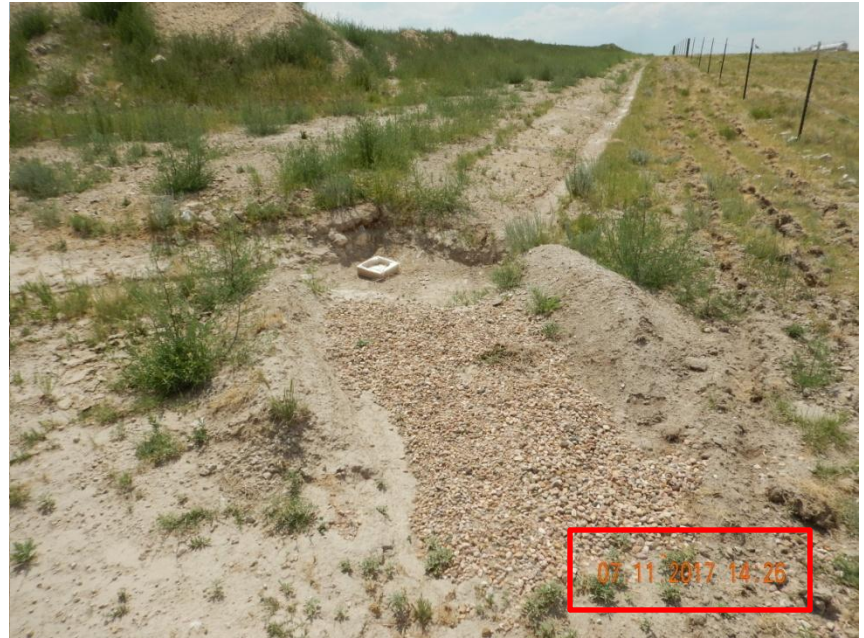
**Photo 10.** Photo taken of the sediment trap in Photo 9 from the July 11, 2017 inspection.

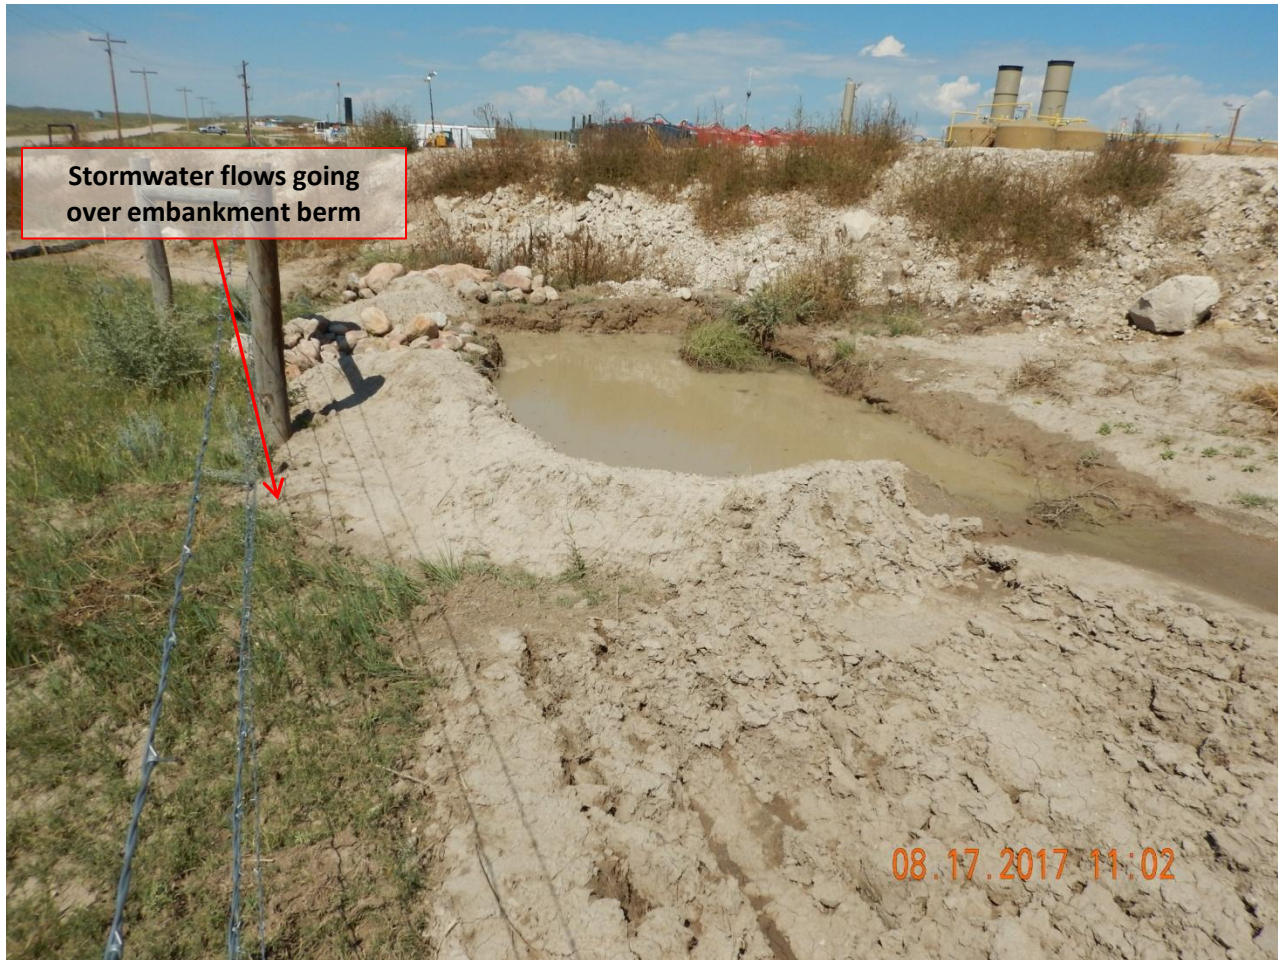
**Photo 11.** Photo taken from the southwest east well pad, facing West. Appears the Operator has enlarged the sediment trap size with two stabilized outlet areas. However, the sediment trap size could be enlarged because it appears flows have discharged over the embankment berms. Embankment material and embankment construction does not appear to be sufficiently compacted, as it appears unconsolidated material is contributing to sediment loss.

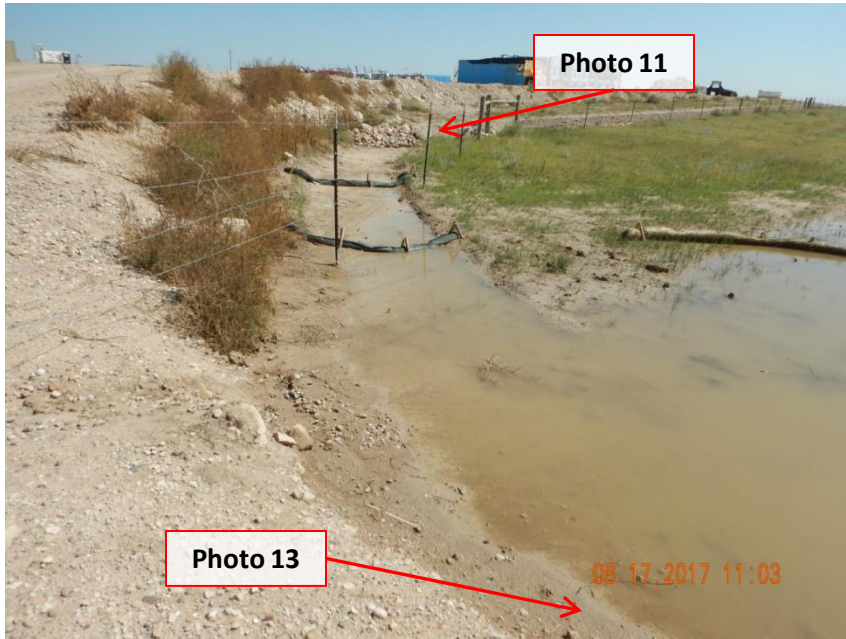
**Photo 12.** Photo taken from the east well pad, west entrance along the east side, facing Northeast. Operator has installed a shallow ditch from the outlet area of the sediment trap to a shallow depression area- refer to Photo 13. Because the sediment trap size is too small sediment would not have enough time to settle out before discharging out of the outlet. Wattles are intended to pool sheet flow (not filter sediment) and it appears the volume of stormwater sheet flow, likely sediment laden flow, is overtopping the wattles.

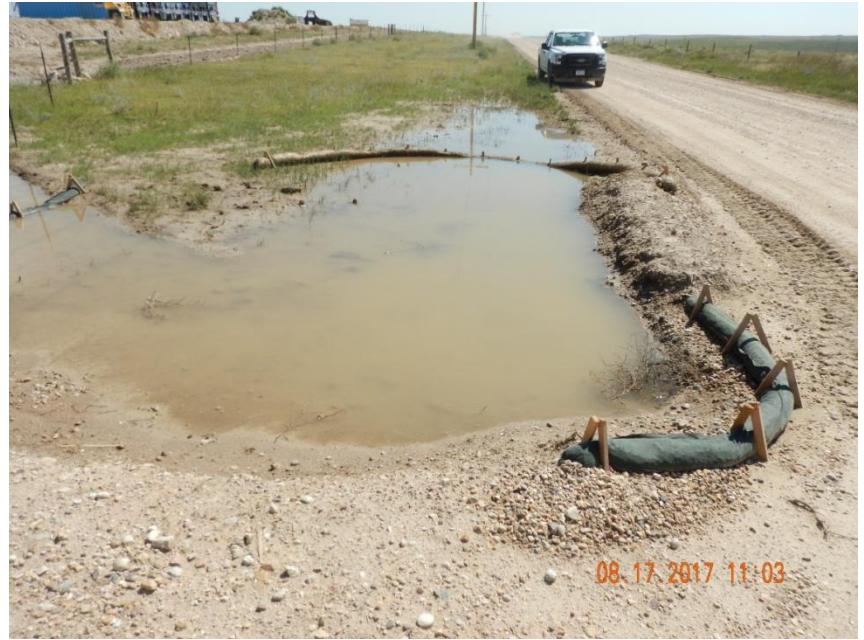
**Photo 13.** Photo taken from the previously mentioned shallow depression area, facing East. Does not appear the depression area with the wattles are pooling stormwater runoff. Appears the volume of stormwater sheet flow, likely sediment laden flow, is overtopping the wattle as shown in this photo.

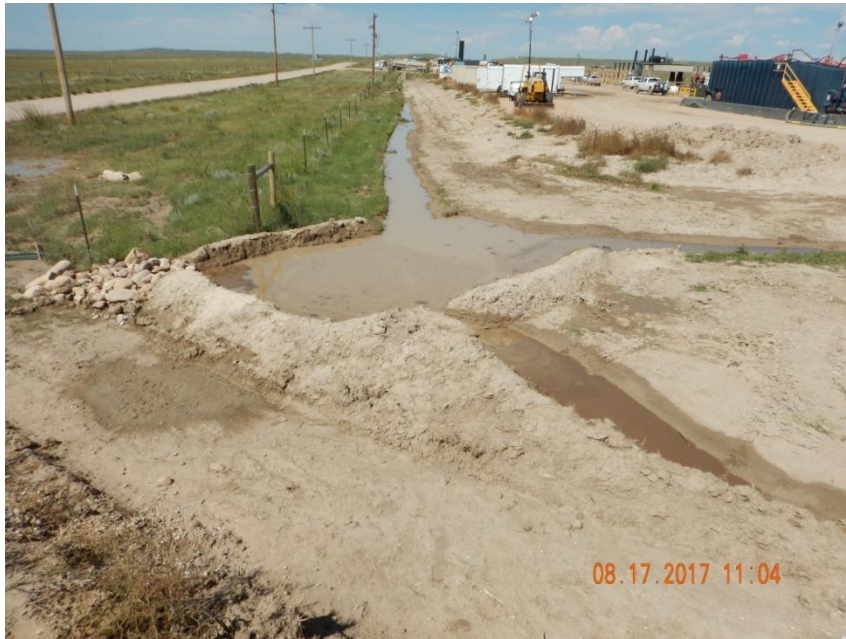
**Photo 14.** Photo taken from the southeast production facility pad, facing West. Appears the Operator has enlarged the sediment trap size. However, the sediment trap size could be enlarged because it appears flows have discharged over the embankment berms. Embankment material and embankment construction does not appear to be sufficiently compacted, as it appears unconsolidated material is contributing to sediment loss. Sediment trap outlet area does not appear to be properly constructed to capture outlet flows.

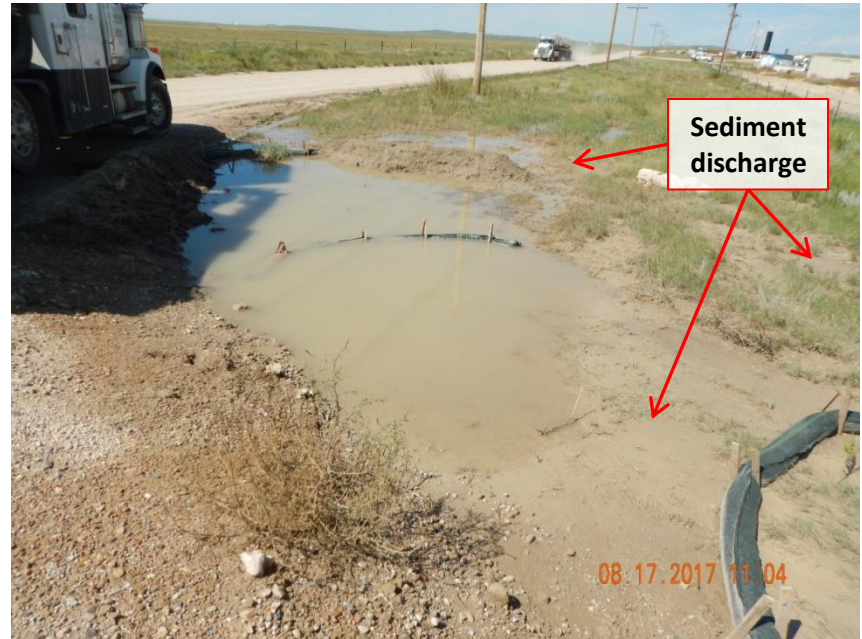
**Photo 15.** Photo taken from the previously shown sediment trap, facing Southwest. Does not appear the wattles are pooling stormwater runoff. Appears the volume of stormwater sheet flow is overtopping the wattle as shown in this photo. Sediment deposition is observed between the wattles and outside of the wattles as shown in this photo.

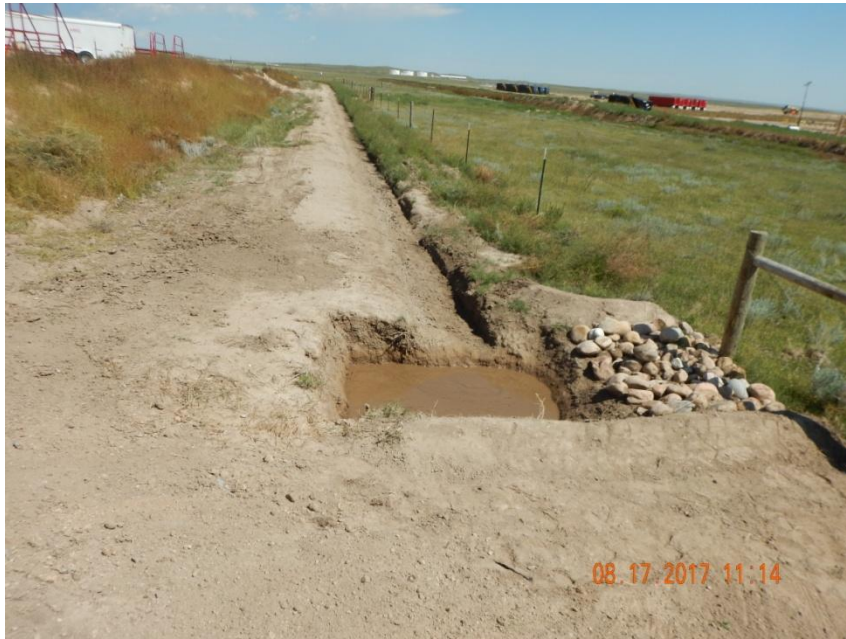
**Photo 16.** Photo taken from the west well pad, east entrance along the east side, facing North. Does not appear the sediment trap size has been enlarged. It appears the Operator has moved the position of the sediment trap outlet and constructed an embankment berm. However, embankment does not appear to be sufficiently compacted, as it appears unconsolidated material could be contributing to sediment loss.

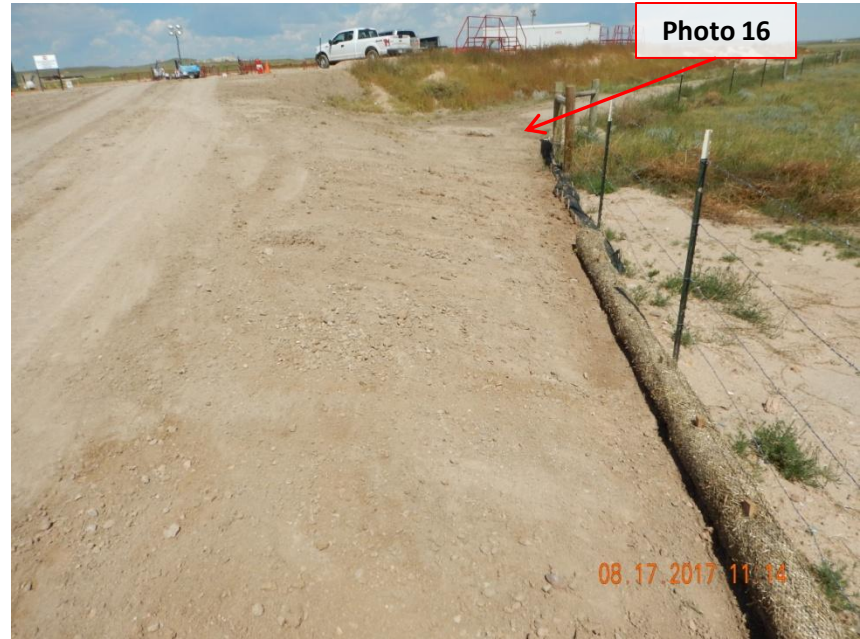
**Photo 17.** Photo taken from the west well pad, east entrance along the east side, facing Northwest. Appears the Operator has made repairs and re-installed wattles along the entrance.

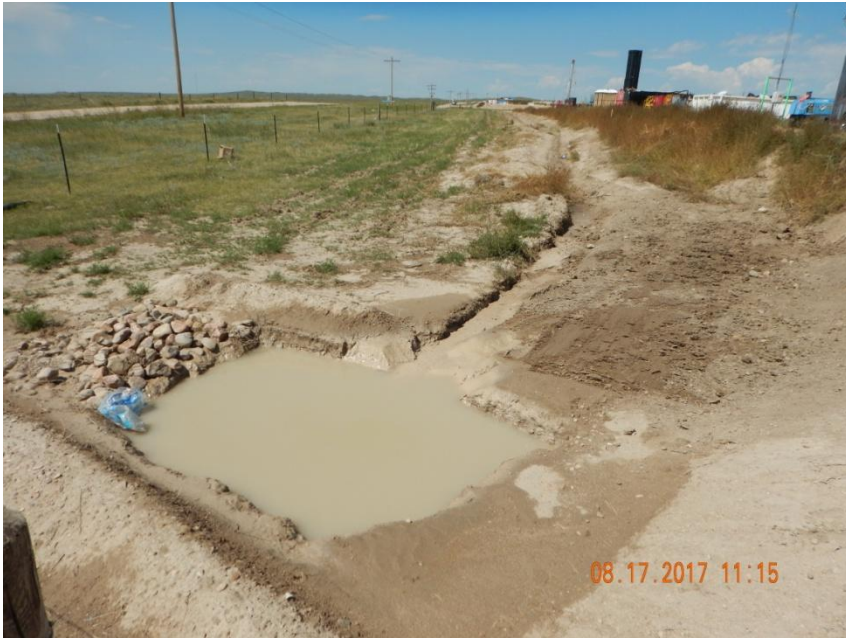
**Photo 18.** Photo taken from the west well pad, east entrance along the west side, facing West. Appears the Operator has installed a sediment trap. However, the sediment trap size could be enlarged because it appears flows have discharged over the embankment berms- see Photo 20. Embankment material and embankment construction does not appear to be sufficiently compacted, as it appears unconsolidated material is contributing to sediment loss. Refer to Photo 18 for a picture taken of this area from the July 11, 2017 inspection.

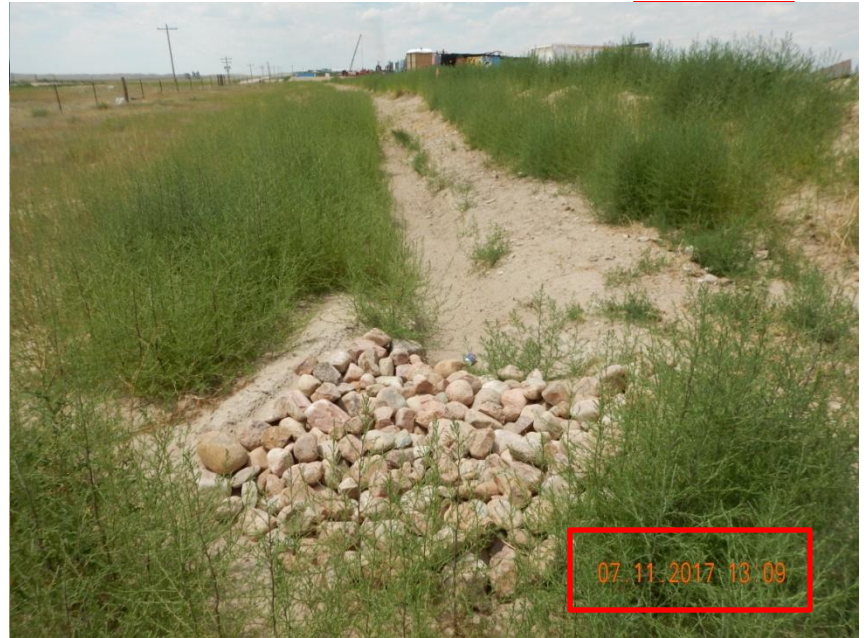
**Photo 19.** Photo taken from the area in Photo 18 from the July 11, 2017 inspection.

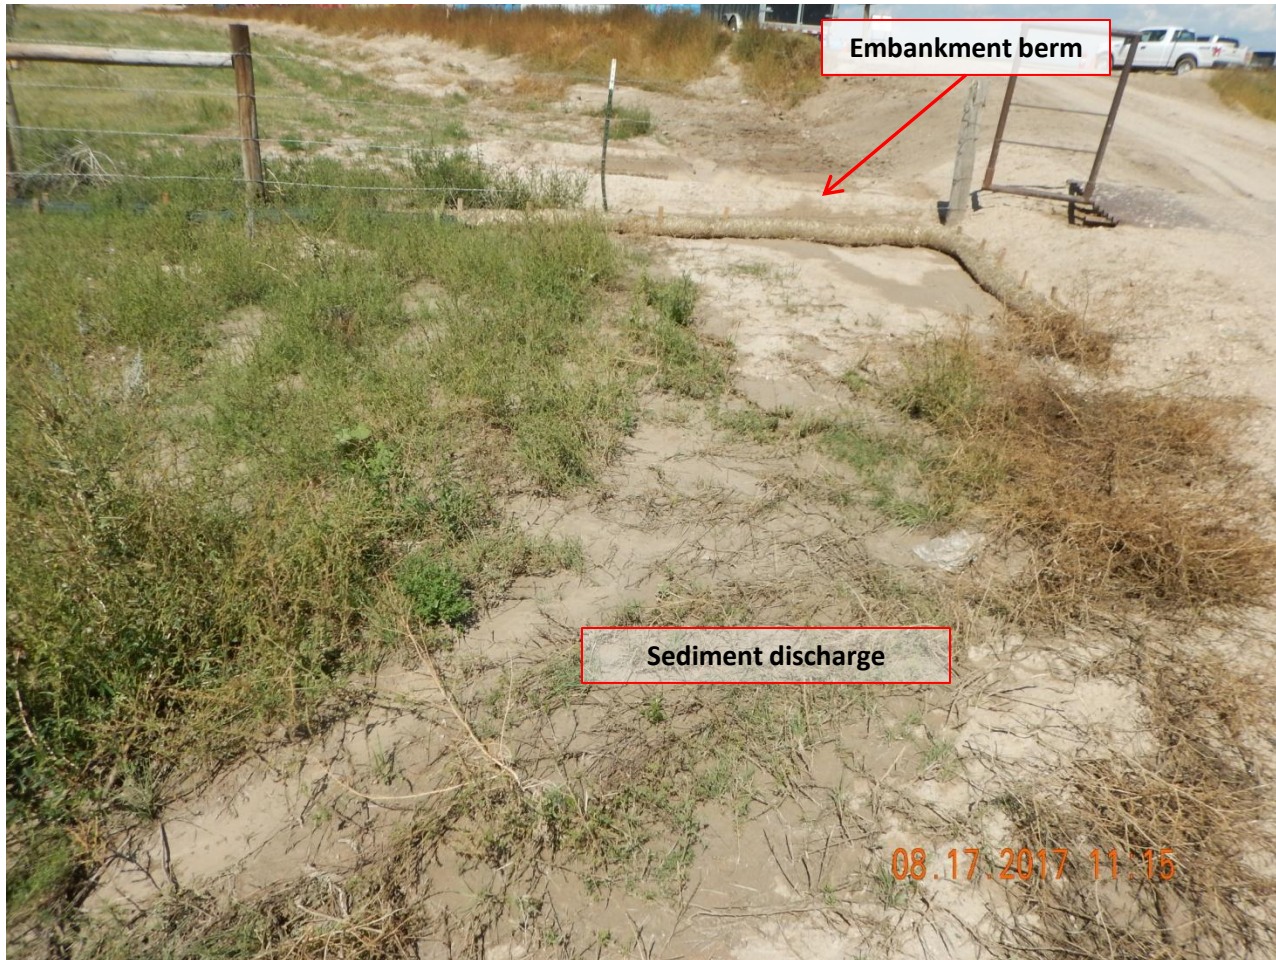
**Photo 20.** Photo taken east of the previously shown sediment trap in Photo 17. Photo illustrates sediment loss from stormwater overflowing from the sediment trap. Does not appear the wattles installed along the outer perimeter of the sediment trap are preventing sediment discharge. Wattles are intended to pool sheet flow (not filter sediment).
