Reclamation and Stormwater Inspection

August 17, 2017

Operator: NOBLE ENERGY INC- #100322

Location ID: 445209

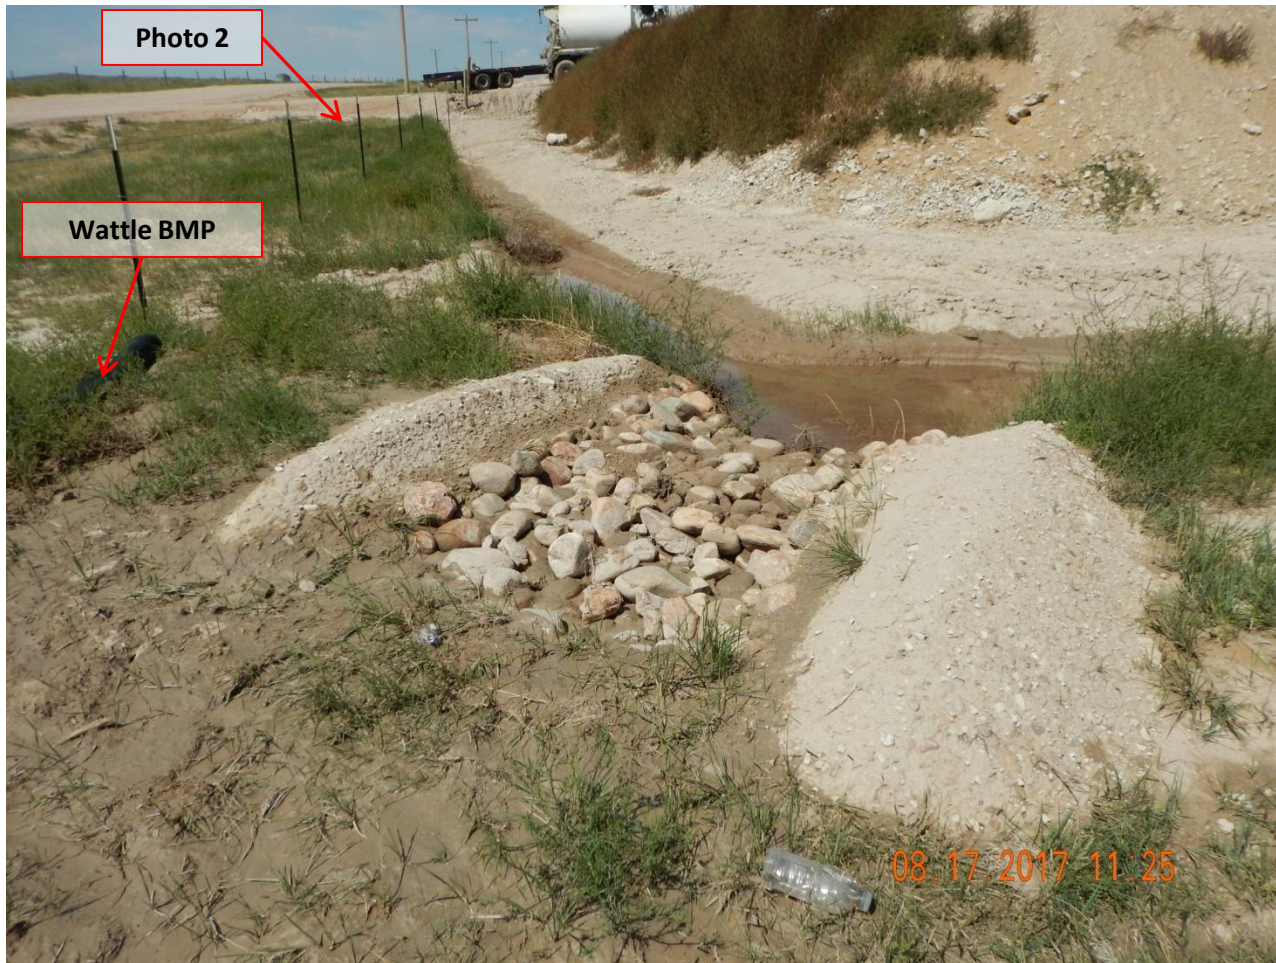
Photo 1. Photo taken from the southeast Tombstone pad, facing West. Sediment discharge observed beyond the outlet area of the sediment trap as shown in this photo. Does not appear the wattle BMP beyond the outlet area of the sediment trap is preventing sediment discharge from location. Sediment trap has not been enlarged since the previous inspection on July 11, 2017.

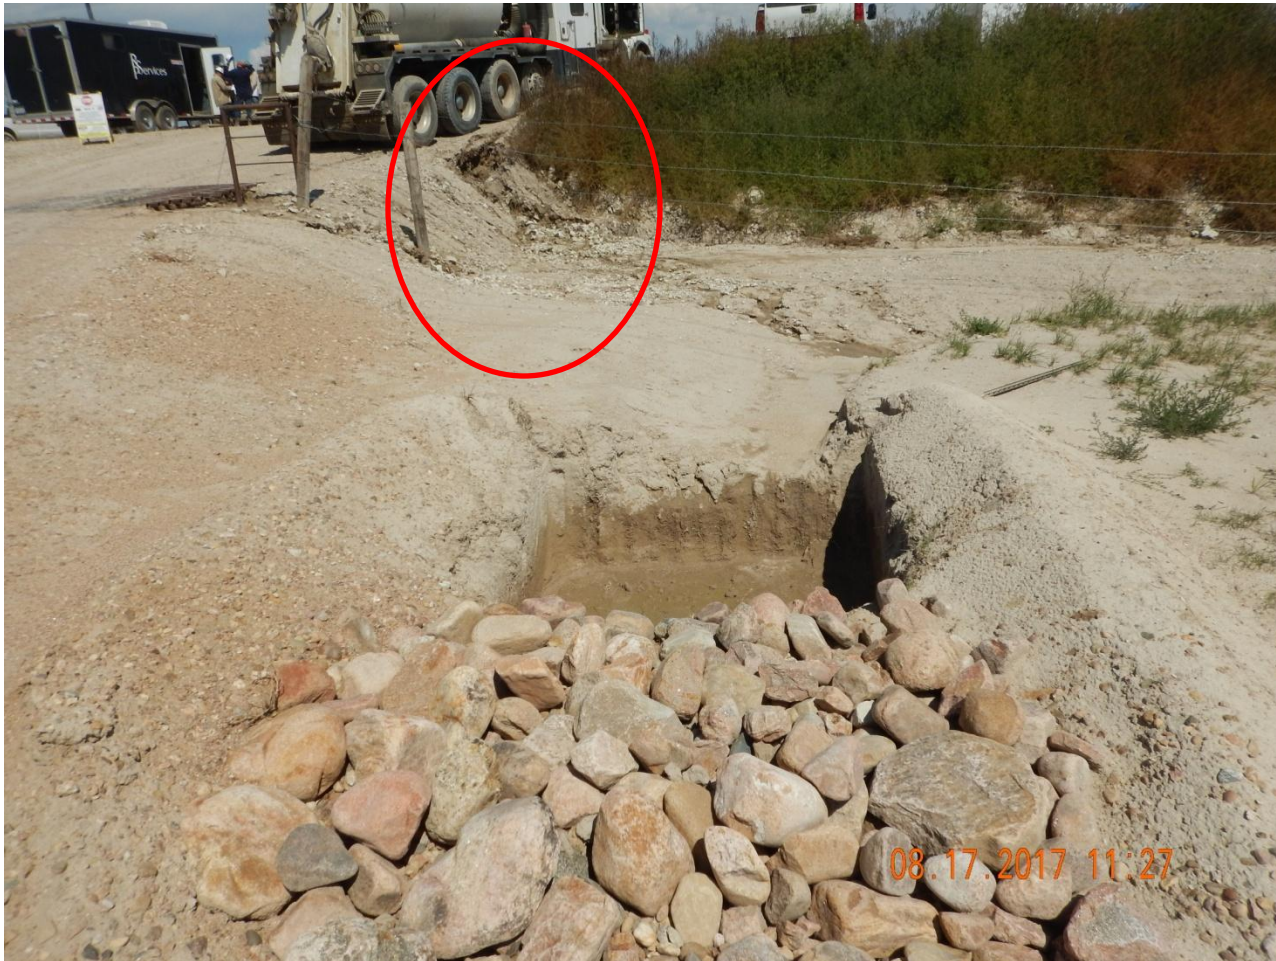
Photo 2. Photo taken from the entrance of the Tombstone pad, along the east side, facing North. Sediment trap has been installed to capture stormwater runoff from the access road. Gully erosion occurring along the east access road entrance (red circle)- refer to Photo 3.

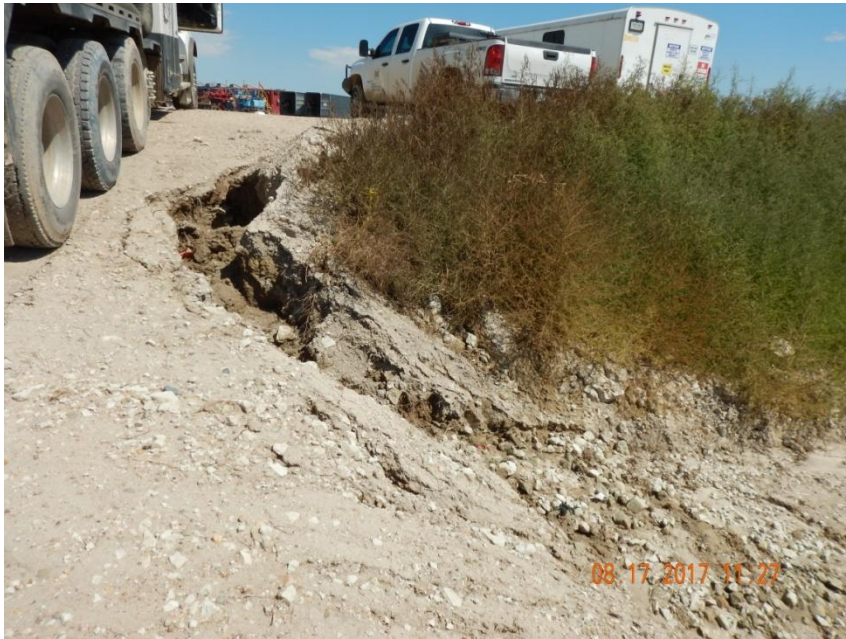
Photo 3. Photo taken from the previously mentioned gully erosion along the entrance of the Tombstone pad, facing Northeast.

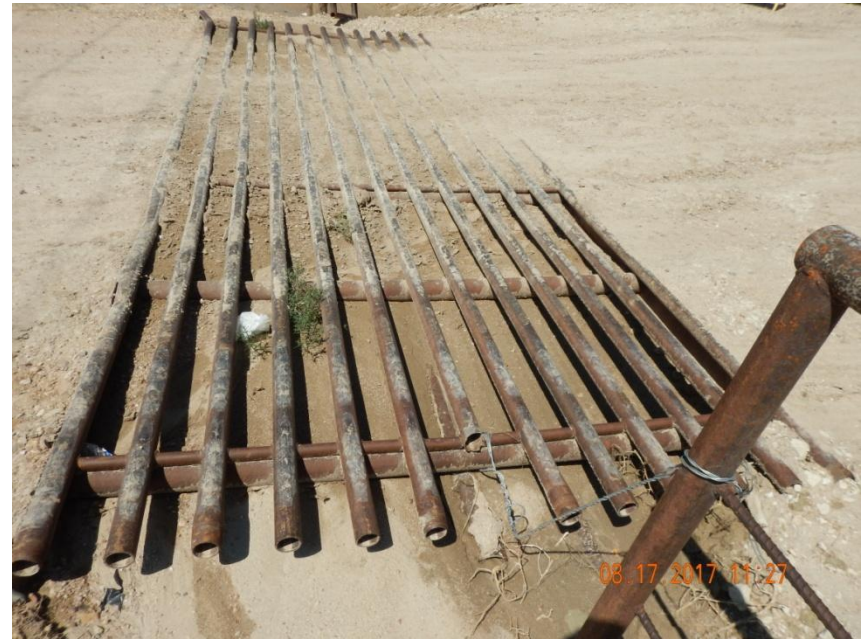
Photo 4. Photo taken from the cattle guard of the Tombstone entrance, facing West. Cattle guard in need of maintenance. COGCC staff observed a crew cleaning out cattle guard while at location.

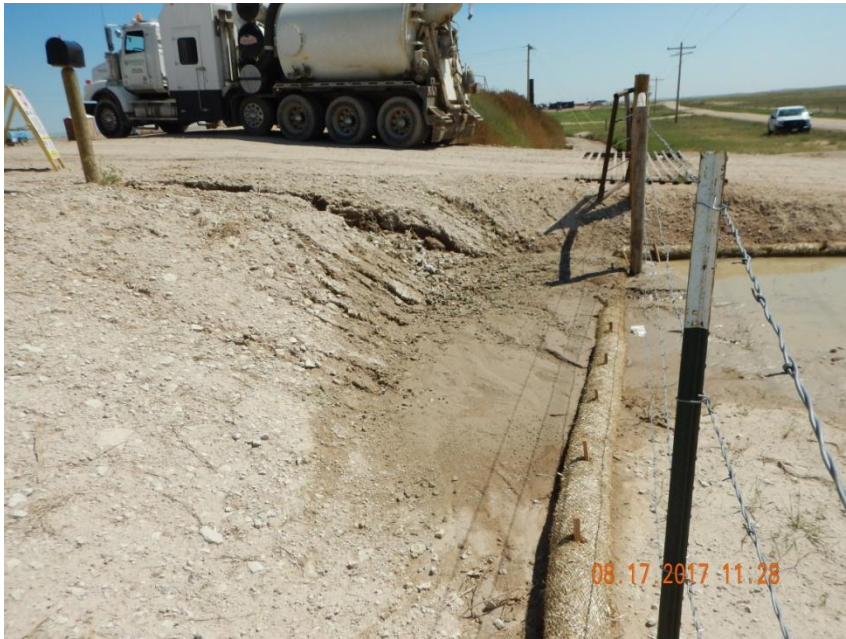
Photo 5. Photo taken from the entrance of the Tombstone pad, along the west side, facing East. Gully erosion occurring along the west entrance access road. Wattle BMPs are not preventing sediment discharge from location.

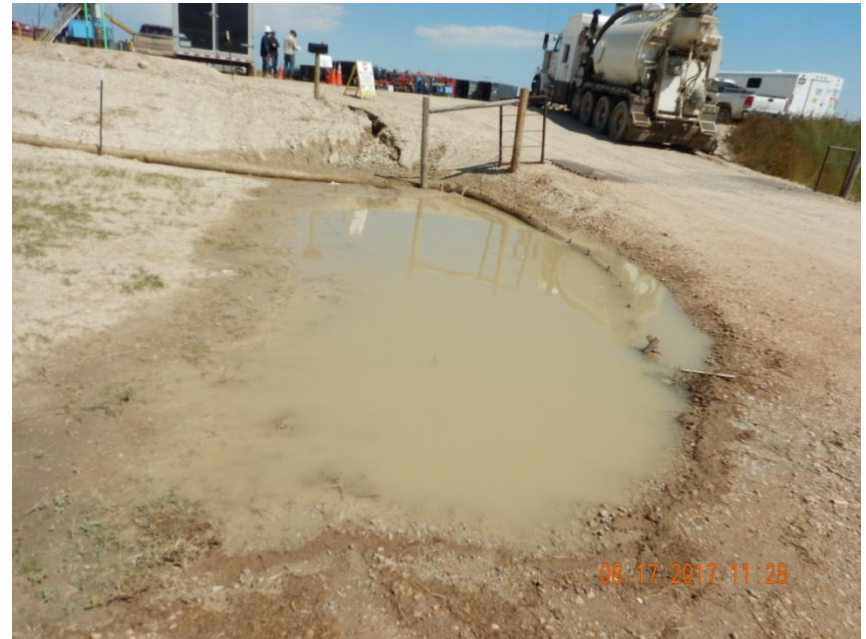
Photo 6. Photo taken from the entrance of the Tombstone pad, along the west side, facing North. Sediment discharge observed, as the wattle BMP does not appear to be sufficient.

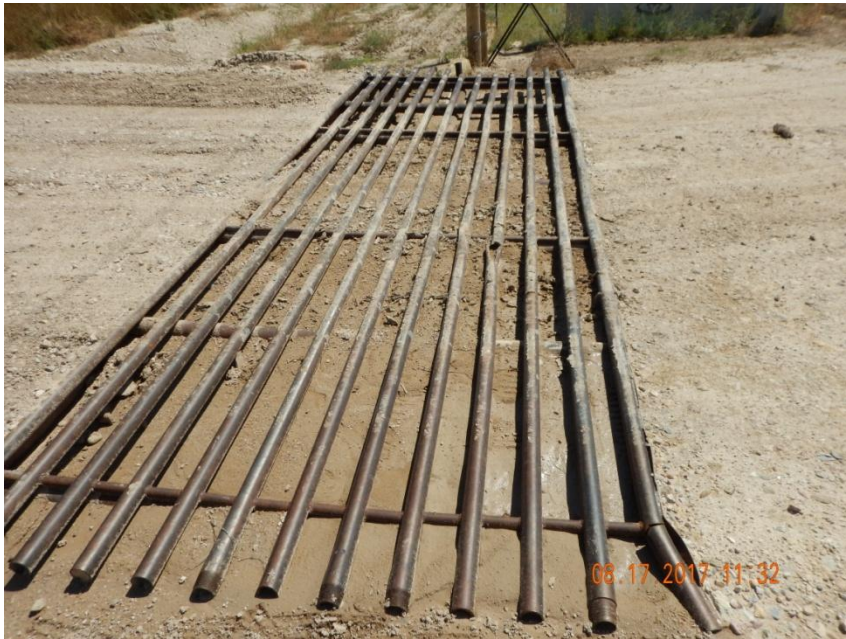
Photo 7. Photo taken from the cattle guard of the Holliday east entrance, facing East. Cattle guard in need of maintenance.

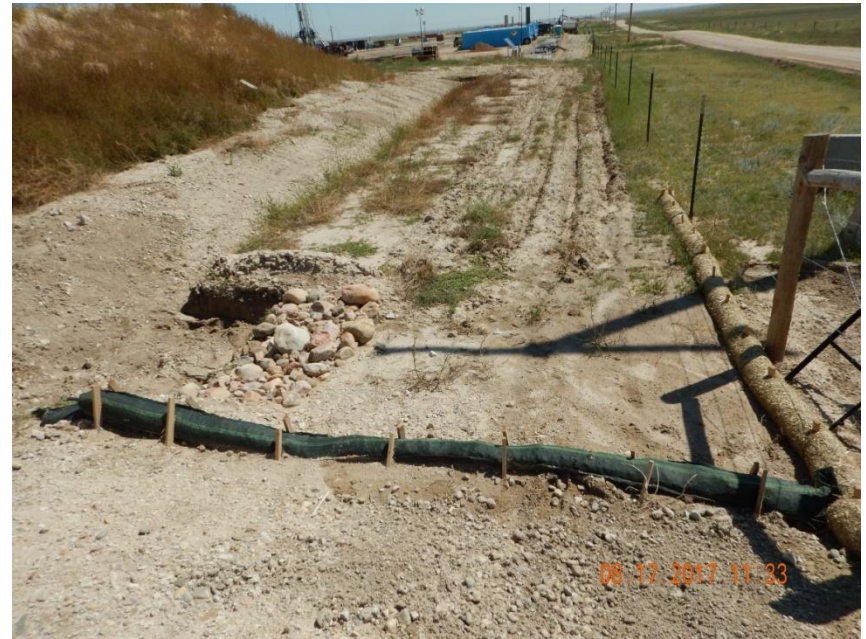
Photo 8. Photo taken from the entrance of the east Holliday entrance, facing East. Sediment trap does not appear to be a sufficient size and does not appear to be constructed with good engineering practices.

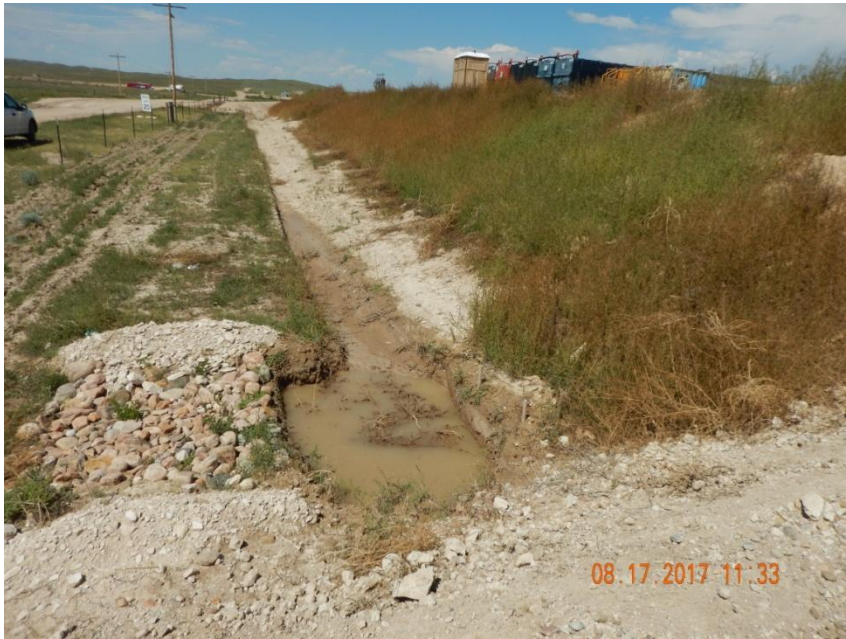
Photo 9. Photo taken from the entrance of the east Holliday entrance, facing West. Sediment trap does not appear to be a sufficient size.

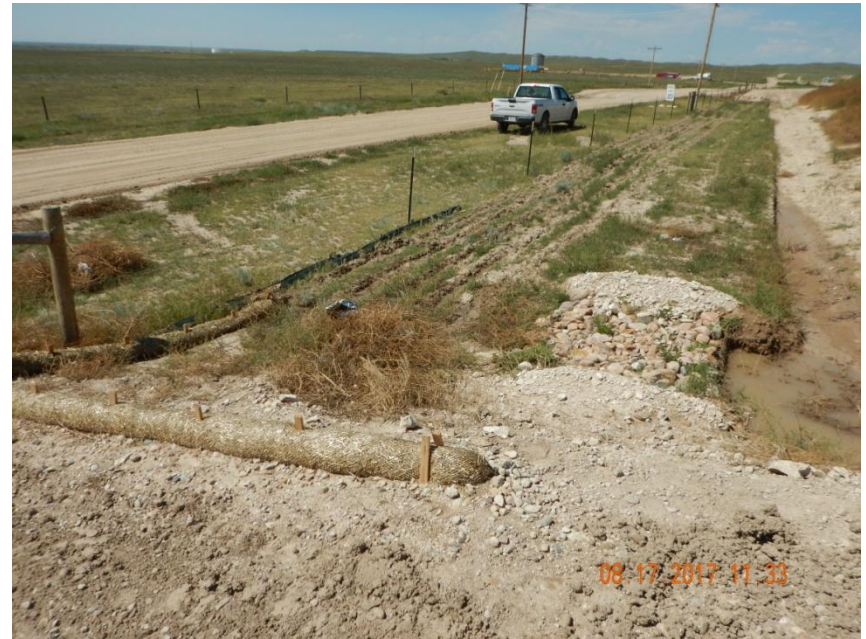
Photo 10. Photo taken from the previous photo, facing Southwest. Other BMPs (surface roughening and wattles) have been installed downgradient of the outlet area but may not be sufficient because the sediment trap appears too small.

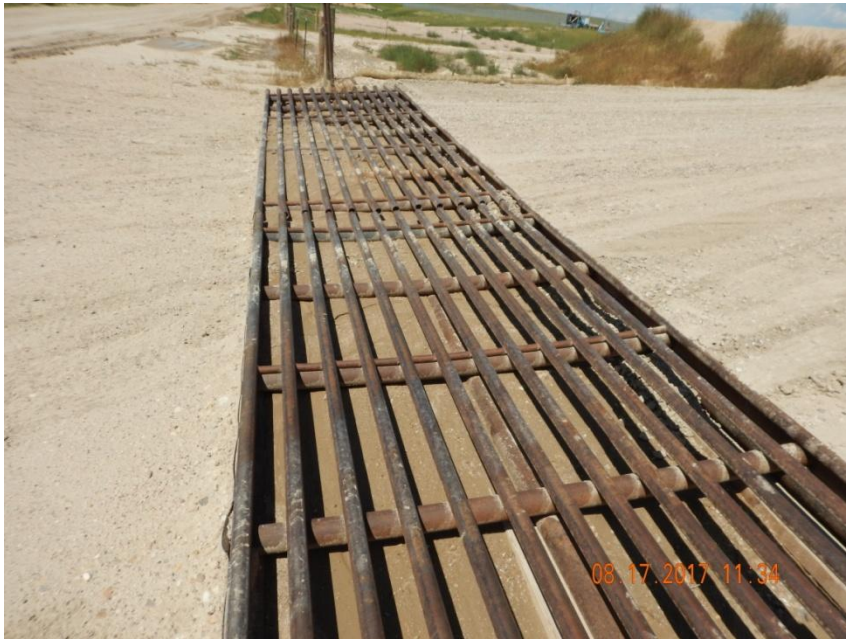
Photo 11. Photo taken from the cattle guard of the Holliday west entrance, facing West. Cattle guard in need of maintenance.

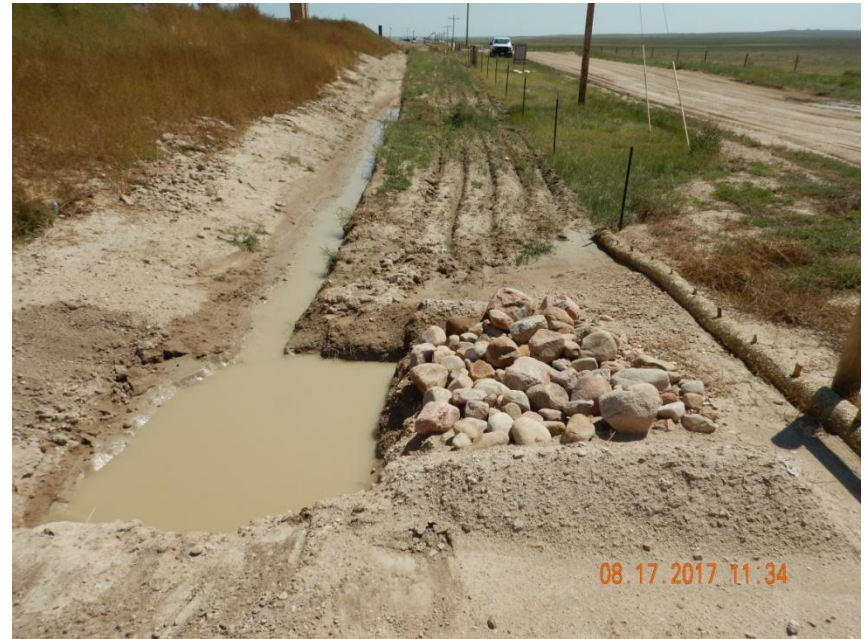
Photo 12. Photo taken from the entrance of the west Holliday entrance, facing East. Sediment trap does not appear to be a sufficient size. Appears flows have discharged over the embankment berms and around the outlet area.

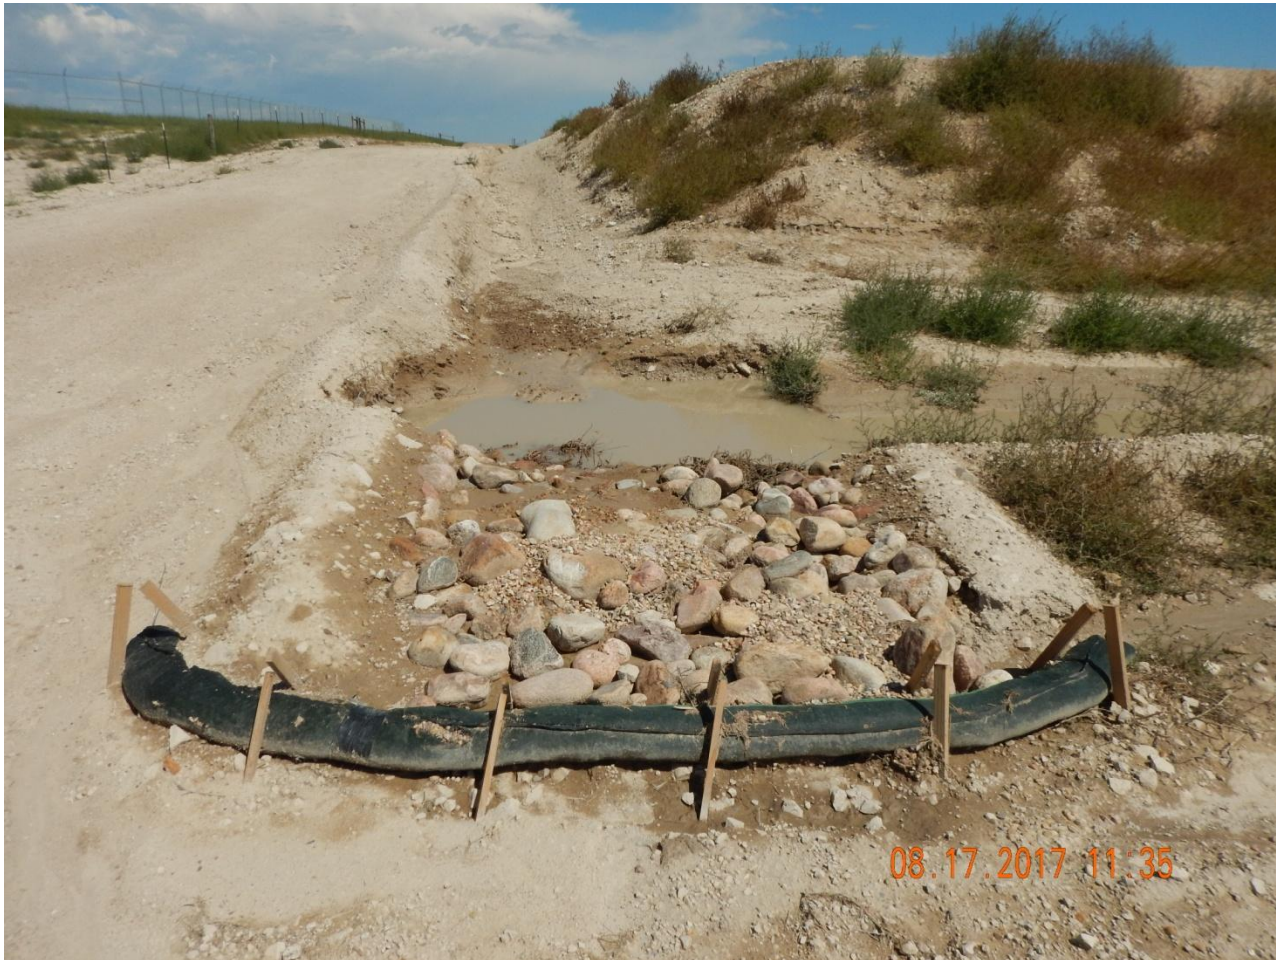
Photo 13. Photo taken from the southwest location of the Holliday pad, facing North. Sediment trap does not appear to be a sufficient size and does not appear to be constructed with good engineering practices. Sediment discharge was observed beyond the outlet area of the sediment trap.
