- Sanchez 3 05-067-05341

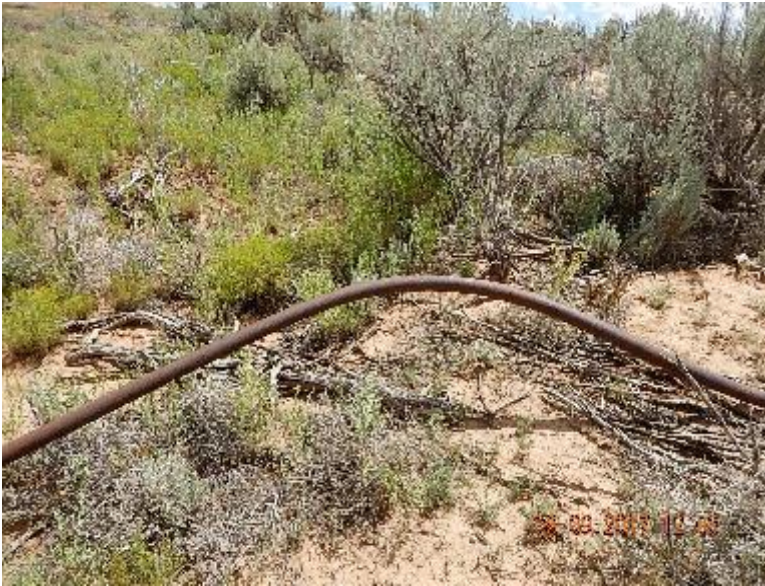
Photo 1: Steel line – disconnected and open on both ends.

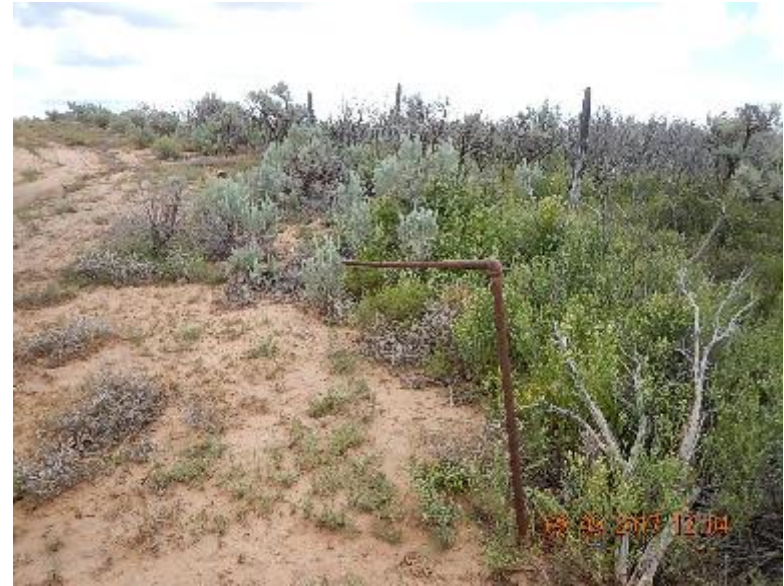
Photo 2: Disconnected 1" steel line.

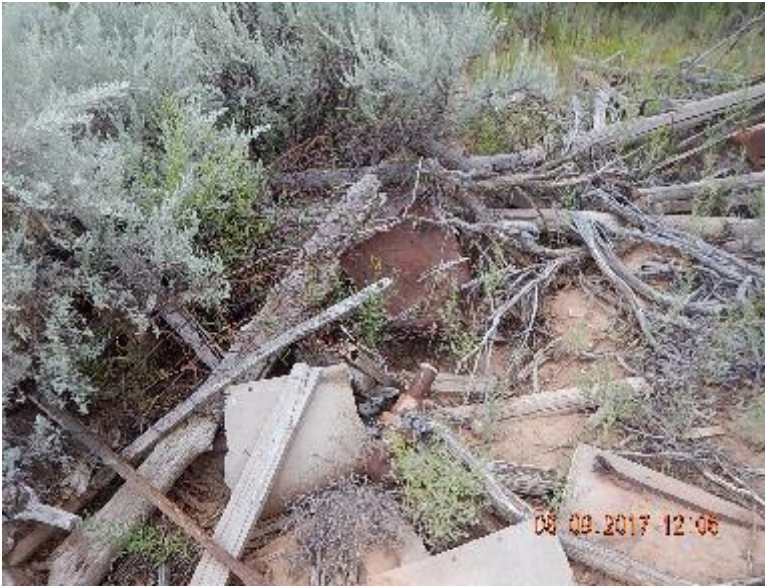
Photo 3: Debris

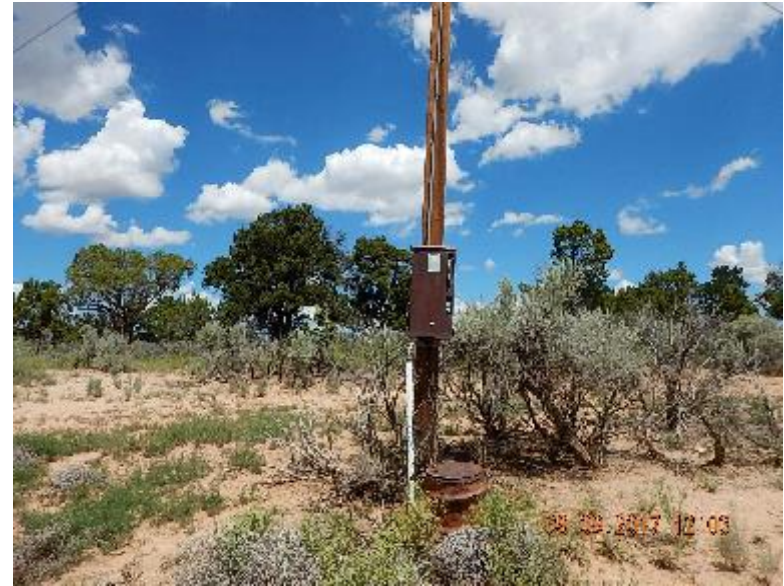
Photo 4: Electrical service panel and power pole.

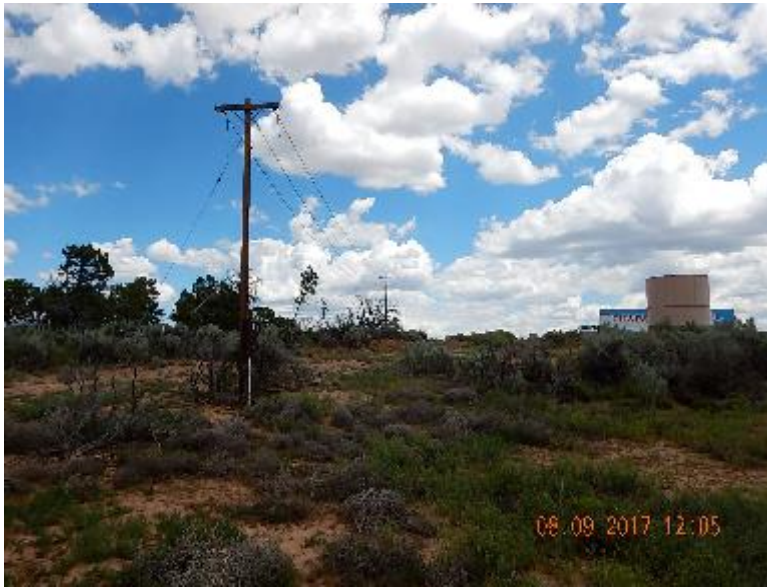
Photo 5: Power poles

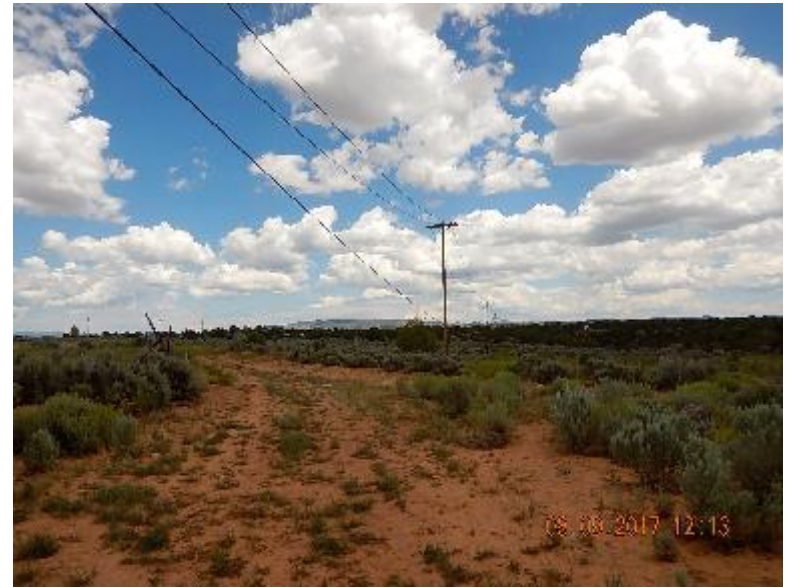
Photo 6: Line broken off power pole at top of location.

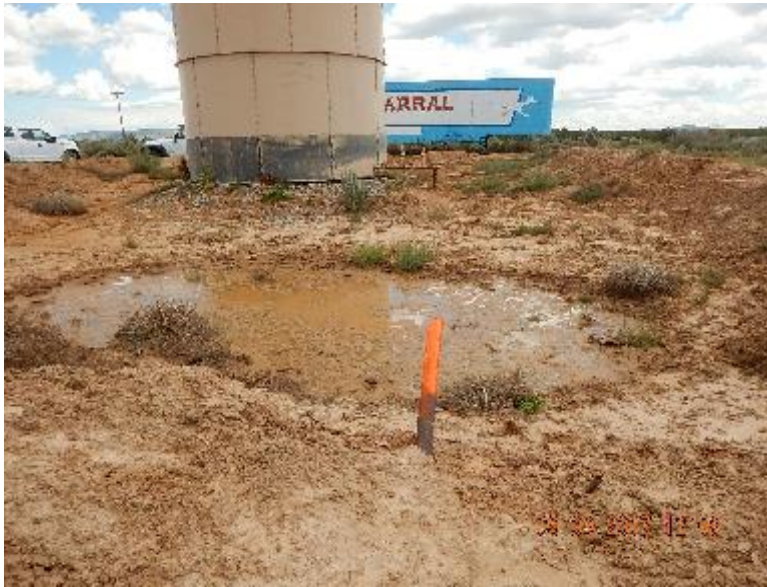
Photo 7: Steel riser in back tank containment berm.

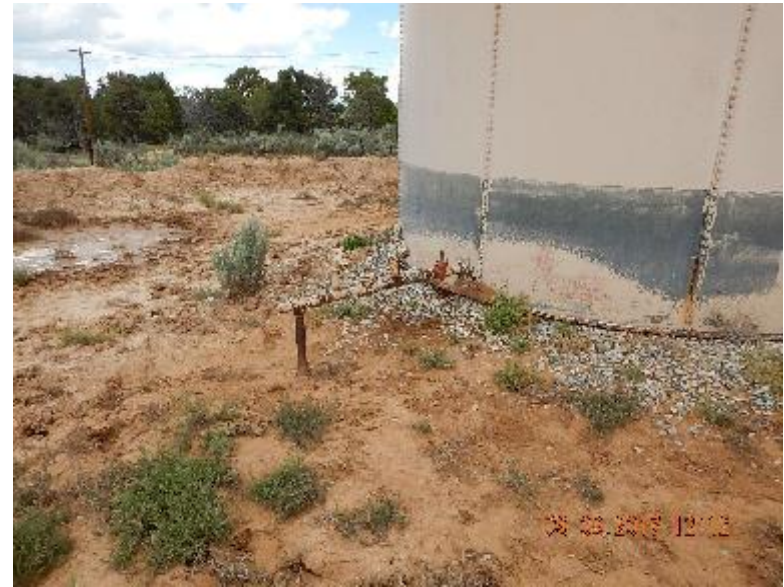
Photo 8: Connected flowline at tank.

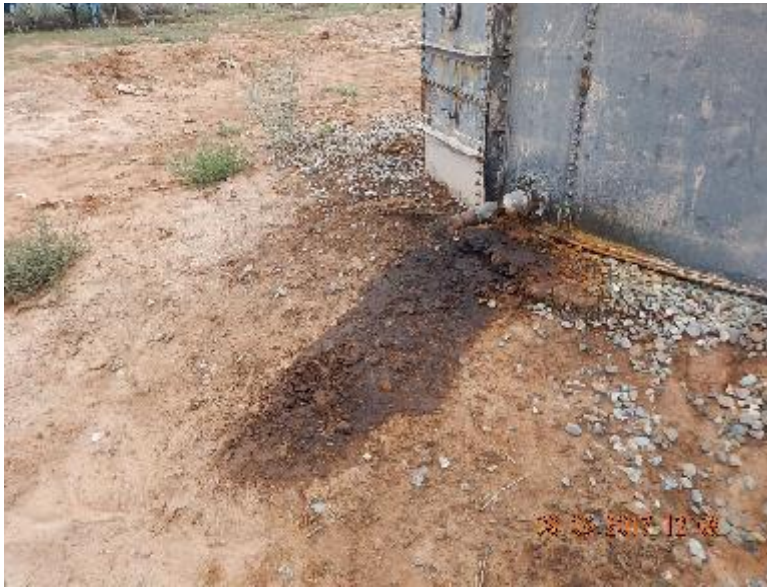
Photo 9: Impacted soil at tank drain.

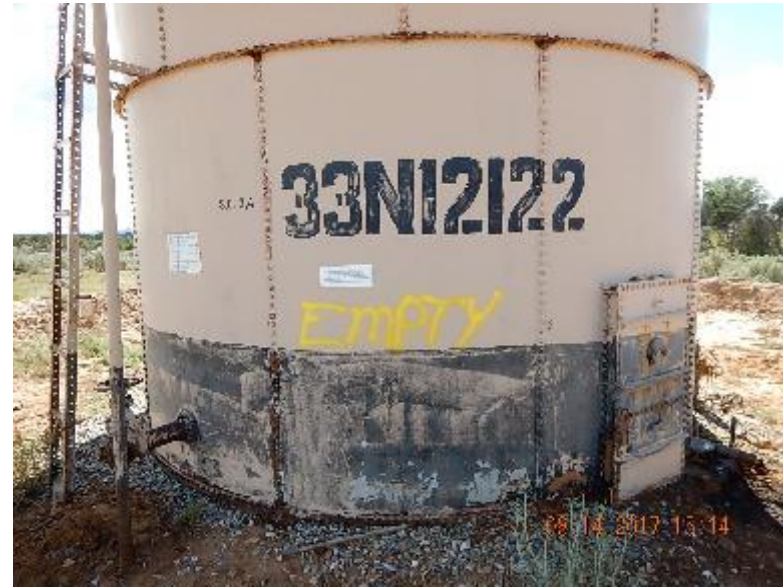
Photo 10: Tank marked empty.
