- JCK 4 05-067-06511

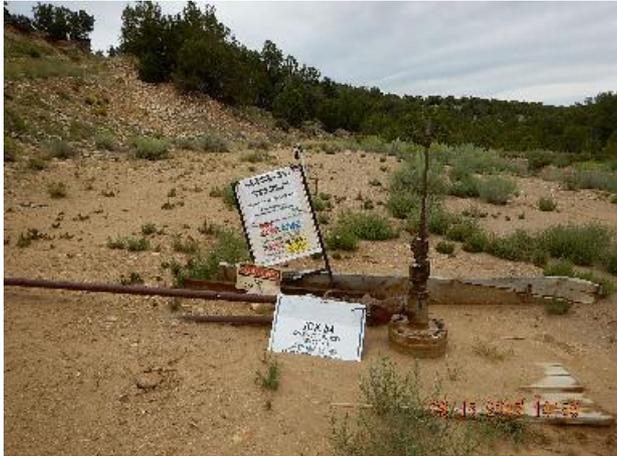
Photo 1: Wellhead signs, sediment flow, and flowlines.

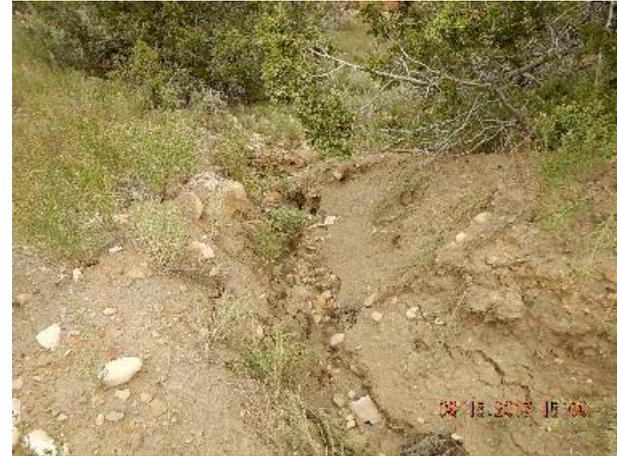
Photo 2: Stormwater flow off NE corner of location.

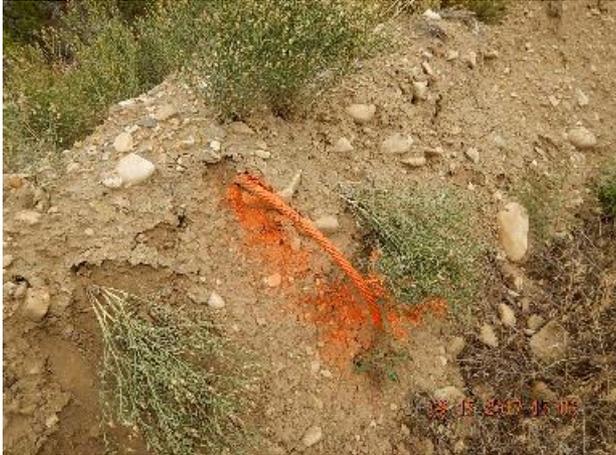
Photo 3: Steel cable in perimeter ditch along E side of location.

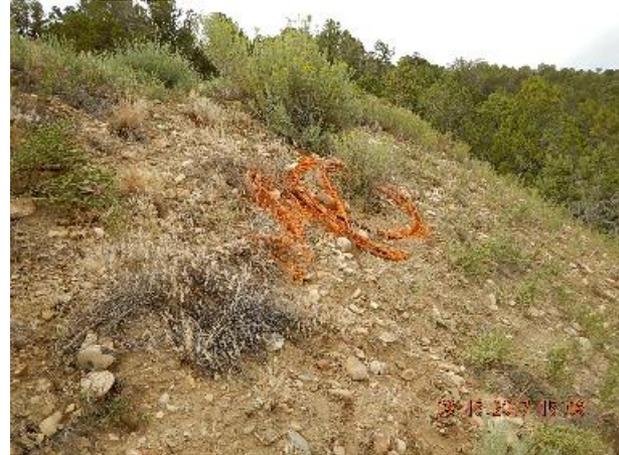
Photo 4: Steel cable over E edge of fill slope.

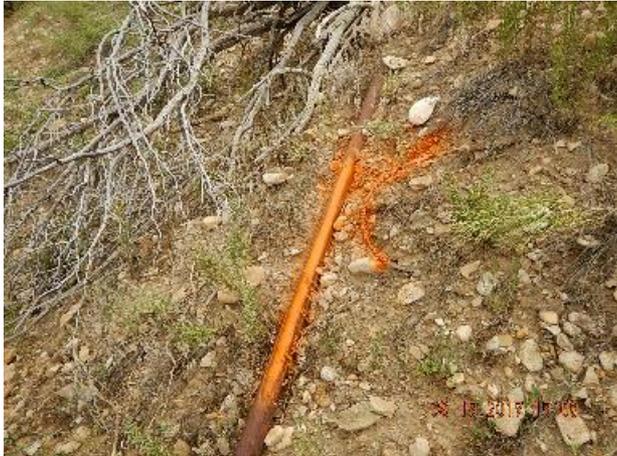
Photo 5: Steel pipe and cable over E edge of fill slope.

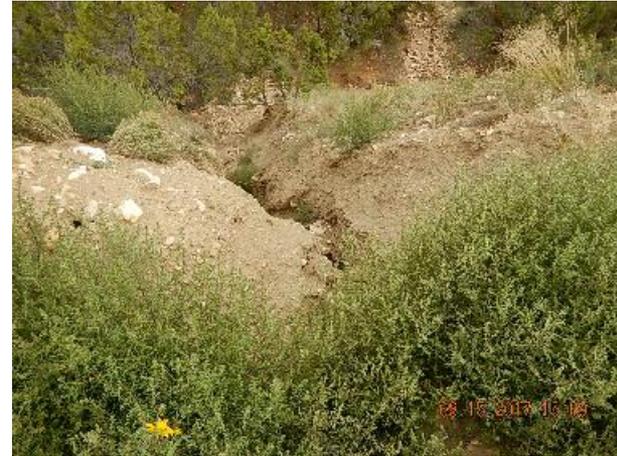
Photo 6: Erosion gully 1 of 3 from breach in berm along E side of location.

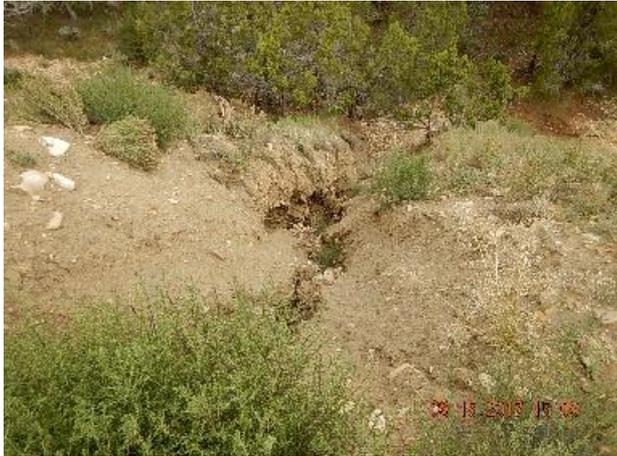
Photo 7: Erosion gulley 2 of 3 from breach in berm on E side of location.

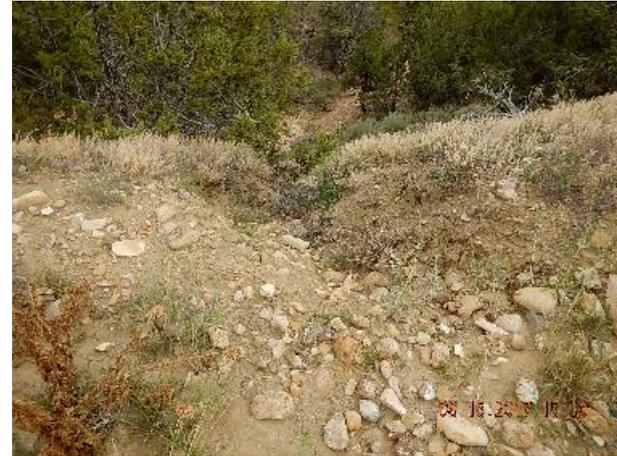
Photo 8: Erosion gulley 3 of 3 from breach in berm in SE corner of location.

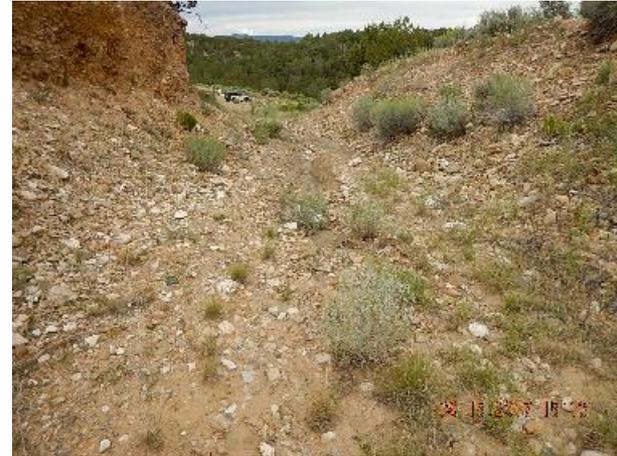
Photo 10: Erosion channel in S access road carrying stormwater and sediment down slope. Flow hits breach in berm and flows off SE corner of location.

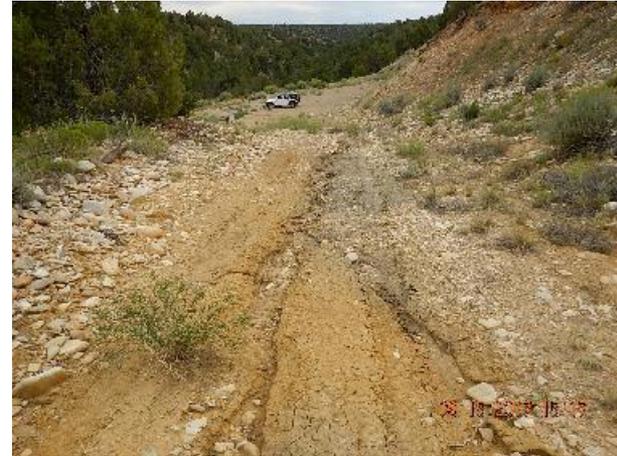
Photo 12: Erosion channels in N access road carrying stormwater and sediment flow onto location.

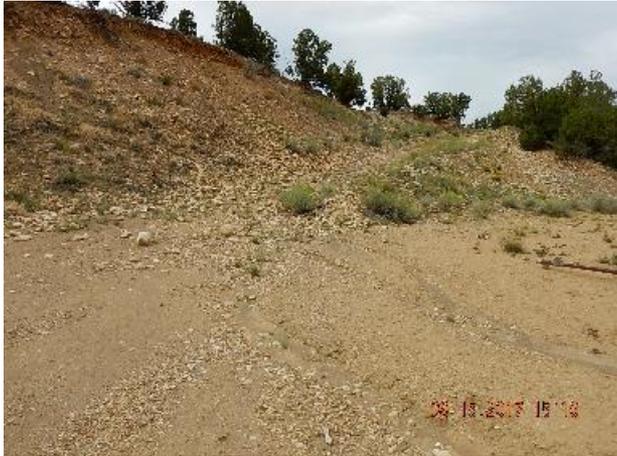
Photo 13: Stormwater and sediment flow onto location from N access road.

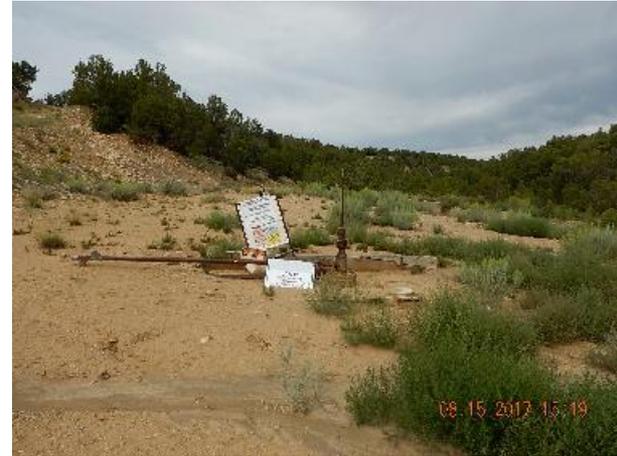
Photo 14: Sediment deposit around well head as it flows into ditch along E side of location and off NE corner of location.
