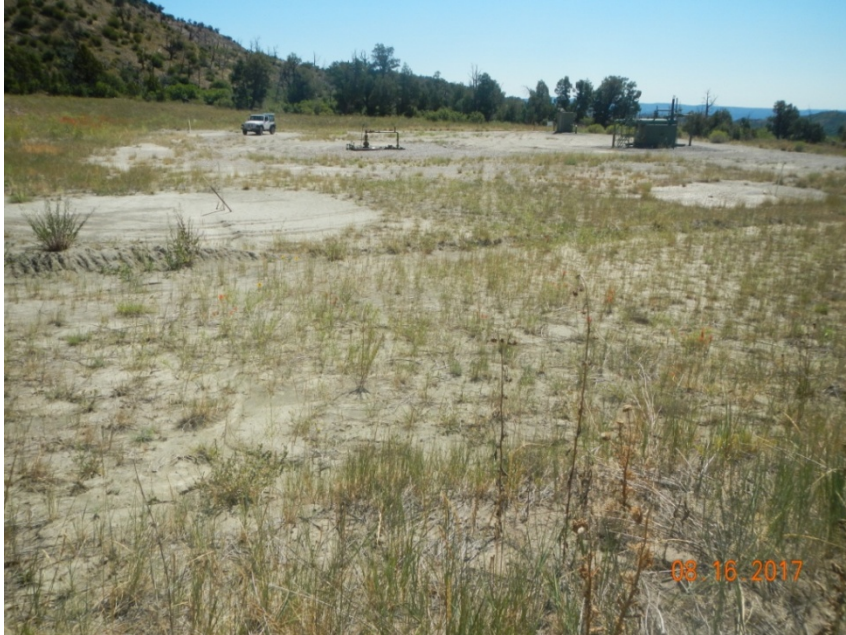
Photo 1: View of the project area from the southwestern corner facing center.

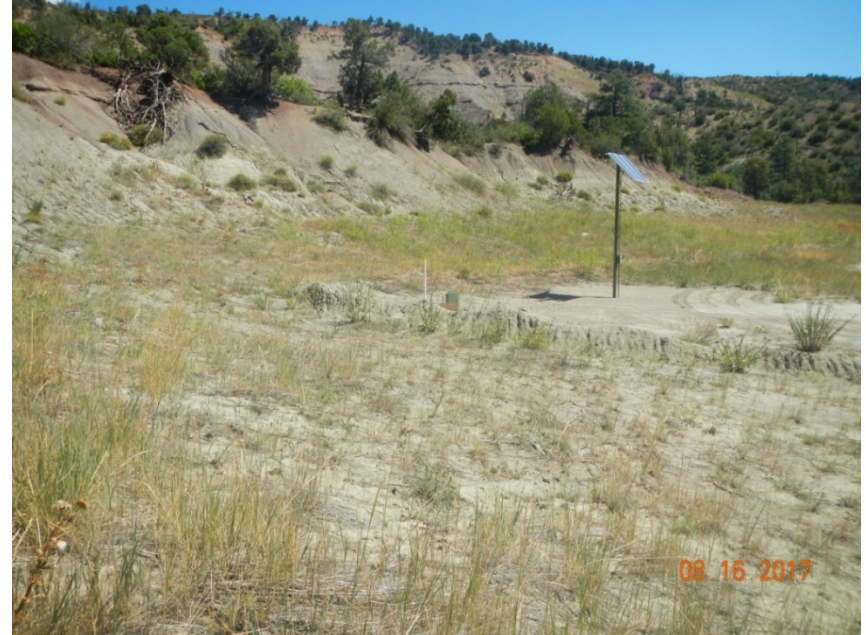
Photo 2: View of the western portion of the project area from the southwestern corner of the well pad facing northward. Revegetation is progressing with grasses such as western wheatgrass (*Pascopyrum smithii*) and dropseed (*Sporobolus* sp.)

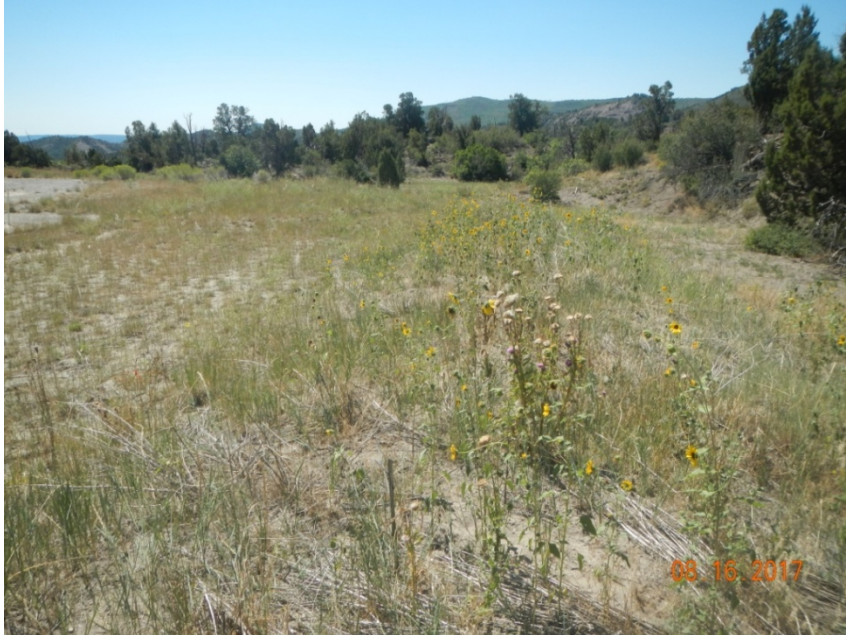
Photo 3: View of the southern portion of the project area from the southwestern corner of the well pad facing eastward.

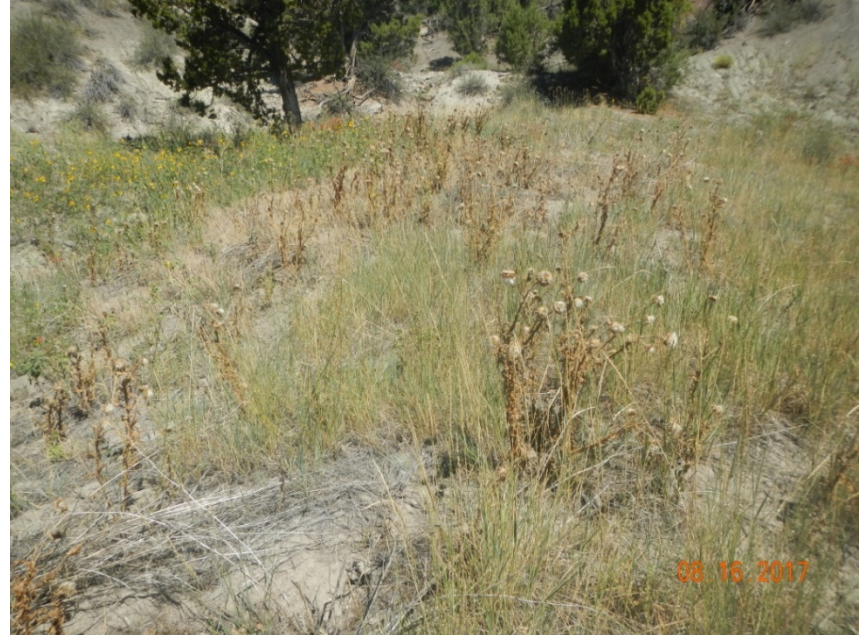
Photo 4: View of musk thistles (*Carduus nutans*) within the project area.

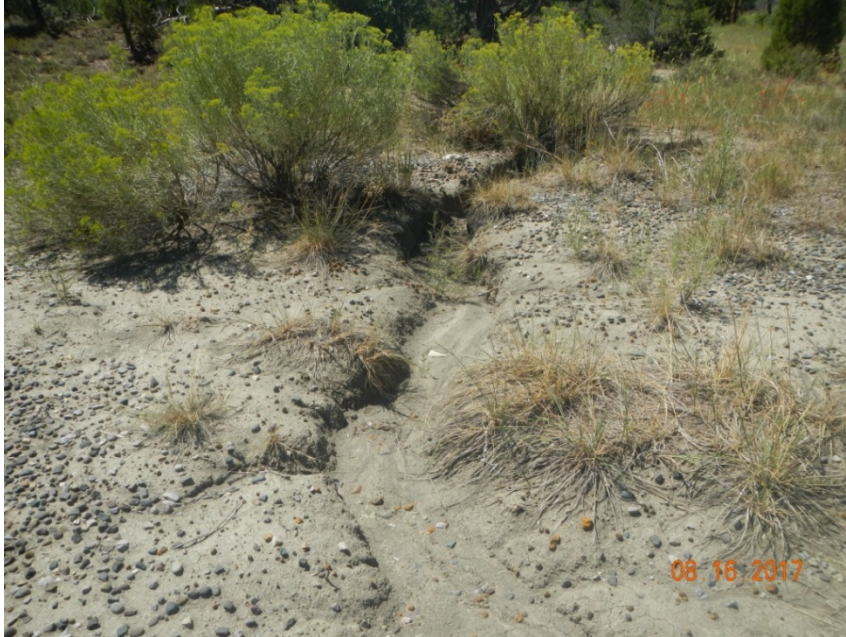
Photo 5: View of erosional channel forming within the eastern portion of the project area.

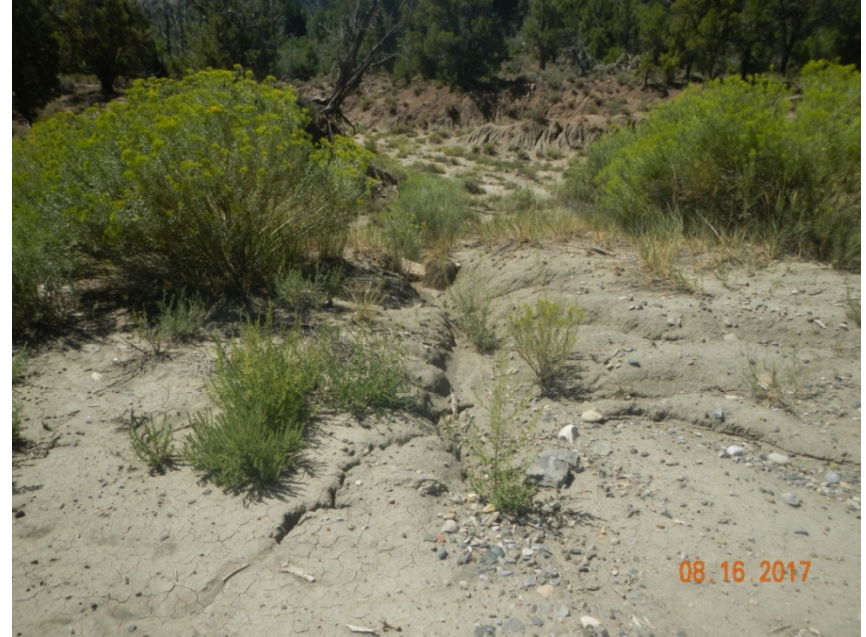
Photo 6: View of another erosional channel forming within the eastern portion of the project area.

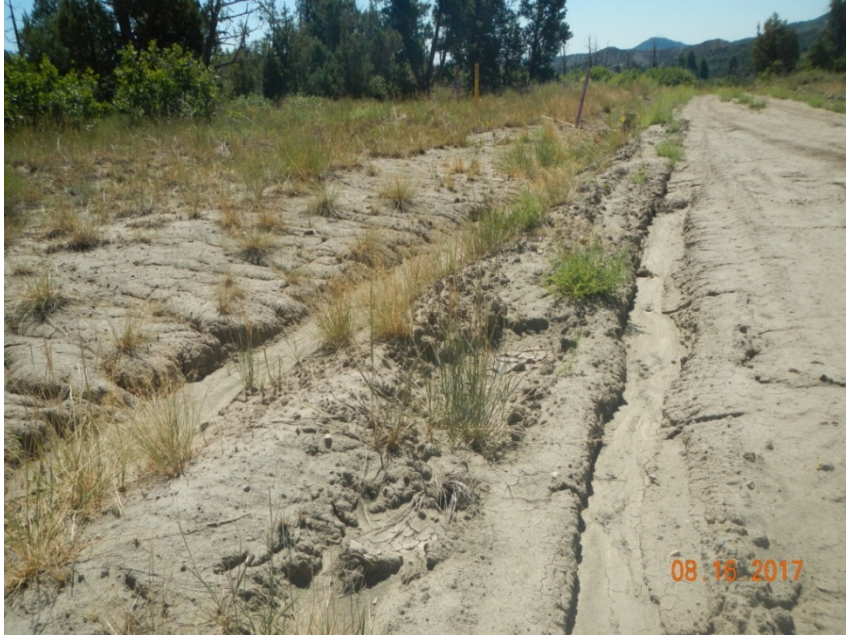
Photo 7: View of erosional downcutting and unstabilized soils near the well pad entrance facing eastward.
