Construction and Stormwater Inspection

August 23, 2017

Operator: EXTRACTION OIL & GAS INC - #10459

Location ID: 430441

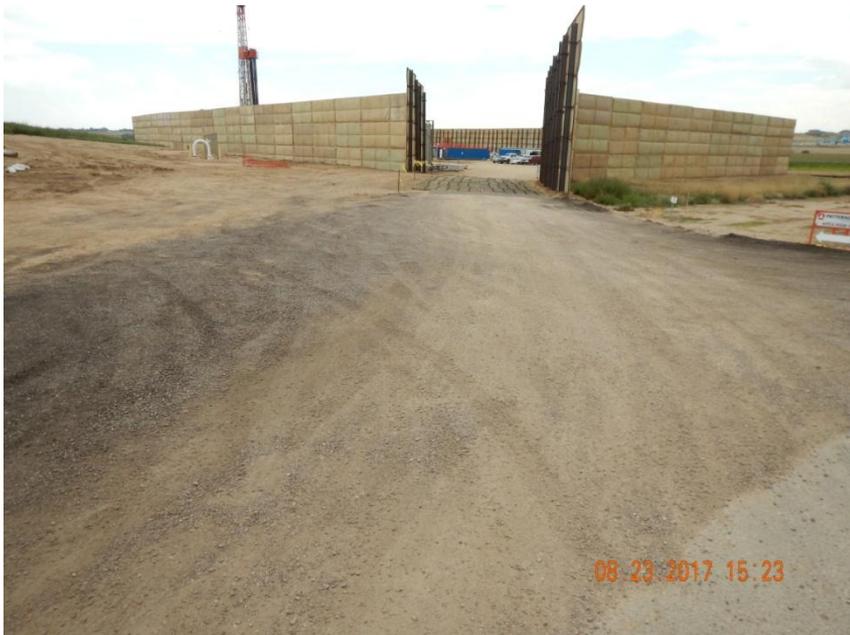
Photo 1. Photo taken from the entrance of location, facing Southeast. Tracking pad devices installed at location.

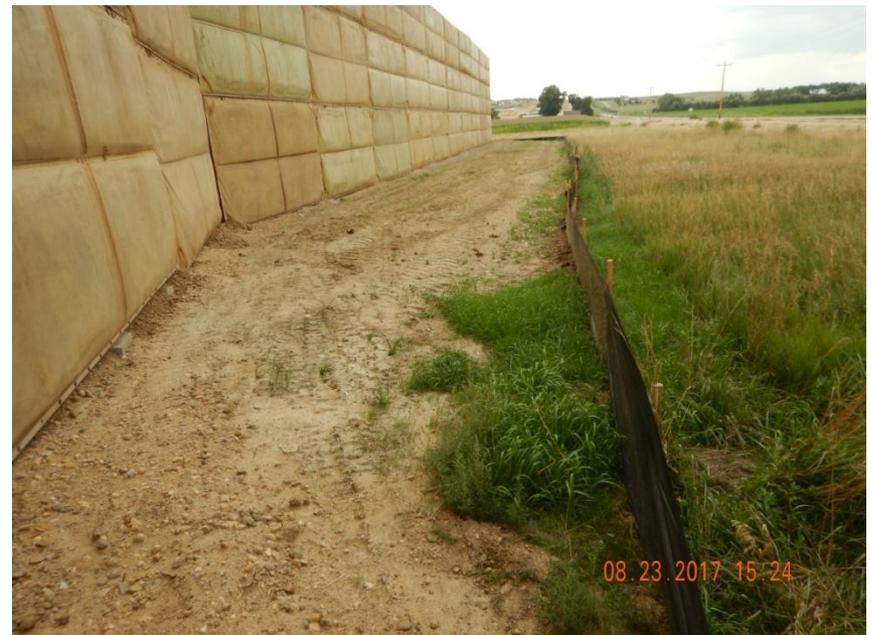
Photo 2. Photo taken from the western location, facing South. Silt fence BMP installed around the western and southern location.

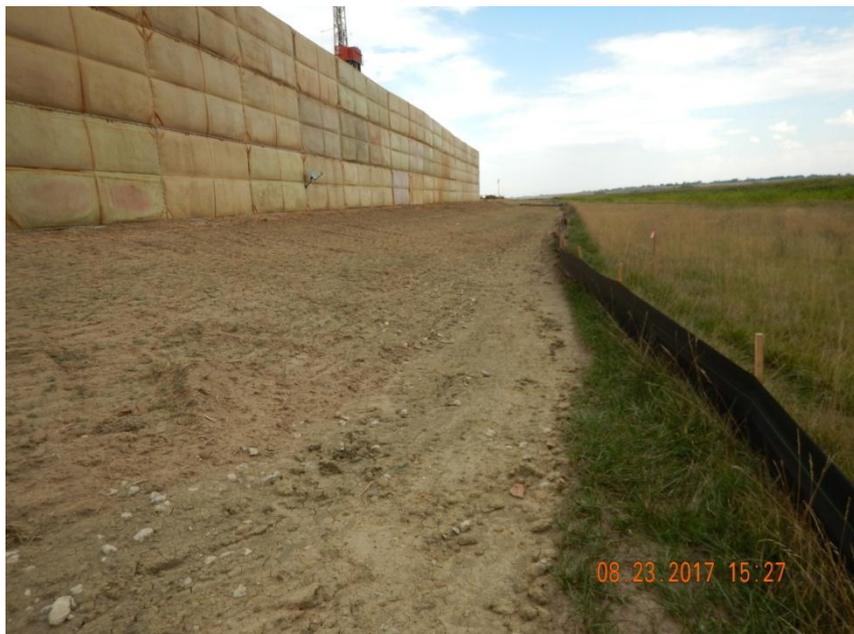
Photo 3. Photo taken from the southwest location, facing East. Tracking pad devices installed at location. Silt fence BMP installed around the western and southern location. A ditch BMP was observed just below the base of the well pad and the southern slope has been tracked perpendicular with equipment.

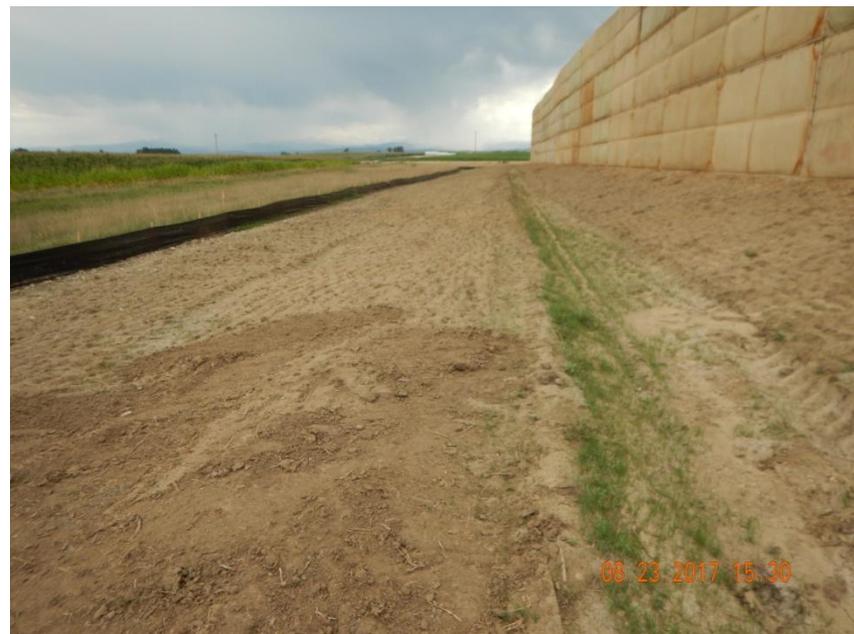
Photo 4. Photo taken from the south-central location, facing West. Silt fence BMP installed around the western and southern location. Silt fence BMP installed around the western and southern location. A ditch BMP was observed just below the base of the well pad and the southern slope has been tracked perpendicular with equipment.

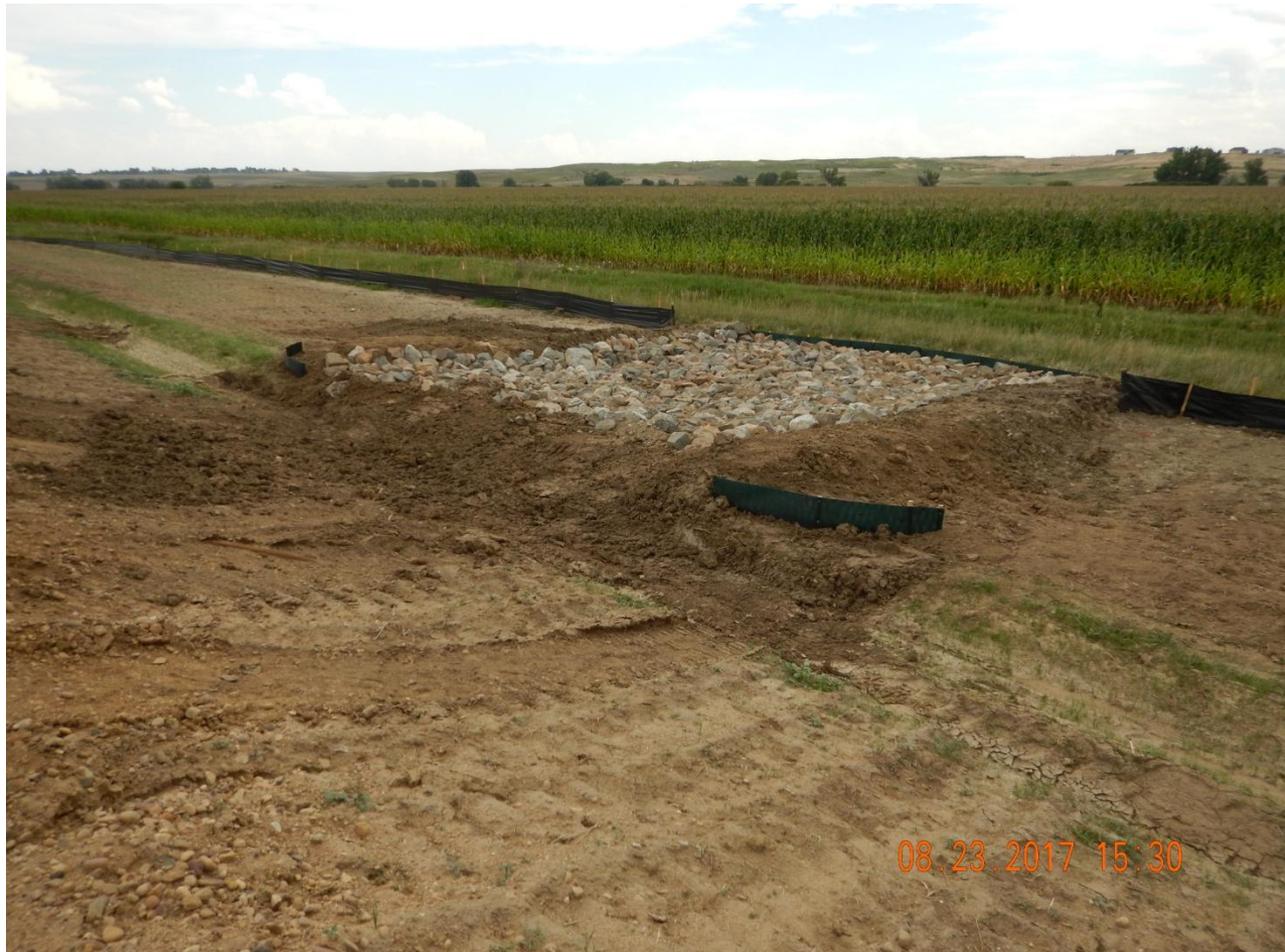
Photo 5. Photo taken from the south-central location, facing Southeast. A stabilized area constructed of rip-rap has been installed to for erosion control. The outlet of the rip-rap has been installed with S-Fence for sediment control- see next photo.

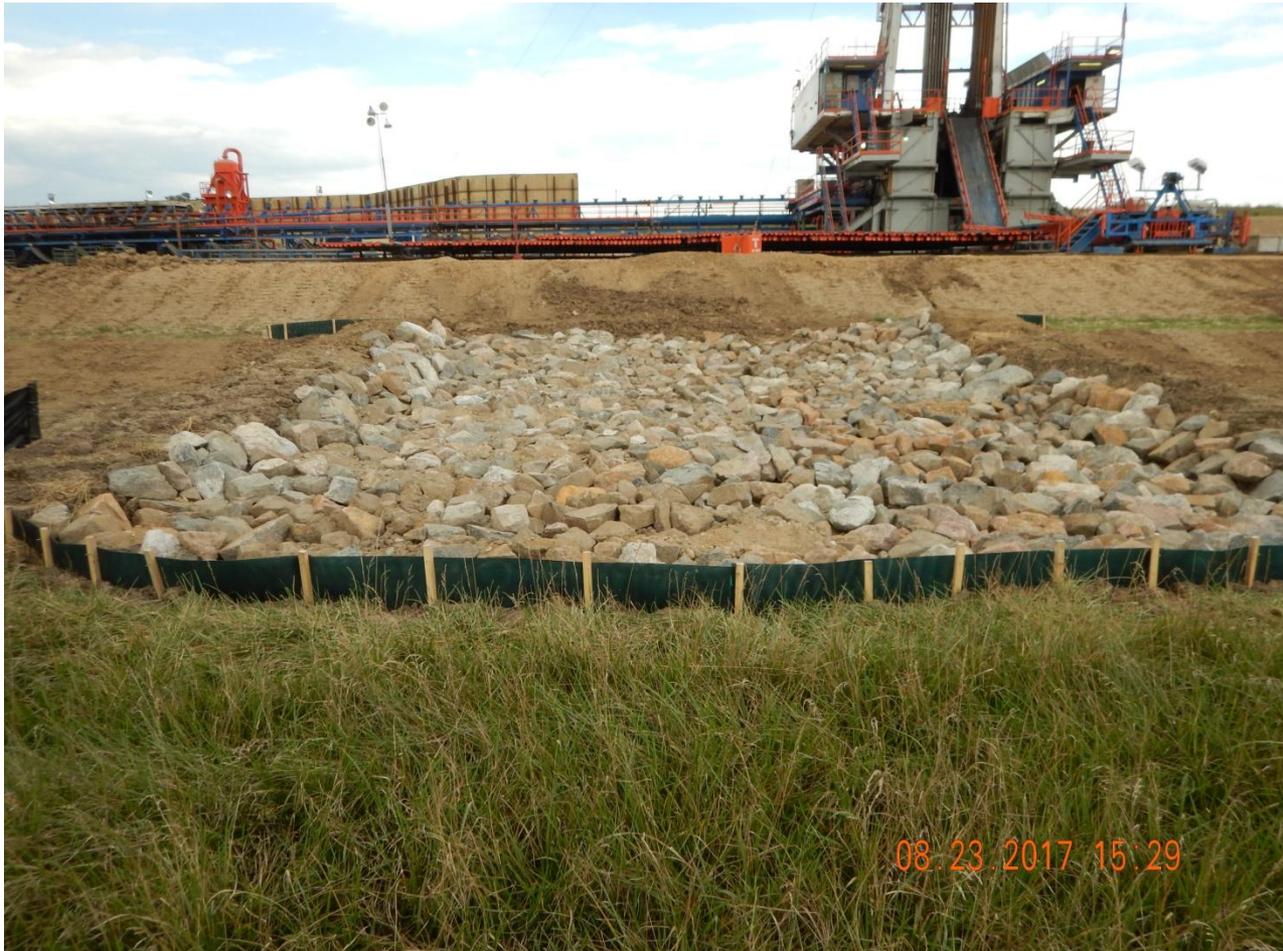
Photo 6. Photo taken from the outlet area of the stabilized rip-rap area, facing North. S-Fence has been installed for sediment control.

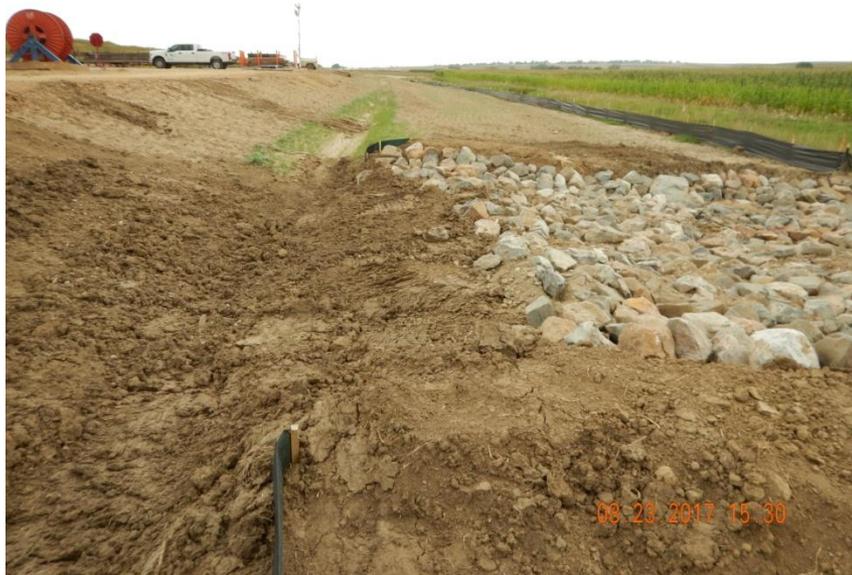
Photo 7. Photo taken from the stabilized area, facing East. Silt fence BMP installed around the western and southern location. A ditch BMP was observed just below the base of the well pad and the southern slope has been tracked perpendicular with equipment.

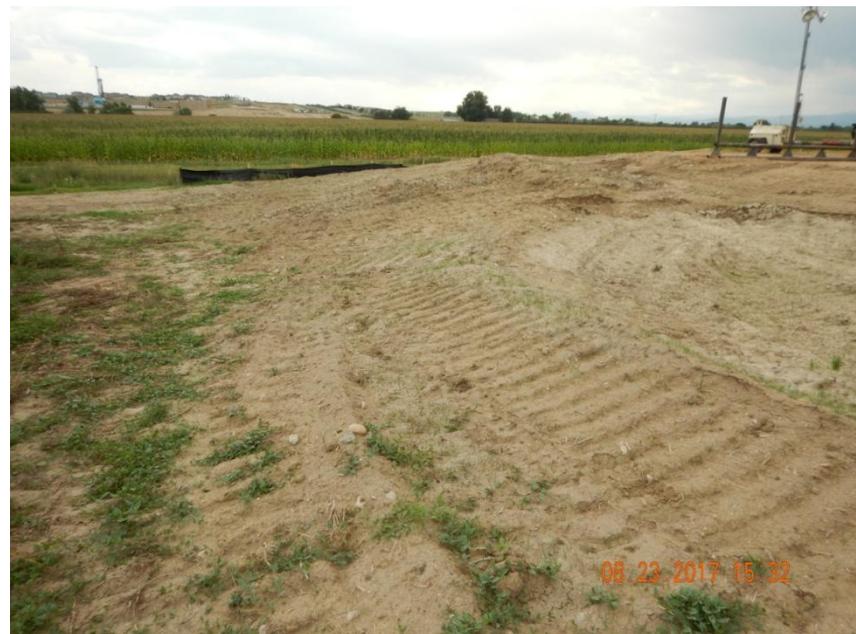
Photo 8. Photo taken from the southeastern location, facing South. Silt fence BMP ended at the southeast corner of the location. Did not observe any sediment or erosion control BMPs along the eastern perimeter of the location.

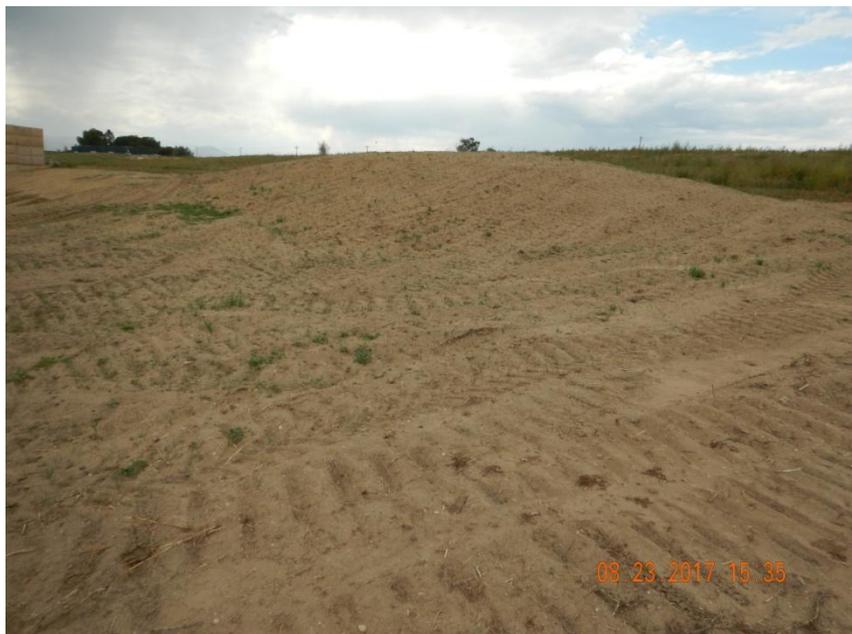
Photo 9. Photo taken from the northeastern location, facing Northwest. Appears to be the topsoil stockpile which has been temporarily stabilized.

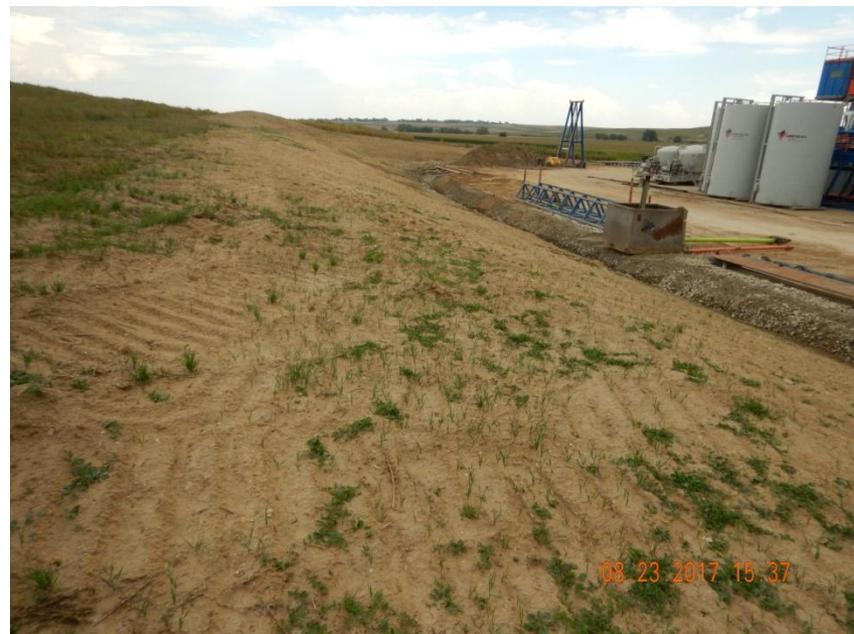
Photo 10. Photo taken from the northeastern location, facing East. The northern cut slope has been tracked perpendicular with equipment for temporary stabilization. Did not observe any BMPs to manage and control for stormwater run-on onto location. Rill erosion starting to occur along the northwestern cut slope- see the next photo.

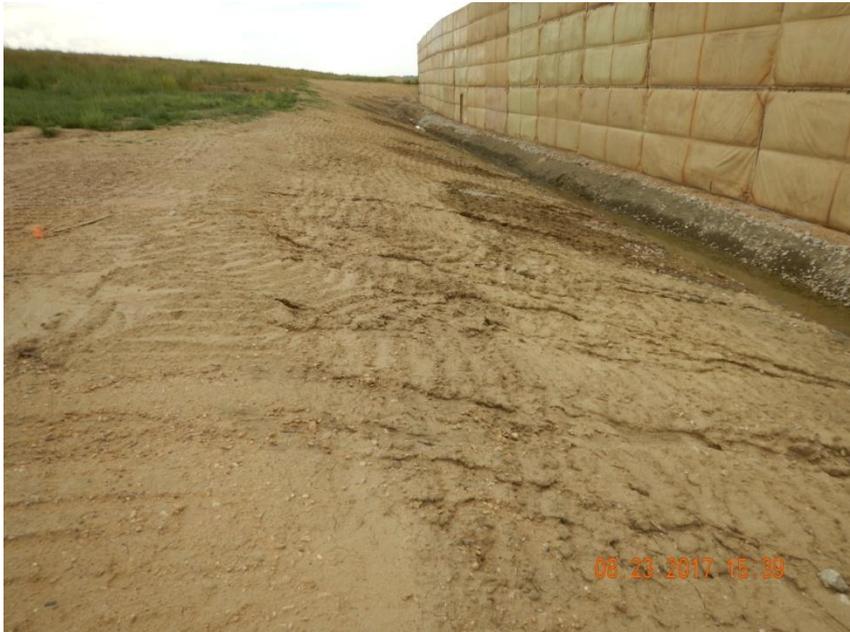
Photo 11. Photo taken from the northwestern location, facing East. Rill erosion starting to develop along the portions of the cut slope. Did not observe any BMPs to manage and control for stormwater run-on onto location. Additional BMPs to manage and control for stormwater run-on onto location should be installed so the northern cut slope can be stabilized.

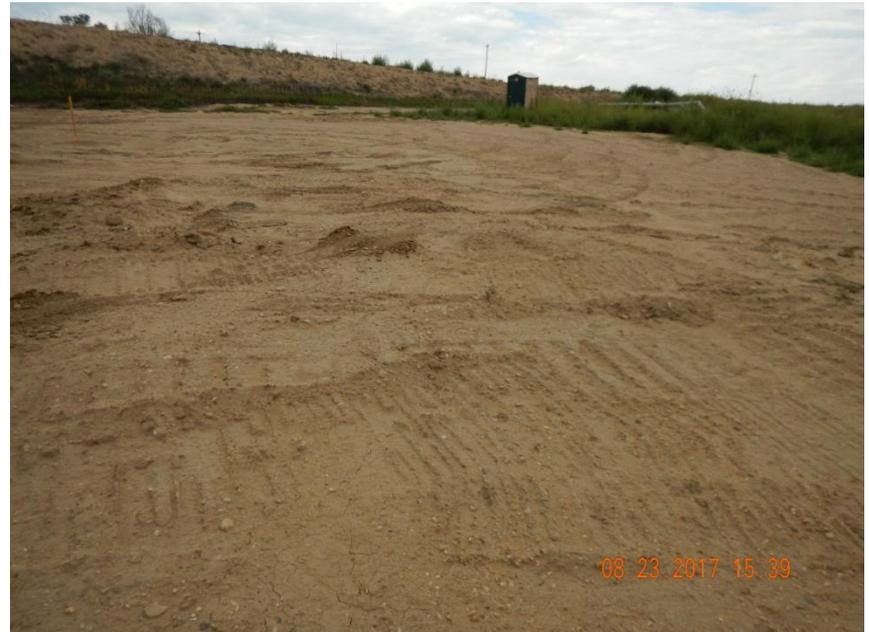
Photo 12. Photo taken from the northwestern location, facing North. Photo taken of the existing production facility for wells associated with Location ID 430206. This area appears to be the source for stormwater run-on onto the northern cut slope.
