Inspection Photos

Operator: H & R WELL SERVICES, INC - 36980

Location ID: 389360

Inspection Doc. Number: 675103913

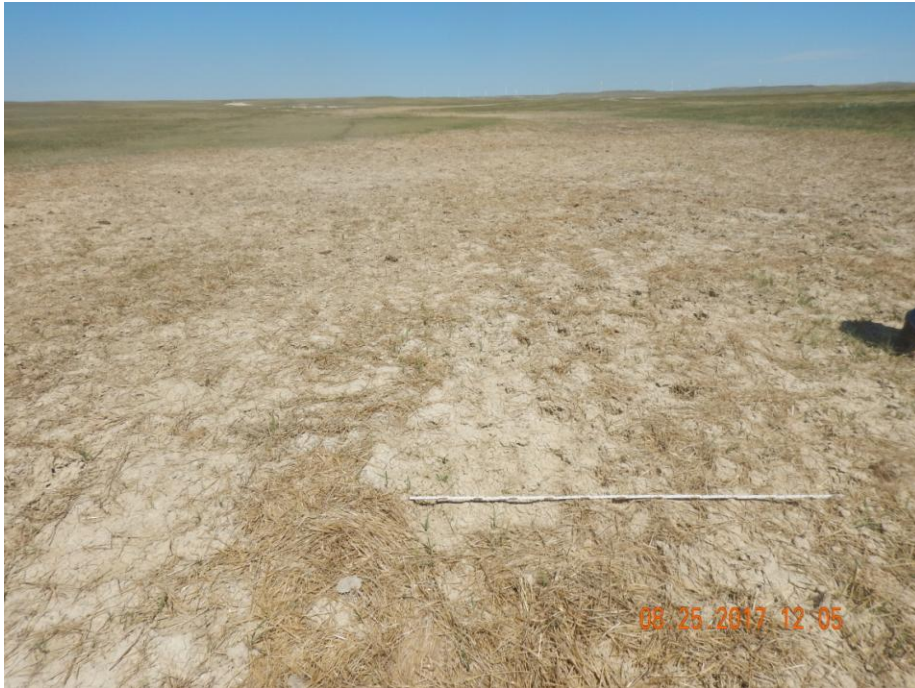
Photo 1: Photo taken from within the drainage, to the south of the location, facing north. Photo shows erosion has been repaired, areas had been seeded with an oat grass species, and straw crimped to stabilize the site.

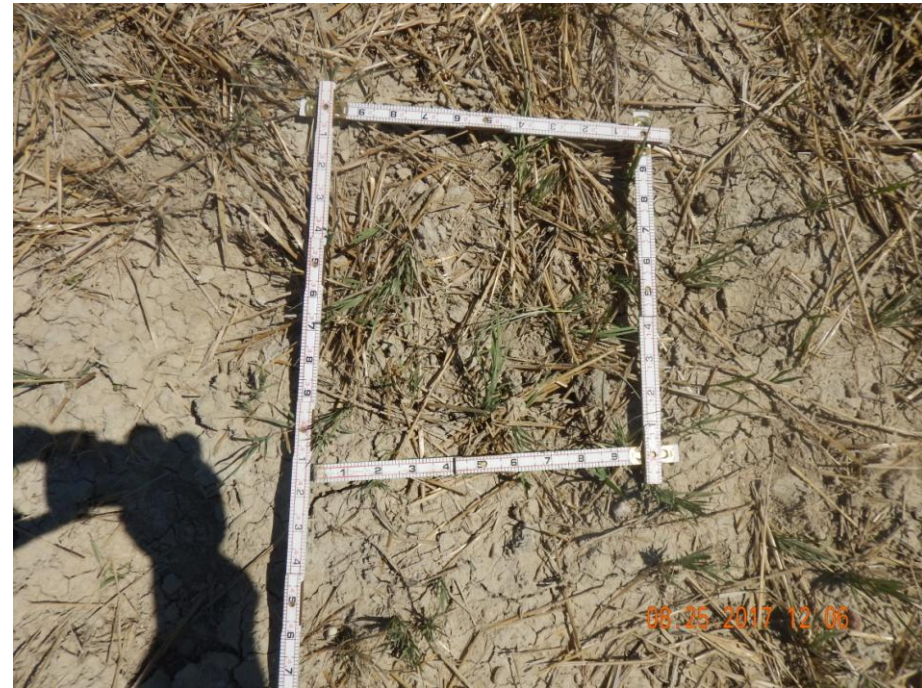
Photo 2: Photo taken from within the drainage, to the south of the location. Photo shows oat grass germination.

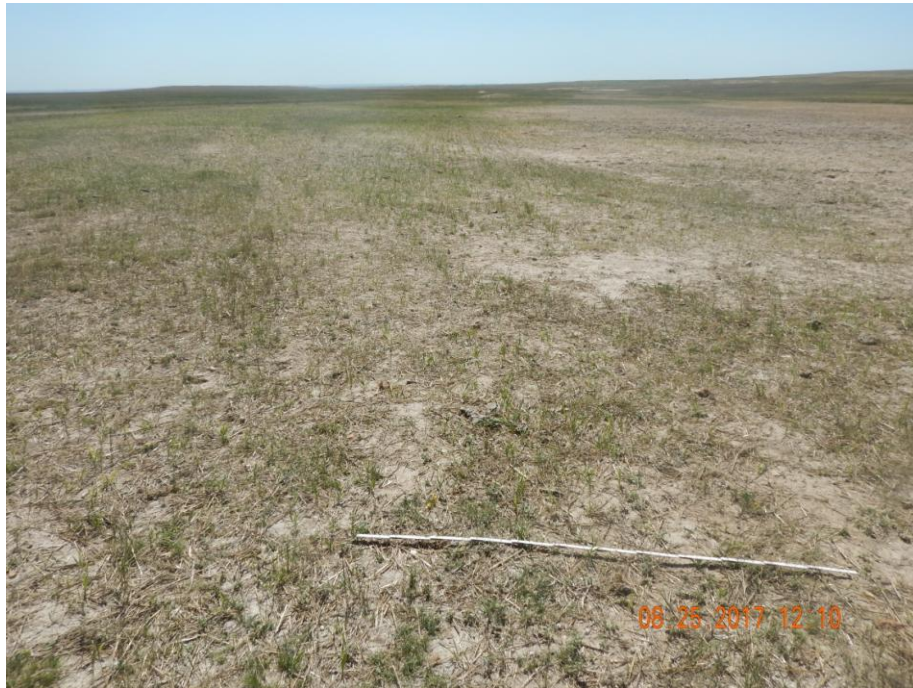
Photo 3: Photo taken from the former battery location, facing south. Photo shows erosion has been repaired, areas had been seeded with an oat grass species, and straw crimped to stabilize the site.

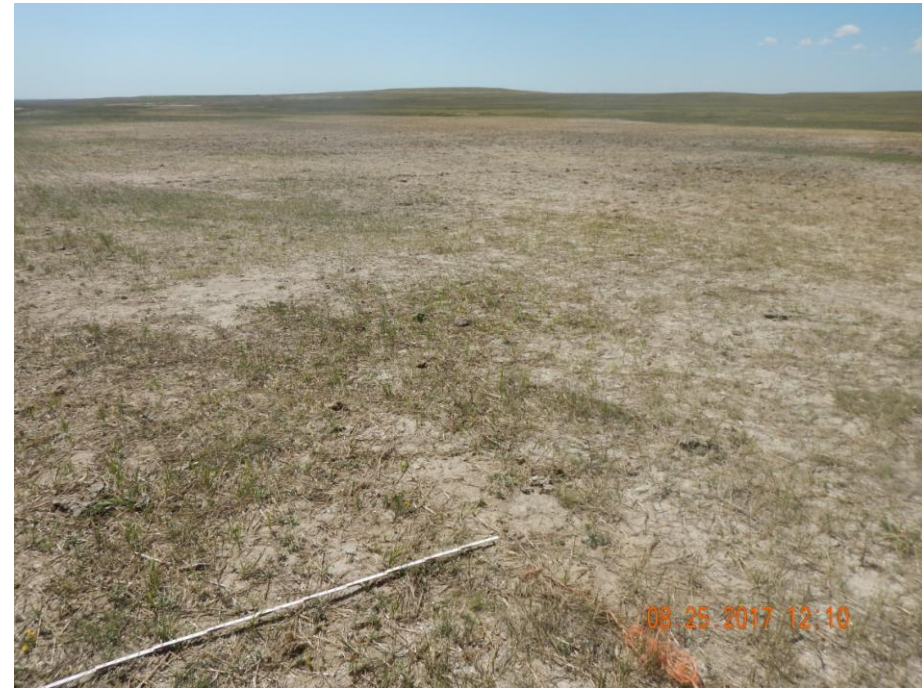
Photo 4: Photo taken from the former battery location, facing southwest. Photo shows erosion has been repaired, areas had been seeded with an oat grass species, and straw crimped to stabilize the site.

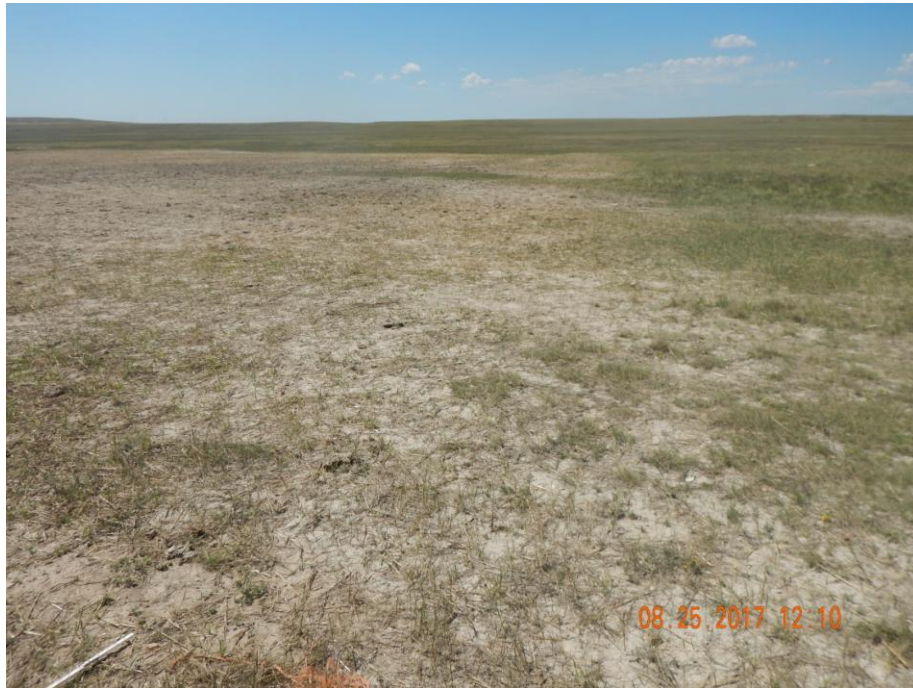
Photo 5: Photo taken from the former battery location, facing west. Photo shows erosion has been repaired, areas had been seeded with an oat grass species, and straw crimped to stabilize the site.

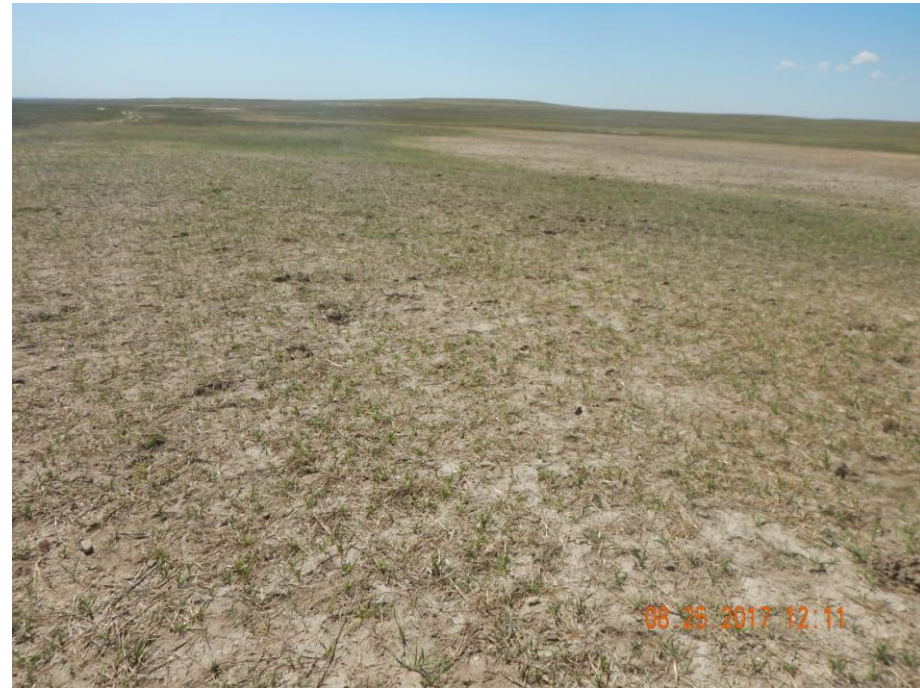
Photo 6: Photo taken from the former battery location, facing south. Photo reclamation over the battery location.

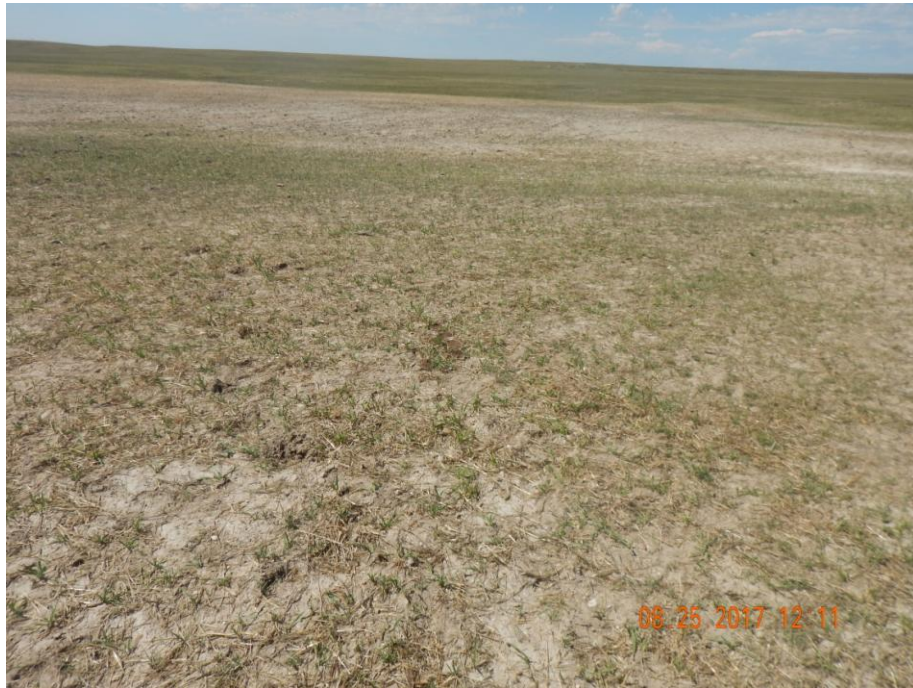
Photo 5: Photo taken from within the drainage, facing west. Photo shows erosion has been repaired, areas had been seeded with an oat grass species, and straw crimped to stabilize the site.

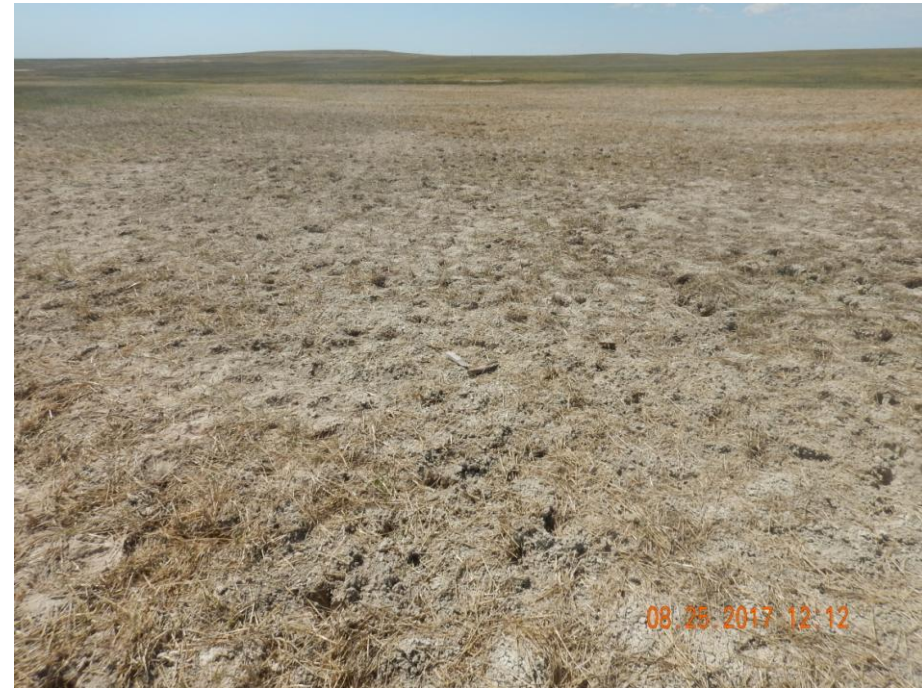
Photo 6: Photo taken within the drainage. Photo shows erosion has been repaired, areas had been seeded with an oat grass species, and straw crimped to stabilize the site. Photo shows areas of the drainage where vegetation does not appear to have germinated and established. These areas may require additional remediation.

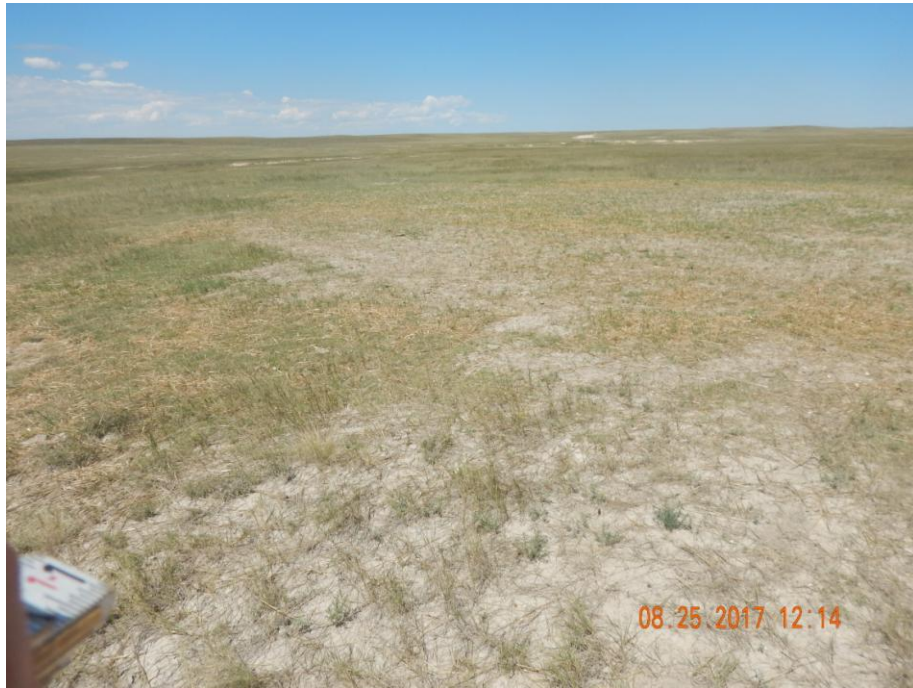
Photo 5: Photo taken the south end of the well location, facing north. Photo shows areas had been seeded with an oat grass species, and straw crimped to stabilize the site.

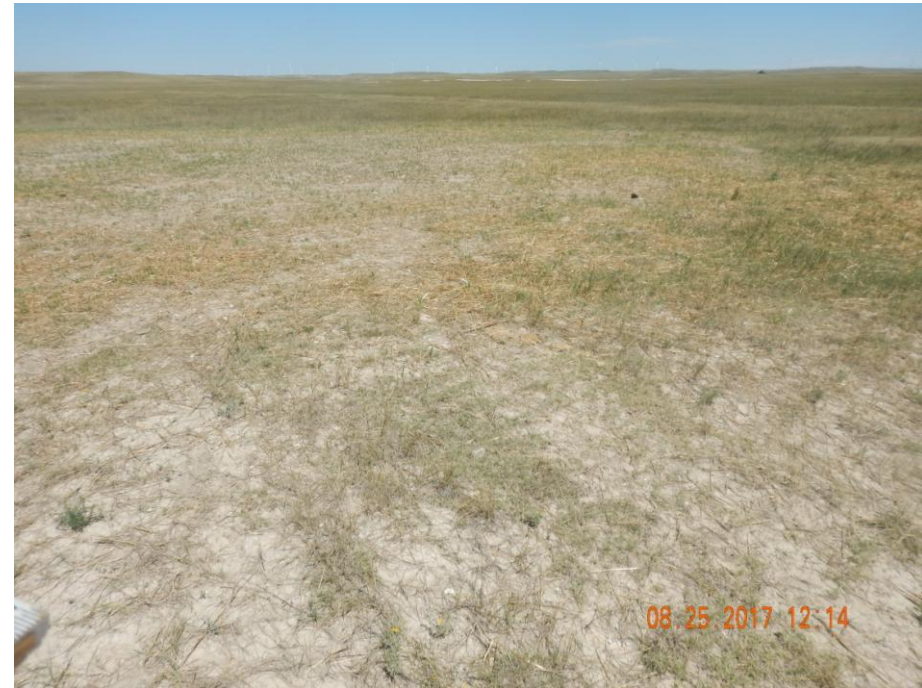
Photo 6: Photo taken the south end of the well location, facing northeast. Photo shows areas had been seeded with an oat grass species, and straw crimped to stabilize the site.
