Inspection Photos
Location Name: XTO Burkett #1-3
API: 05-067-06464

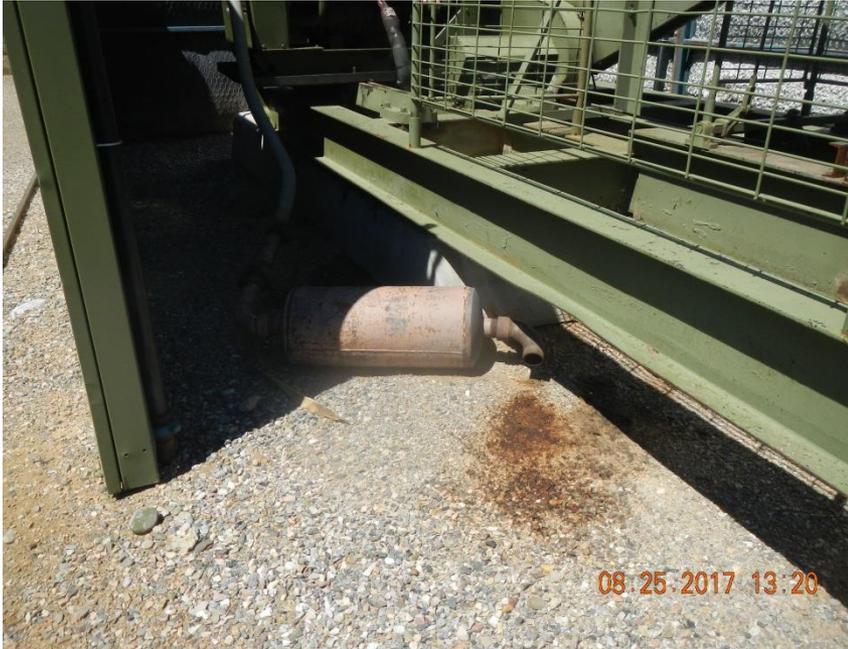
Stained soil beneath prime mover exhaust.

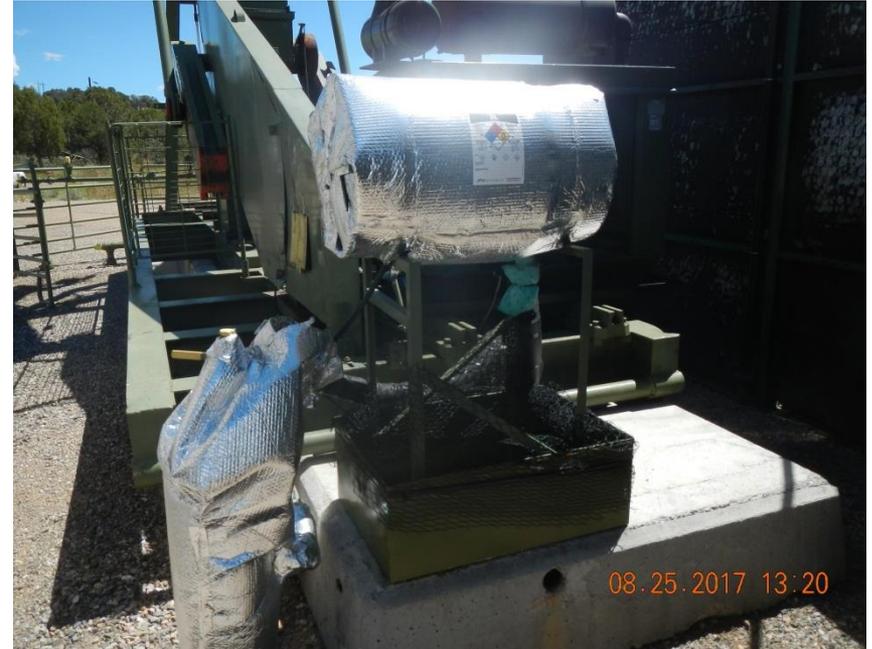
Secondary containment for lube oil container.

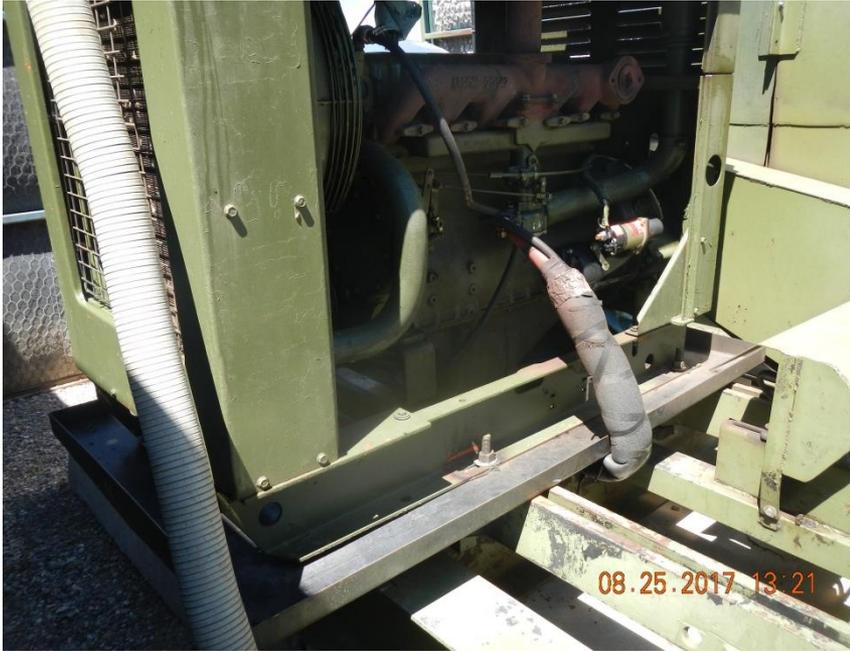
Drip pan for prime mover engine.

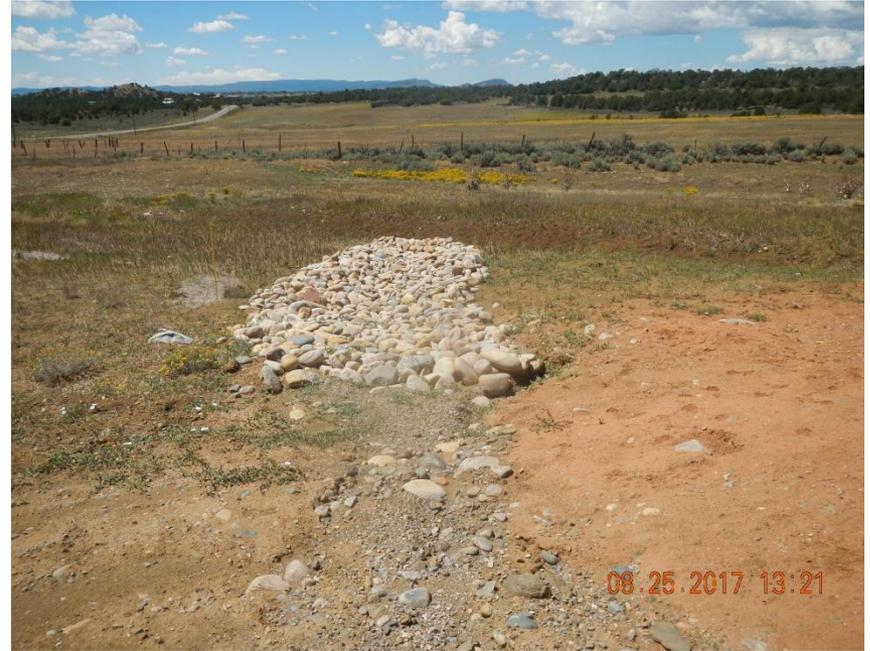
Location BMP.
