Inspection Photos  
Location Name: Allard 30-8-5  
API: 05-057-06124

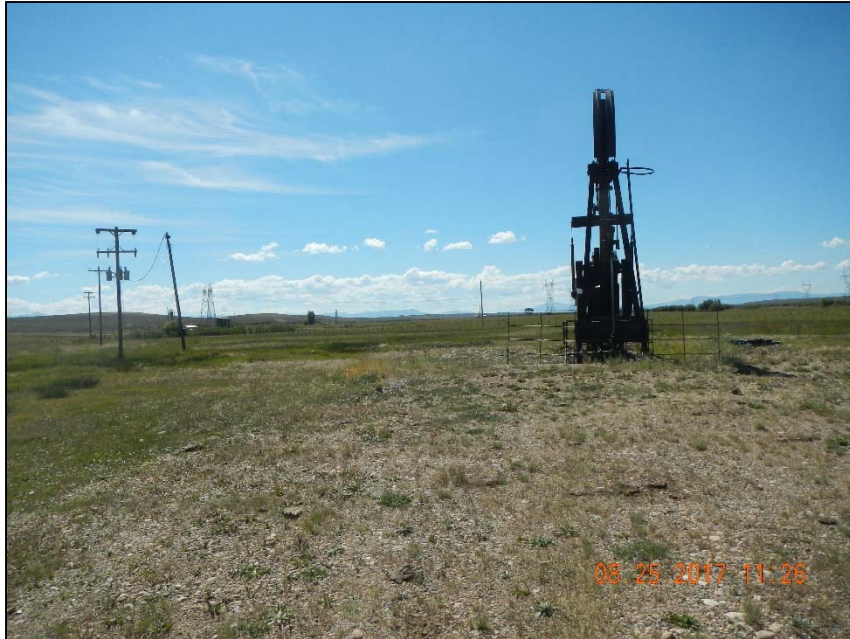
**Photo 1. Overview of wellhead portion of location taken at the entrance facing south.**

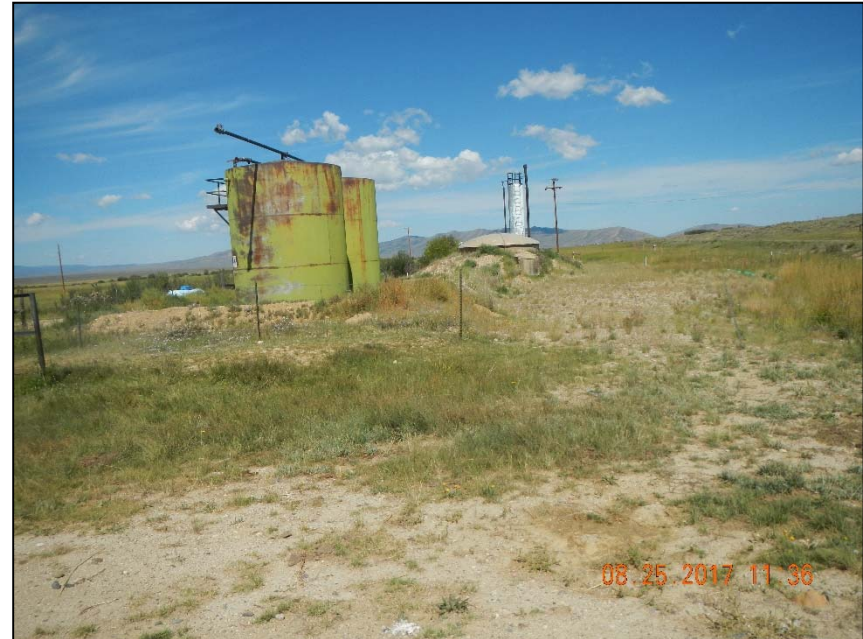
**Photo 2. Overview of battery portion of location taken at the entrance facing north.**

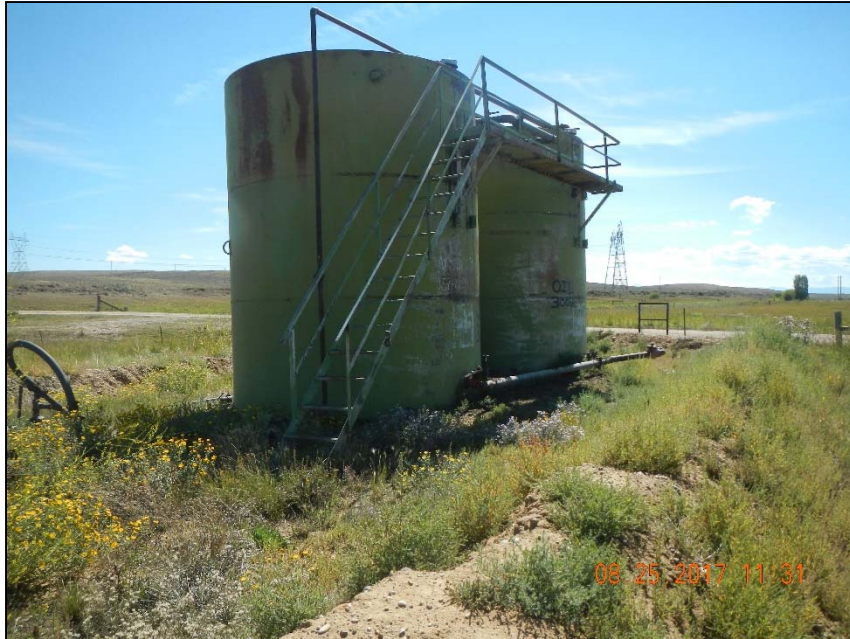
**Photo 3. Weeds and vegetation in tank berm.**

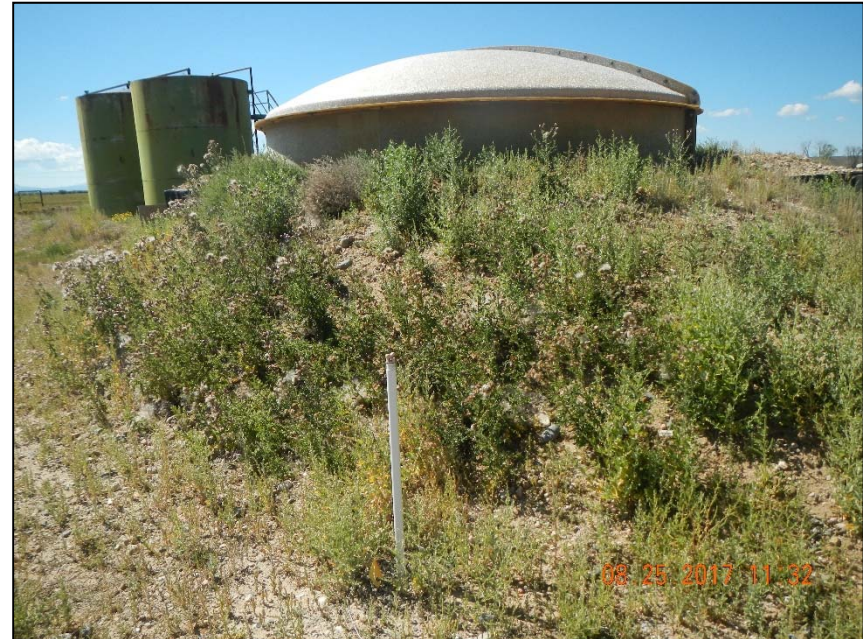
**Photo 4. Fiberglass tank with no berm.**

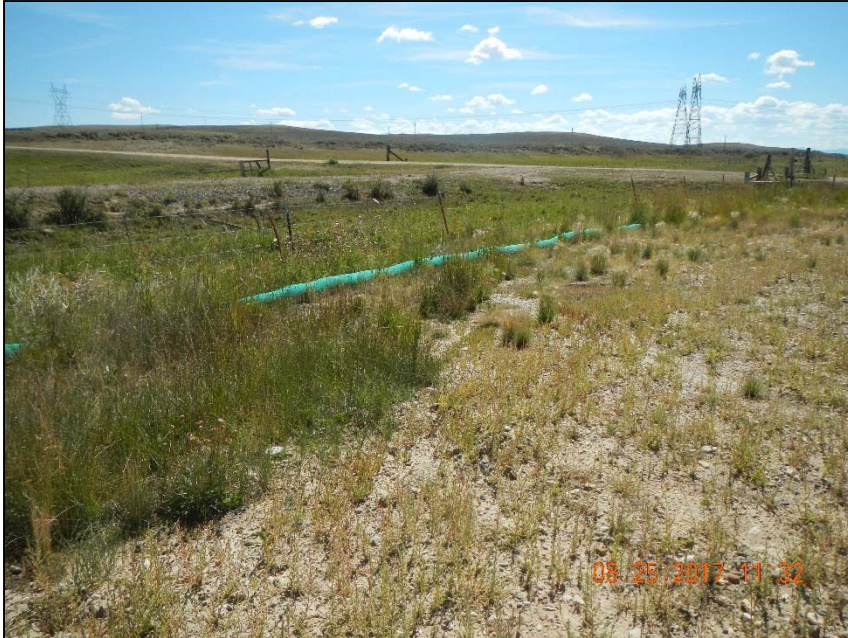
**Photo 5. Inadequate stormwater BMP and maintenance.**
