Inspection Photos
Location Name: XTO Huber Lewis #2-33
API: 05-067-07794

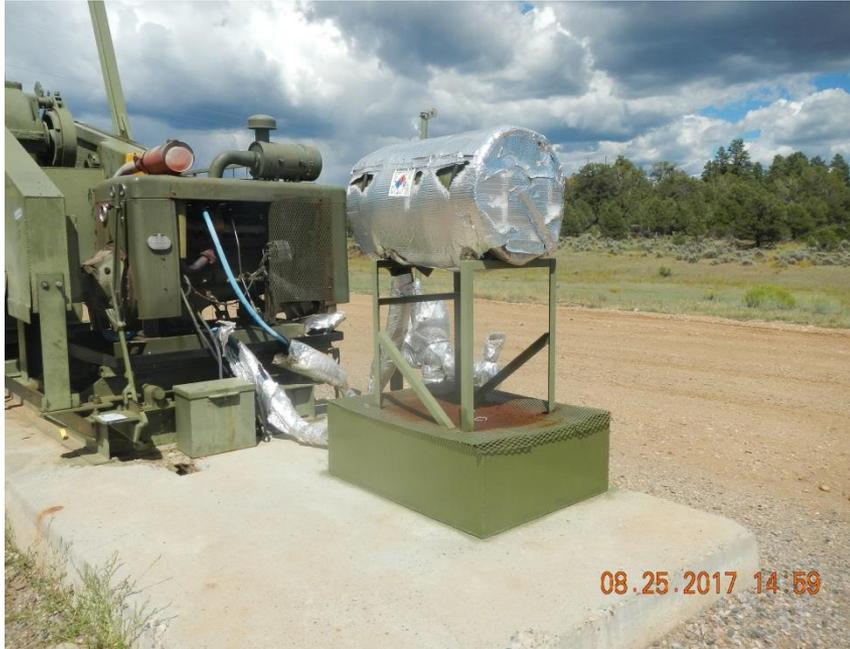
Lube oil container with secondary containment.

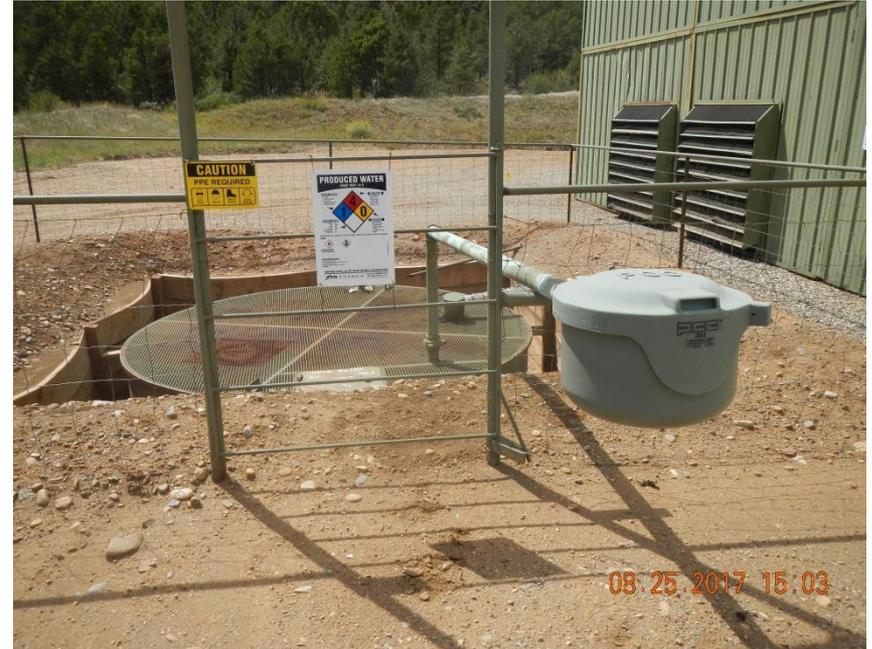
Drip pot on load out line.

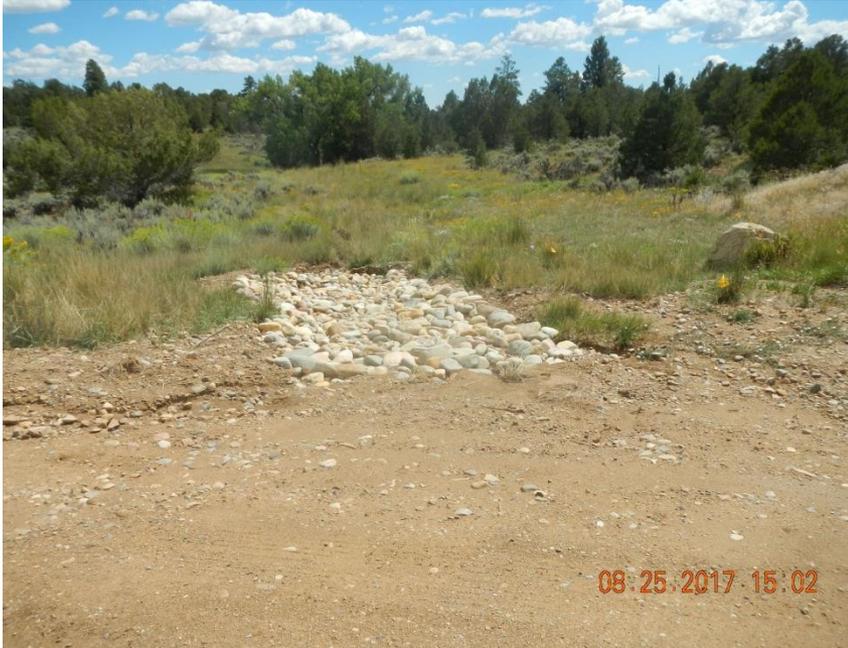
Location BMP.

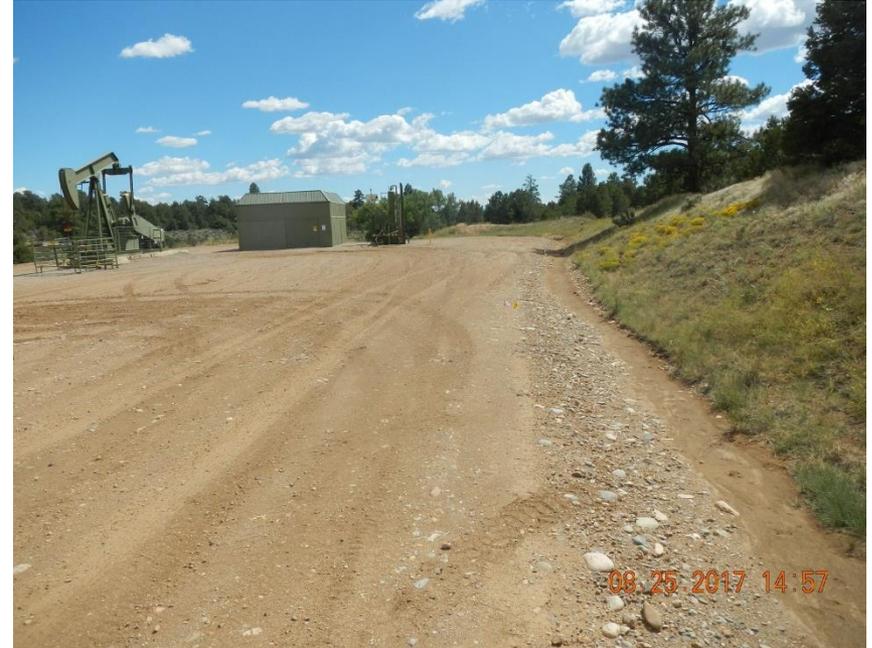
Run on diversion ditch.
