Inspection Photos
Location Name: Alex Miller #1
API: 05-123-08976

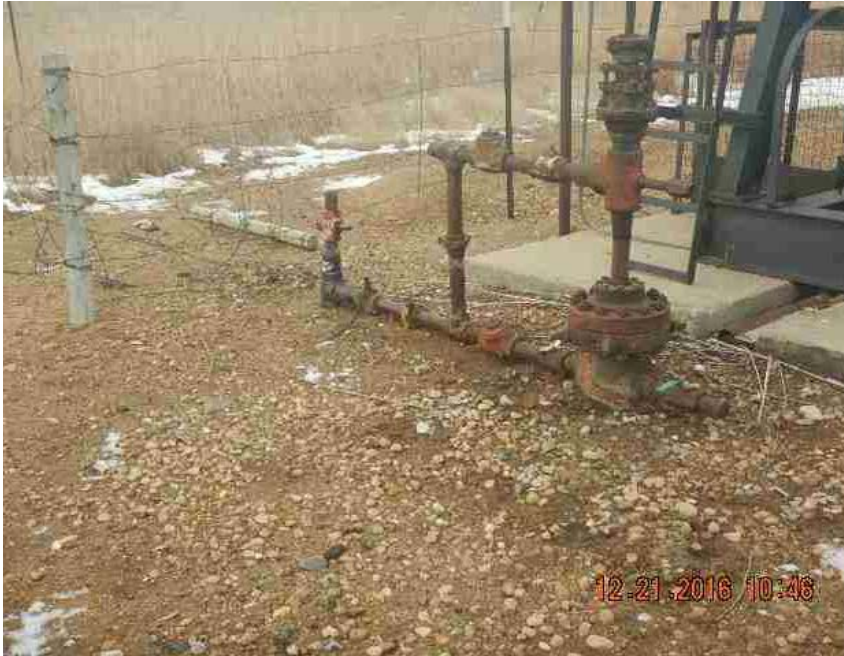
Photo from prior inspection for comparison

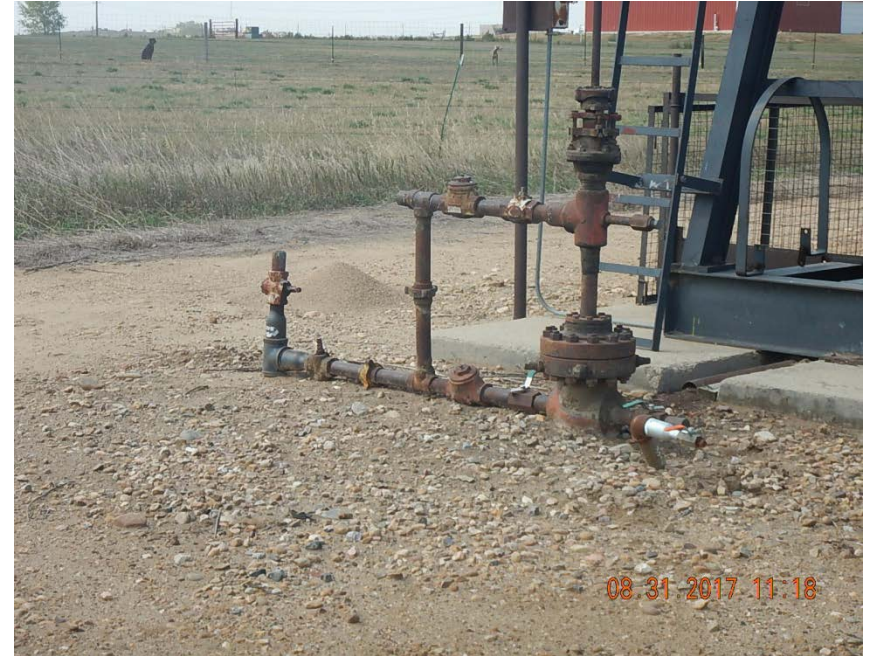
Photo 1: Fence removed, bradenhead plumbed to surface.

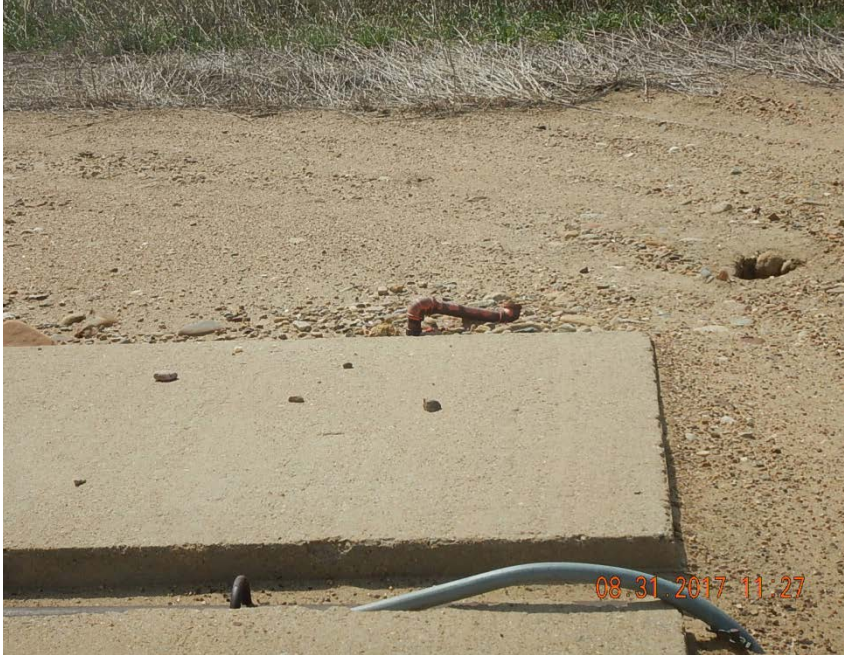
Photo 2: Marked riser at SE corner
