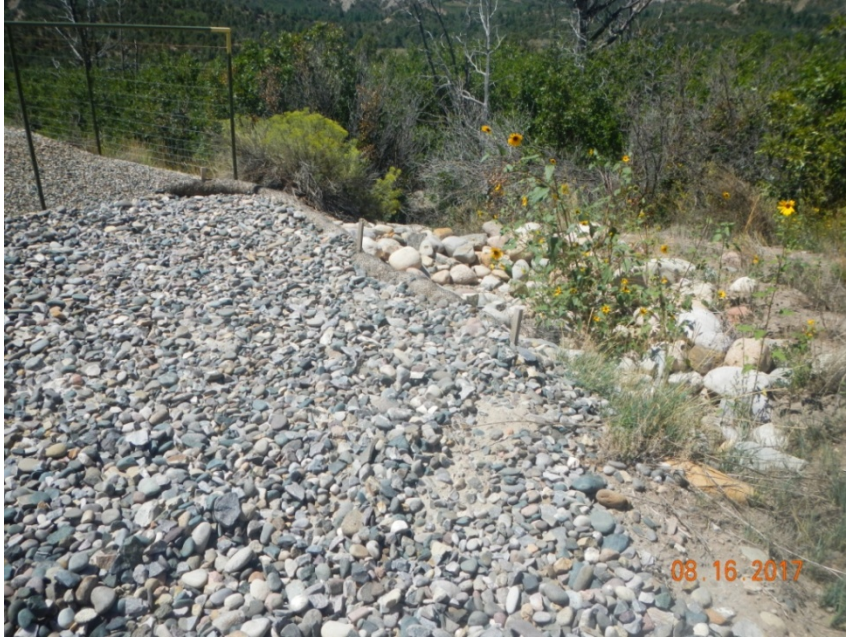
**Photo 1: View of area documented in previous inspection with erosive channel, that is armored and stabilized at this time.**

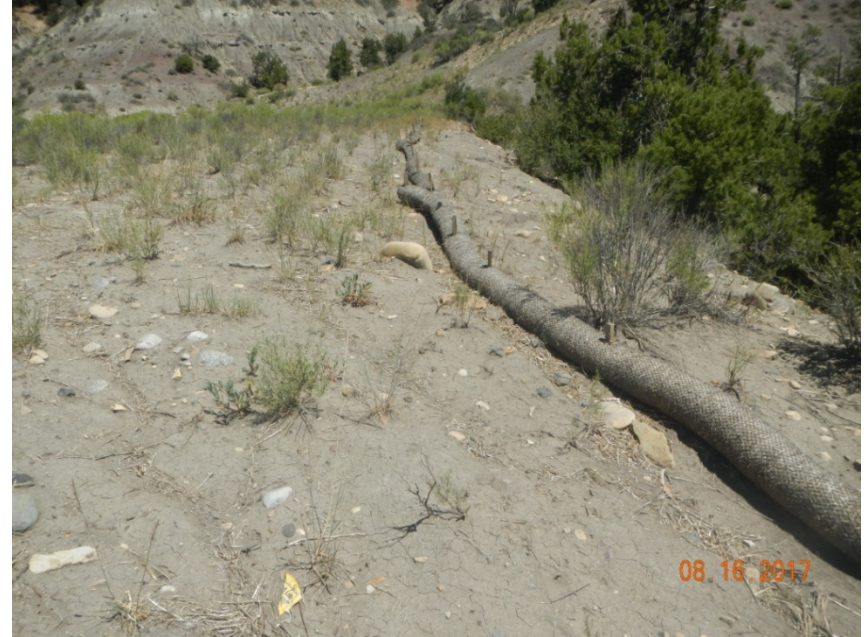
**Photo 2: View of straw wattles placed along the eastern edge of the well pad, appear to be functioning at this time.**

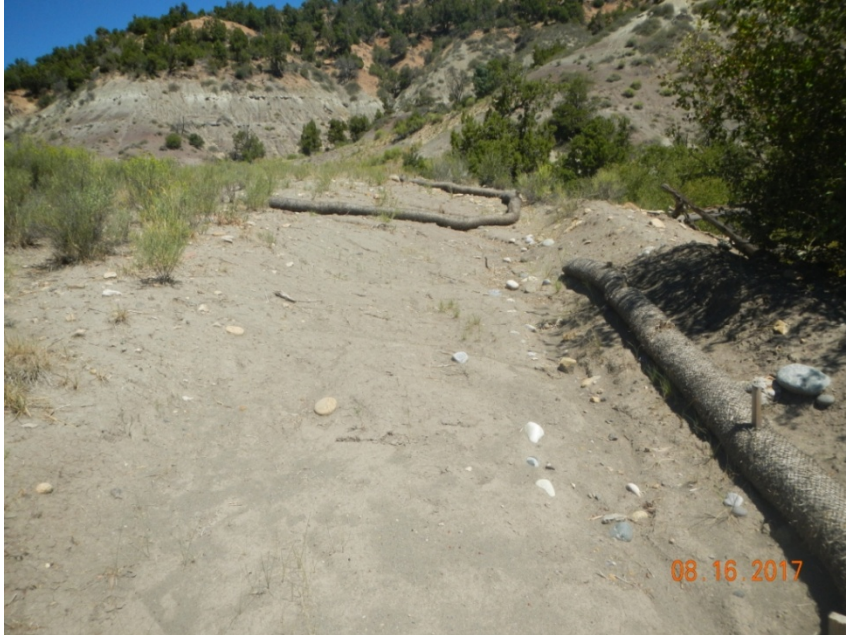
**Photo 3: View of wattles where stormwater flows down the southeastern portion of the project area.**

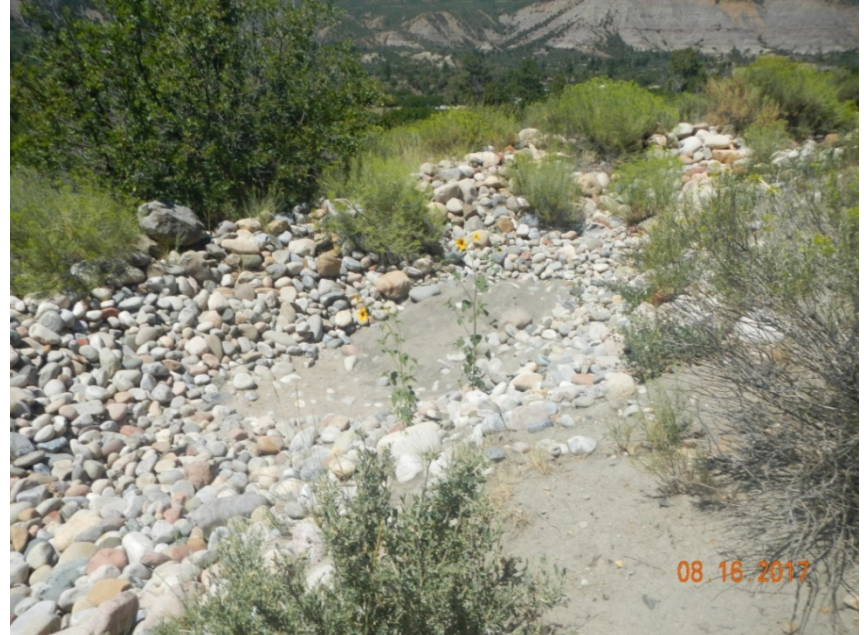
**Photo 4: View of cobble-armored silt trap in the southern portion of the project area.**

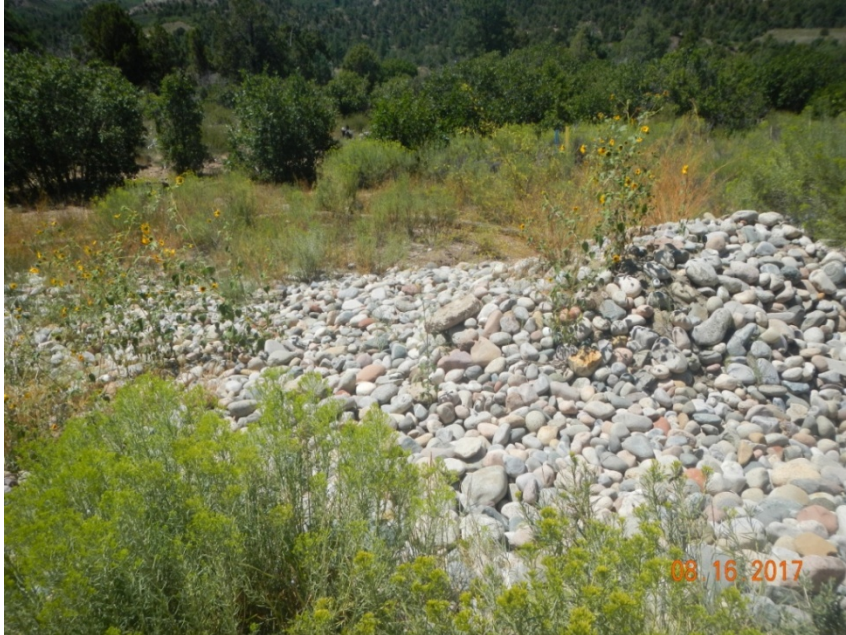
**Photo 5: View of newly armored cobble-overflow channel in silt trap in the southern portion of the project area.**
