Inspection Photos
Location Name: Resler #22-27
API: 05-121-10345
Inspection Date: August 16, 2017

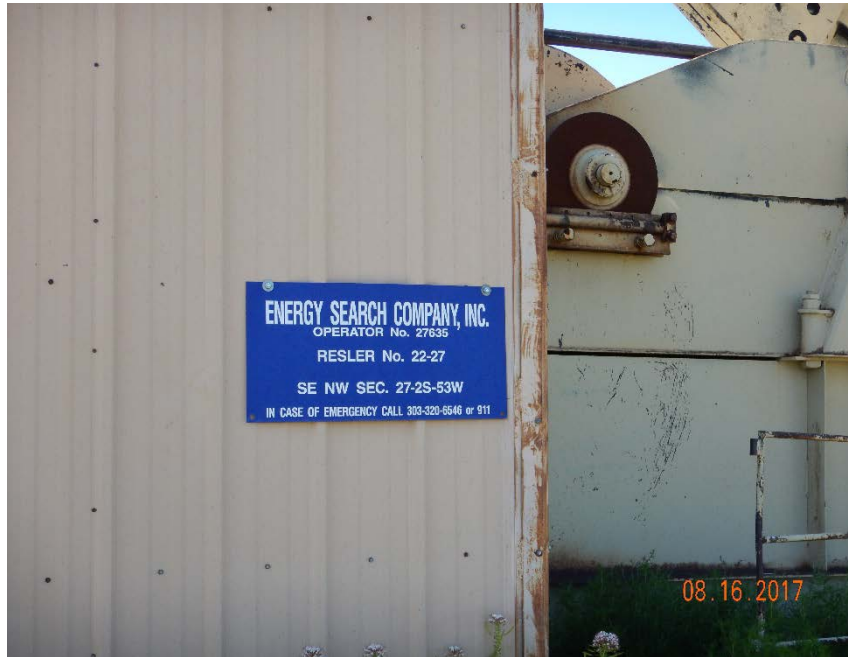
Photo 1 – Well sign attached to shed.

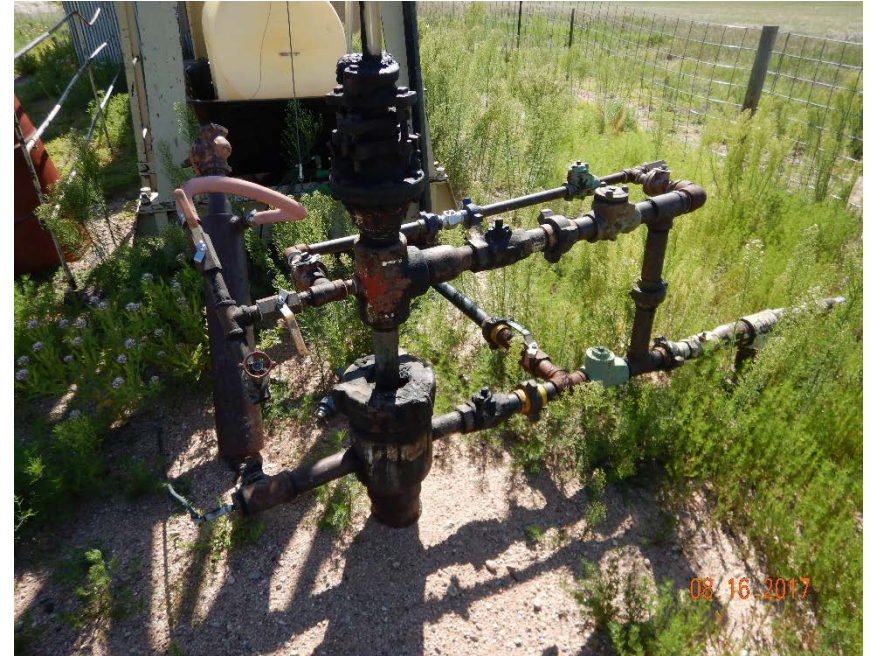
Photo 2 – Wellhead and uncontrolled weeds.

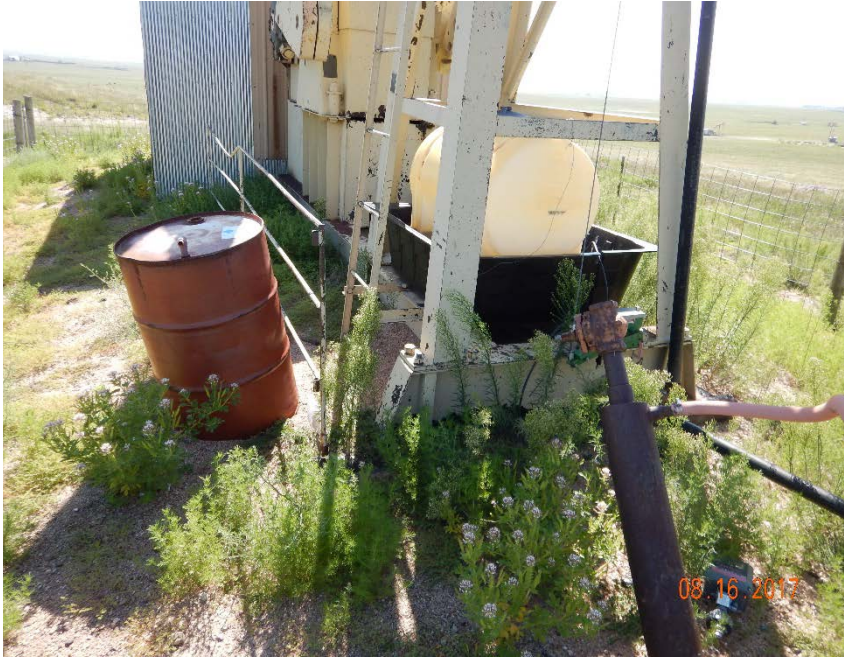
Photo 3 - Unlabeled 55-gallon drum lacking secondary containment and day tank beneath pumping unit with adequate secondary containment.

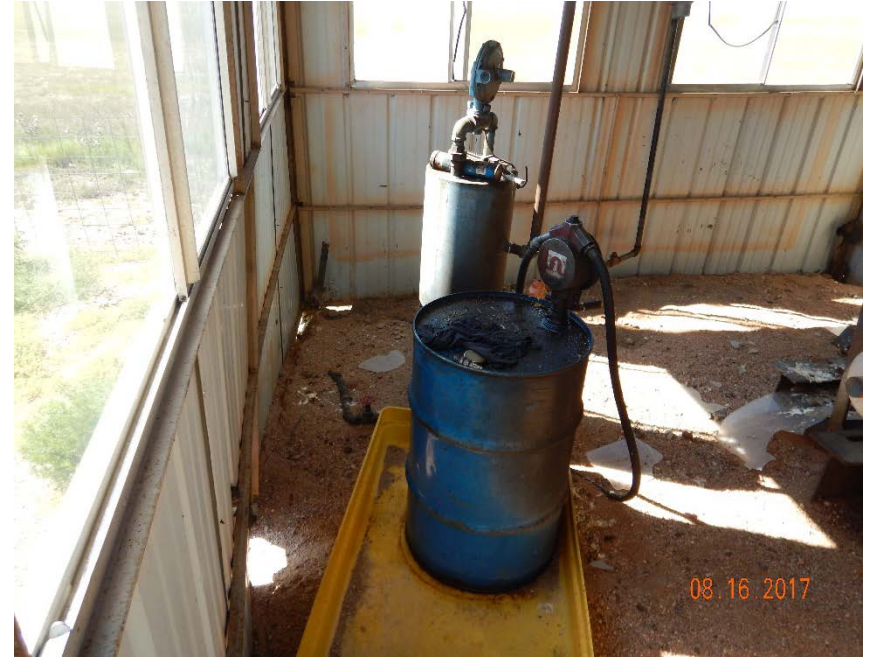
Photo 4 – Storage drum inside of shed with adequate secondary containment. Note: broken glass in background.

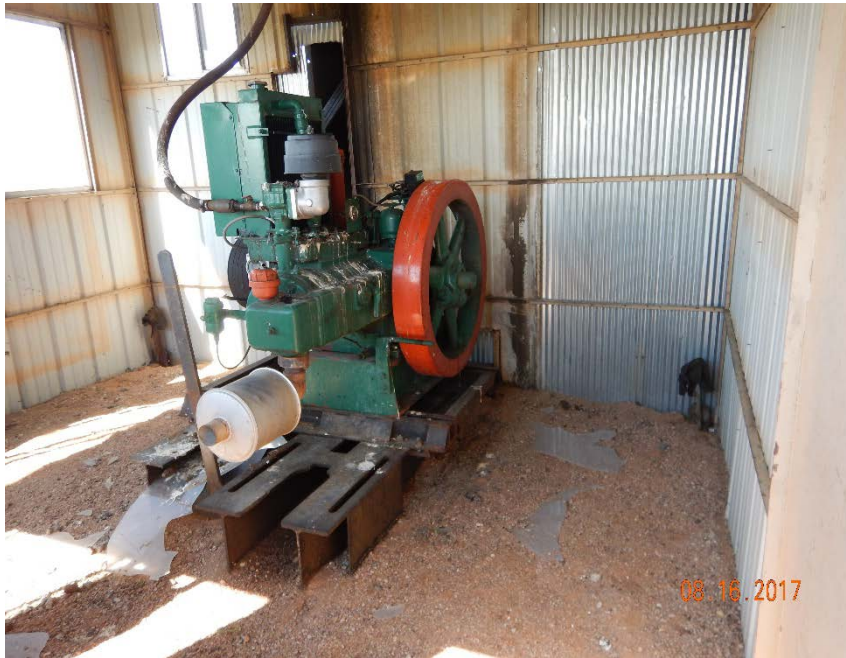
Photo 5 – Prime mover with broken glass inside of shed.

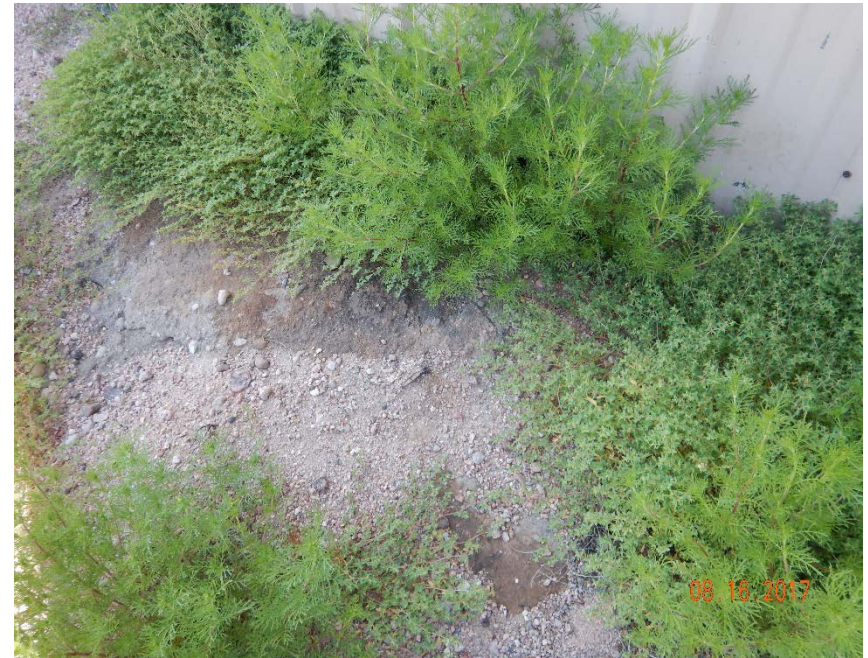
Photo 6 – Historical accumulation of asphaltic material outside of pump jack shed (1).

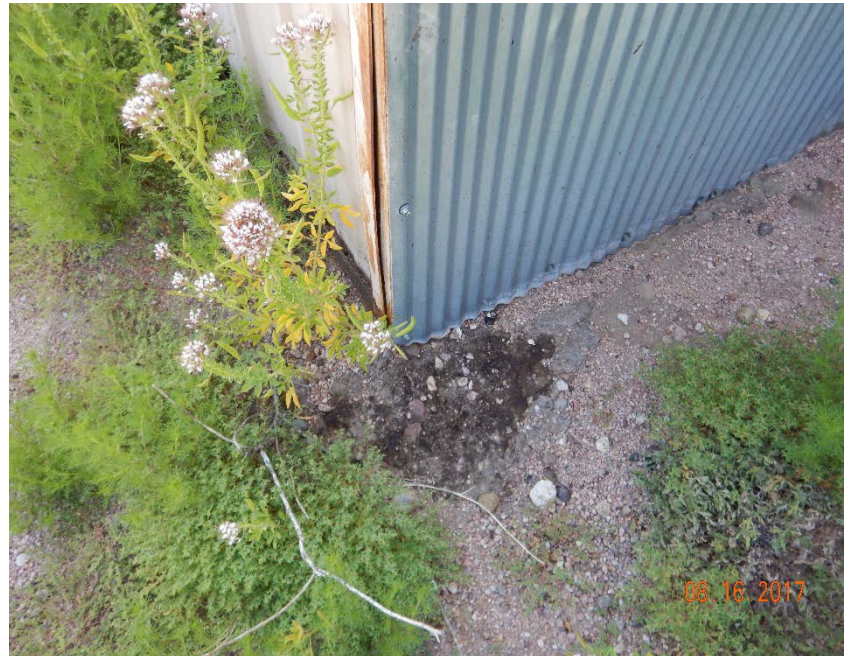
**Photo 7 - Historical accumulation of asphaltic material
outside of pump jack shed (2).**
