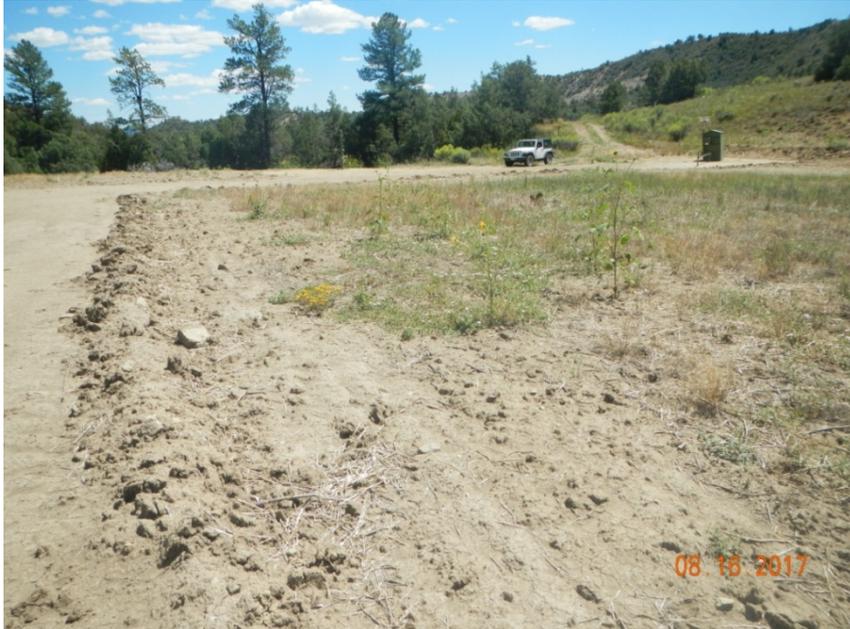
Photo 1: View of the project area from the western edge facing south eastward. Revegetation was recently conducted in portions of the interim reclamation area.

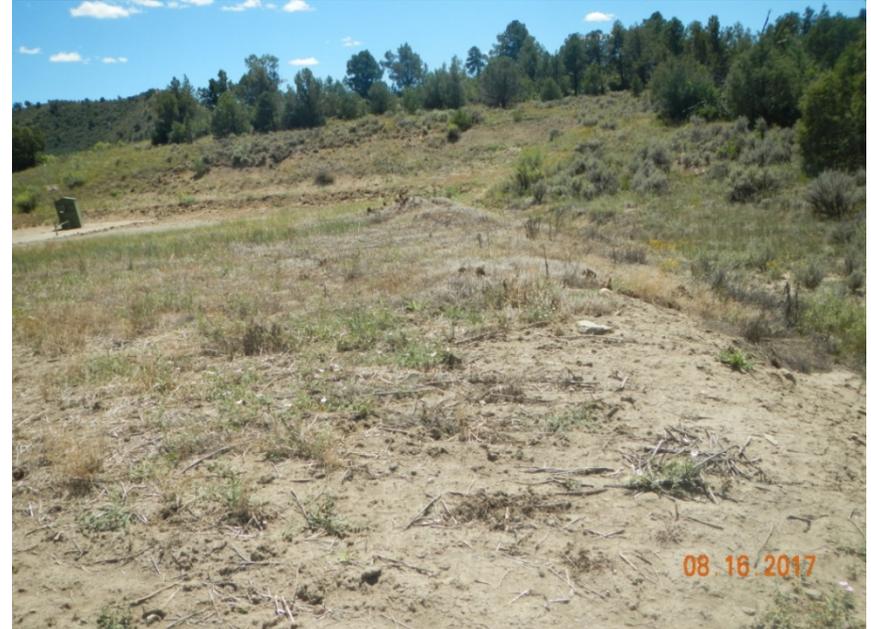
Photo 2: View of the southwestern portion of the project area from the western edge facing southward.

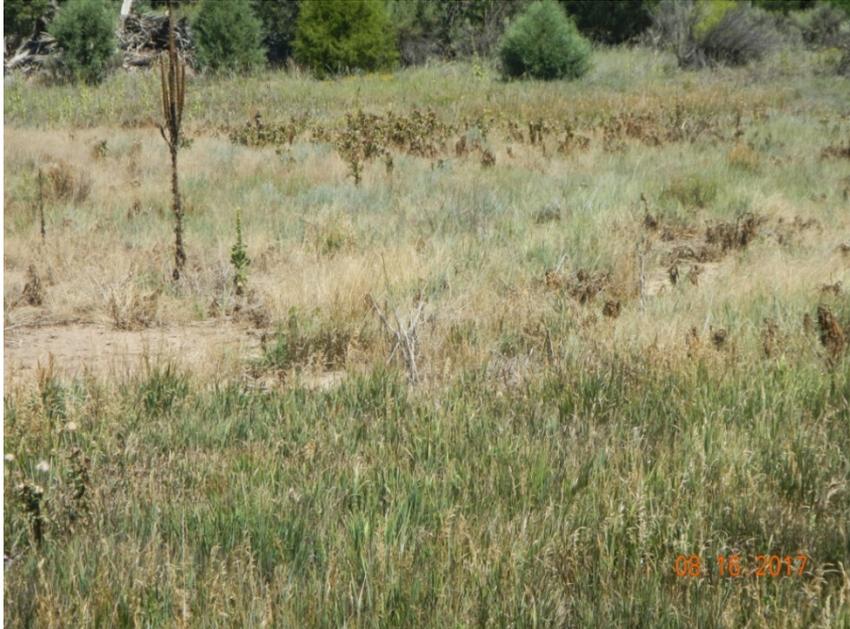
Photo 3: View of musk thistles (*Carduus nutans*) in the eastern portion of the project area that appear to have been treated. As many are in seed, subsequent treatments will be needed.

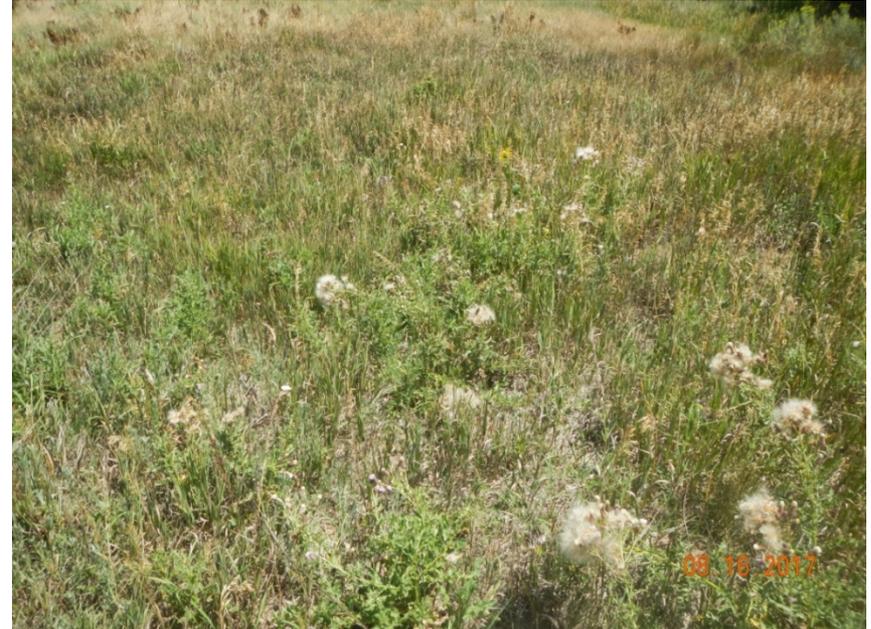
Photo 4: View of Canada thistles (*Cirsium arvense*) within the project area.
