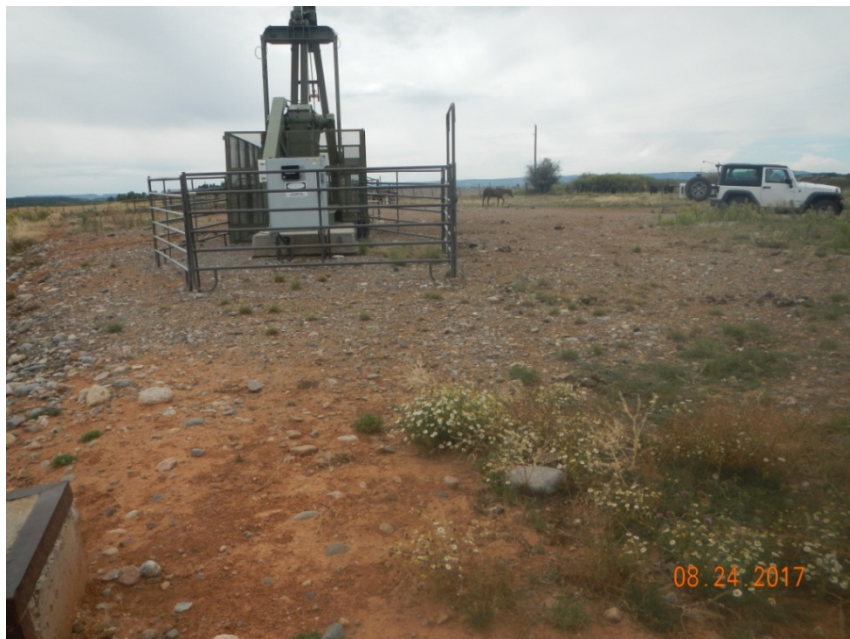
Photo 1: View of the project area from the southeastern corner facing center.

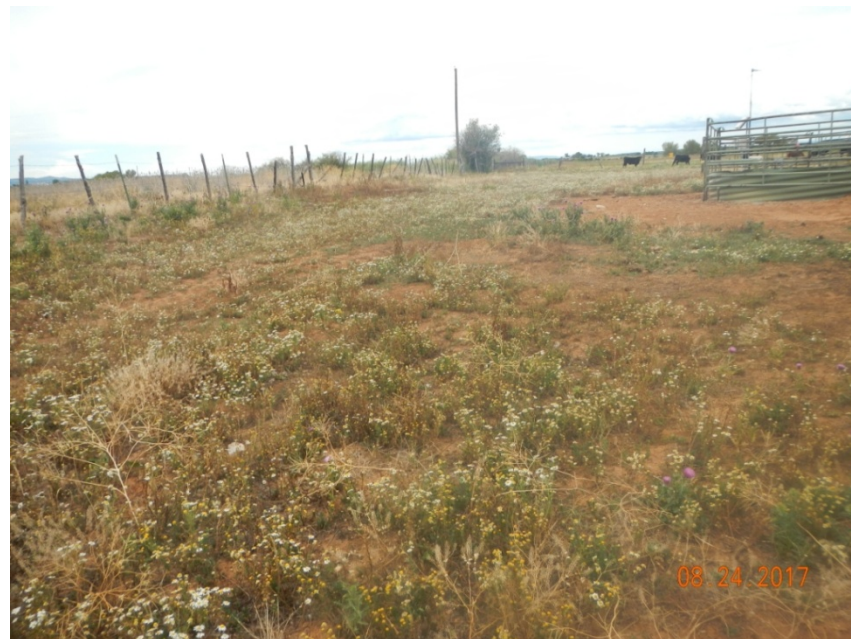
Photo 2: View of the southern portion of the project area from the southeastern corner facing westward. Revegetation is sparse and appears to be largely comprised of weeds such as chamomile (*Anthemis* sp.)

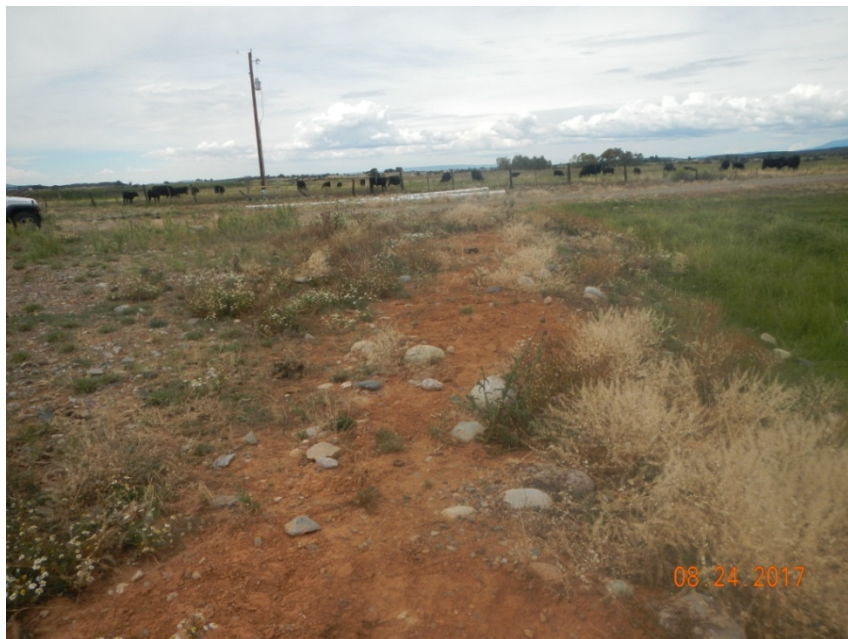
Photo 3: View of the northern portion of the project area from the northeastern corner of the well pad facing westward.

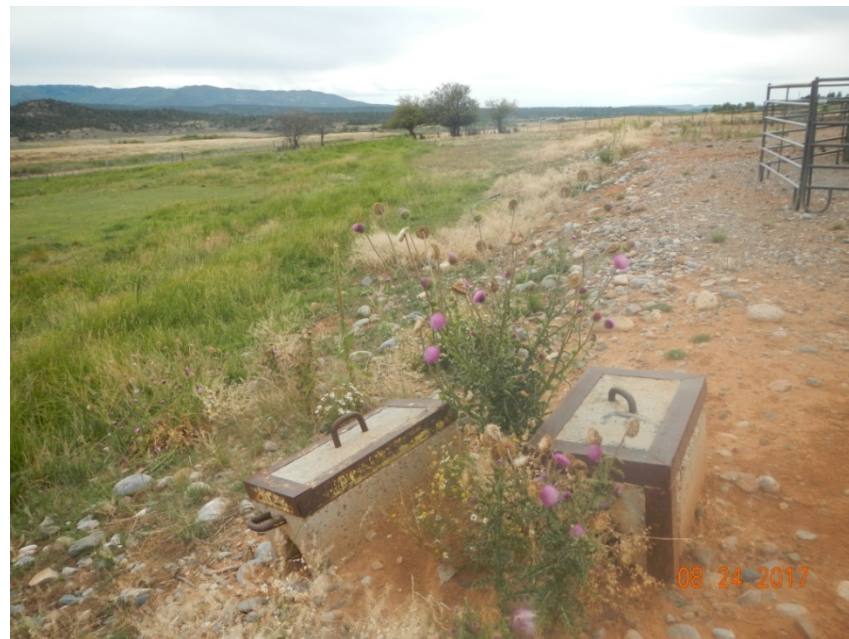
Photo 4: View of the eastern portion of the project area facing southward. Unused anchors in foreground do not appear needed.
