COGCC staff, Kris Neidel Inspected the Bingman #1-14 on 8/9/2017 the weather was cloudy and 80 degs. Upon arrival, it was observed that the road had recently been bladed, it appeared that soil had been added to road. The berms around the production tanks had been increased in size, piece of plastic can be seen incorporated into the berm. There were pieces of plastic, what appeared to be liner material around the location; incorporated in the pad, on the pad, incorporated in the berm, incorporated in the access road, Inspector stopped counting plastic pieces at 26. . The stockpiled material that was a part of Remediation Project number 10272 is no longer piled on location. The well was SI at the time of inspection. Operator should continue to communicate with COGCC staff for plan forward to compliance. and plans set out in Remediation Project.

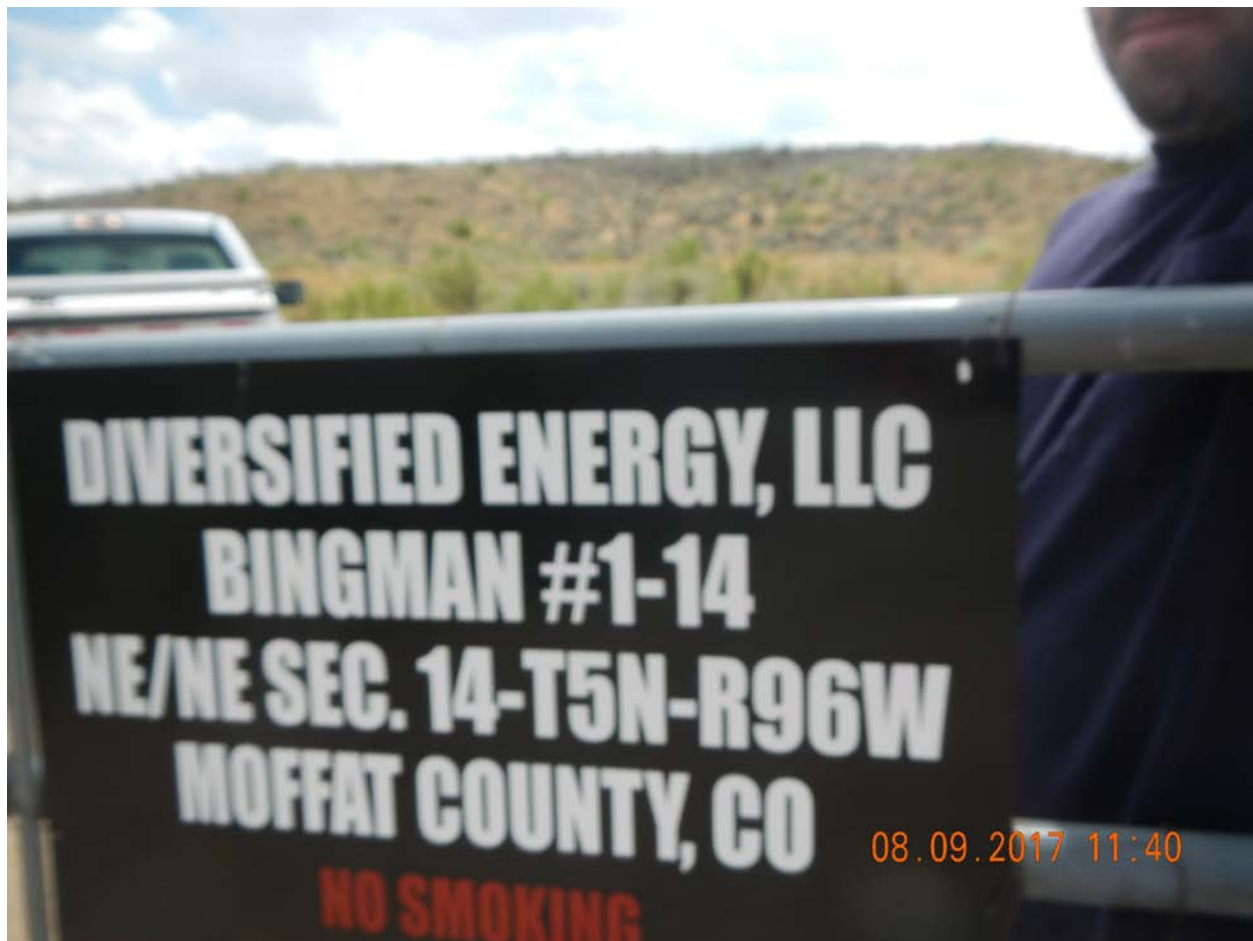
Access sign on gate

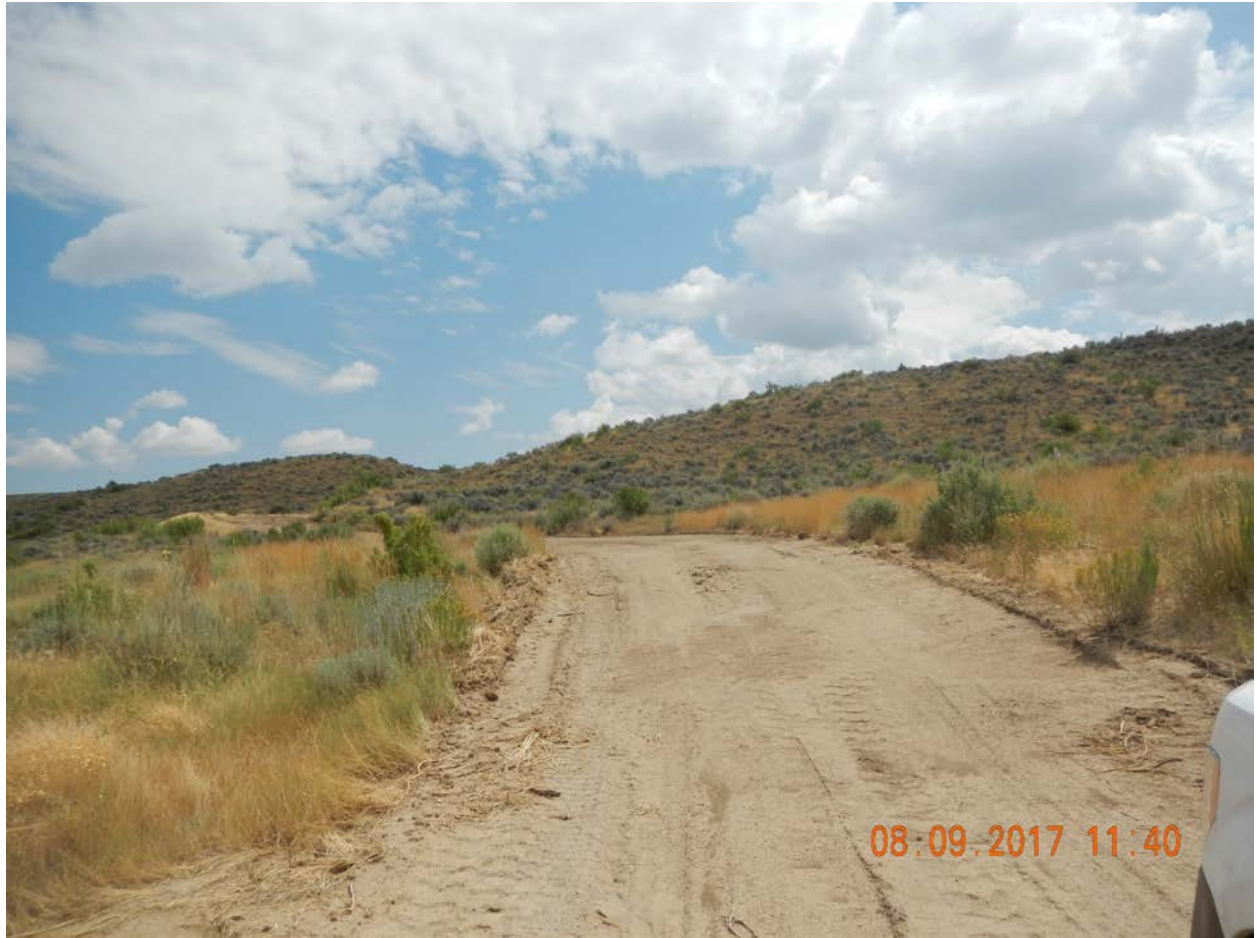
Access road

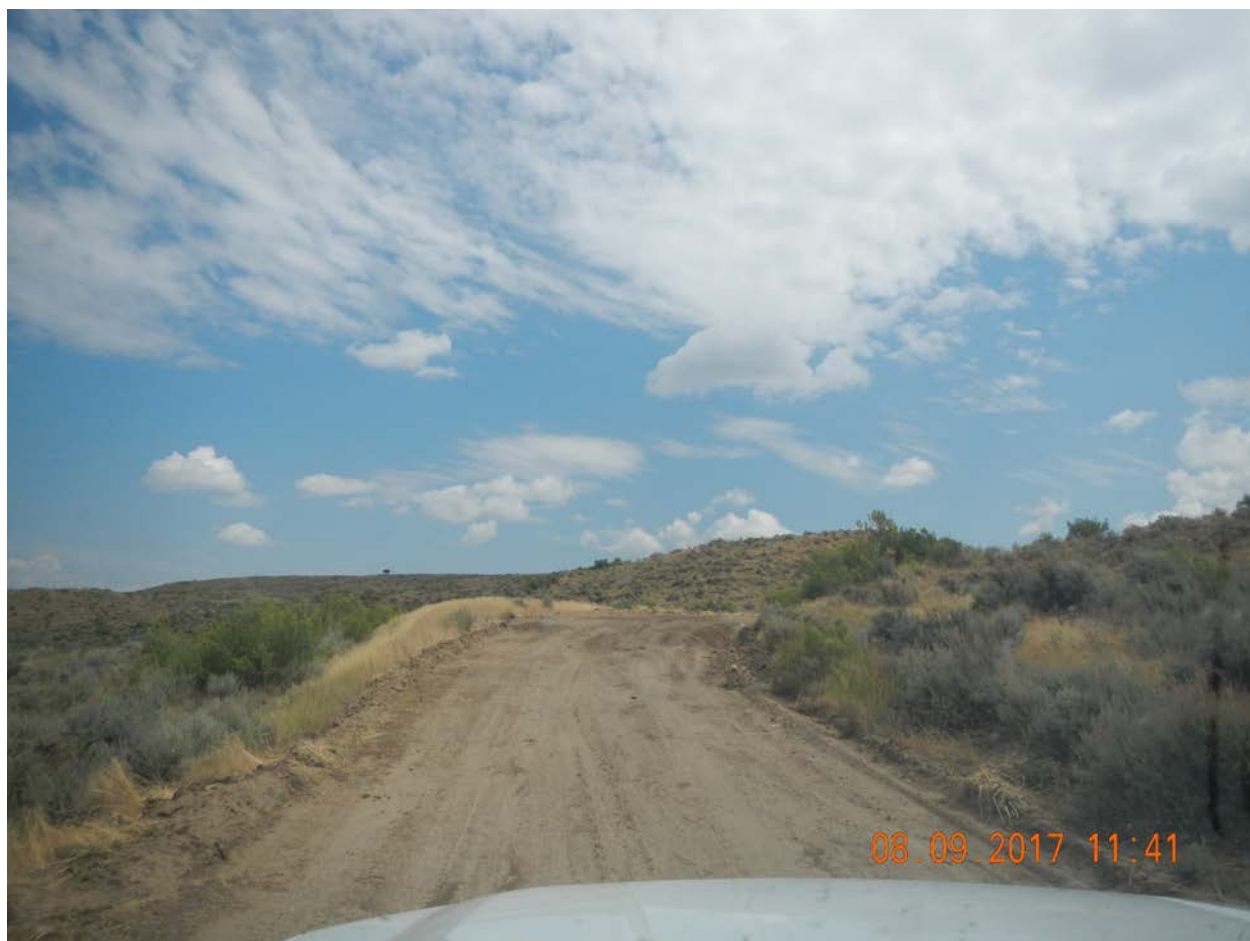
Access road

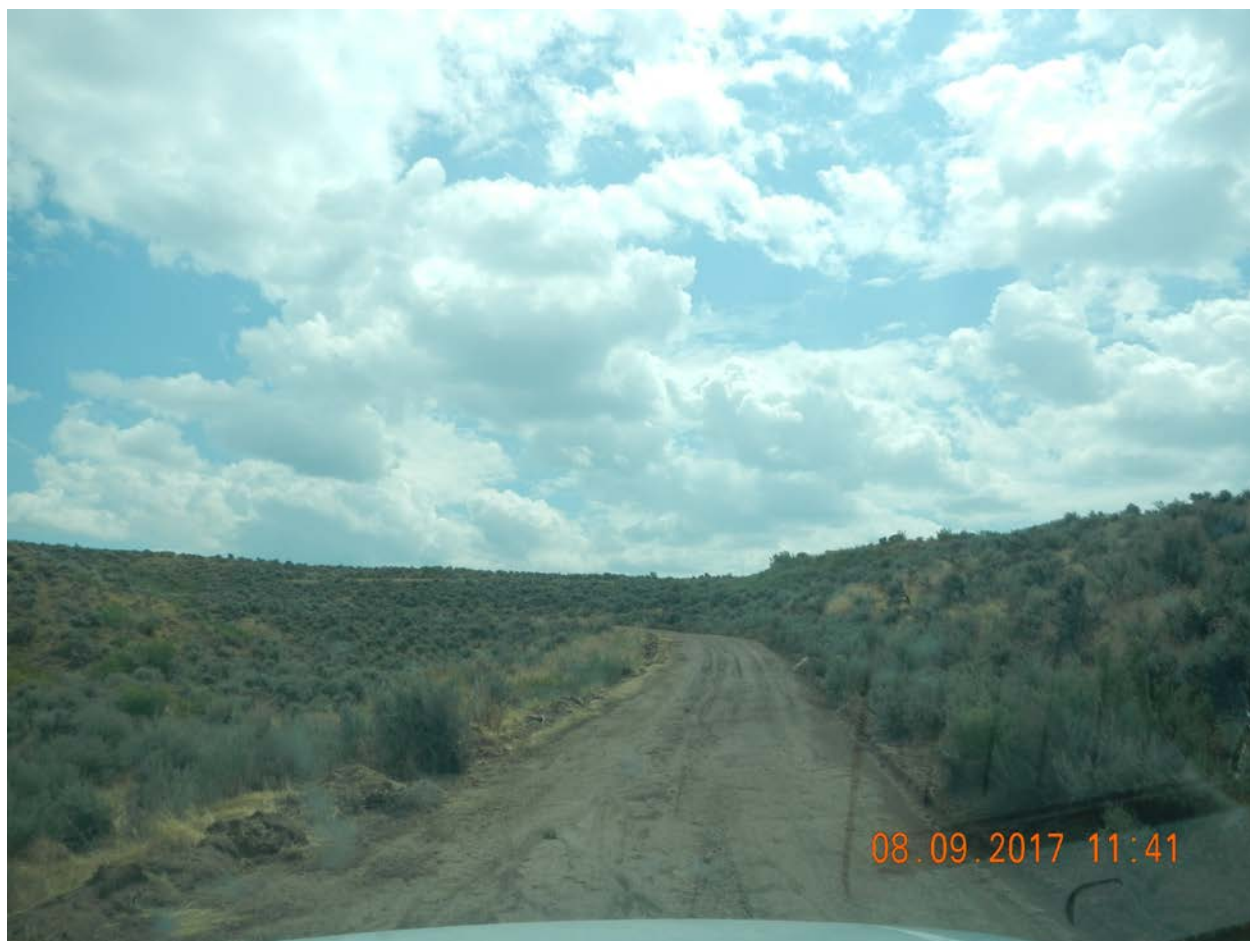
Access road

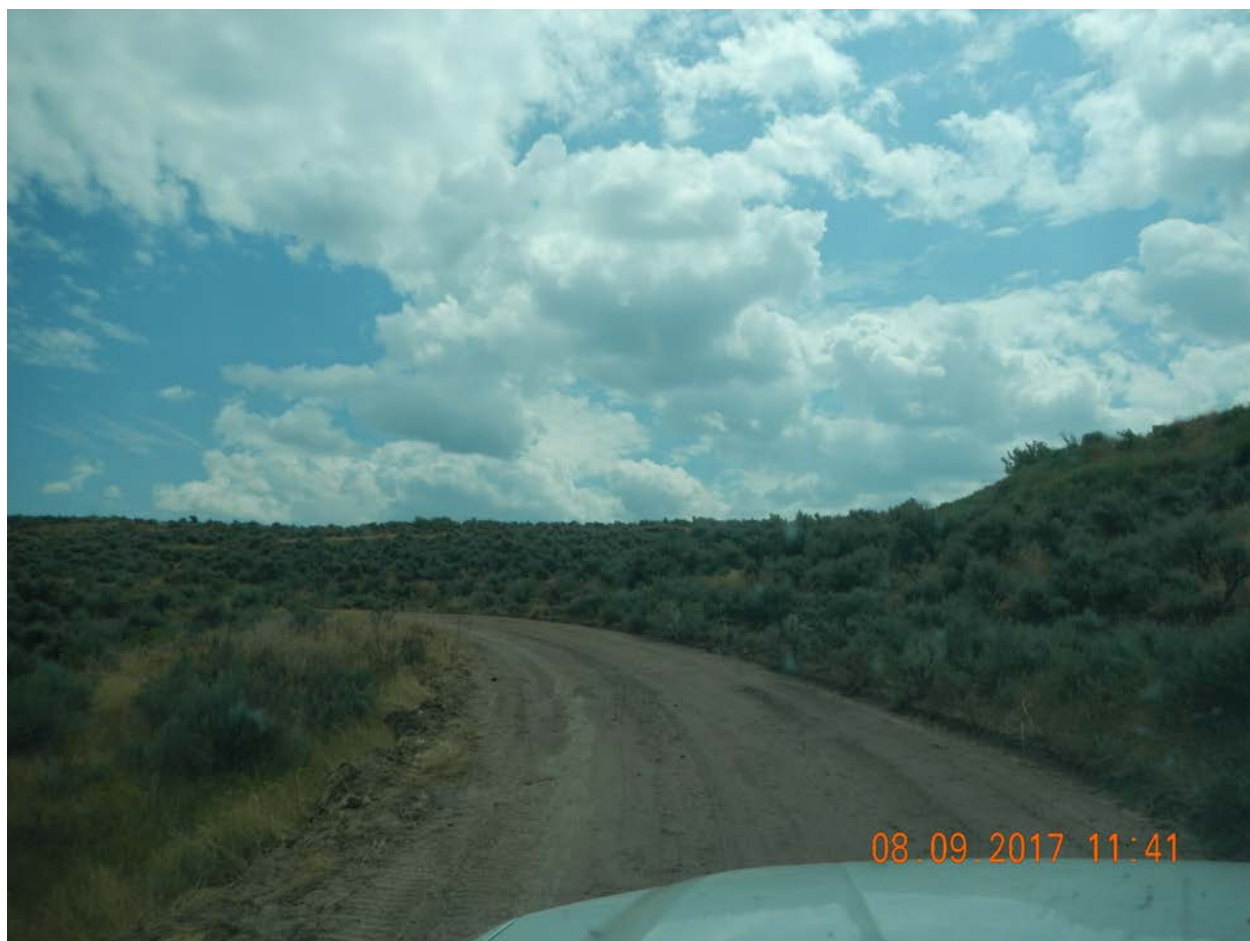
Access road

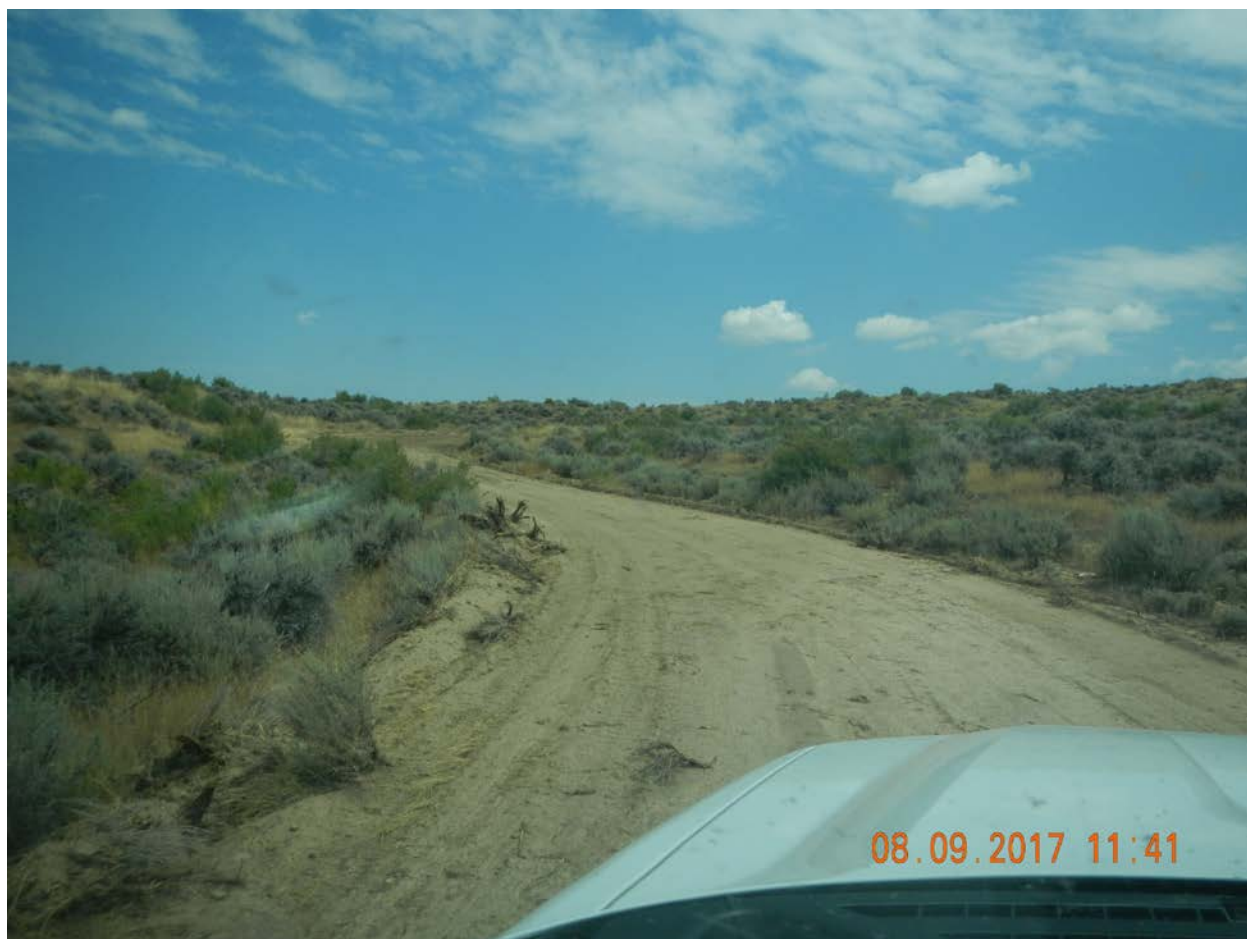
Access road

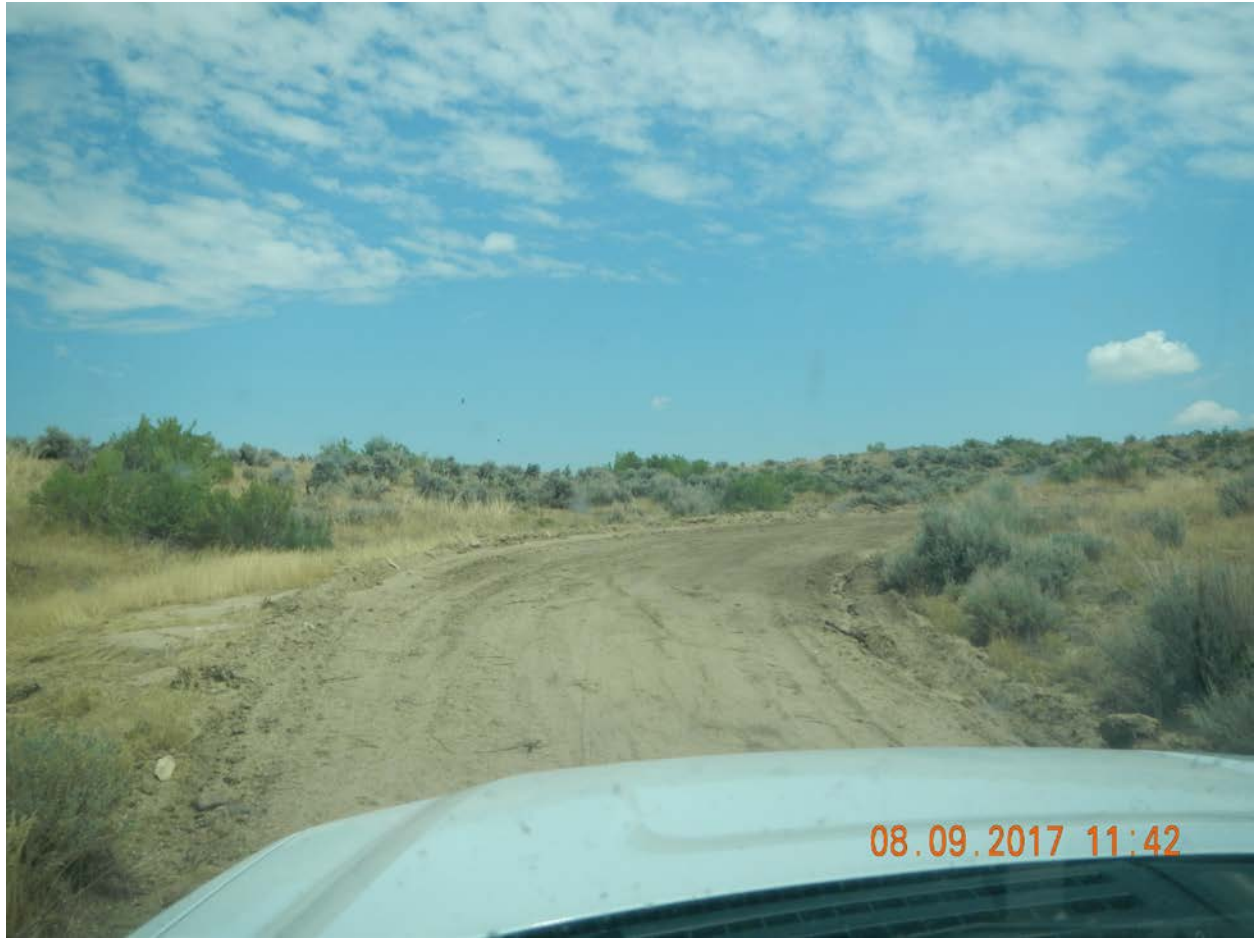
Access road

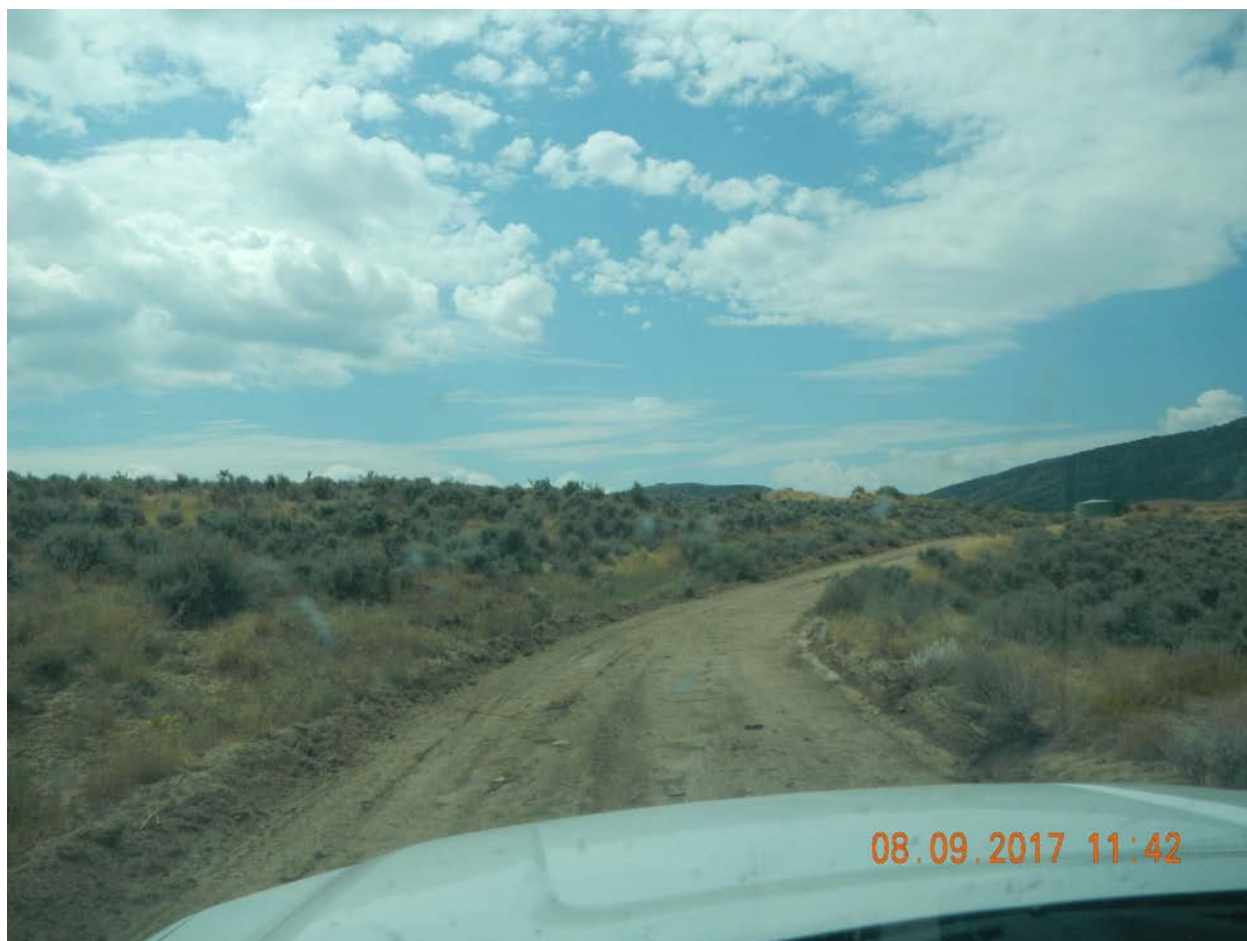
Access road, production tanks in background

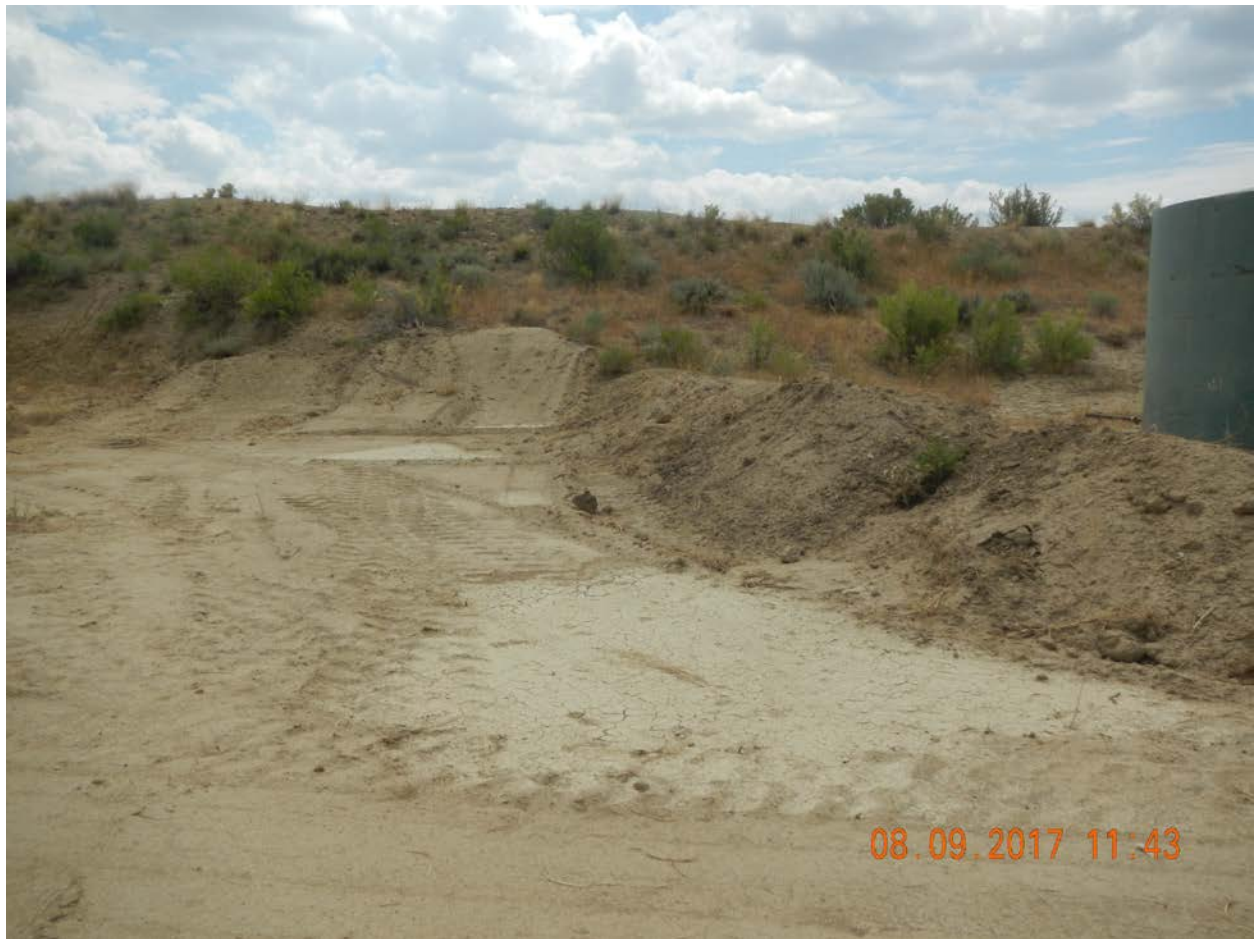
Dirt work on pad

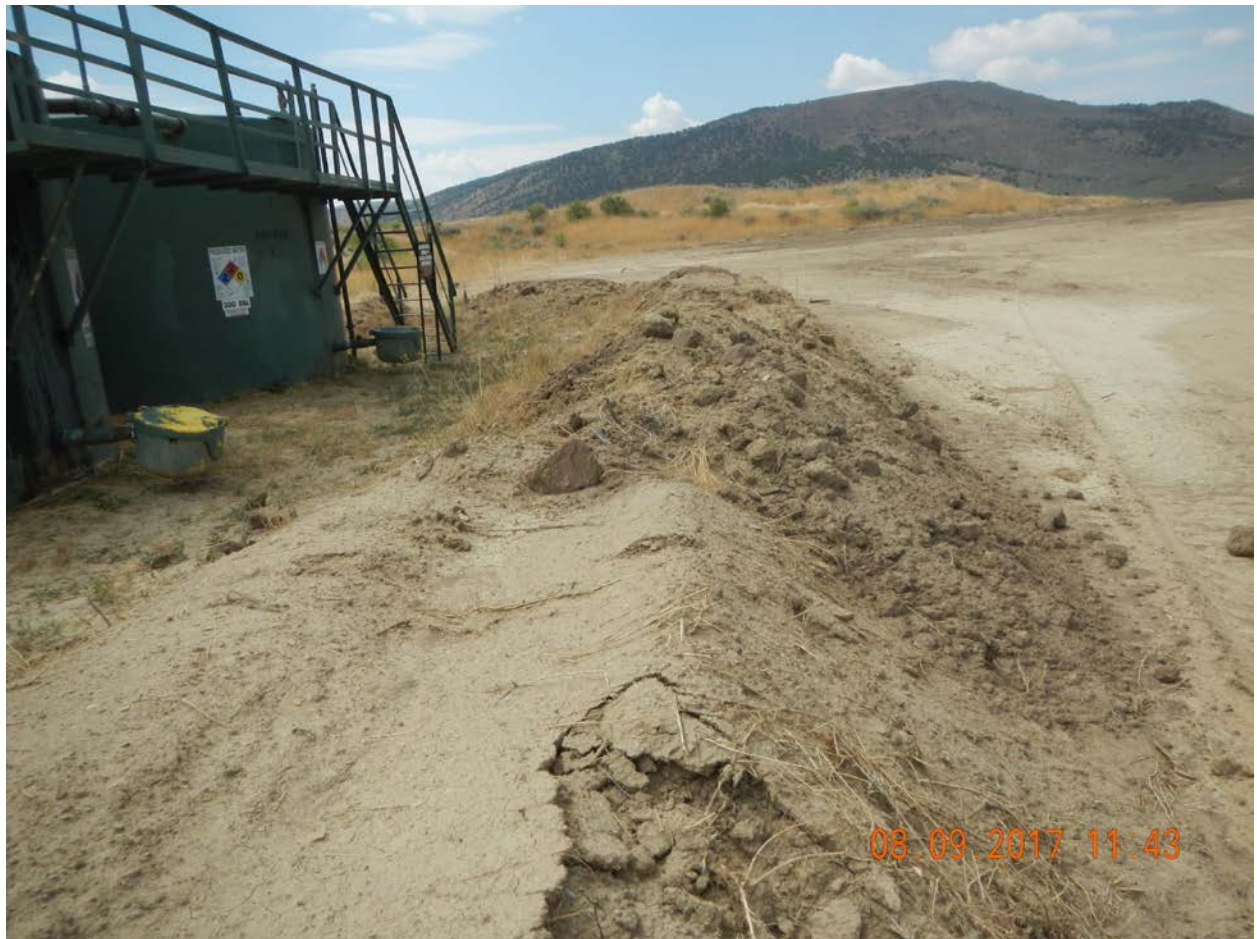
Dirt work on pad

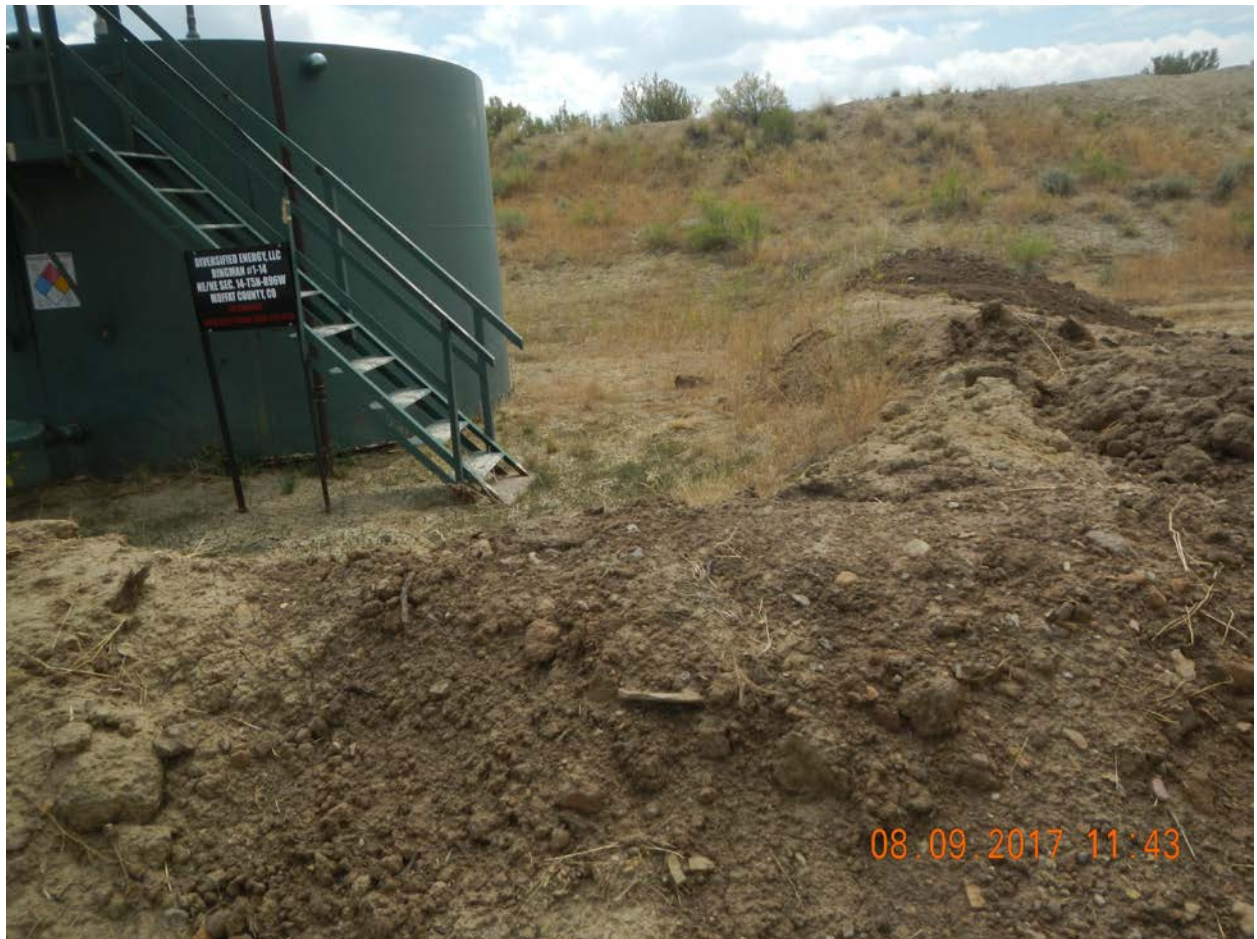
Increased berms

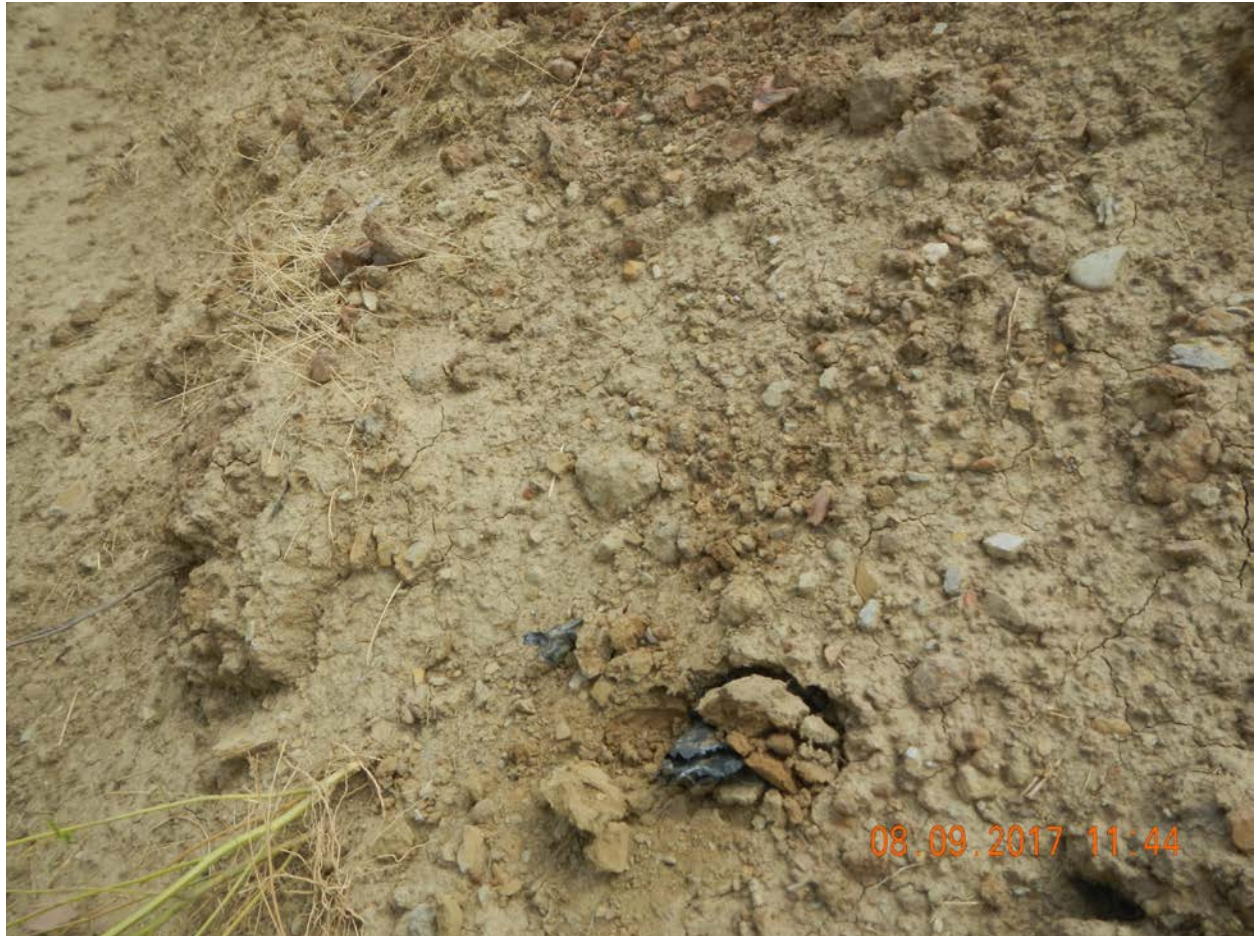
Increased berms, plastic in berms

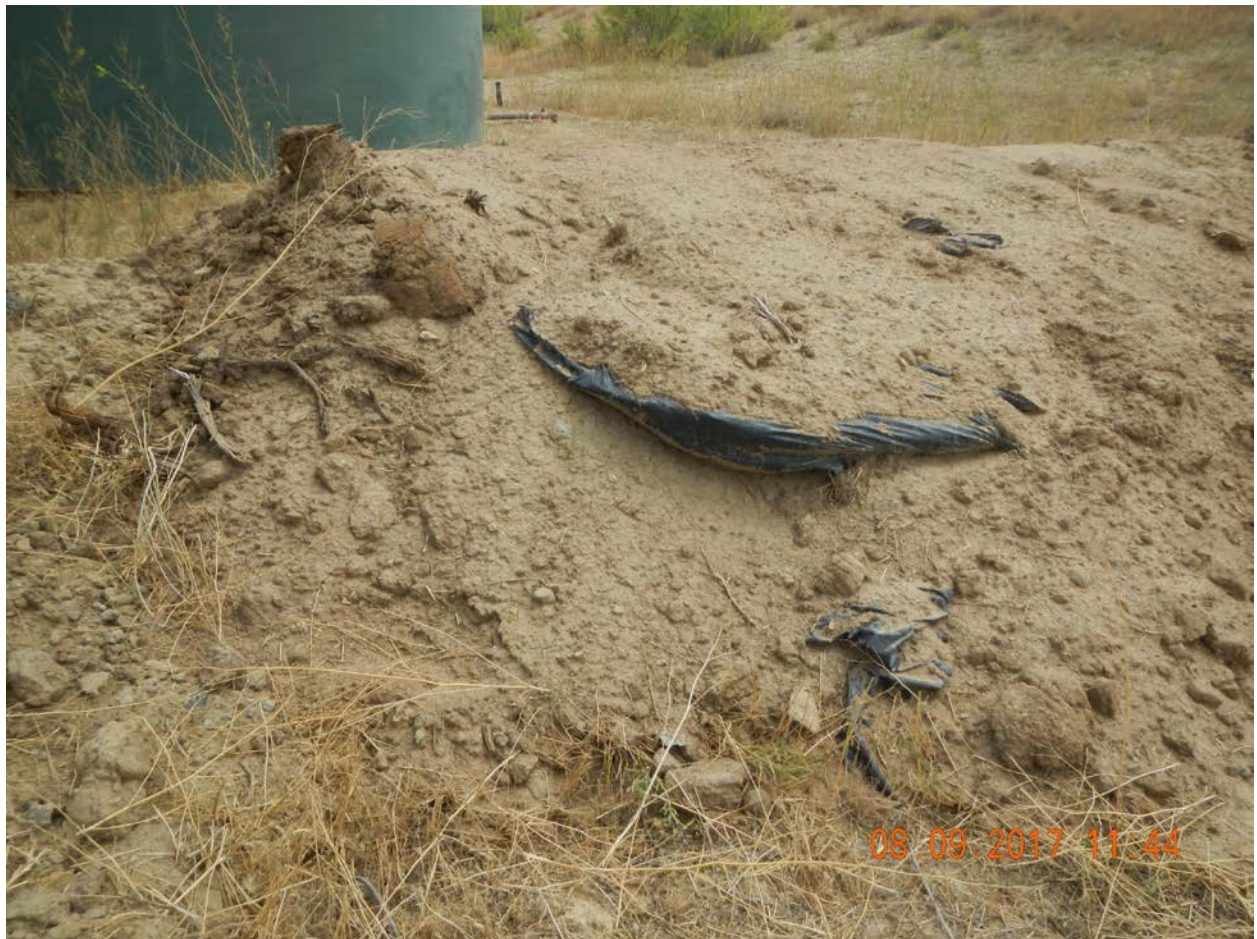
Increased berm size, plastic incorporated in berm

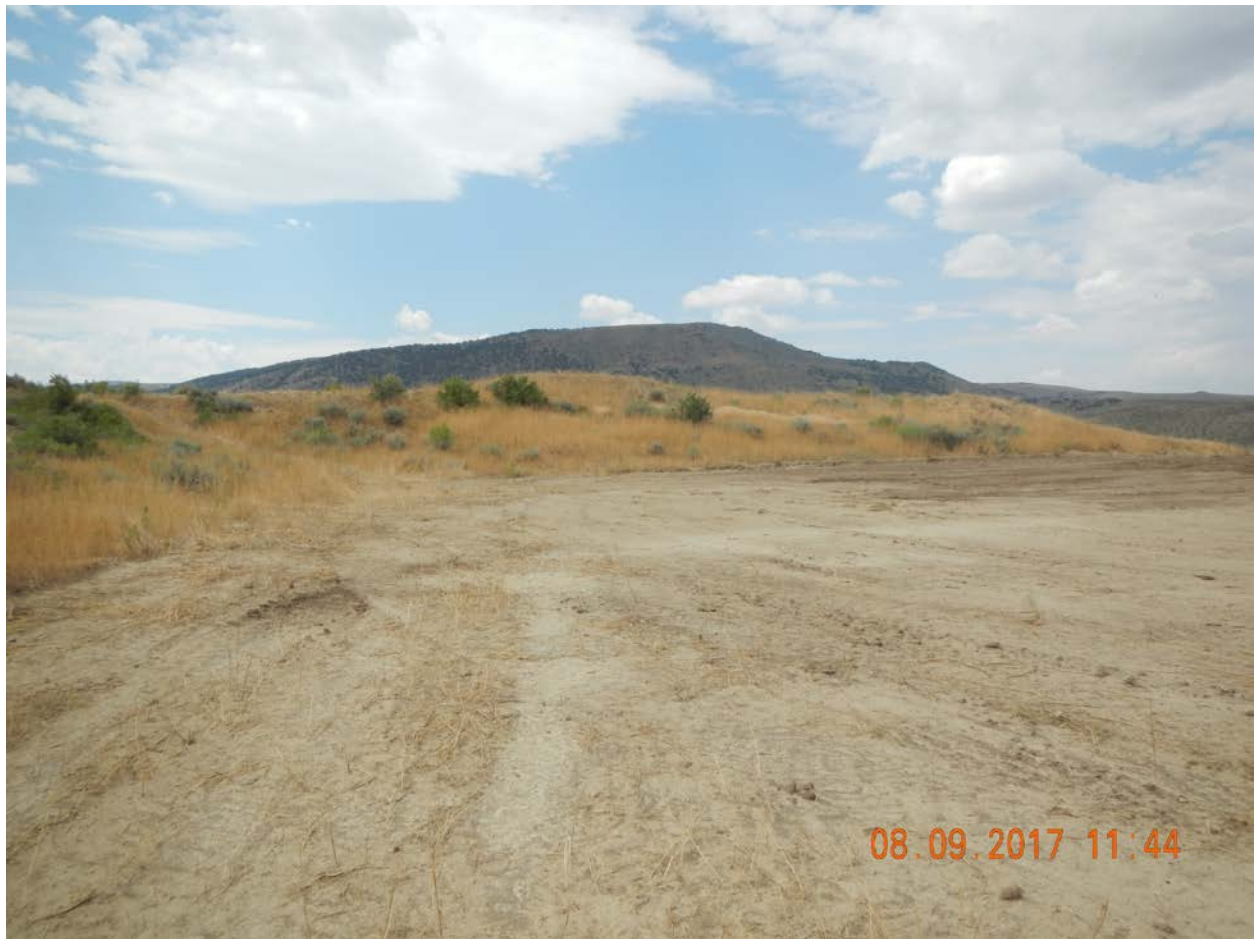
Back right of pad shows area of former stockpiled soil

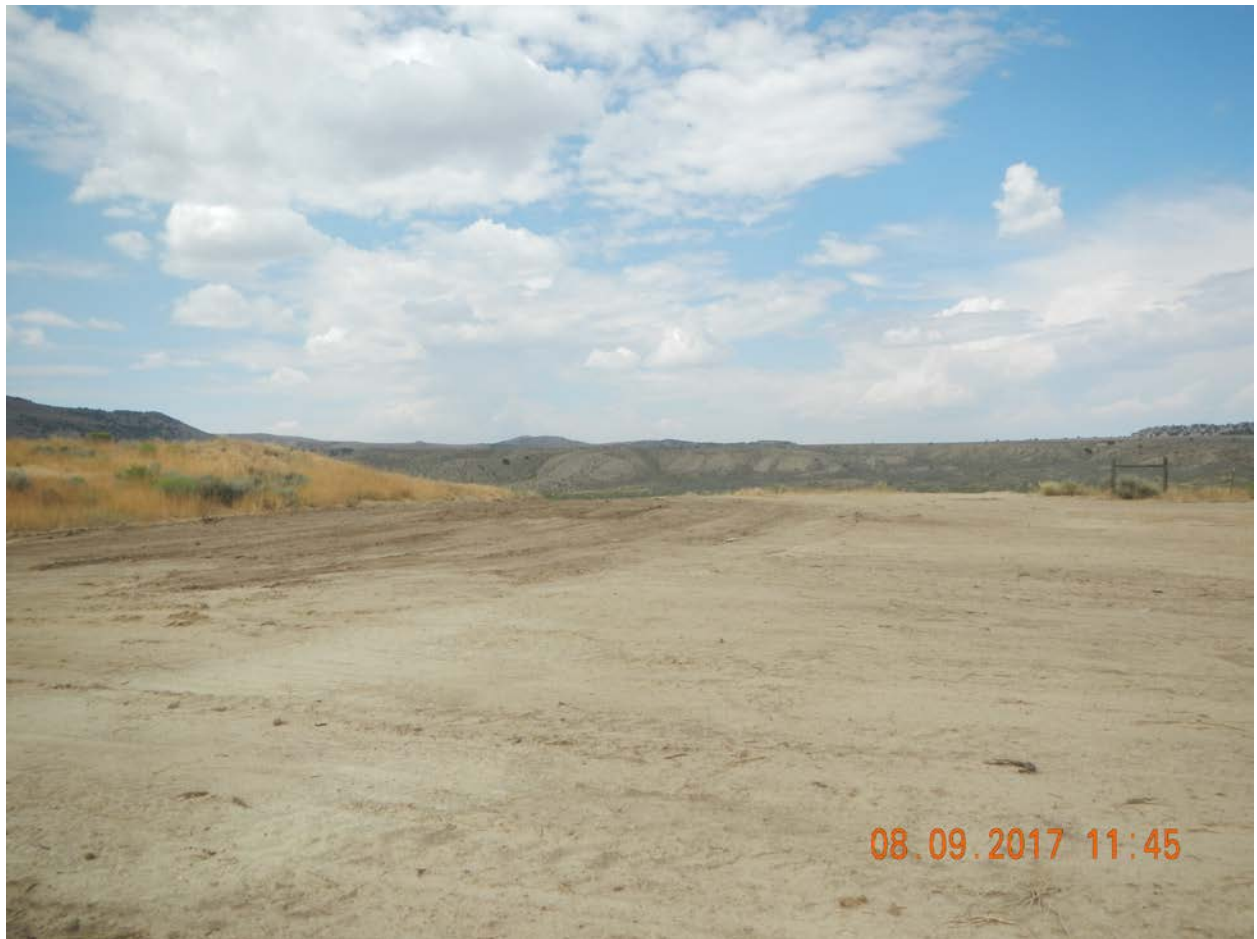
area of former stockpiled soil

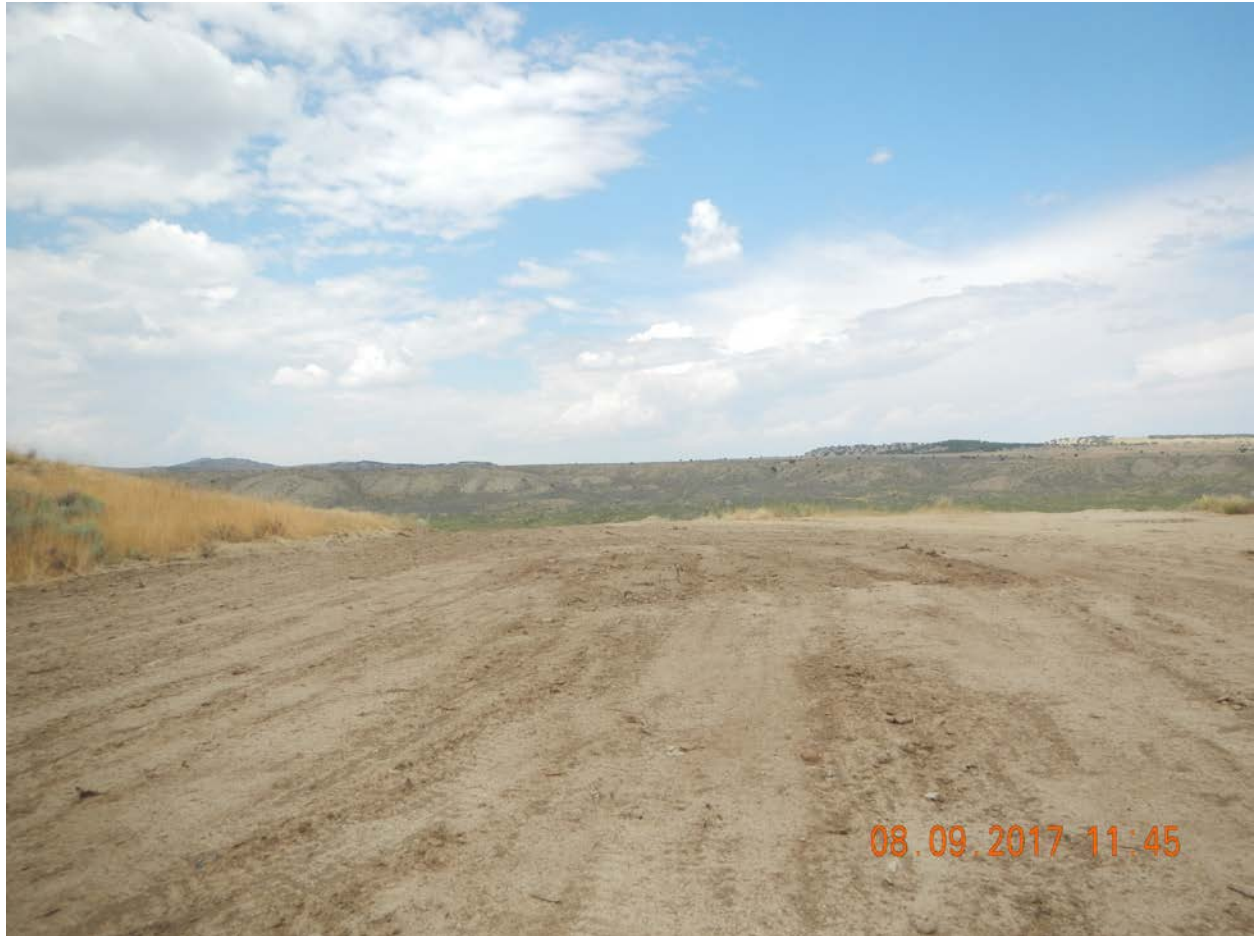
area of former stockpiled soil

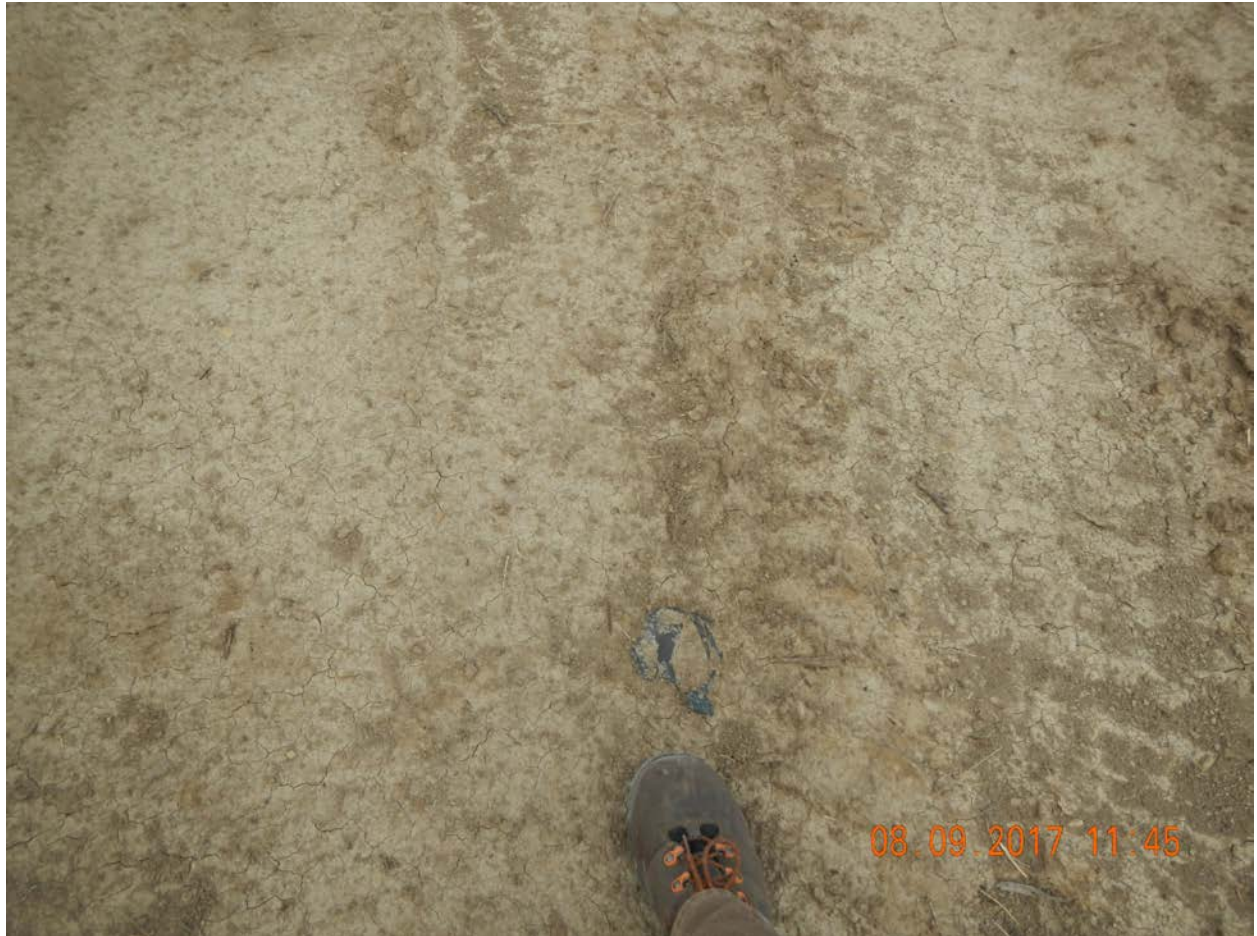
Plastic observed on the pad

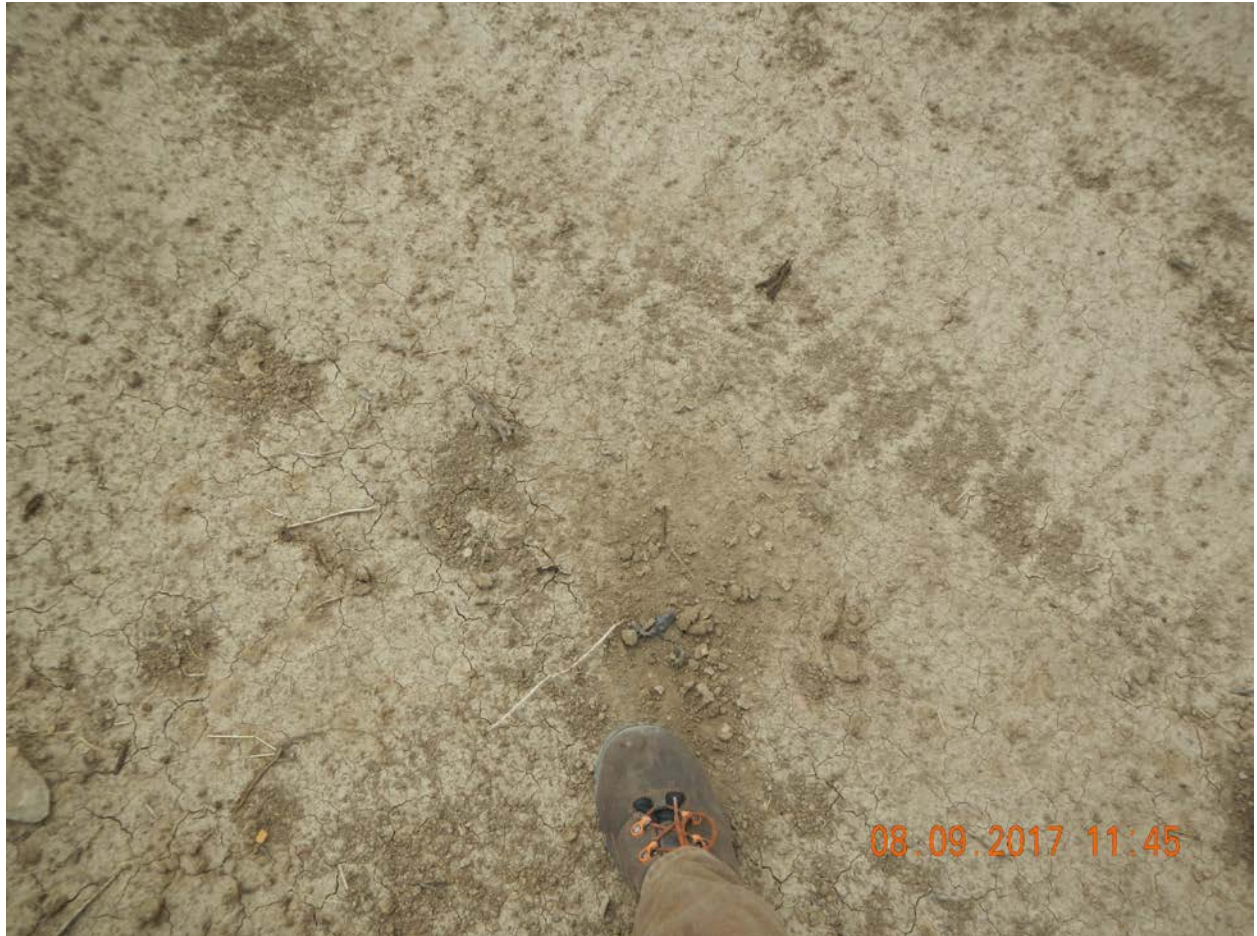
Plastic observed on the pad

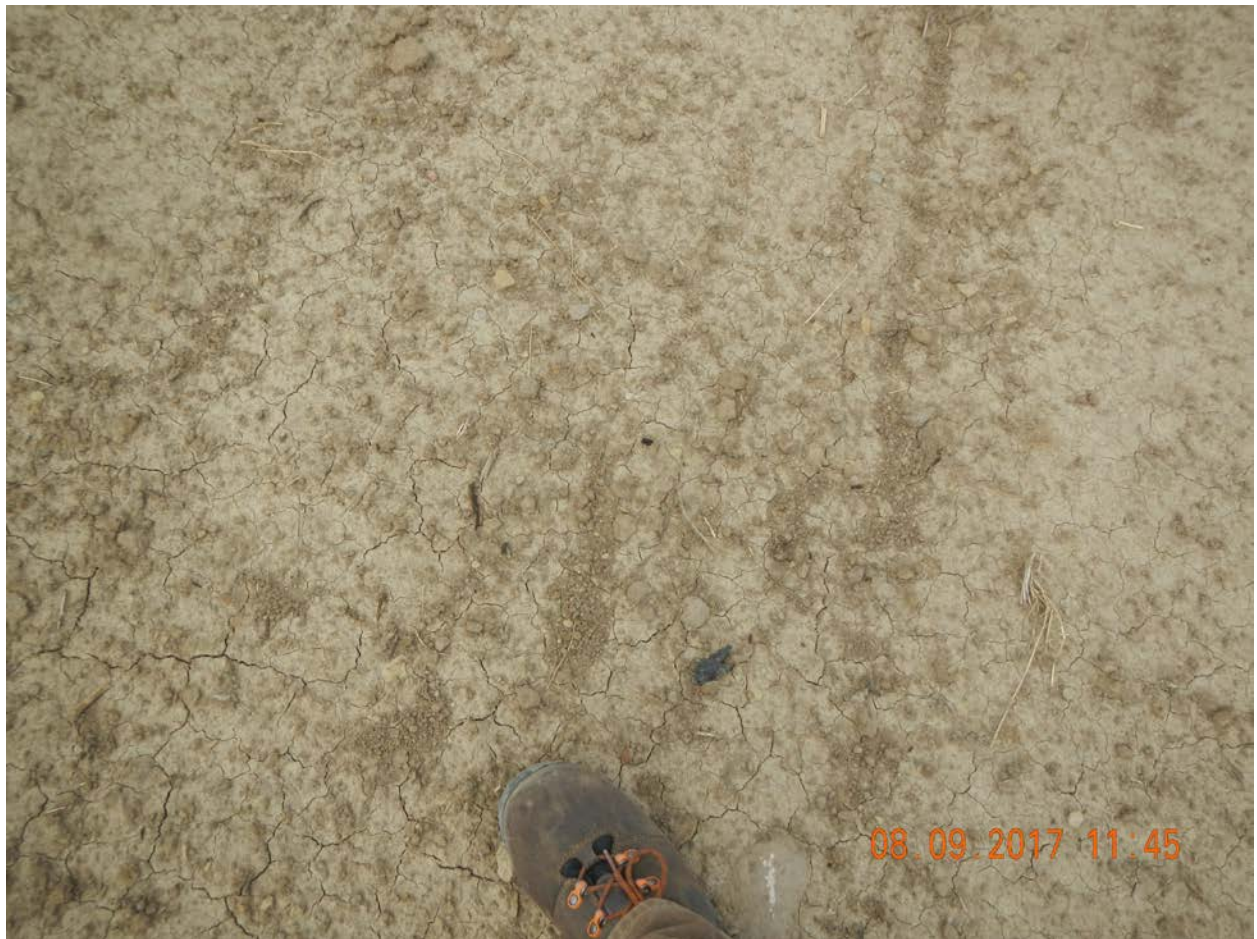
Plastic observed on the pad
