COGCC staff, Kris Neidel Inspected the Bingman #1-14 on 8/9/2017 the weather was cloudy and 80 degs. Upon arrival, it was observed that the road had recently been bladed, it appeared that soil had been added to road. The berms around the production tanks had been increased in size, piece of plastic can be seen incorporated into the berm. There were pieces of plastic, what appeared to be liner material around the location; incorporated in the pad, on the pad, incorporated in the berm, incorporated in the access road, Inspector stopped counting plastic pieces at 26. . The stockpiled material that was a part of Remediation Project number 10272 is no longer piled on location. The well was SI at the time of inspection. Operator should continue to communicate with COGCC staff for plan forward to compliance. and plans set out in Remediation Project.

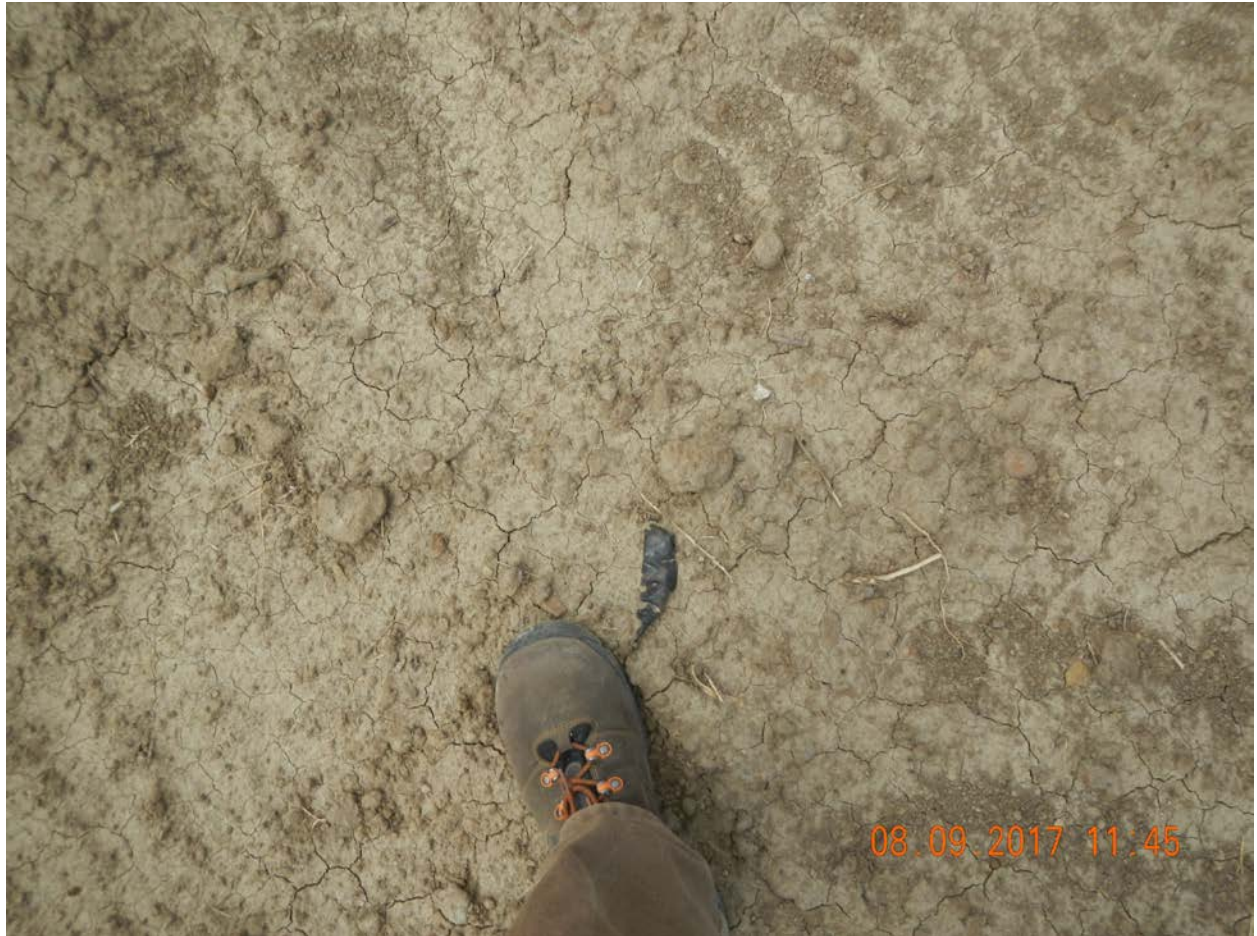
Plastic observed on the pad

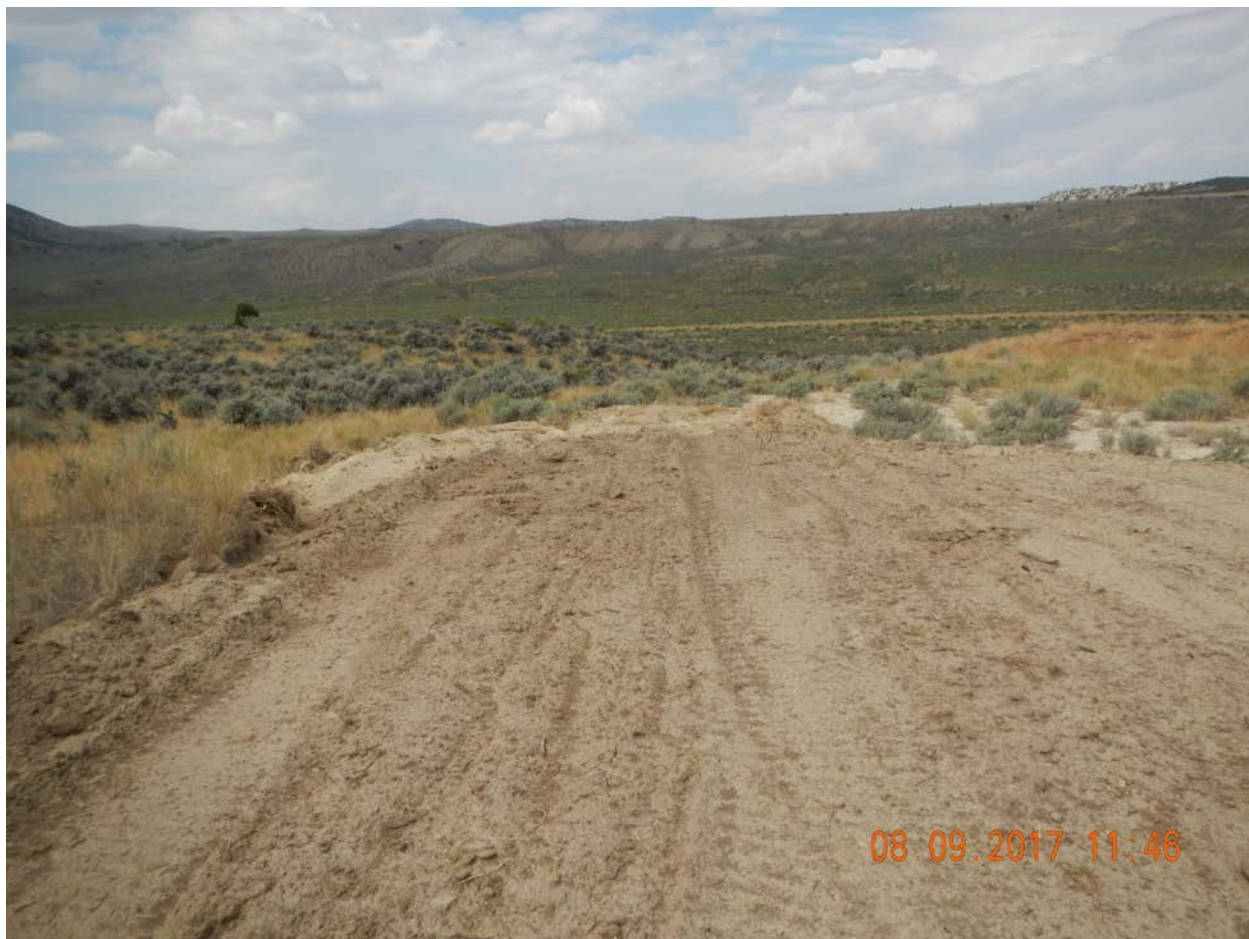
Area of former stockpiled soil, looking west

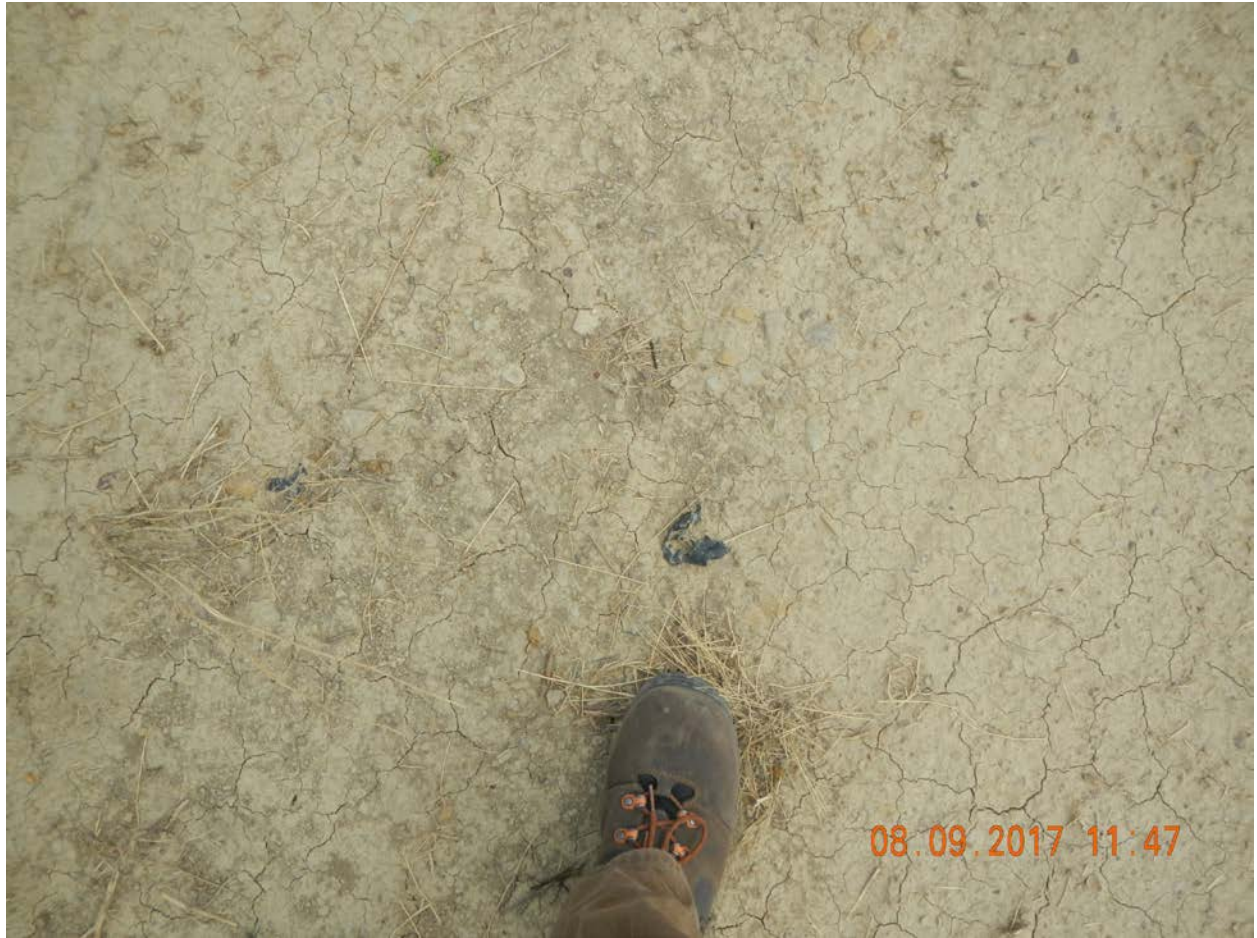
Plastic observed on the pad

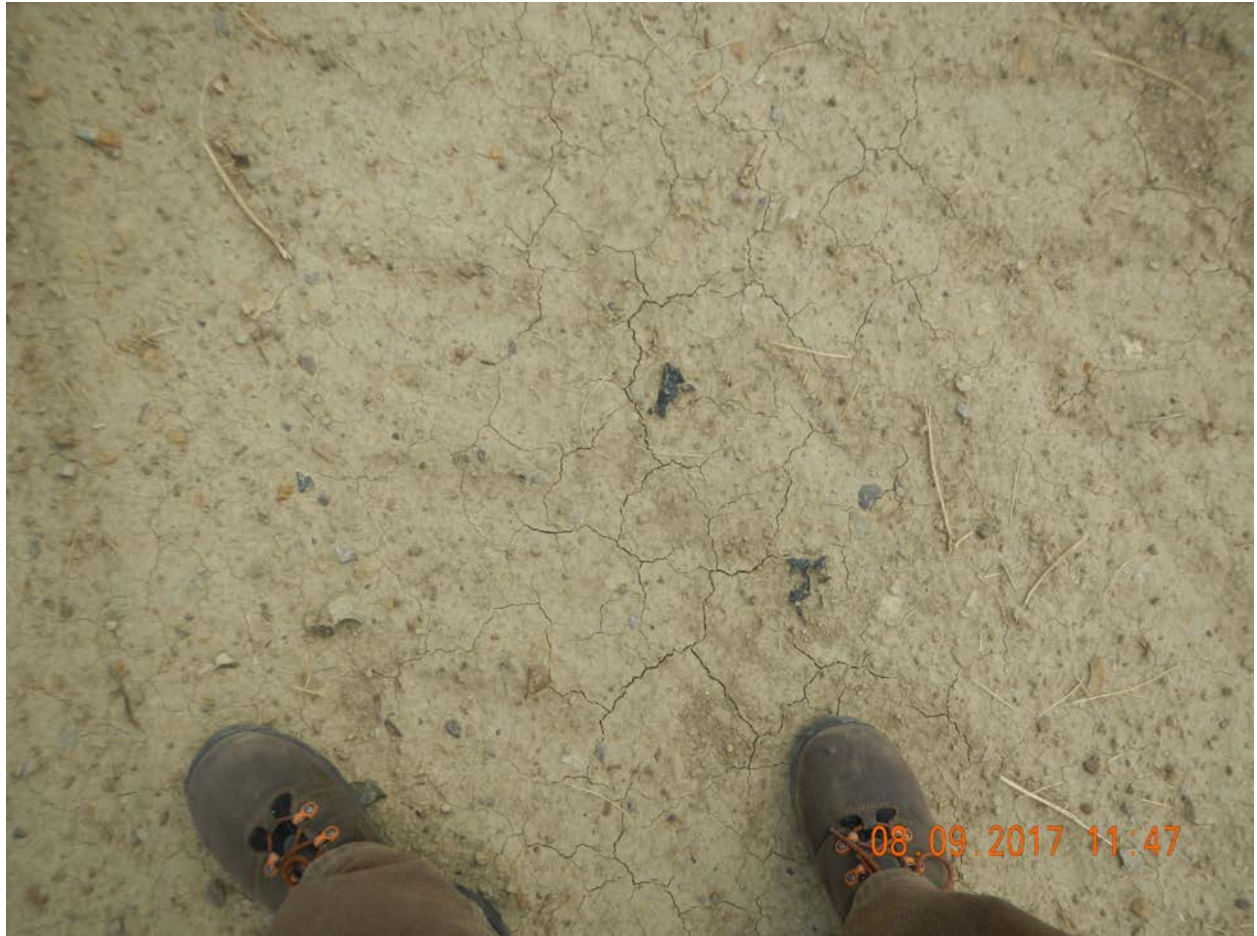
Plastic observed on the pad

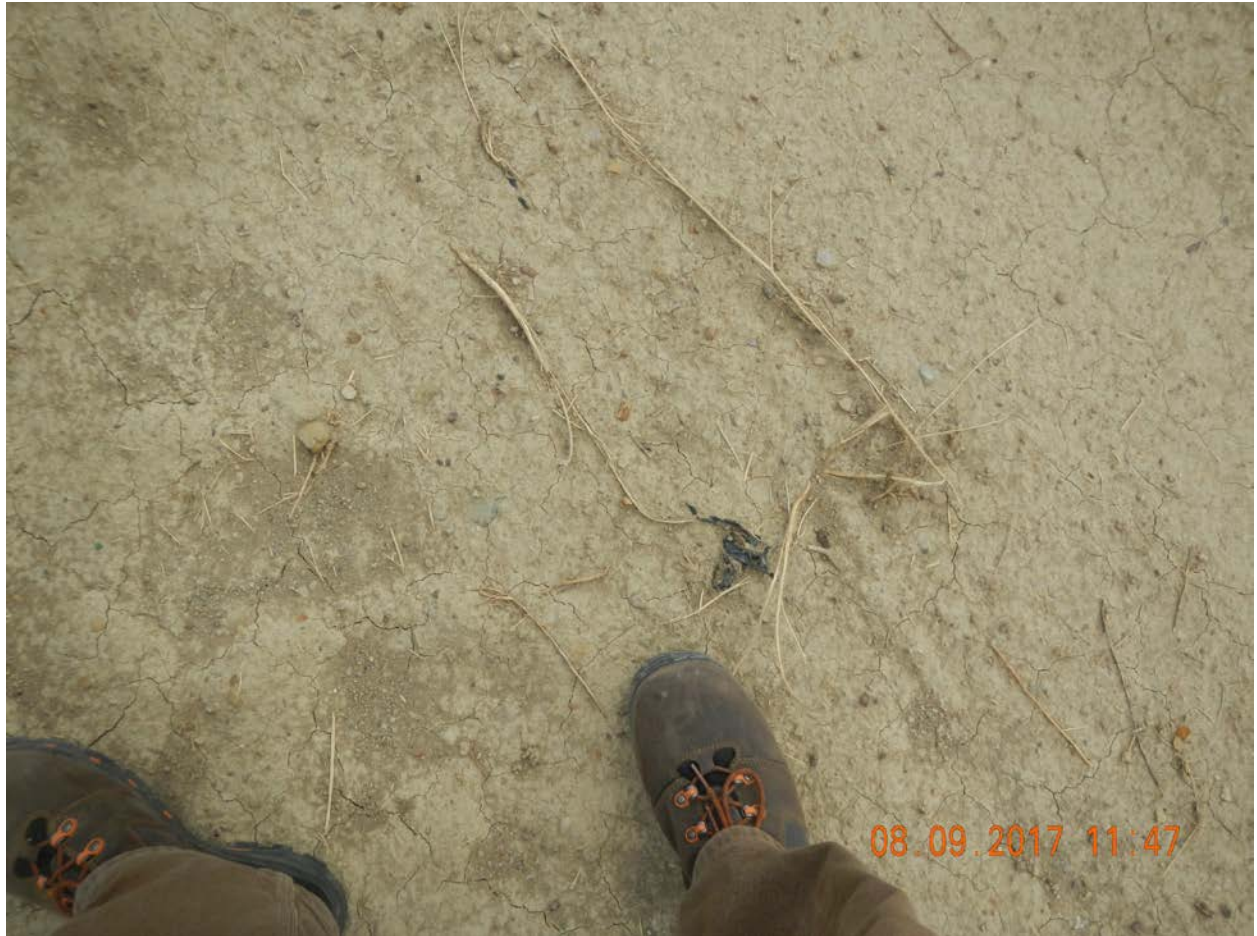
Plastic observed on the pad

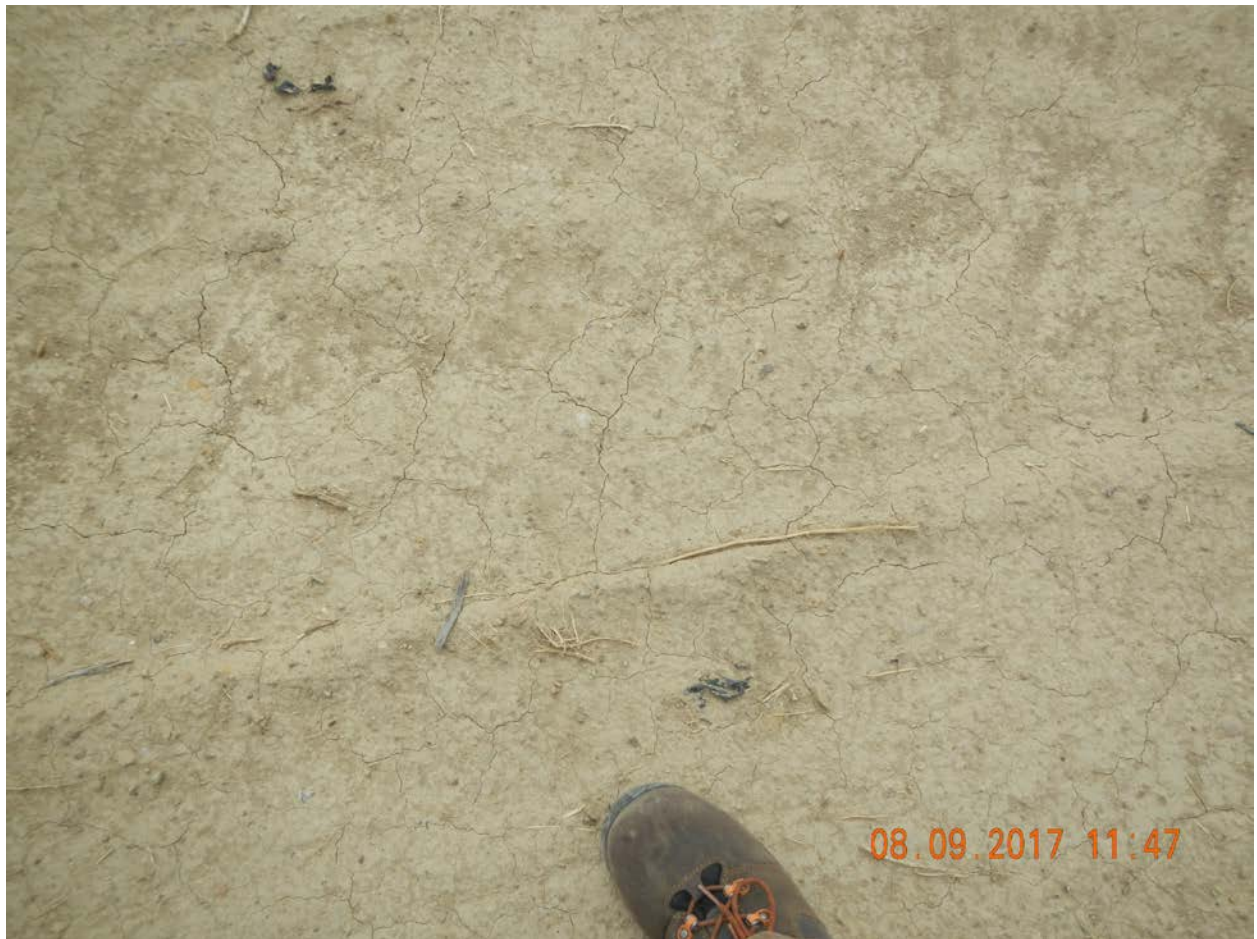
Plastic observed on the pad

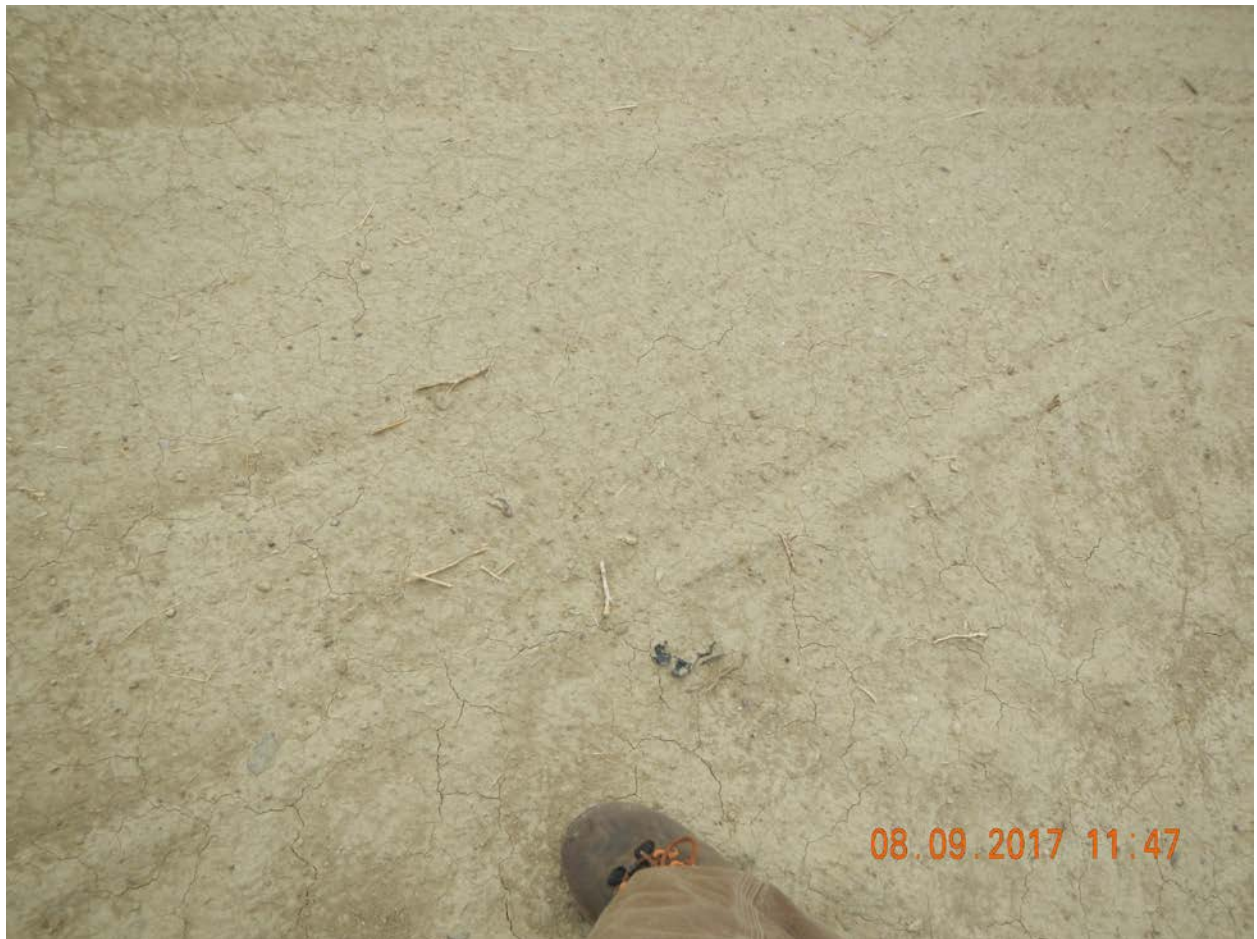
Plastic observed on the pad

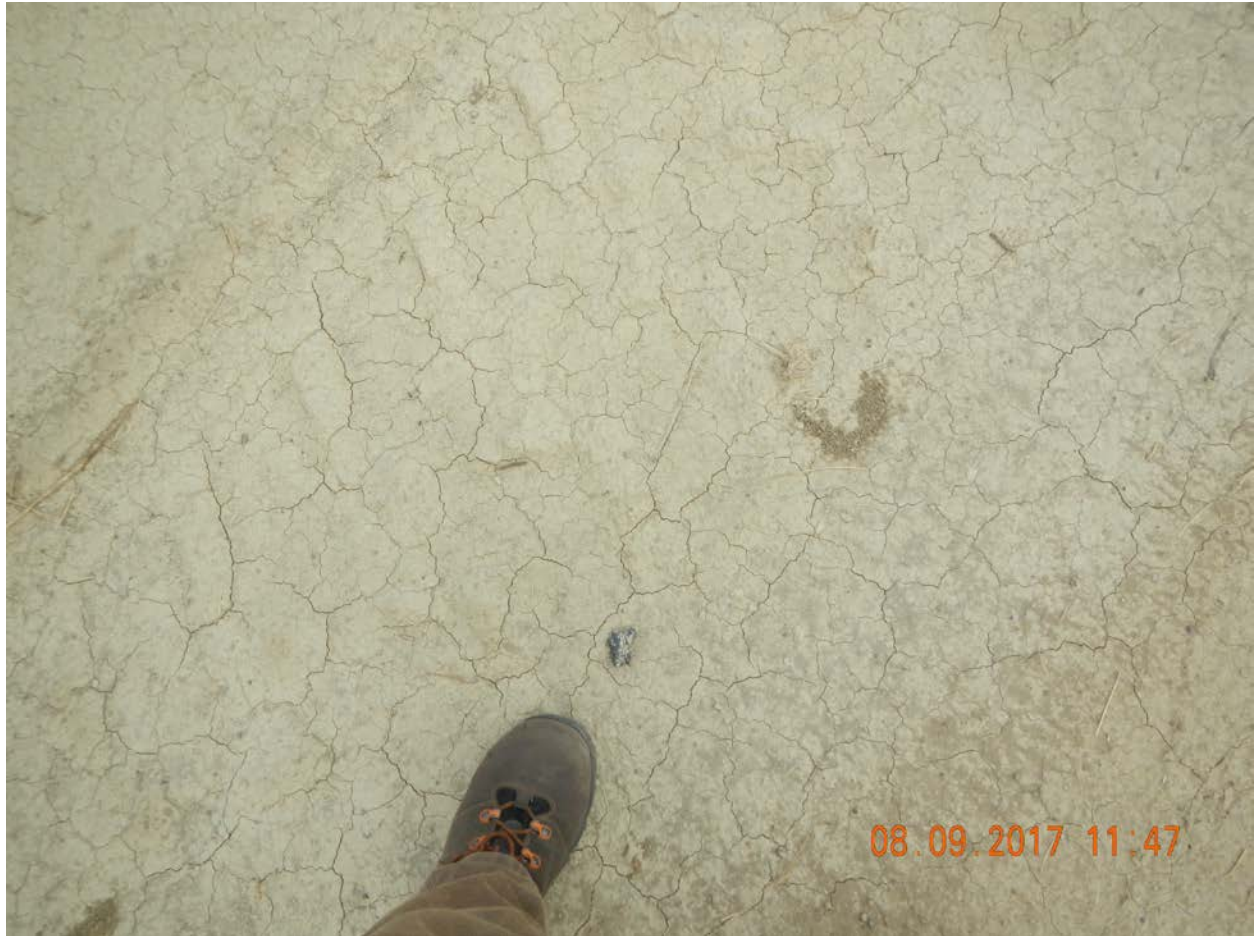
Plastic observed on the pad

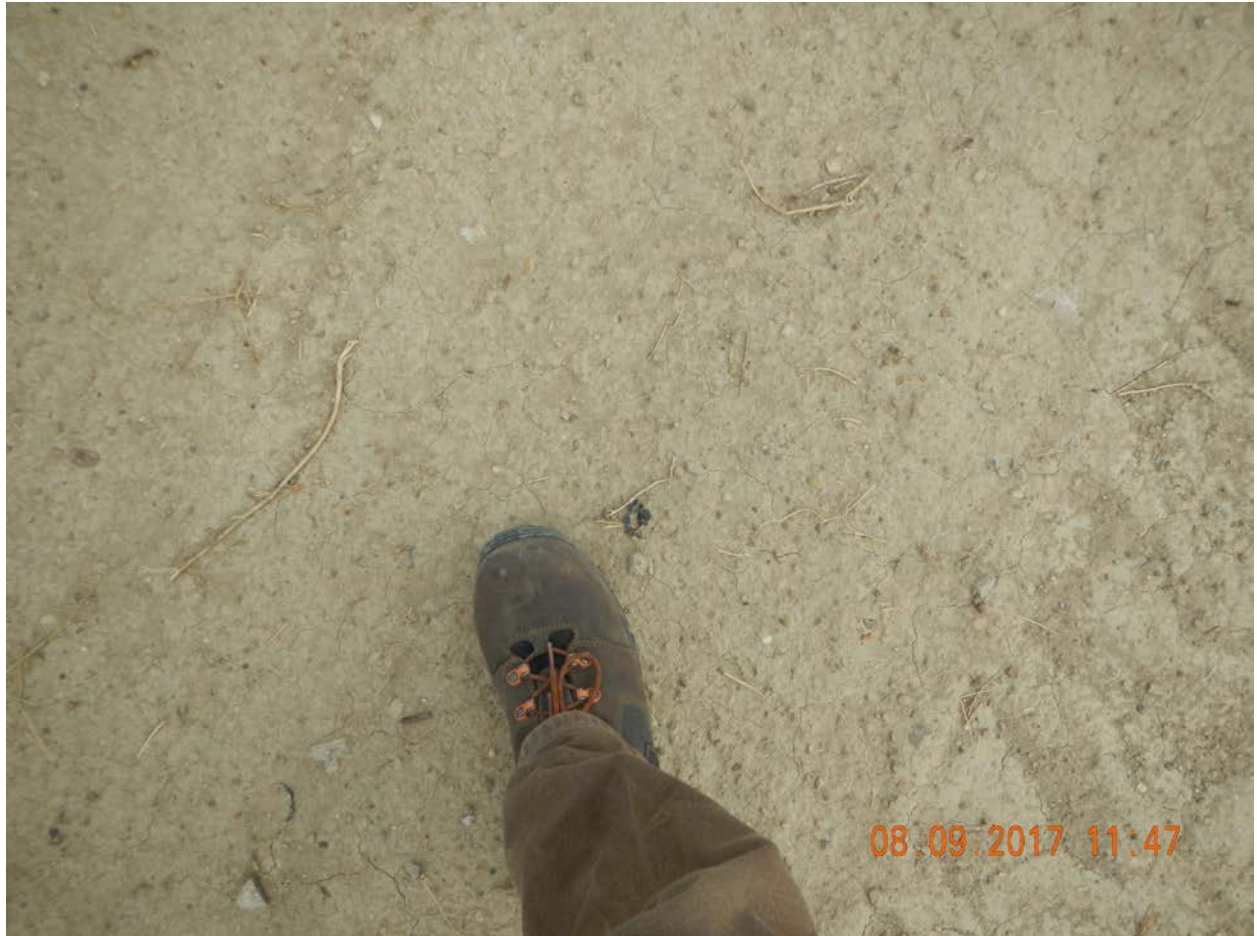
Plastic observed on the pad

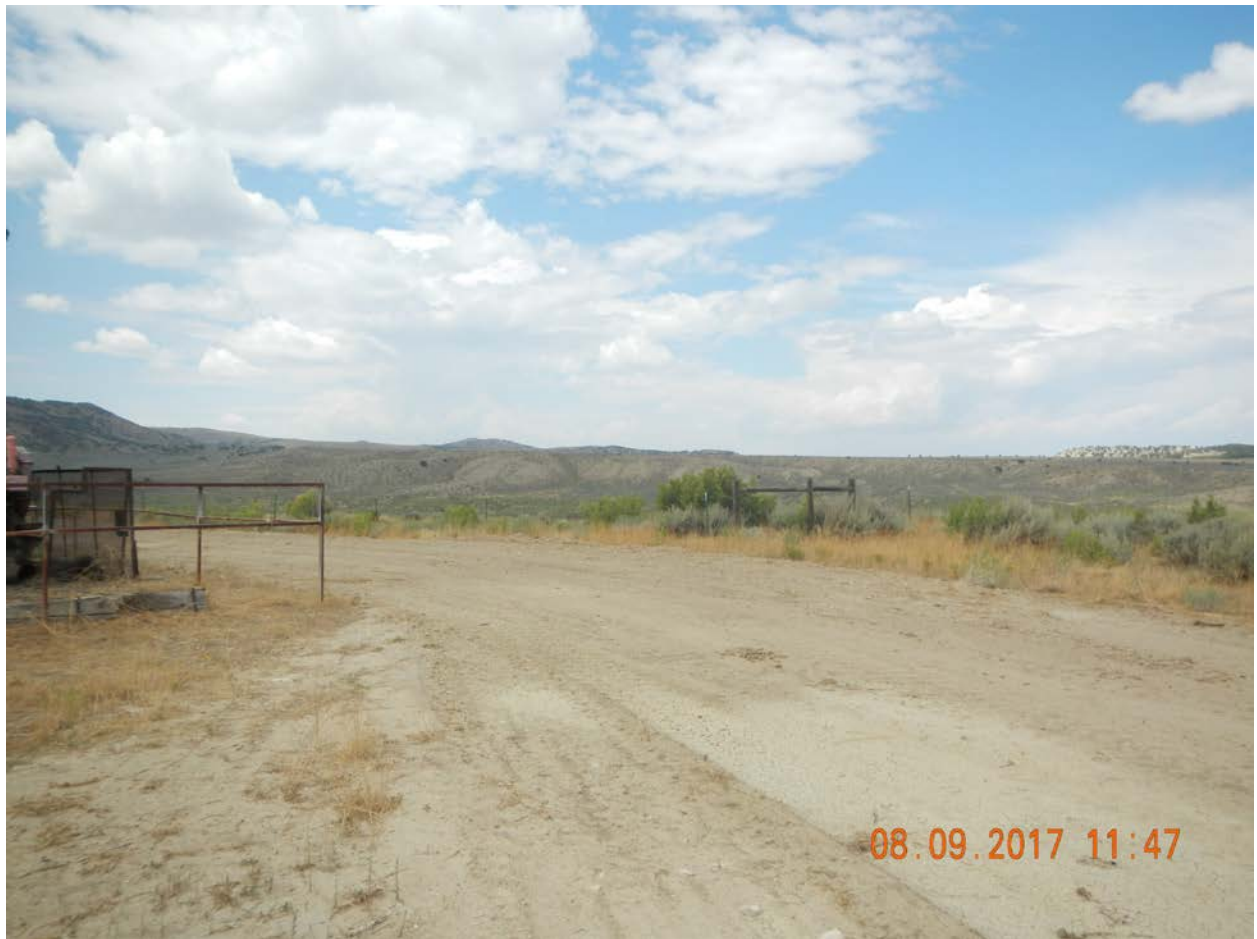
Well on left, access road on right.

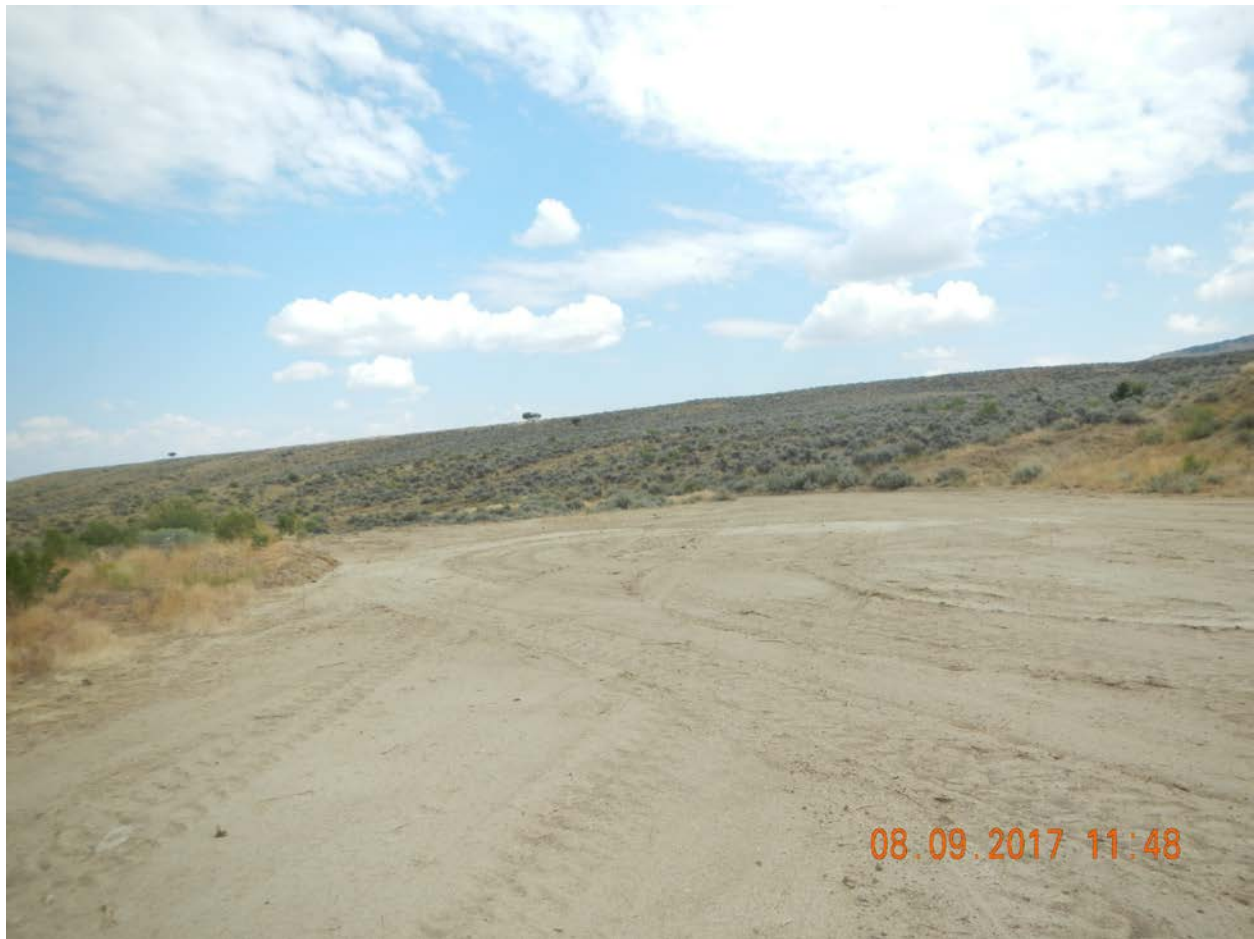
Looking northeast toward access road from pad.

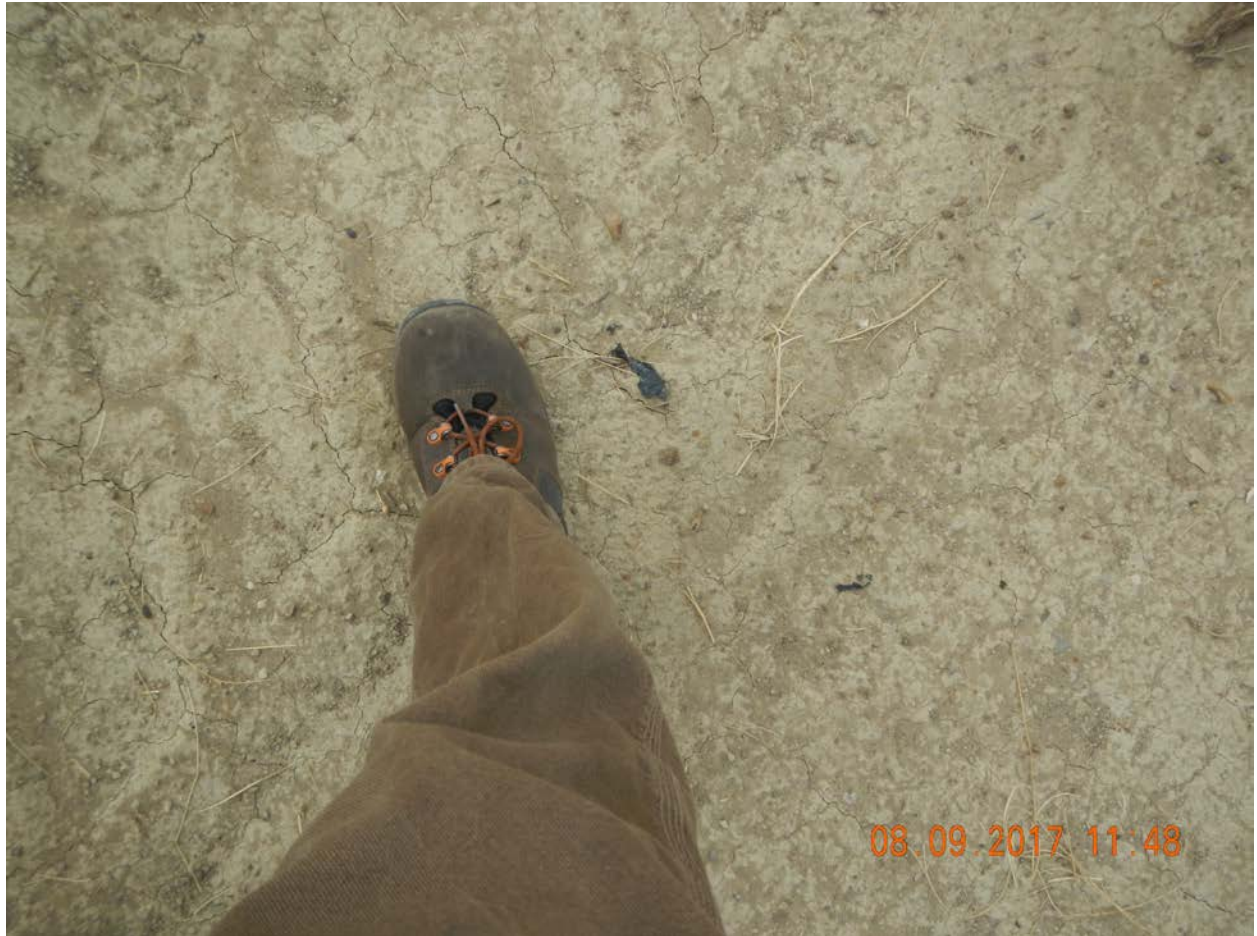
Plastic observed on the pad

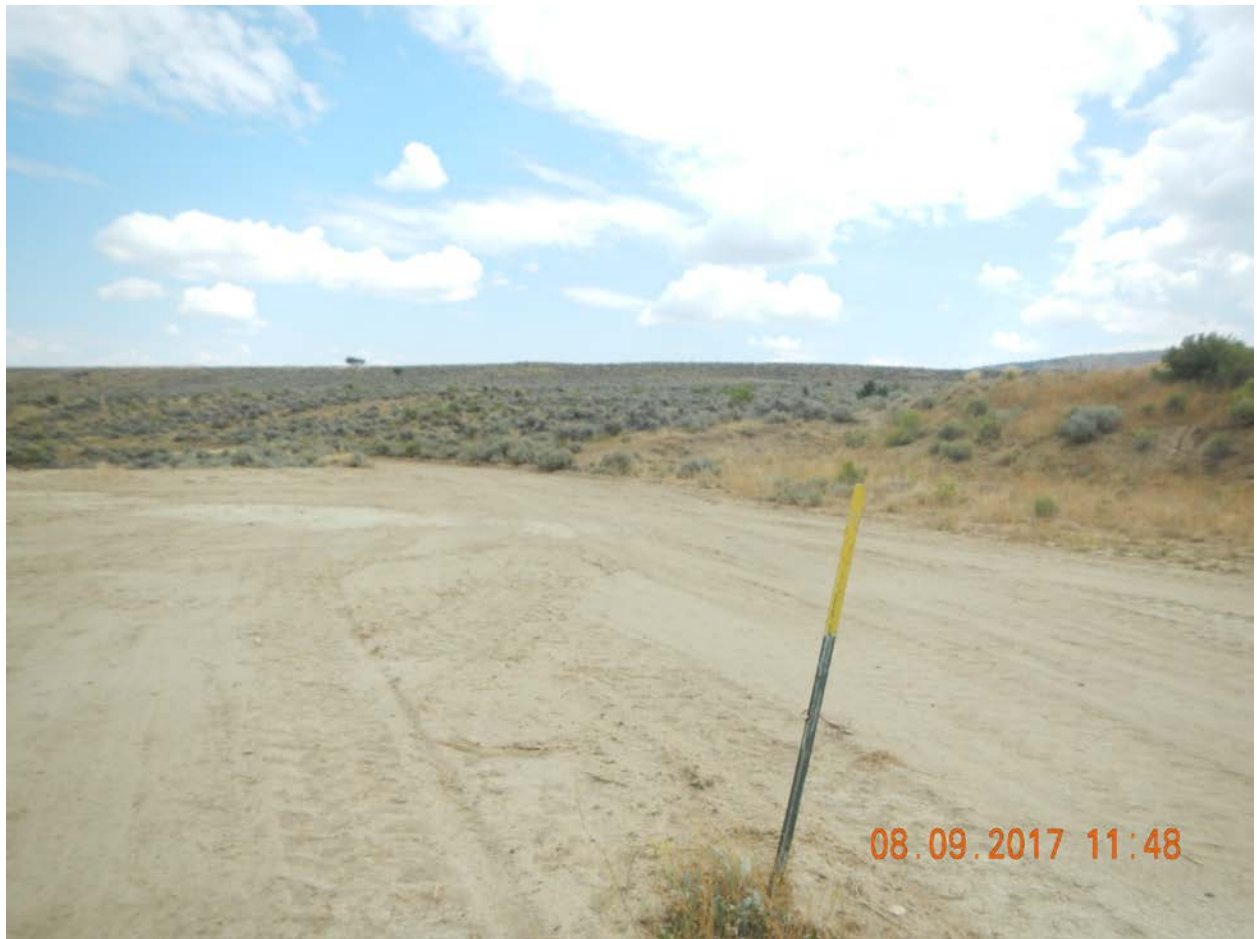
Northeast Deadman, looking at access road from pad.

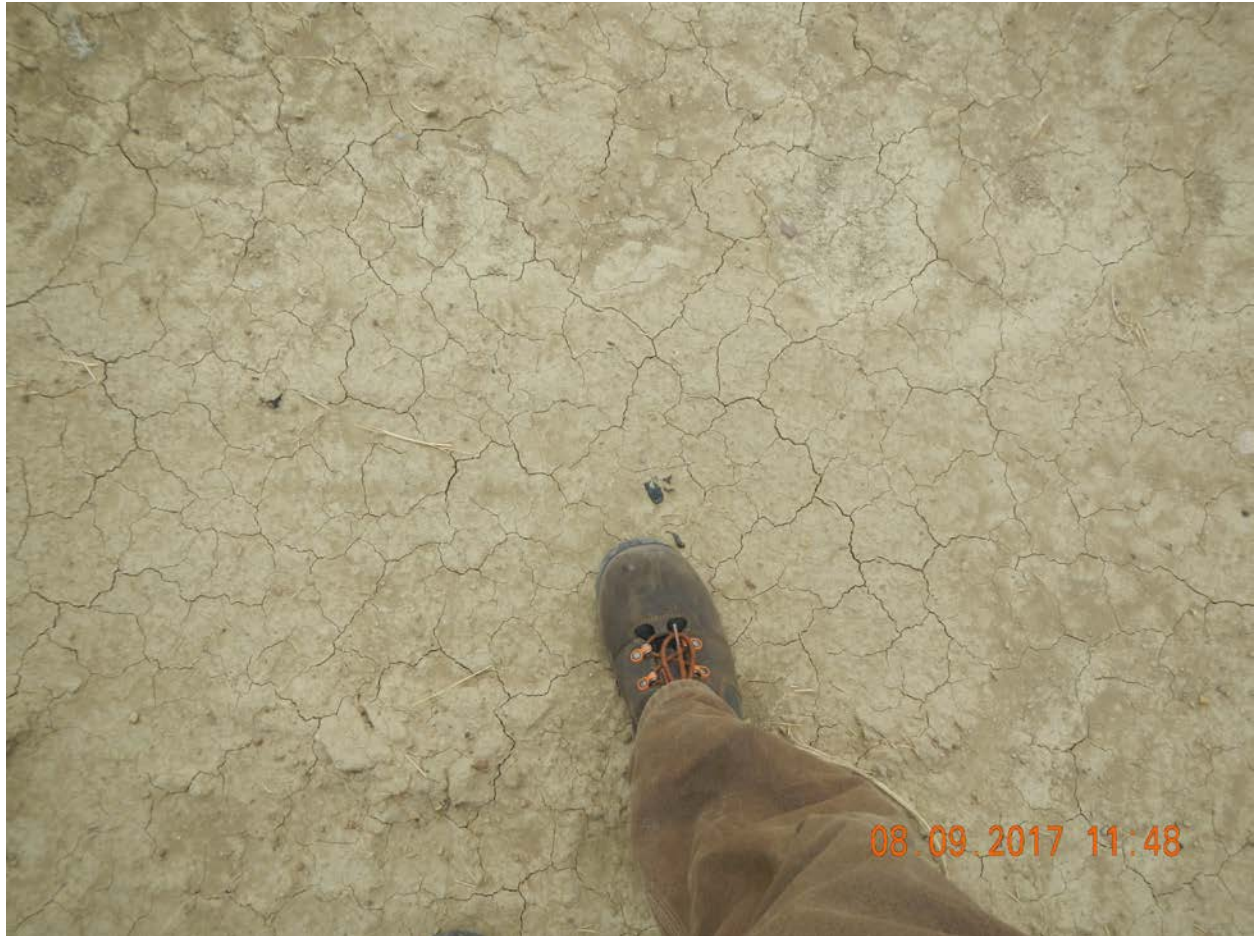
Plastic observed on the pad

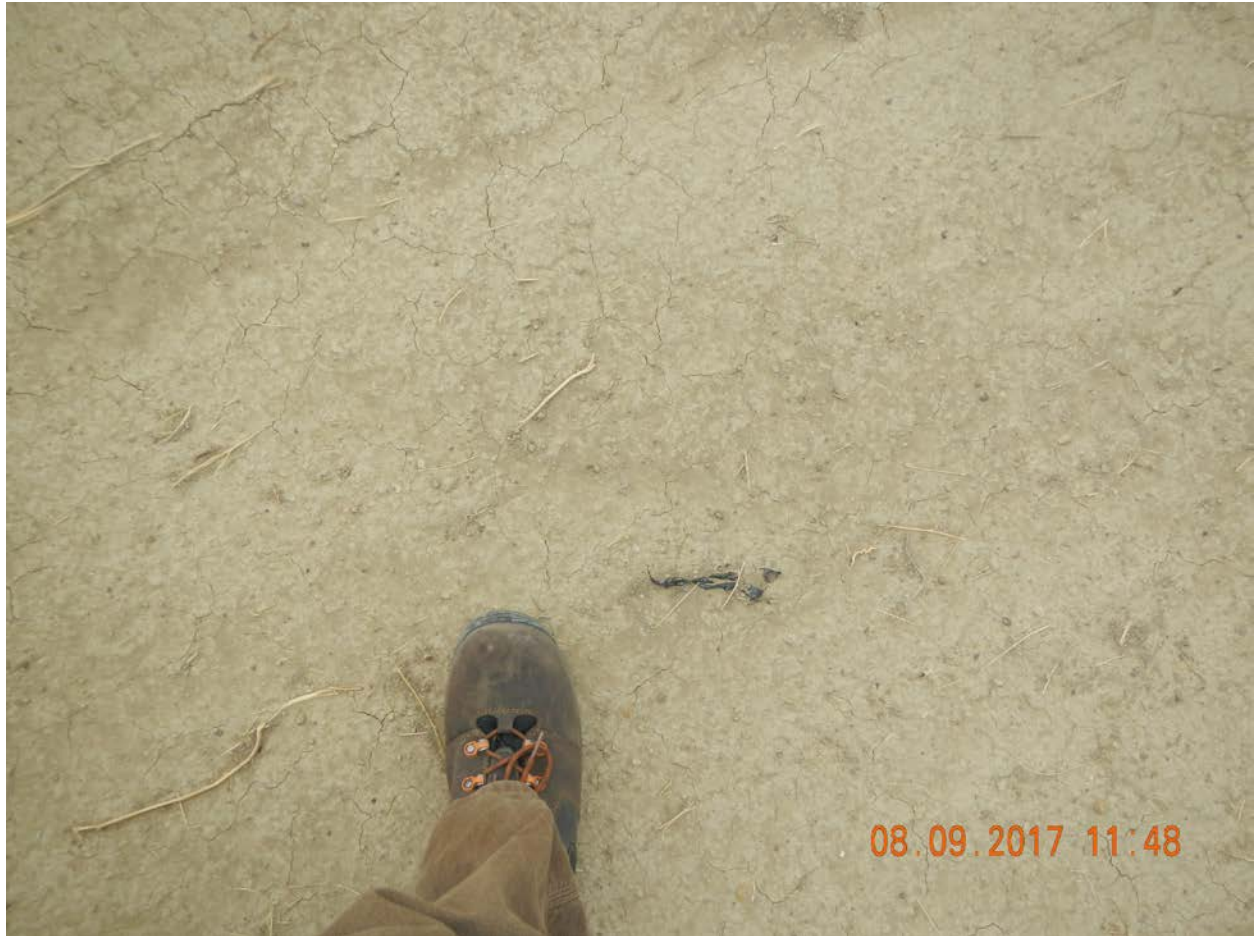
Plastic observed on the pad

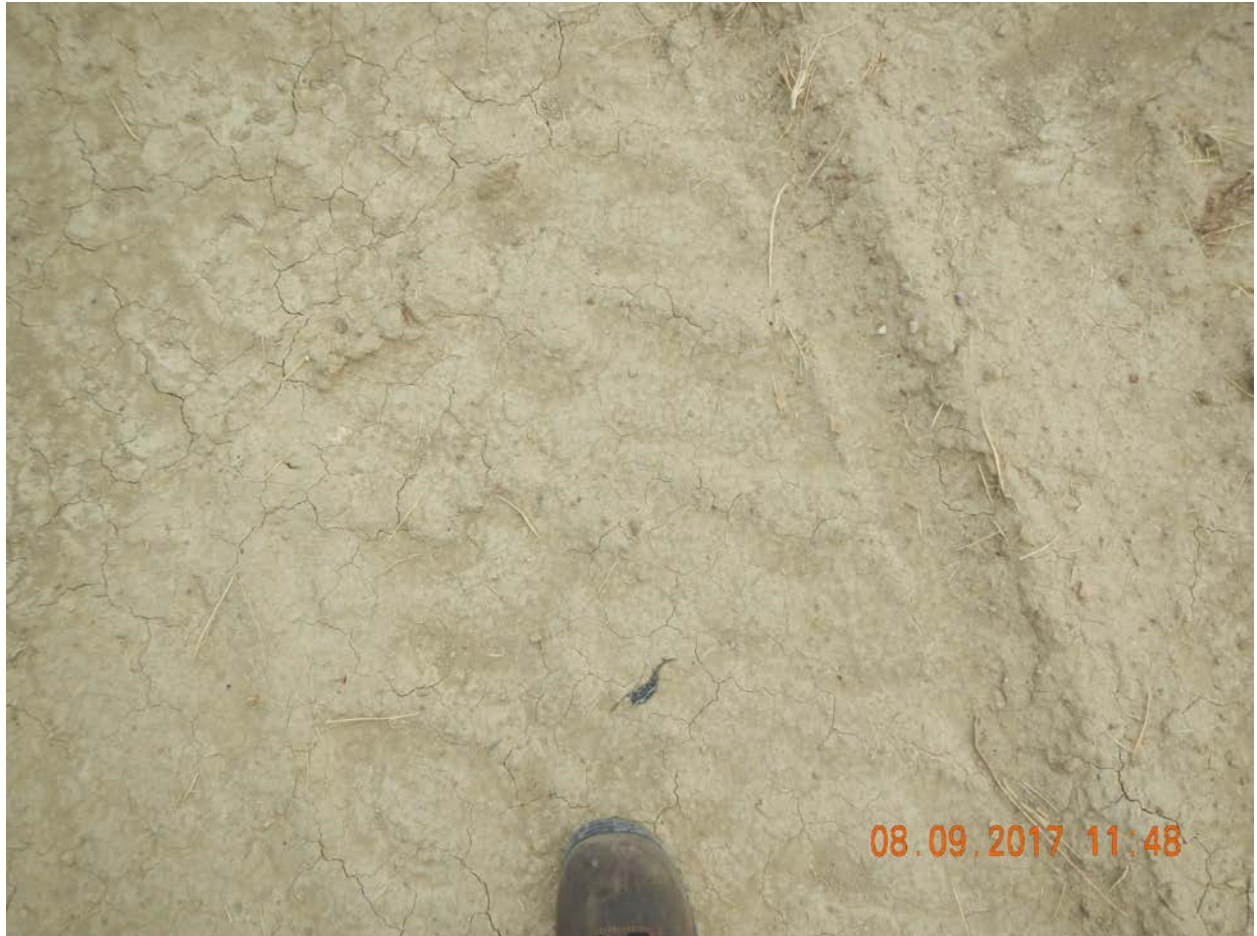
Plastic observed on the pad

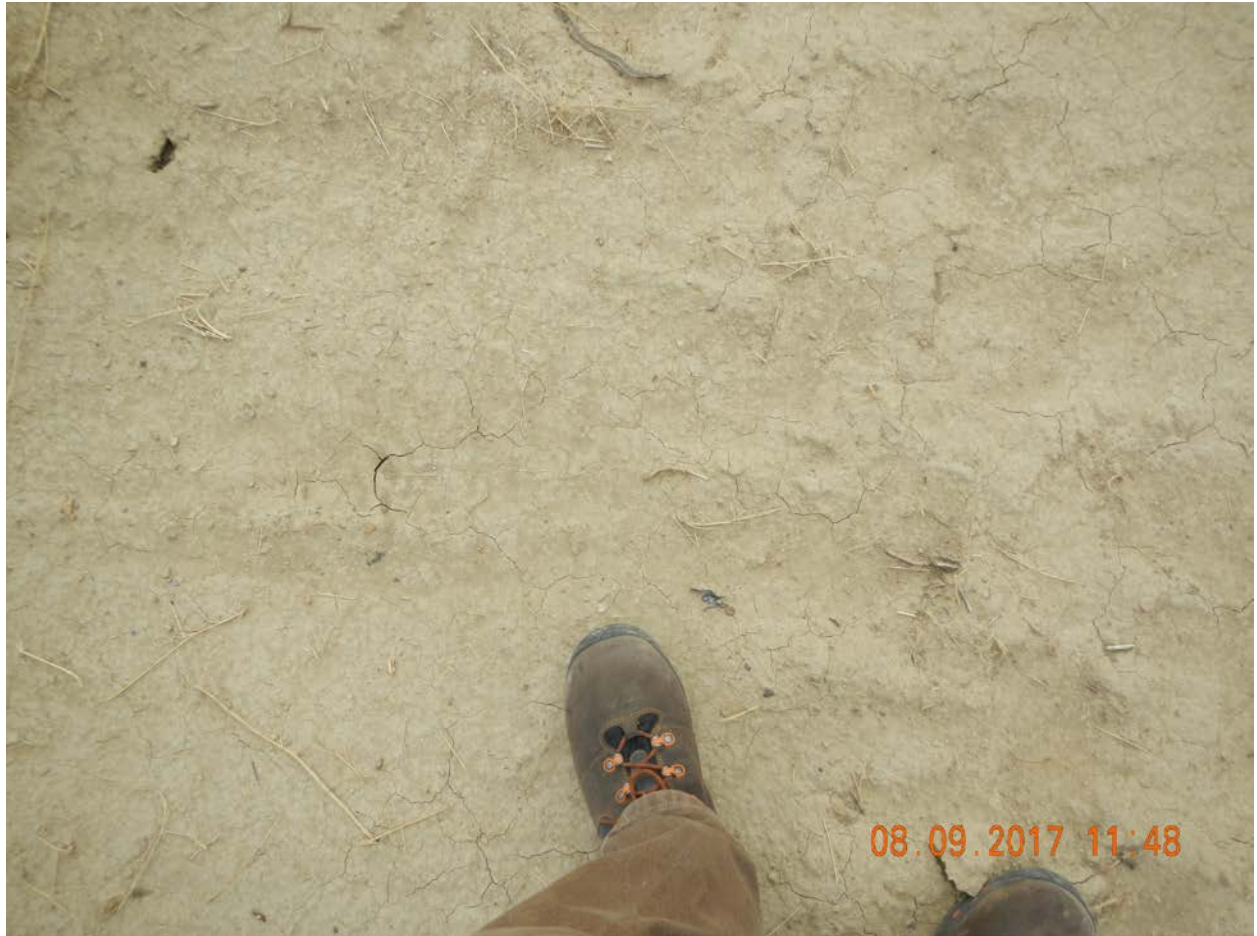
Plastic observed on the pad
